SEISMIC REHABILITATION OF COLUMN TO PIER CAP
ACCELERATED BRIDGE CONSTRUCTION
CONNECTIONS AND ACOUSTIC
EMISSION MONITORING
ASSESSMENT

Joel Edgar Parks

A thesis submitted to the faculty of
The University of Utah
in partial fulfillment of the requirements for the degree of

May 2014

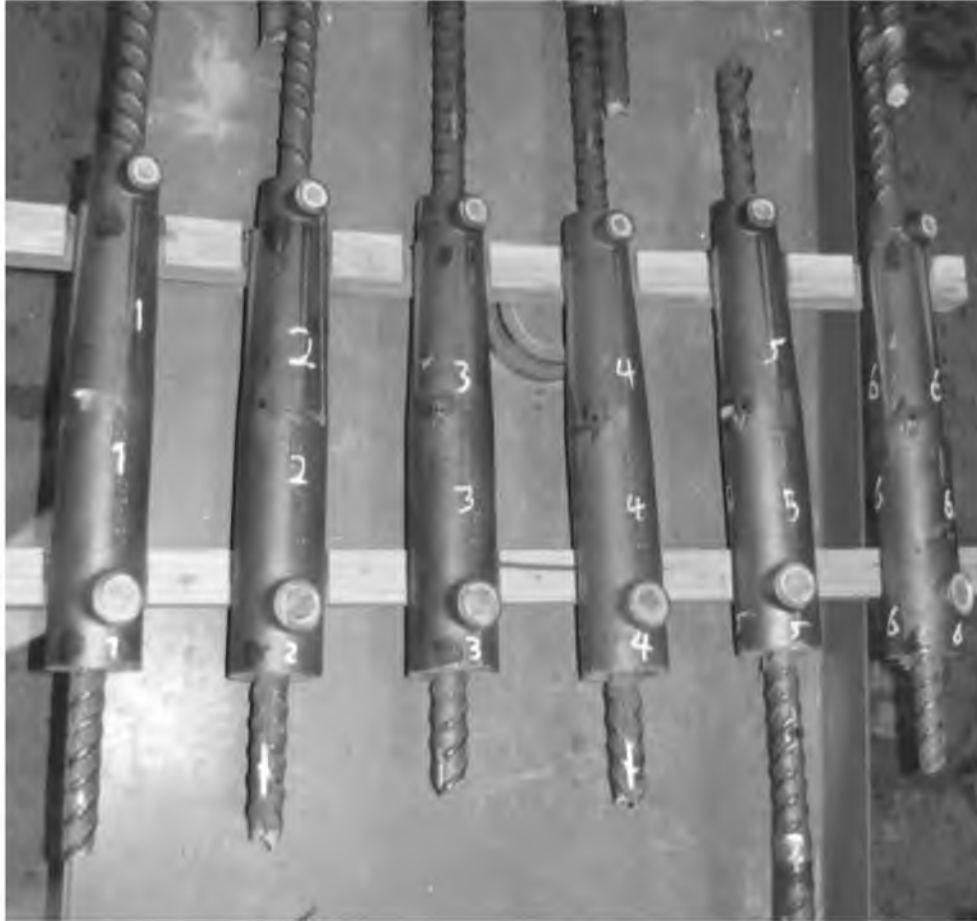
Sleeve ID	Load Rate (in/min)	Maximum Load (kips)	Maximum Rebar Stress (ksi)	%F _y *	Failure Mode
NMB-1-F	4.0	81.17	103.35	1.72	Field Dowel Failure
NMB-2-F	4.0	80.65	102.69	1.71	Field Dowel Failure
NMB-3-S	0.4	80.09	101.98	1.70	Field Dowel Failure
NMB-4-S	0.4	79.91	101.74	1.70	Field Dowel Failure
NMB-5-S	0.4	79.55	101.29	1.69	Factory Dowel Failure
NMB-6-F	4.0	77.33	98.46	1.64	Field Dowel Failure

Figure 22. NMB Splice Sleeve Failure Mode

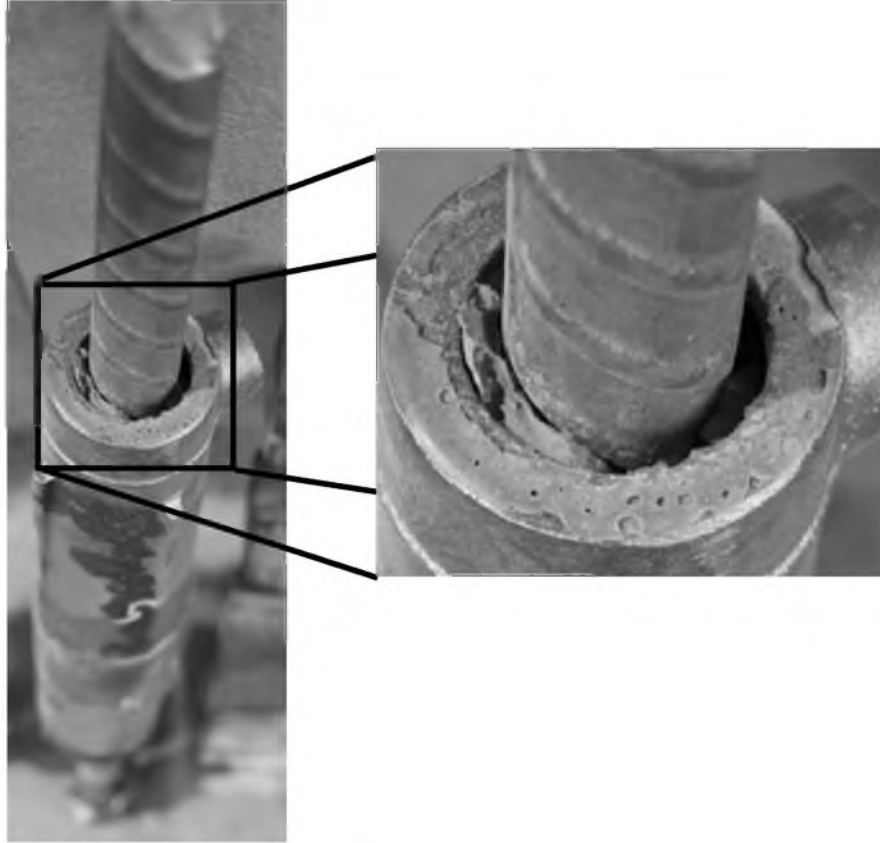
After the tests were completed, the rubber end cap plug was removed from the factory dowel side of the sleeve to inspect the integrity of the grout. From the inspection, it showed there had been some necking of the bar at the factory dowel end of the sleeve as well. The necking of the factory dowel, however, caused less breaking of the grout on the field dowel side. Figure 24 shows the typical integrity of the grout on the factory dowel end. The depth of the broken grout on the factory dowel end of the sleeve ranged from 1/4 in. to 1/2 in.

Figure 24. NMB Splice Sleeve Factory Dowel Grout Integrity

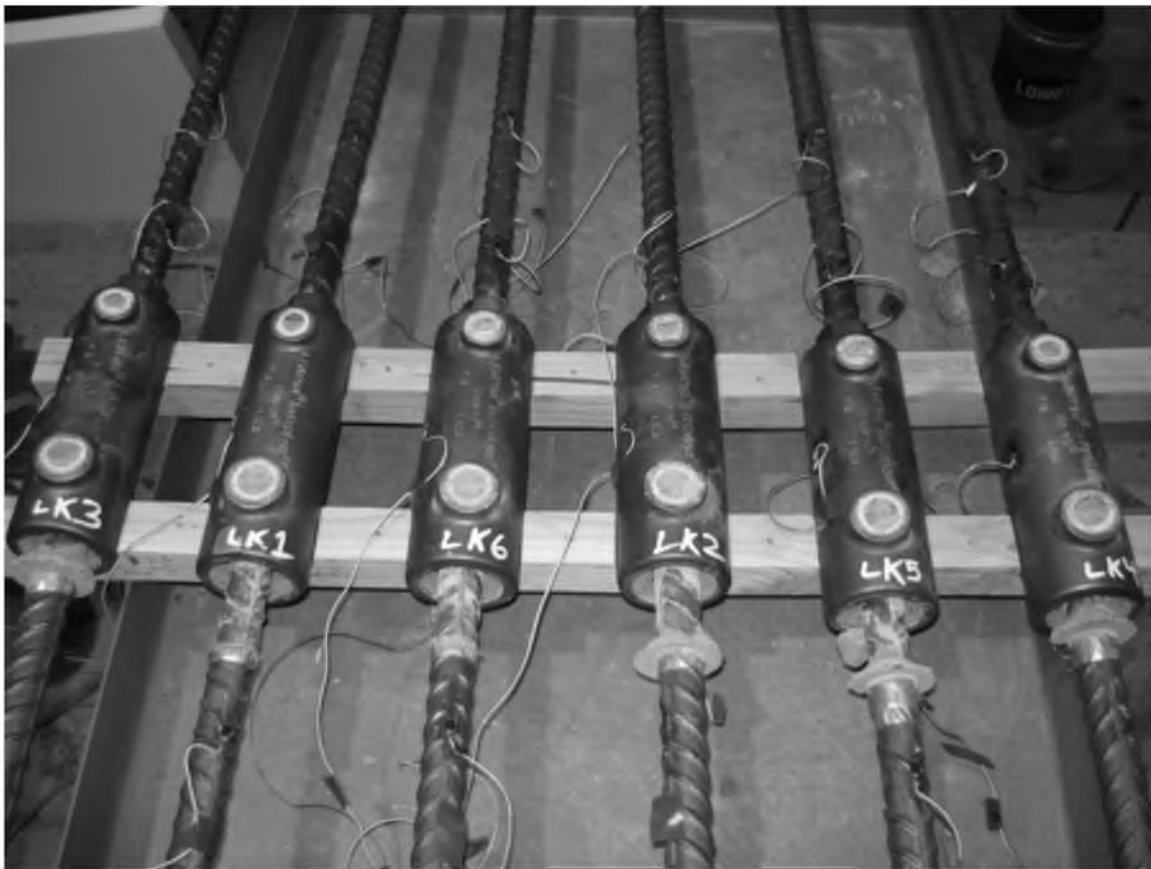
rates. Lenton-1-F, Lenton-2-F, and Lenton-6-F were loaded at a rate of 4.0 in./min, while Lenton-3-S, Lenton-4-S, and Lenton-5-S were loaded at a rate of 0.4 in./min. Table 7 shows the results of all six Lenton Interlock splice sleeve tension tests. Neither the load rate nor the void at the top of the sleeve seemed to affect the performance of the sleeves. All six of the tension tests resulted in the field dowel being pulled out of the grout. Figure 25 shows the six Lenton Interlock splice sleeves and their failure mode. During the test, the bar was not completely pulled from the sleeve, because once the bar began to pull out, the splice sleeve was unable to maintain the load and it was decided to stop the test. In Figure 25, there is a small ring of duct tape on the field dowel which marked the bottom of the sleeve. For the sleeves that do not have a grout cone left on the bar, the ring of duct tape can be a reference of how far the bar was pulled out. The pull out of the bar ranged from 3/4 in. up to 2 in.

Sleeve ID	Load Rate (in/min)	Maximum Load (kips)	Maximum Rebar Stress (ksi)	%F _y *	Failure Mode
Lenton-1-F	4.0	69.72	88.77	1.48	Field Dowel Pull Out
Lenton-2-F	4.0	71.54	91.08	1.52	Field Dowel Pull Out
Lenton-3-S	0.4	66.39	84.53	1.41	Field Dowel Pull Out
Lenton-4-S	0.4	68.00	86.58	1.44	Field Dowel Pull Out
Lenton-5-S	0.4	64.61	82.27	1.37	Field Dowel Pull Out
Lenton-6-F	4.0	69.07	87.95	1.47	Field Dowel Pull Out

Figure 25. Lenton Interlock Splice Sleeve Failure Mode

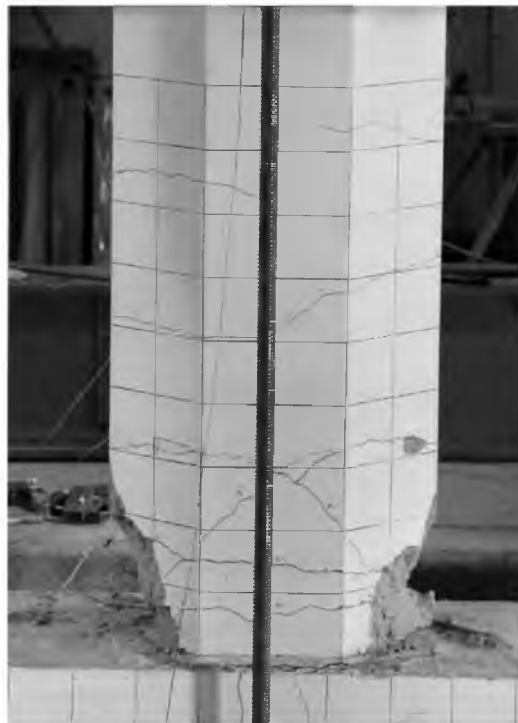
The structural integrity of the column cross-section is compromised by extensive spalling and severe structural cracks. The integrity of the column cross-section can be reestablished by relocating the plastic hinge in the column to an area just above the original plastic hinge. From

Figure 76. PCLEN-2 Column Damage

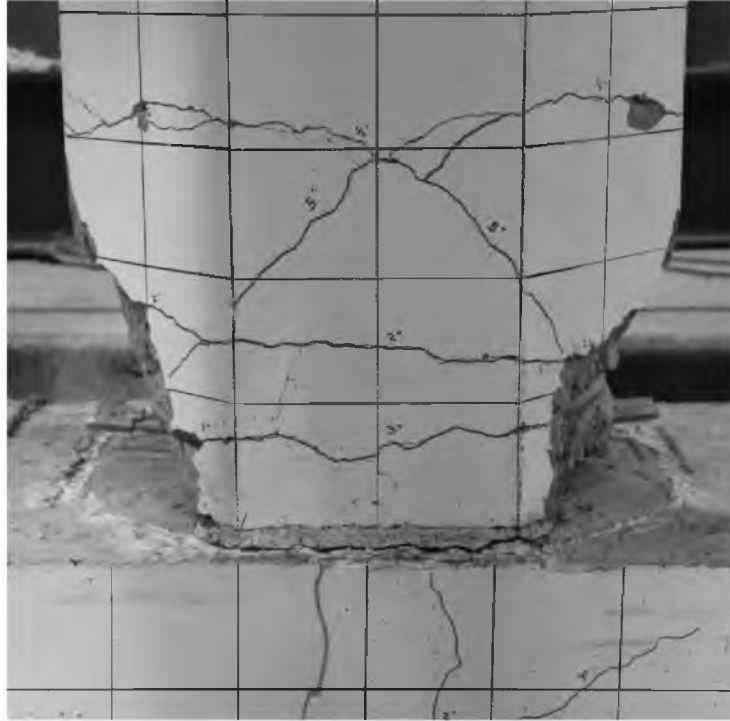
Figure 77. PCLen-2 Column Damage Close Up

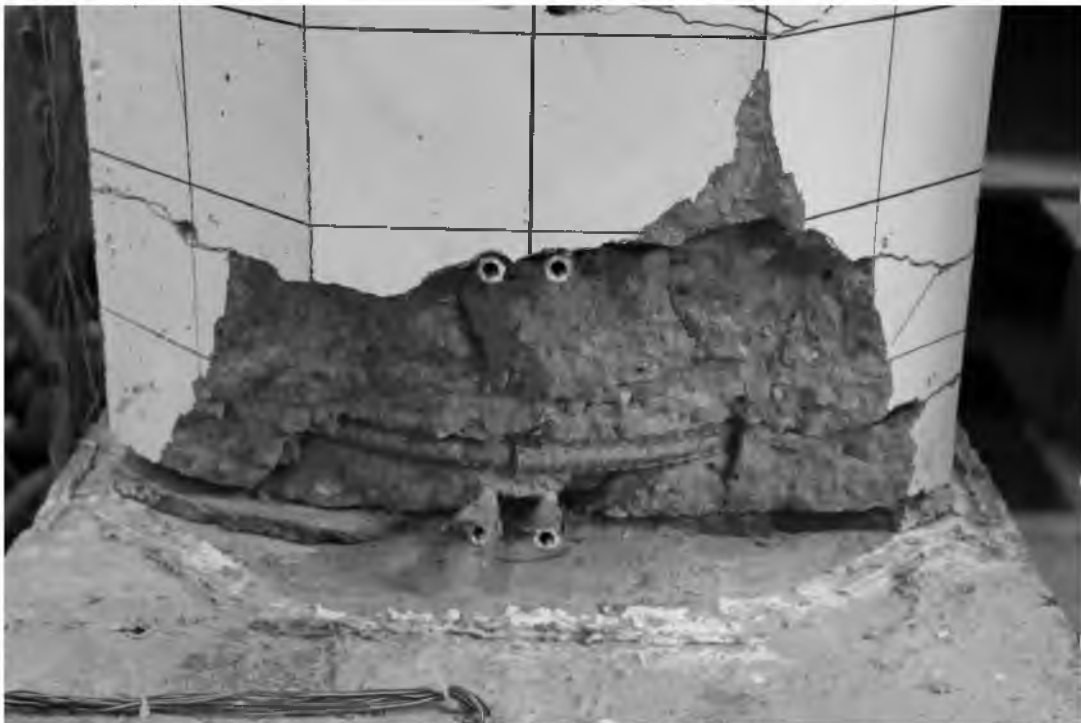
Figure 78. PCLen-2 West Face Damage

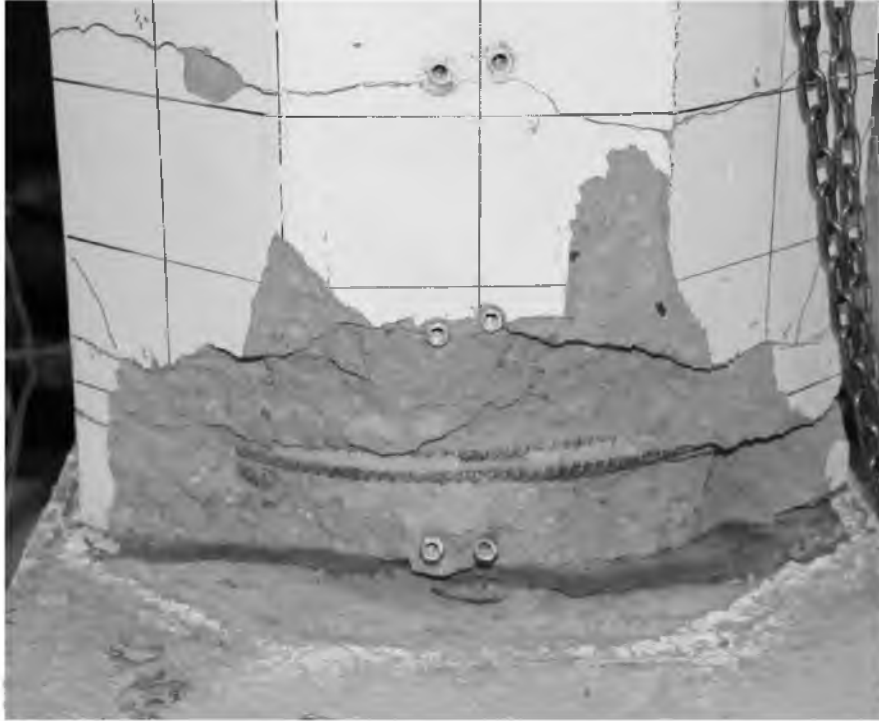
Figure 79. PCLen-2 East Face Damage

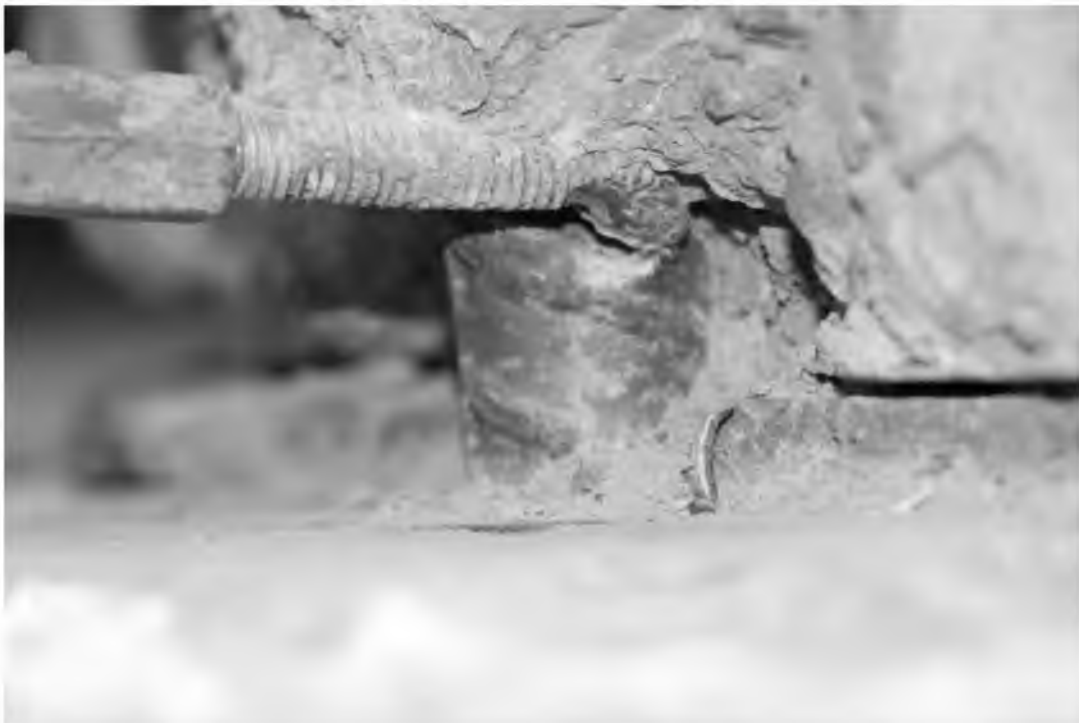
Figure 80. PCLen-2 Fractured West Longitudinal Bar

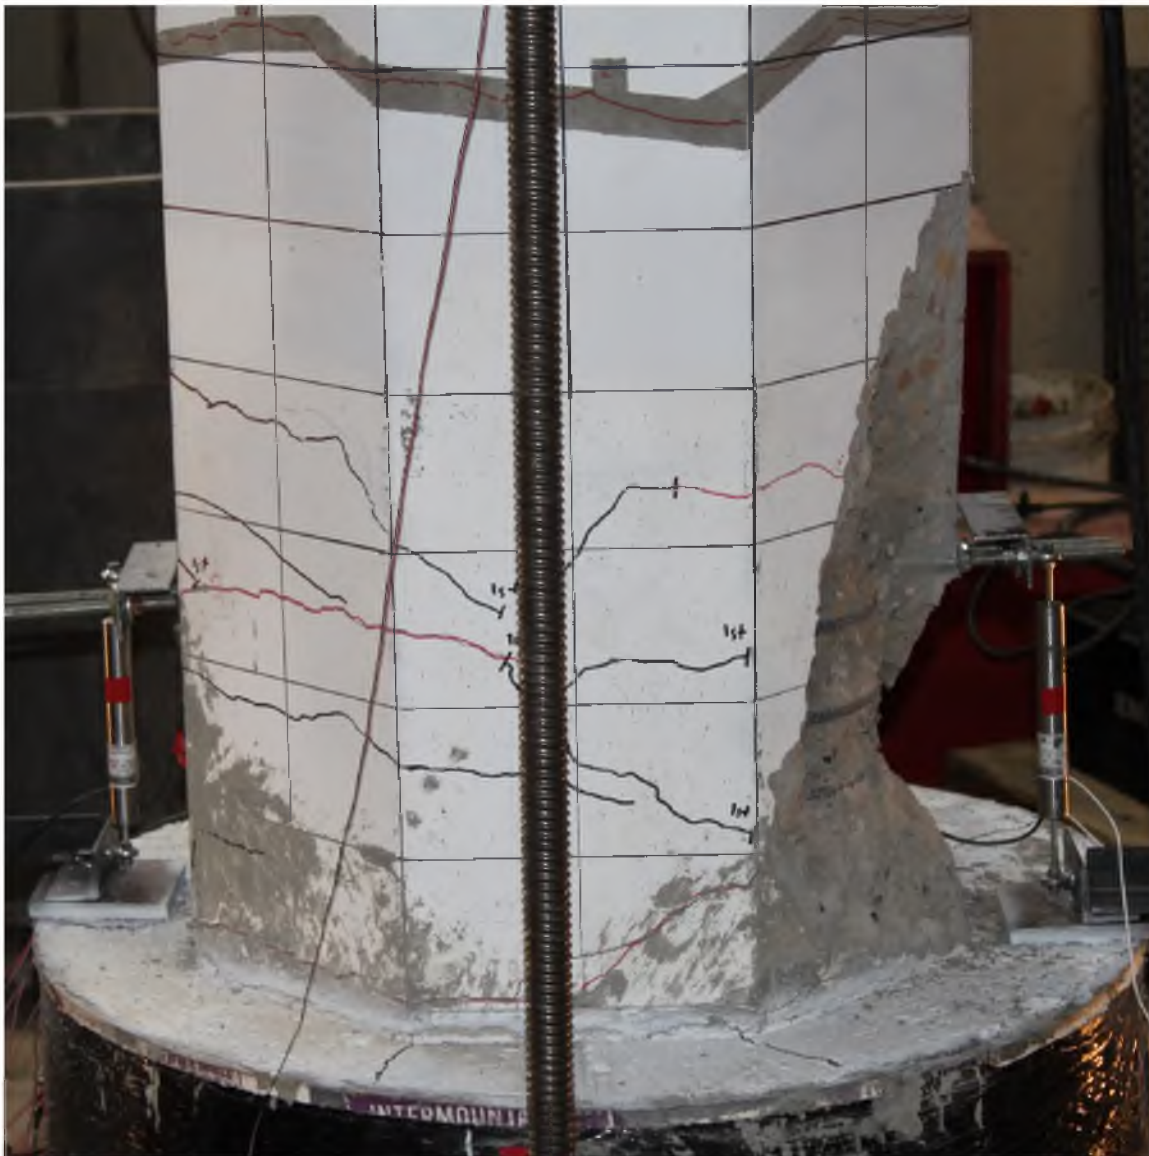
Figure 94. PCLen-2R Monotonic Pushover Damage

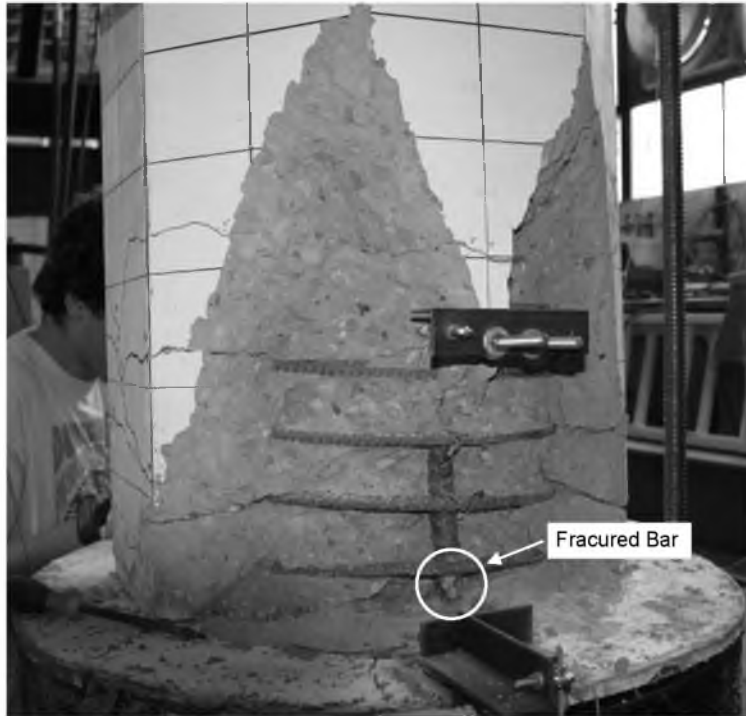
Figure 103. PCLen-2R East Face Final Damage

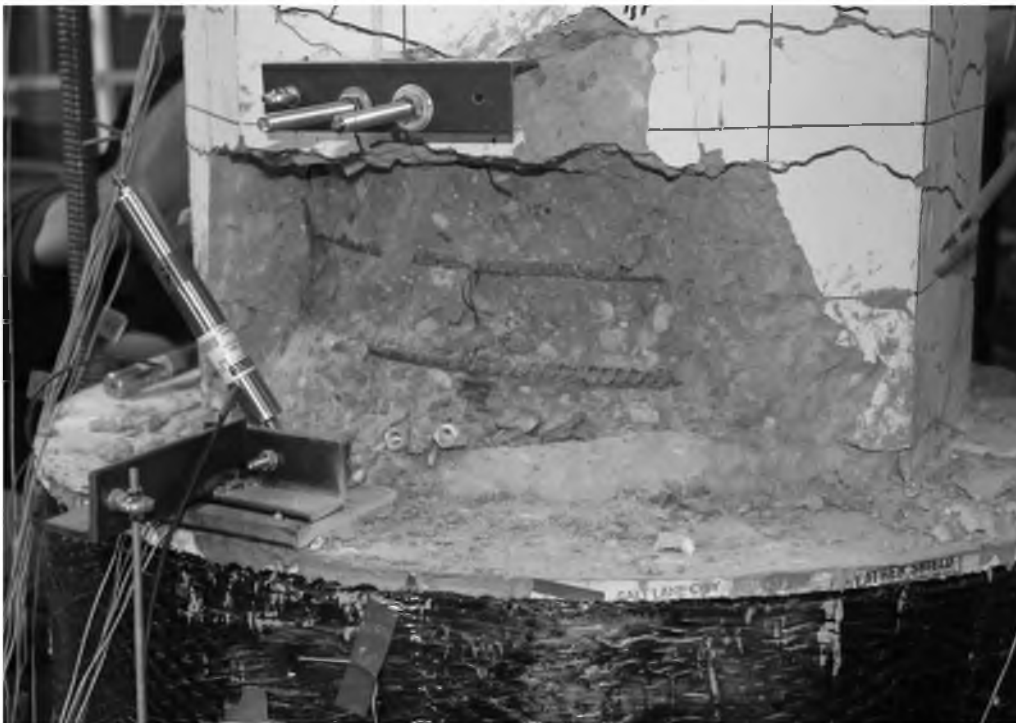
Figure 104. PCLen-2R West Face Final Damage

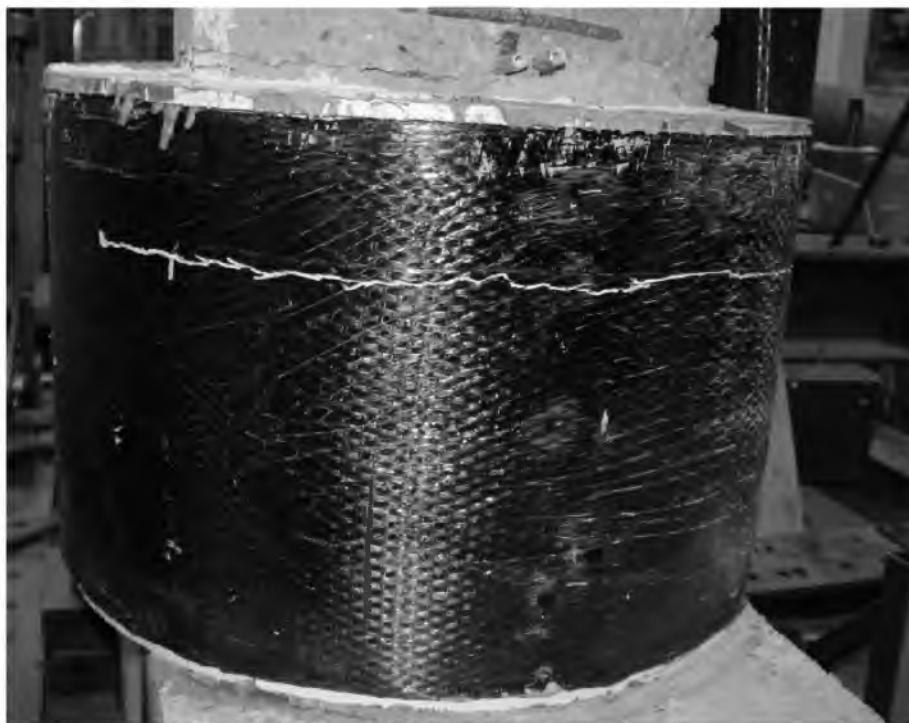
Two notable observations during the test are marked on the hysteresis in Figure 105. The square marks the cycle where transverse cracking of the CFRP jacket began to occur and the circle denotes fracture of the column longitudinal reinforcement. Note that there is no apparent change in the hysteresis, due to the transverse CFRP crack. The cracking of the CFRP jacket occurred just above the top of the headed bars and is shown marked by a white line in Figure 106. This crack was not observed during the cyclic test, but was instead identified by the AE event history which will be discussed later. The crack in the CFRP had a final width of 0.125 in., a length of 38.75 in., and only existed on the west side of the jacket. The crack was caused by an increased curvature demand on the repaired section when the column was pushed to the west.

Figure 106. PCLEN-2R Transverse CFRP Crack

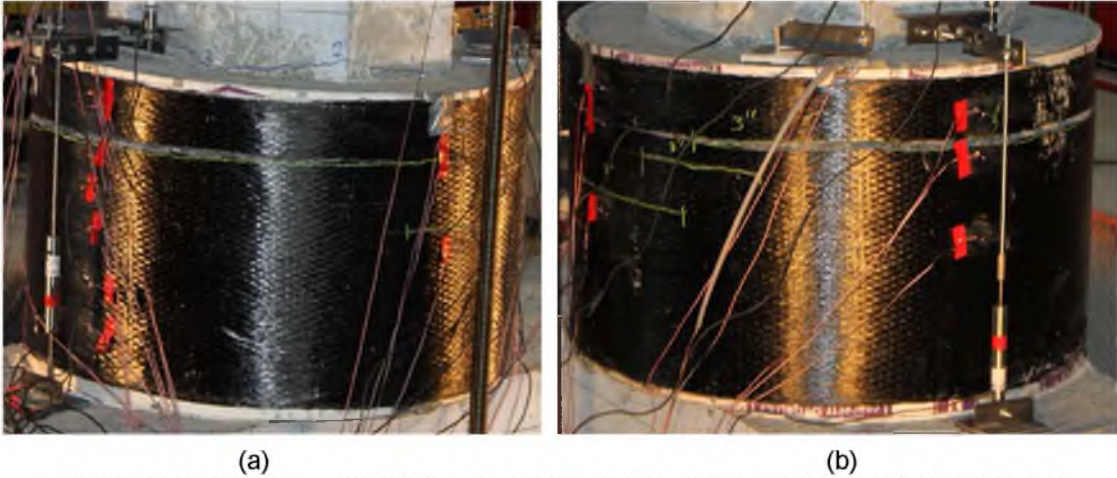
Figure 118. Transverse CFRP Crack: (a) West Side of Jacket; (b) East Side of Jacket

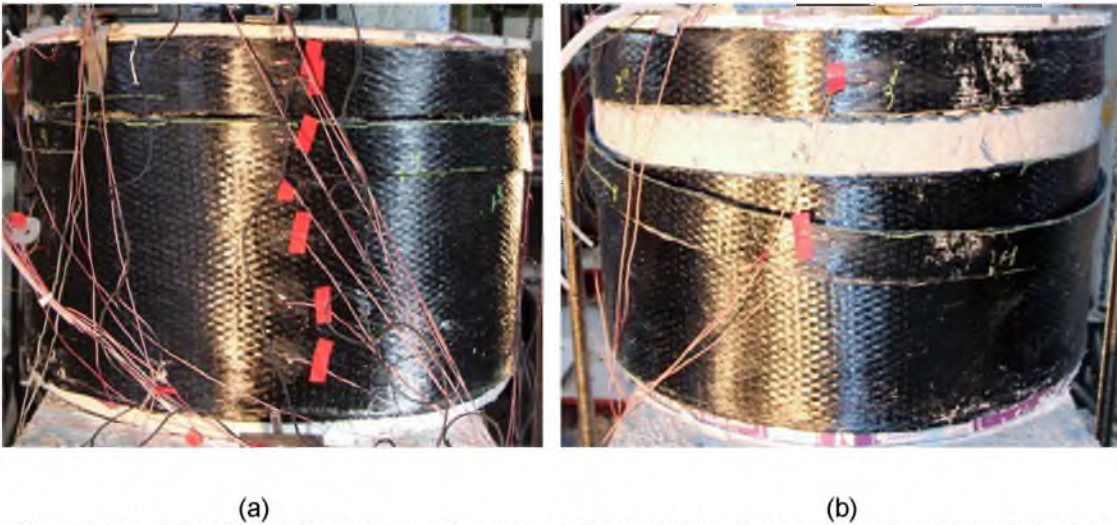
Figure 119. PCLen-3R First Jacket Fracture: (a) West Side of Jacket; (b) East Side of Jacket

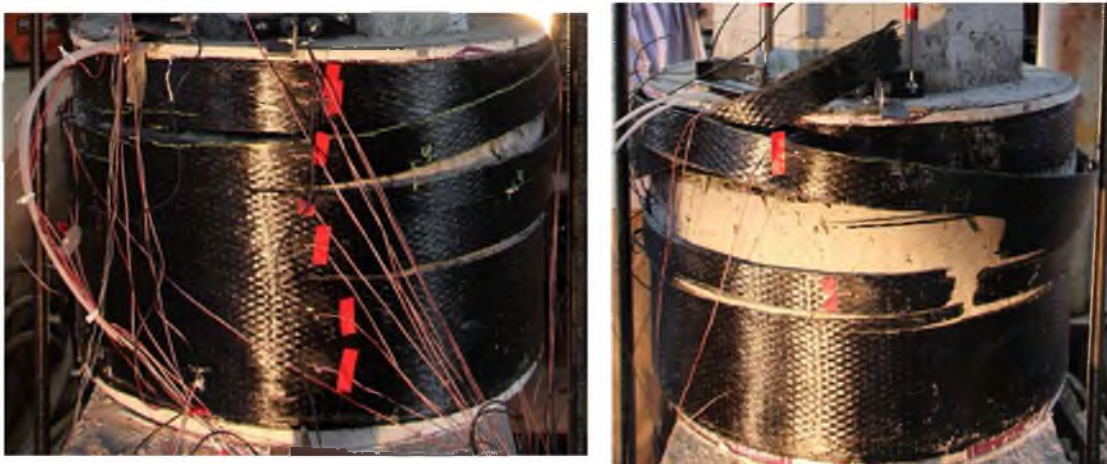
Figure 120. PCLen-3R Second Jacketed Fracture: (a) West Side of Jacket; (b) East Side of Jacket

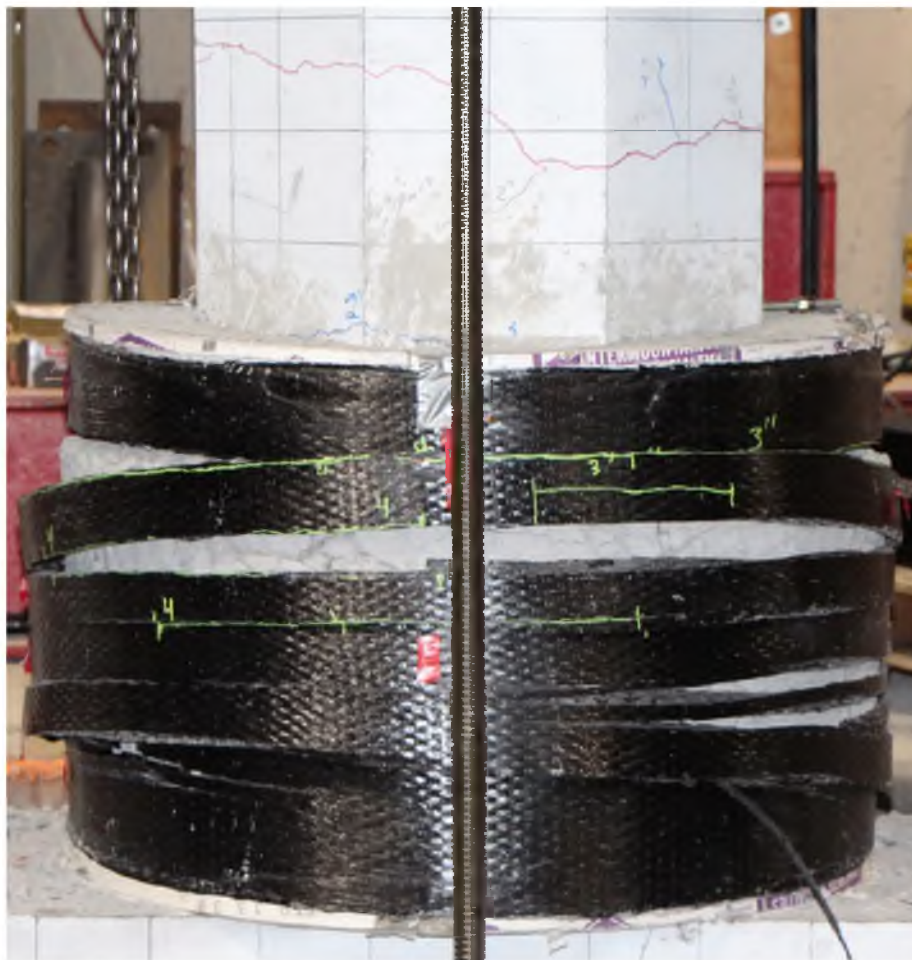
Figure 121. PCLen-3R Final Damage
