HMS Hampshire 100

Survey Report

Location: Atlantic Ocean, waters west of Orkney, Scotland

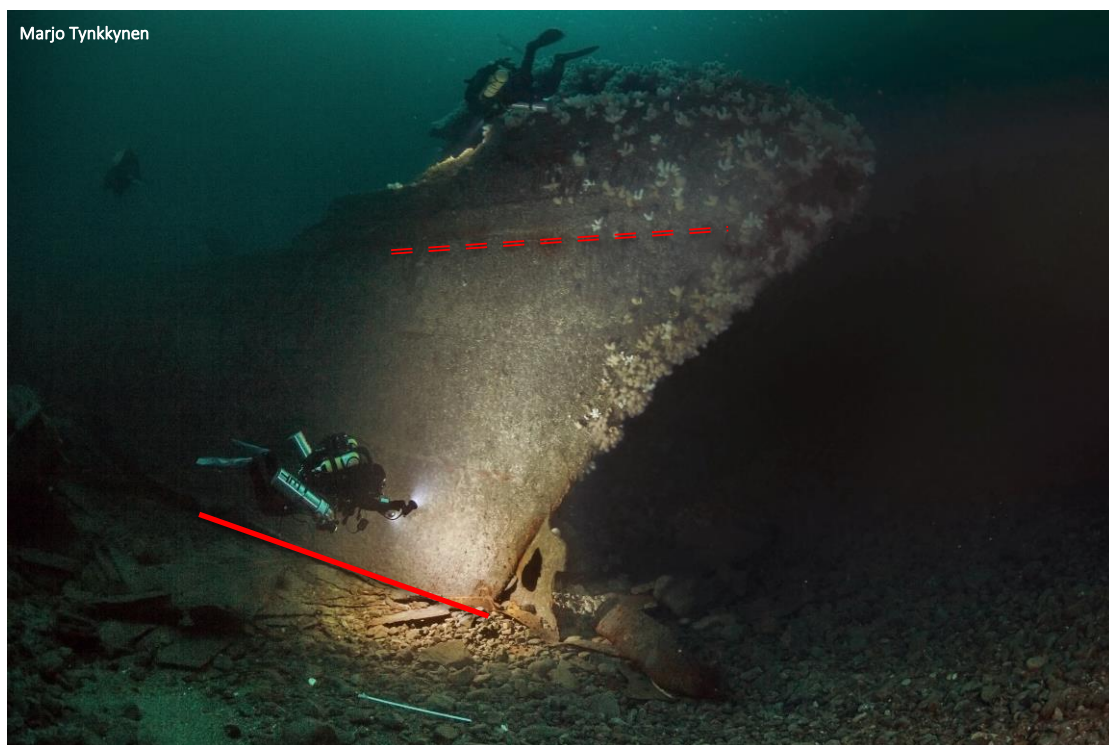
Figure 34: The intact stem – to right of shot. Damage to her keel can be seen top left

In Figure 34, the lower single red line delineates the top of the vertical armour belt. The top dashed red lines delineate the bottom of the armour belt. The two deck levels formerly above the belt have been crushed.

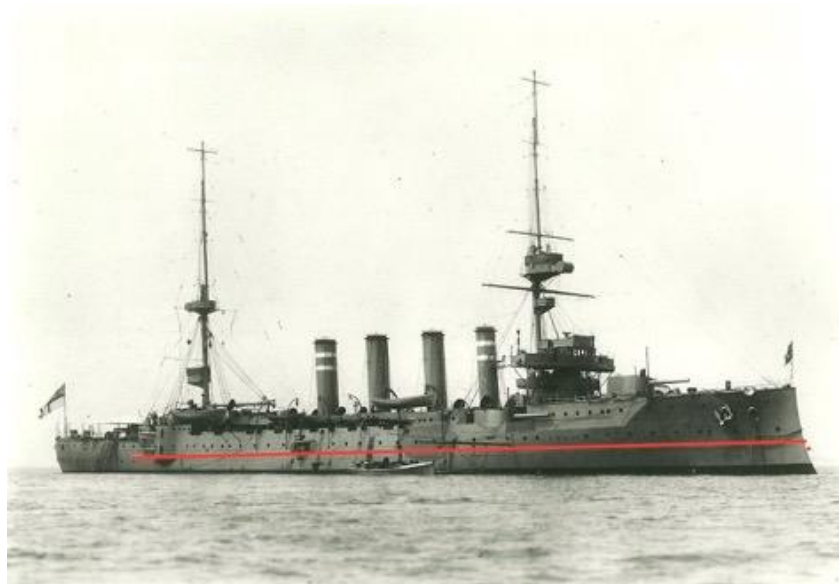
Figure 35: The red line delineates the top of the waterline main armour belt

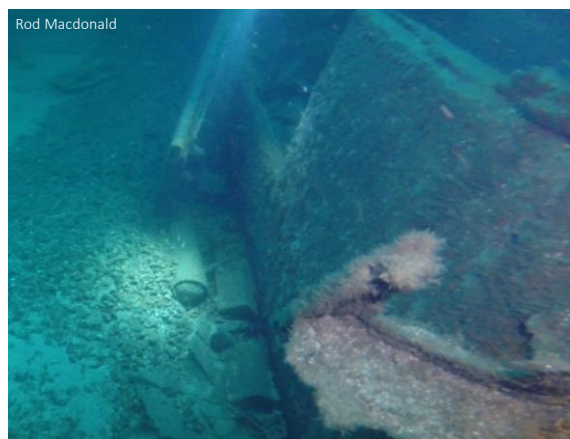
- One section of armour belt plate on the starboard side has been displaced and now rests on the seabed above a possible torpedo body.

Figure 39: Armour belt

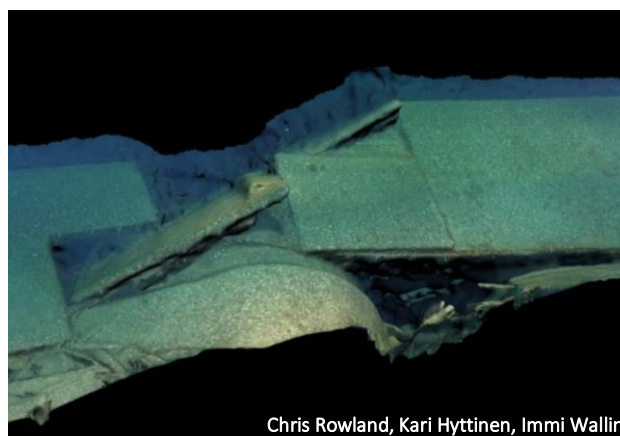
- On the port side adjacent to A-turret plates have been displaced. Inside the damaged area at this point the ammunition hoist trunking is intact and still attached to A-turret, although it now leans to starboard.

Figure 40: 3D image of port side displaced armour plate near A-turret

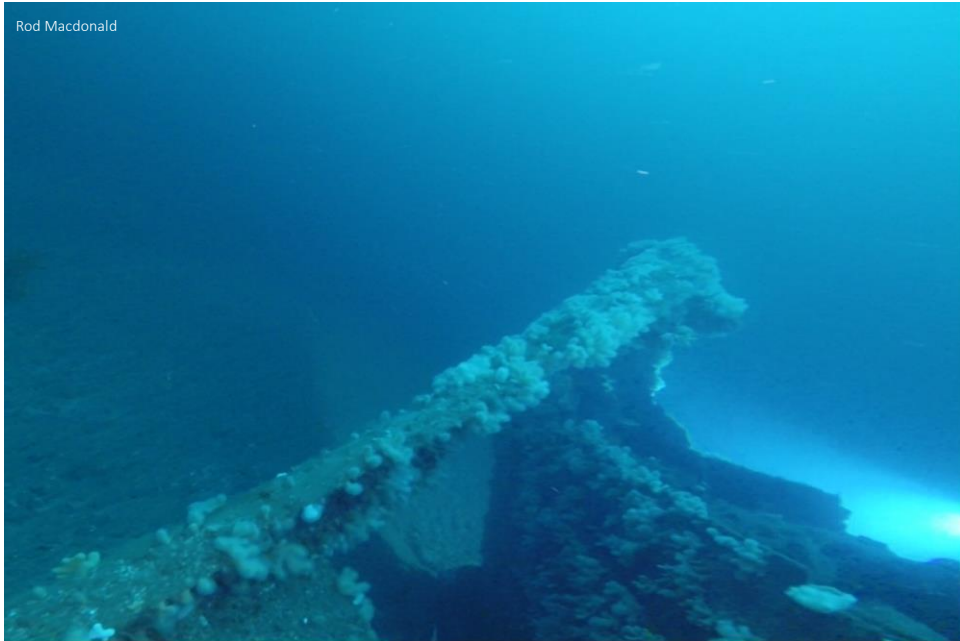
Figure 43: Starboard view of bow showing severed keel

Lying on the seabed surrounding the bow are many pieces of hull plating. The majority of these lie under the broken keel on the starboard side.

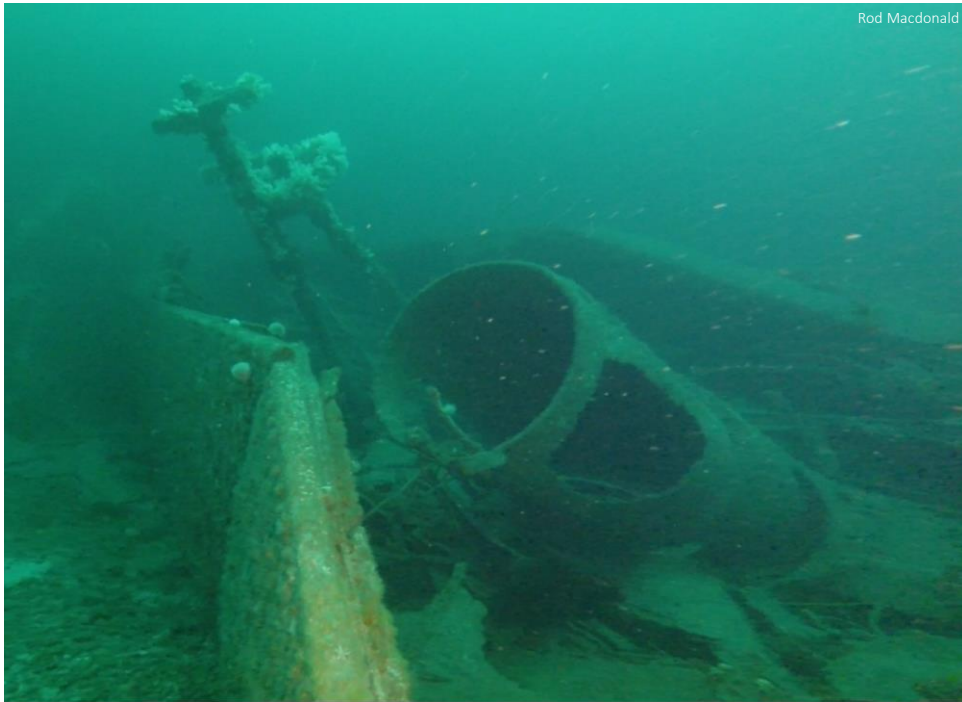
A-turret ammunition hoist trunking lies in the bow debris just aft of the three capstan shafts and leans to starboard. It is still attached to the gun, which is displaced to port and just visible on the seabed. The trunking shows signs of decay consistent with 100 years of submersion in saltwater, but is otherwise undamaged.

Figure 47: Starboard waterline vertical armour belt plates to left of shot, with A-turret ammunition hoist trunking in foreground and capstan drive shafts and gearing beyond

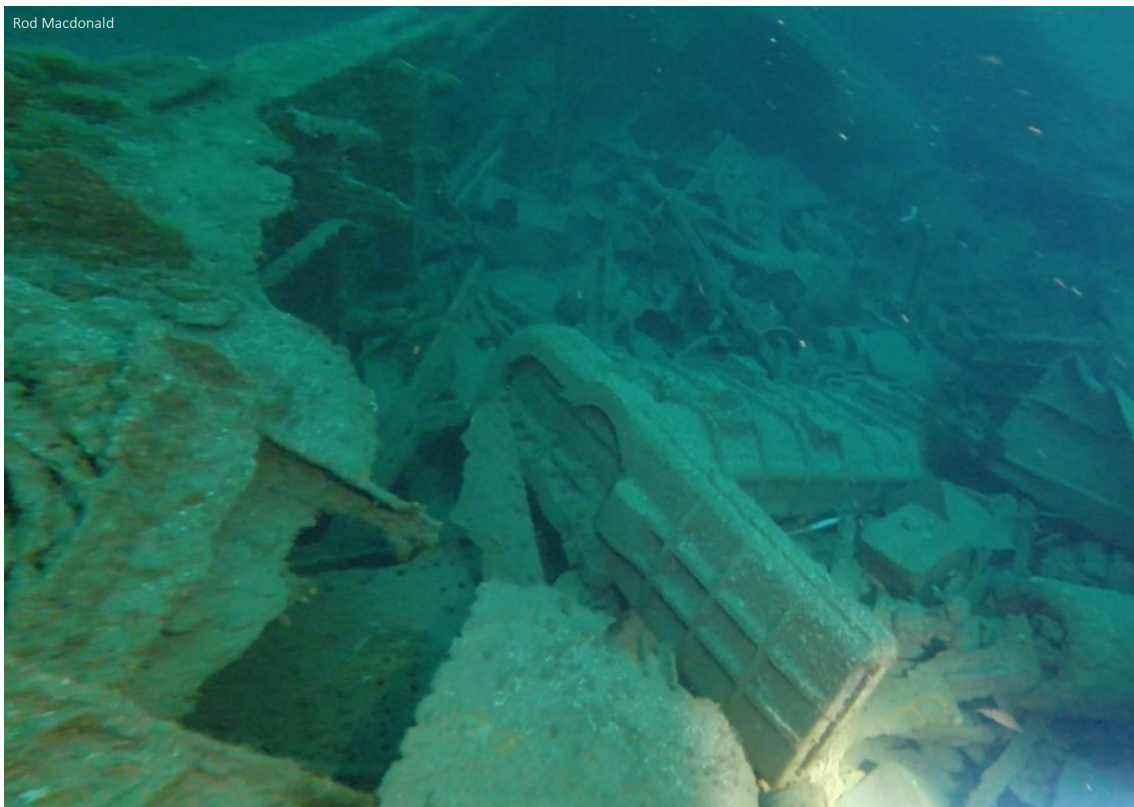
HMS HAMPSHIRE's two lateral submerged torpedo tubes were positioned on the Platform Deck between frame Nos 33 and 37. The starboard torpedo tube lies in the damaged area of the bow in the approximate correct longitudinal position, although it now rests lower in the wreckage. The tube appears complete and undamaged with the inner torpedo door attached. On the seabed the outer door is visible in severed hull plating to starboard. The port side tube was not located during the survey. The port side tube outer door, however, remains in situ in the port hull plating. Intact torpedo warheads lie in the bow wreckage adjacent to the tube and a possible torpedo body lies outside the wreck, flush with the starboard side of the hull.

Figure 49: Looking forward towards the bow, the starboard torpedo tube can be seen in the debris

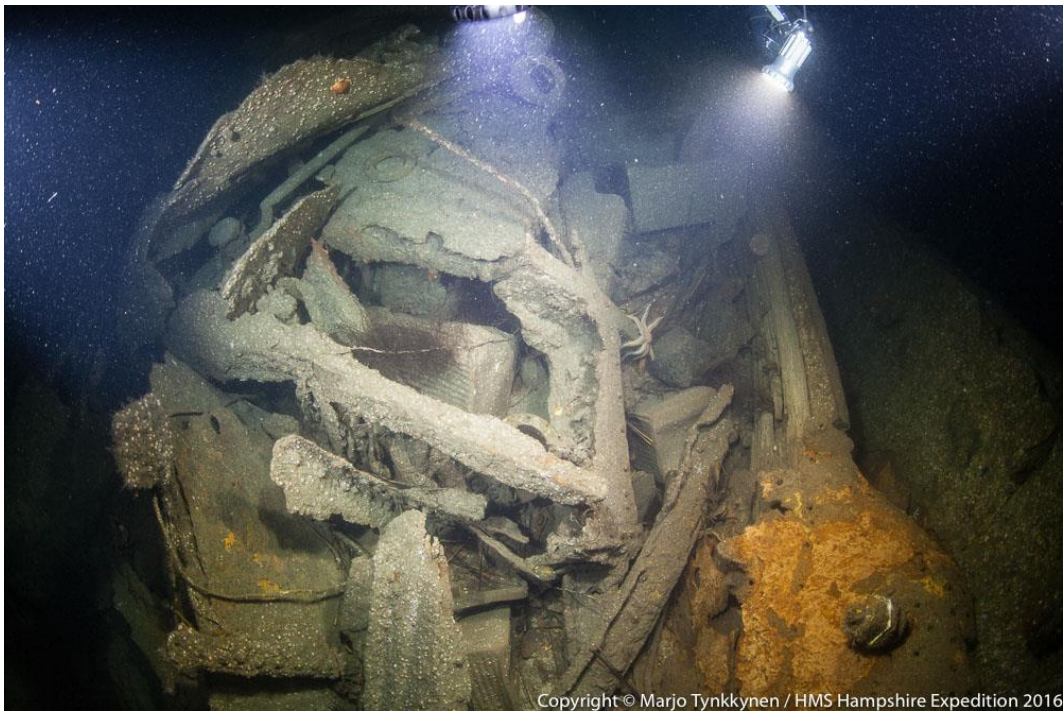
Figure 53: Cordite in ribbed brass flash-proof storage boxes lie in the bow wreckage adjacent to internal timber support for the armoured belt. Note the large stud nut in bottom right

armour belt to protect the inner ship are also visible. A large stud nut (to bottom right of image) secures the bolt that goes through the inner ship's side and is tapped into the back of the armour belt plating.

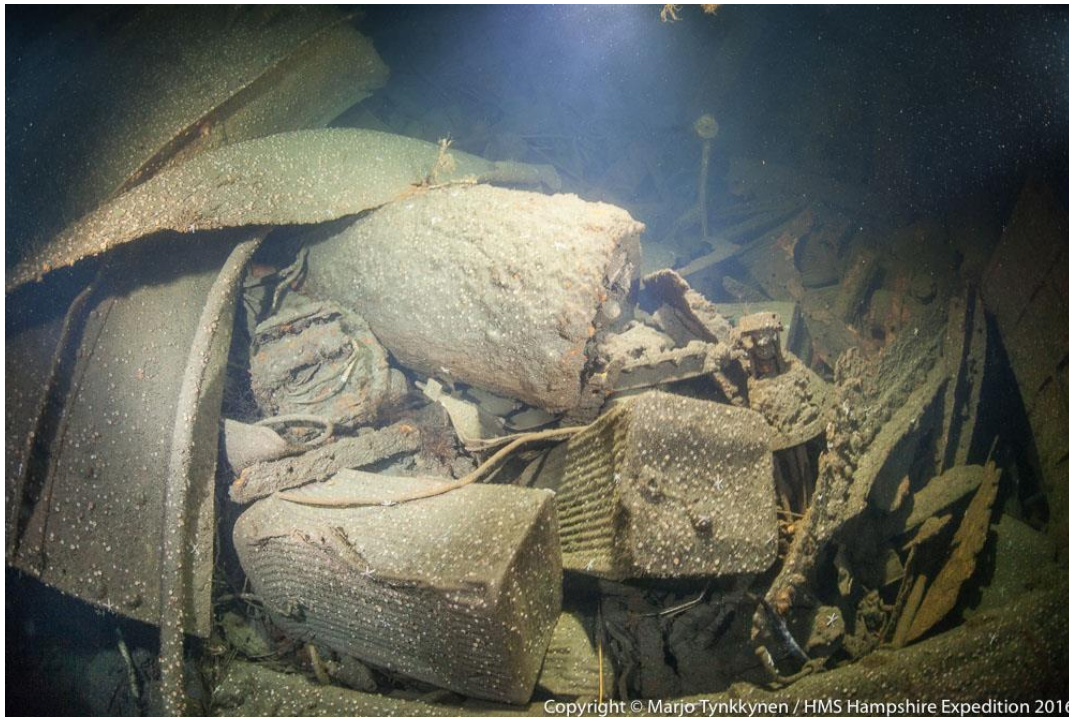
Figure 54: 7.5-inch flash-proof ribbed brass cordite storage boxes in vicinity of P & Q-turret magazine

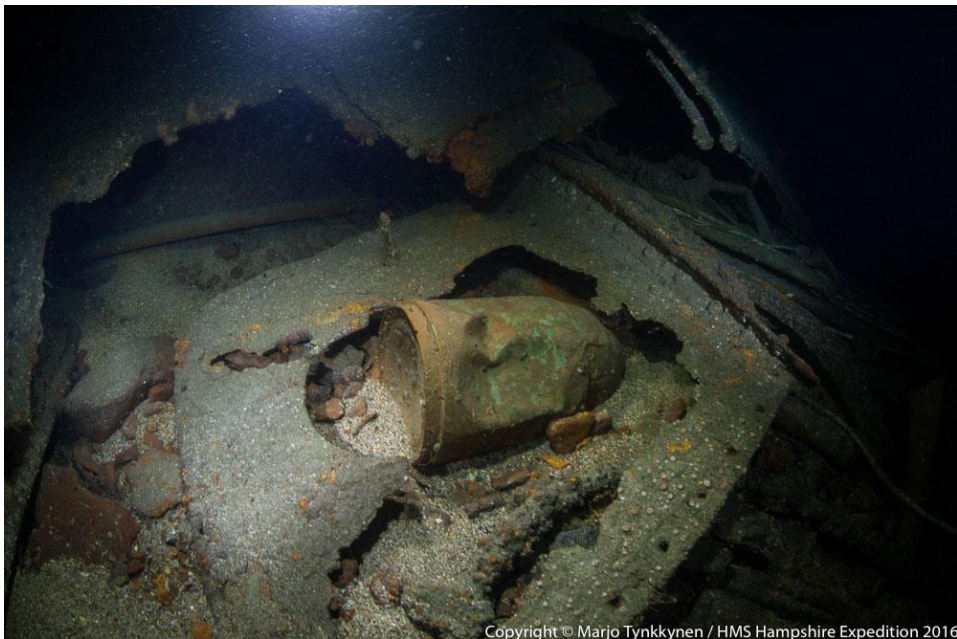
Figure 56: A brass torpedo warhead casing showing hydrostatic pressure damage (The degree of damage suggests the warhead is not loaded with explosive and might be for drill or practice)

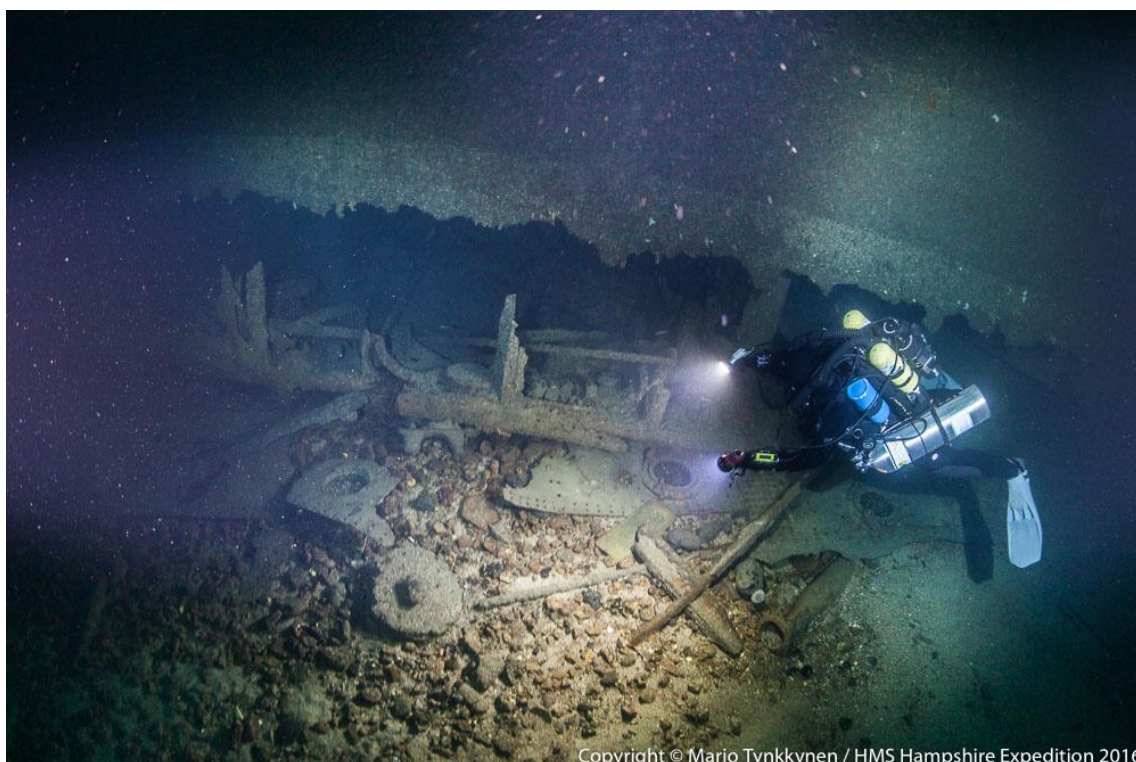
It is noteworthy to add that prior to the wreck's closure in 2002, members of the survey team had dived the site in 1997 and 2000 respectively. Their anecdotal evidence compared with some video footage taken during the same period show that most of this hull plating was still in situ at that time.

Figure 68: Hull plating has decayed and fallen away from the Main Deck on the starboard side, leaving portholes on the seabed

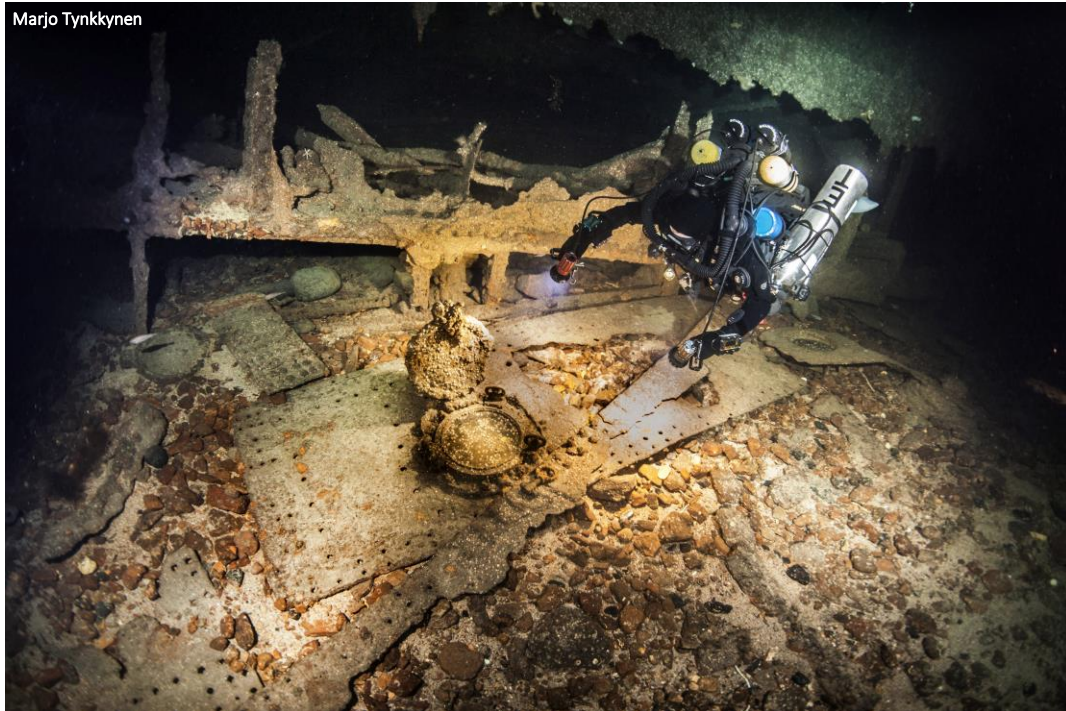
Figure 69: Starboard side Main Deck porthole, still located in the hull plating, now lies on the seabed with deadlight still open

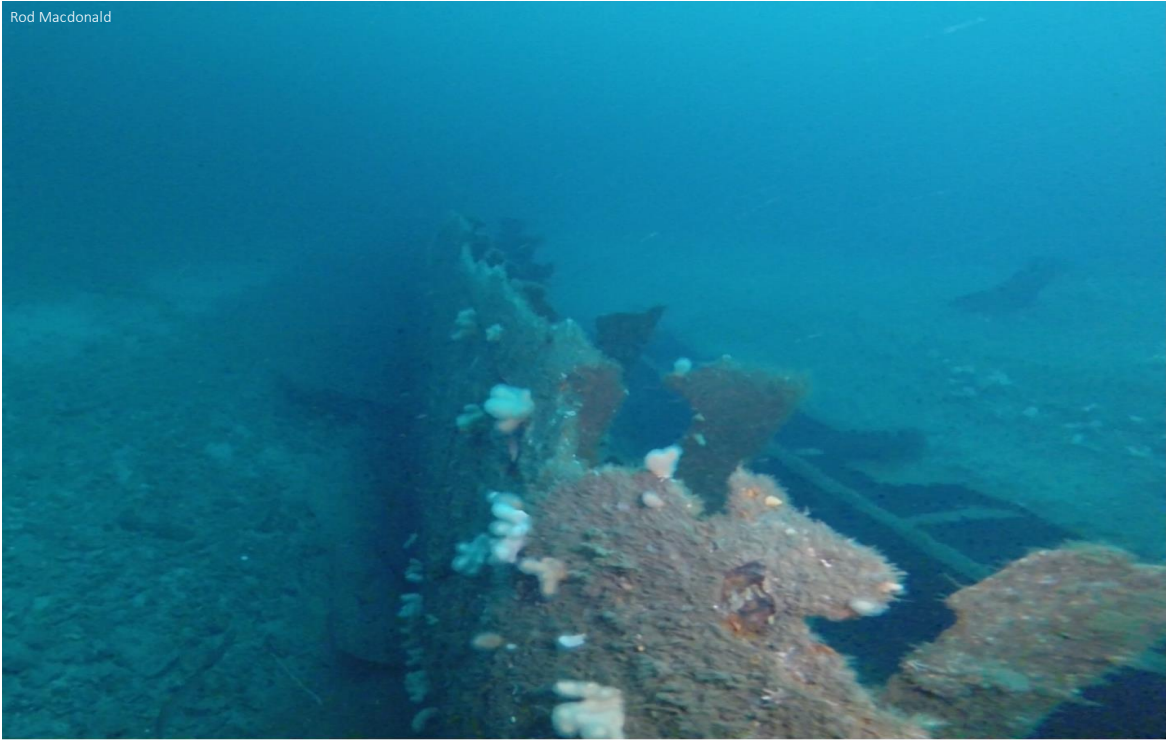
Figure 76: Looking forward along starboard side - fissure in the hull

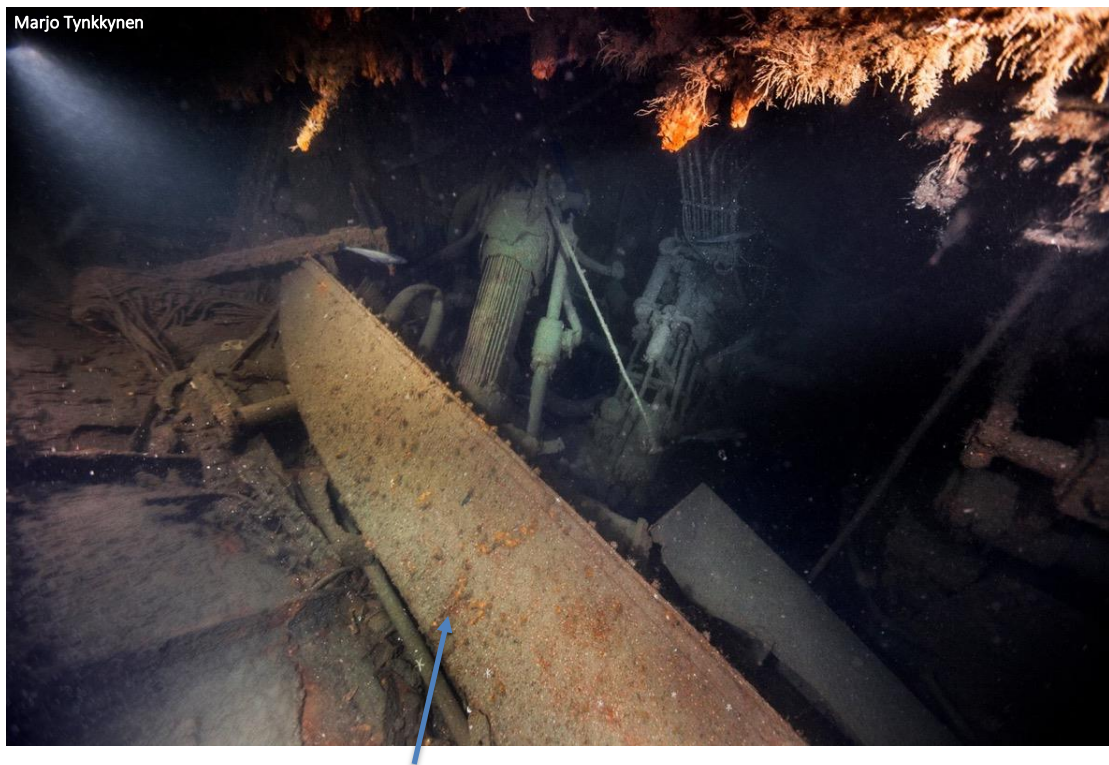
Both bilge keels remain on the ship, although the aft section on the port side has broken and fallen into the fissure and now lies alongside condensers and evaporators.

Figure 79: The aft end of the port bilge keel is visible in the fissure lying alongside evaporators

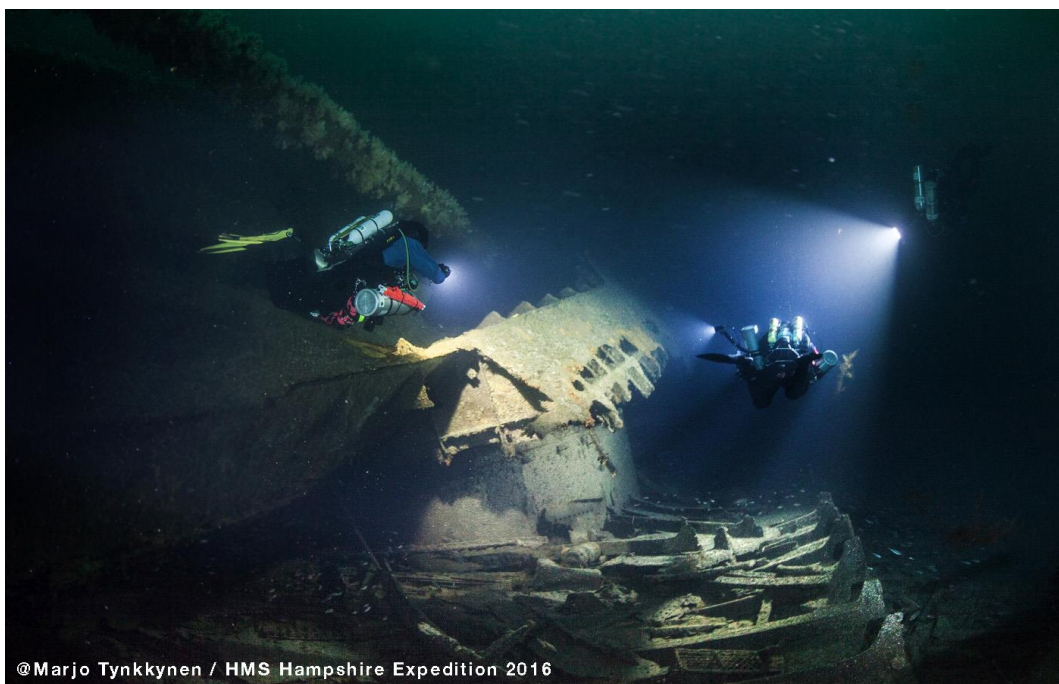
The stern section is propped up on her port side supported by Y-turret. The majority of the hull plating for the Main Deck and the Lower Deck has corroded away from the aft casemate to the stern leaving a substantial gap under the ship. Surviving hull material from this area lies face down on the seabed. Y-turret 7.5-inch gun barrel cannot be seen and appears to be swung to starboard – the direction of capsizing – and is now buried in the seabed under the wreck.

Figure 85: The back of Y-turret gunhouse seen from astern with the free section of the port prop shaft above. The barrel appears to be swung to starboard in the direction of her capsizing

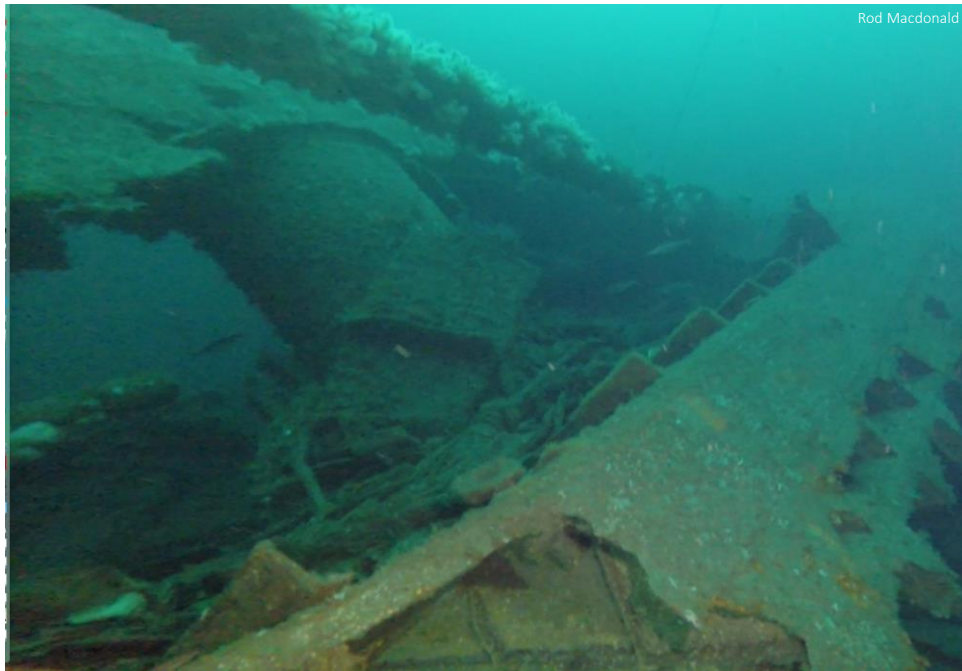
Figure 86: Y-turret ammunition hoist and the port side propeller shaft are visible through the decayed stern

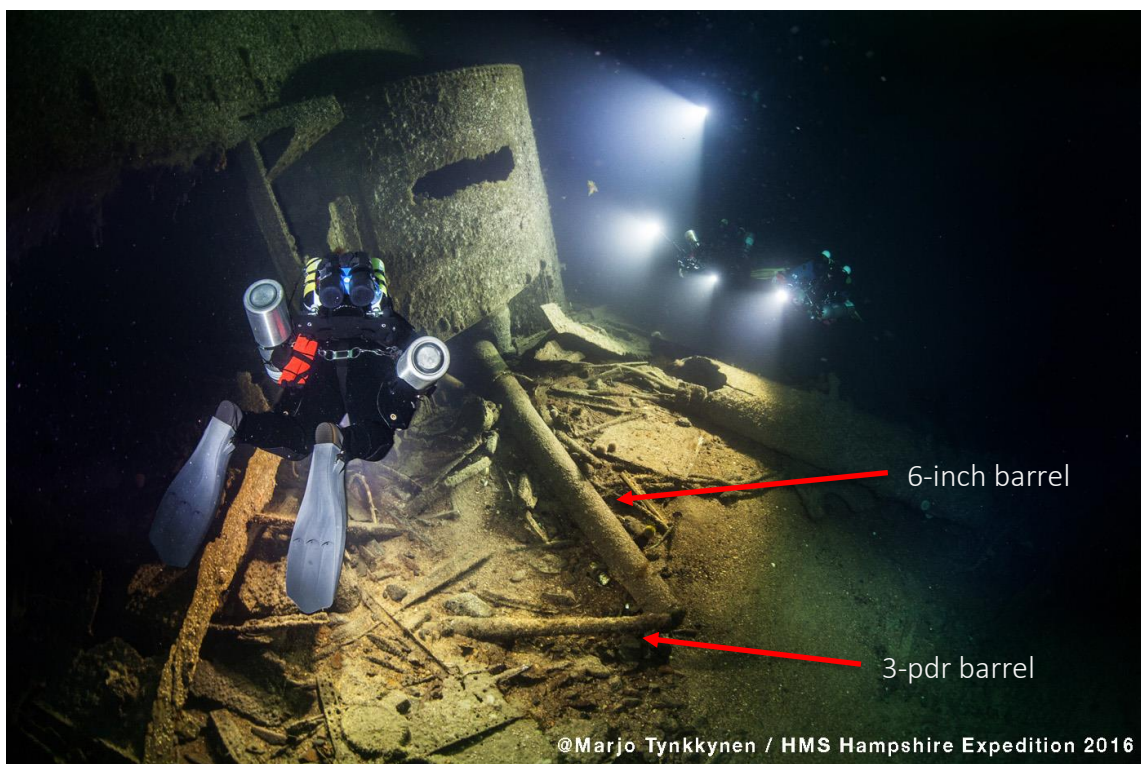
The barrel of a 3-pdr gun protrudes from the seabed perpendicular to the 6-inch gun barrel. The mount is buried, but it is highly likely to be a Vickers.

Figure 90: The superfiring Y1 6-inch gun barrel projects from the (now lower) firing port. The plated off lower 6-inch gun Y3 firing port can be seen above – its plate rusted through horizontally. The barrel of a buried QF 3-pdr rises up from the left to meet it

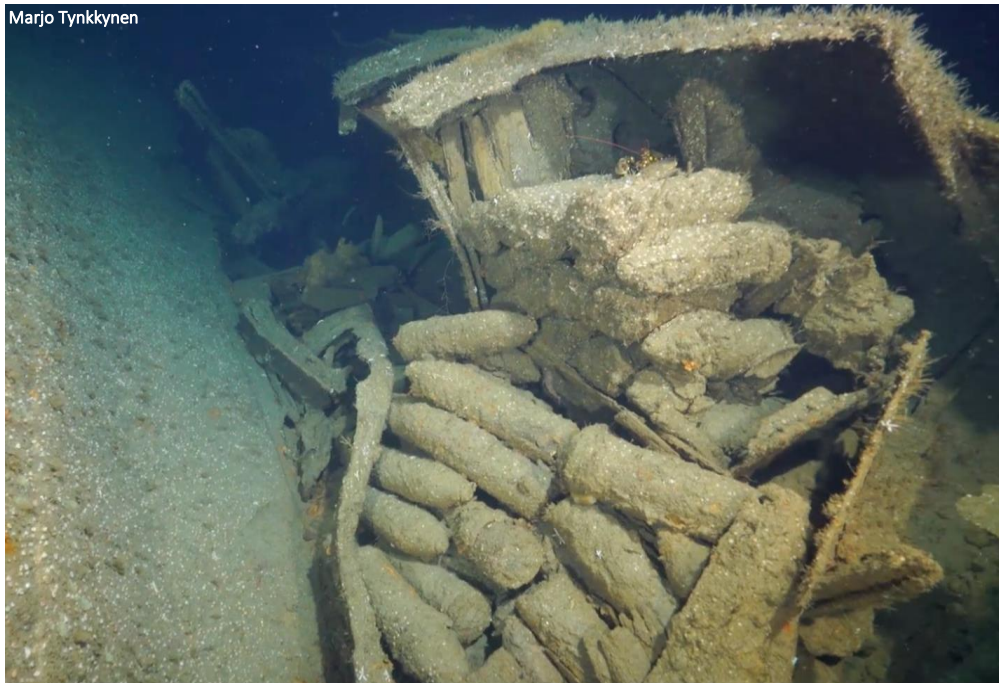
Figure 101: Port aft Shell Room. Sagging keel plating is seen to the left, having split and collapsed down to expose the shell room hard up against the port side of the ship to right of shot

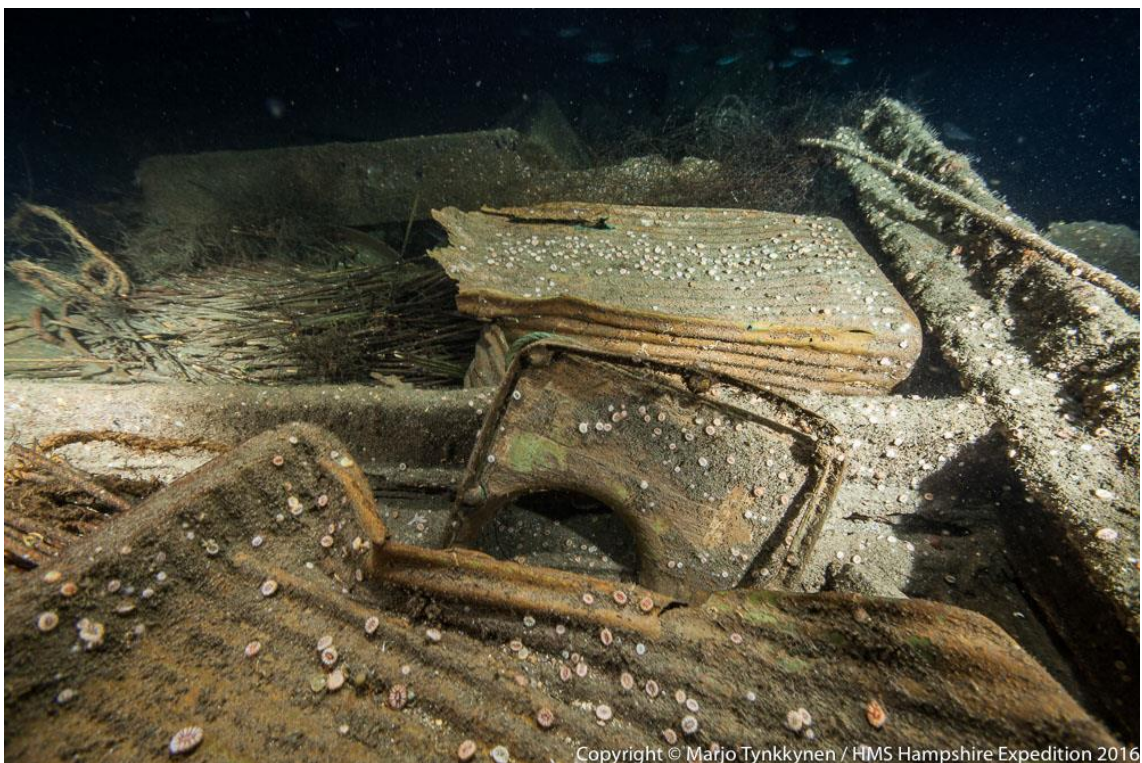
Figure 105: Ribbed flash proof brass cordite cases for 7.5" or 6" BL guns. These cases have sustained hydrostatic pressure damage and have burst open, spilling cordite sticks from within. The cordite would have been contained in silk bags, which have evidently rotted away

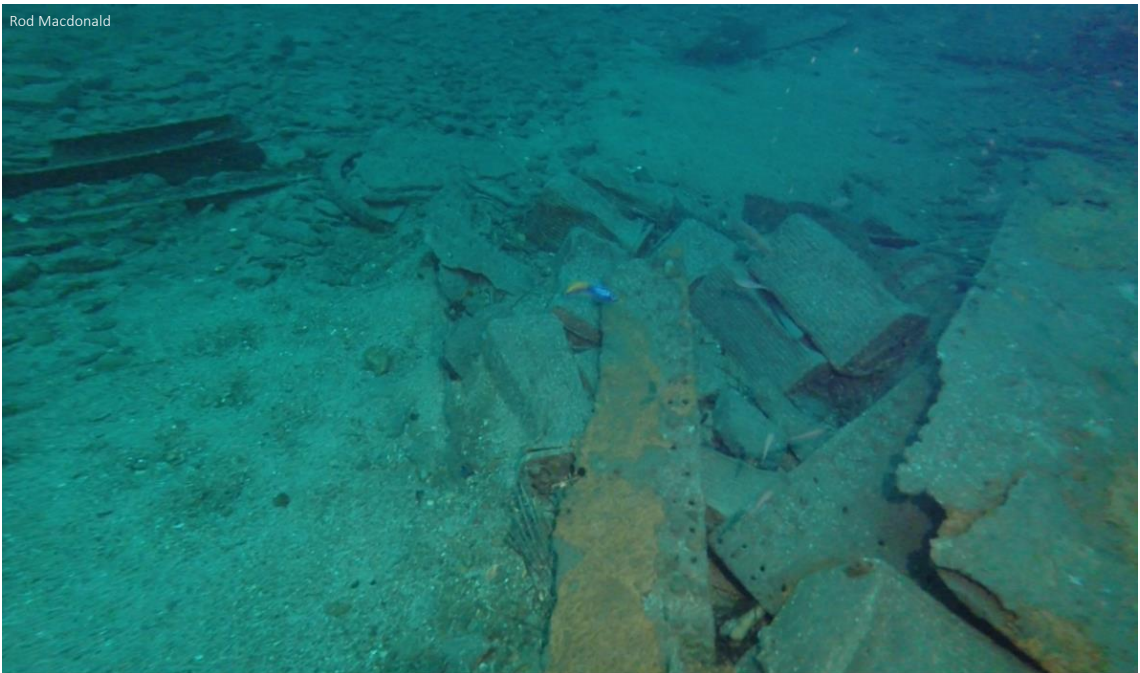
Figure 107: Boxes of cordite have fallen from the fissure on the port side to lie on the seabed

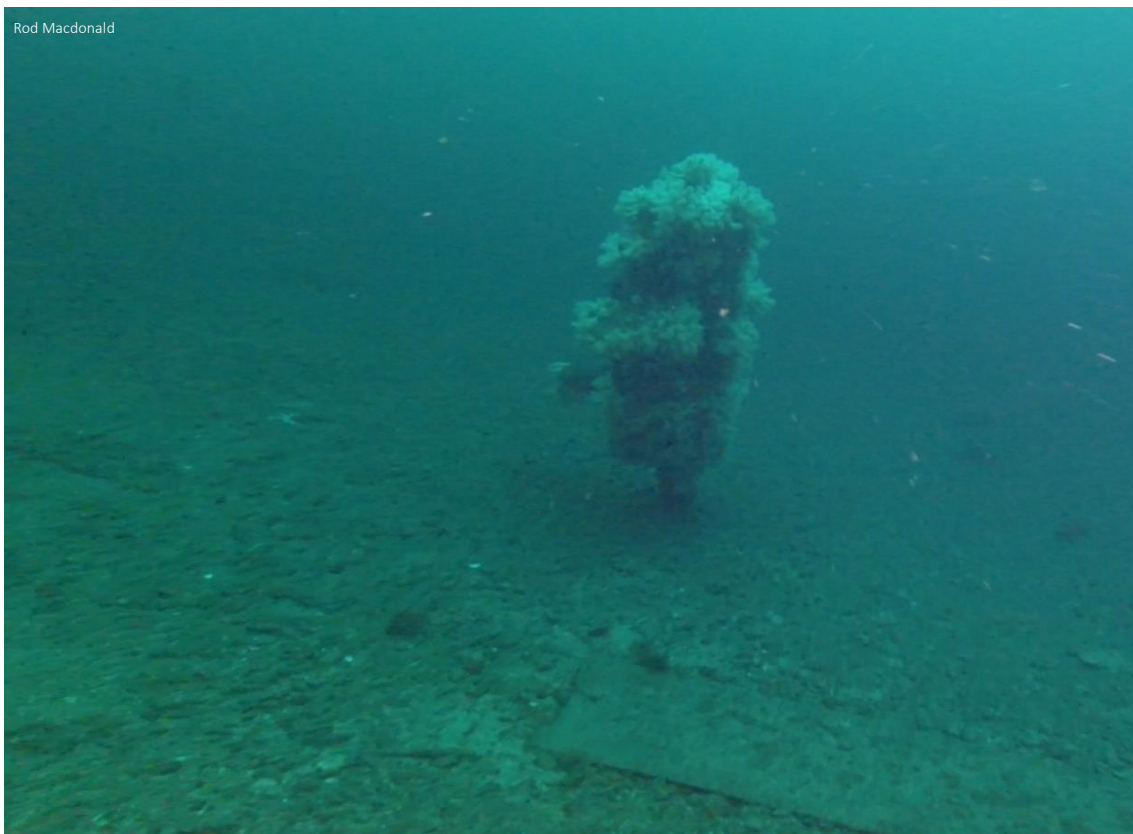
Figure 115: A 6-inch Vickers Mk VII gun has fallen from its mount as the ship capsized and impaled itself barrel first in the seabed

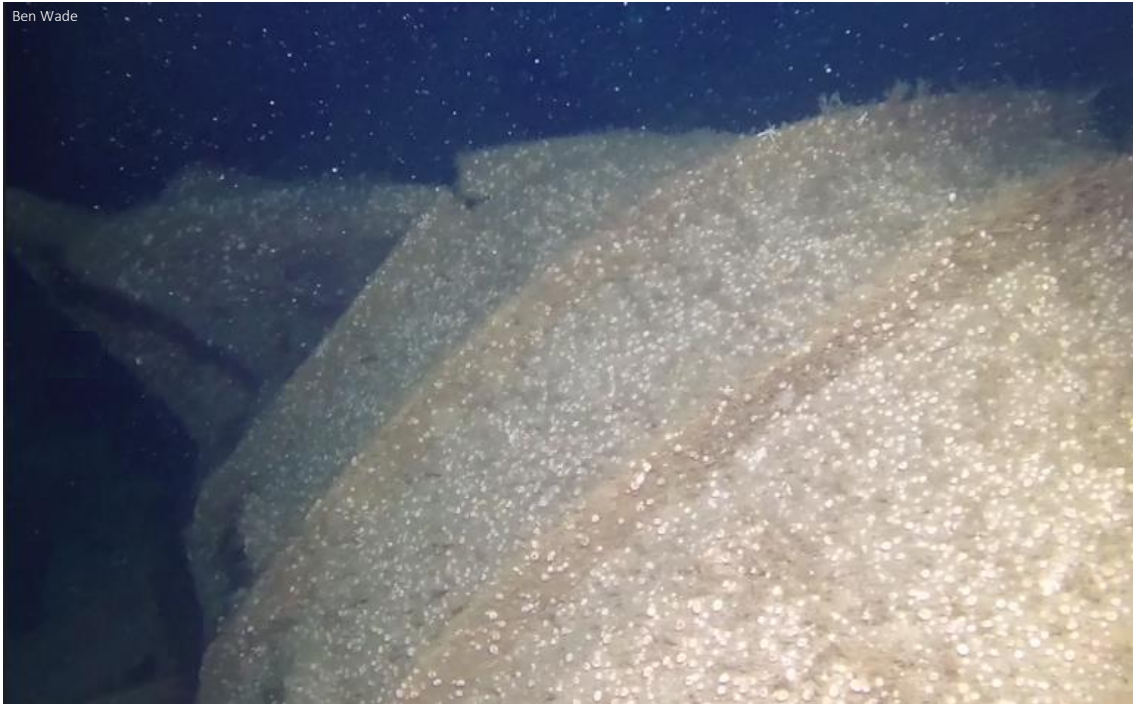
Figure 121: Bulkhead looking to port across the ship: note the cracking damage

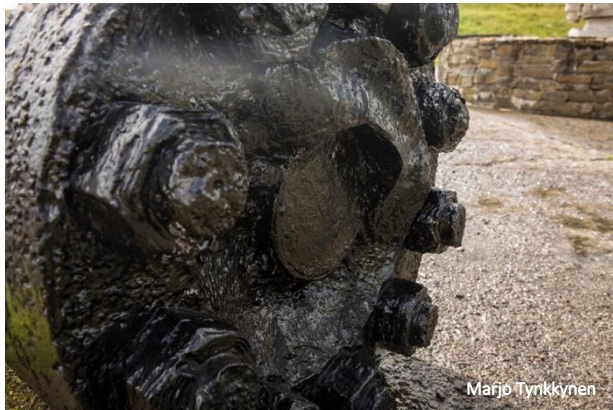
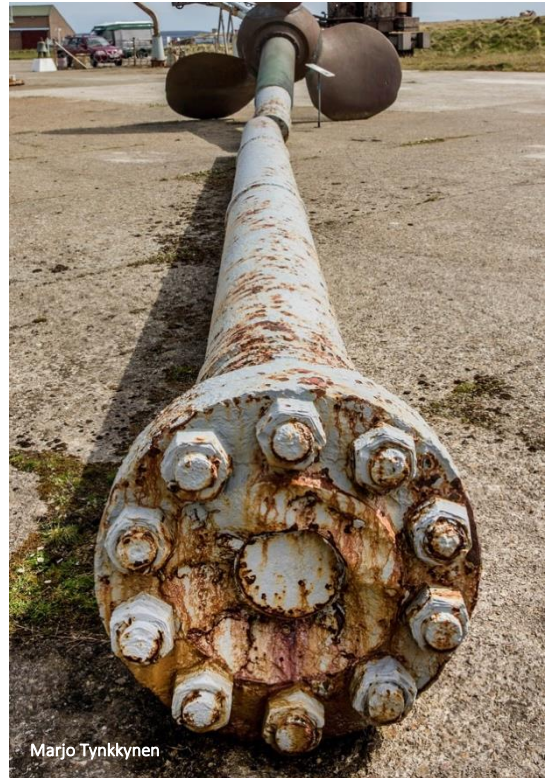
Divers from the 1983 survey reported that the starboard propeller shaft had broken at a flange just outside the shaft casing. The bracket close to the propeller, supporting the shaft, was broken at the hull. The starboard propeller itself was lying on the seabed beside the wreck. The diving licence precluded removing items from the wreck, but the divers believed it did not prevent them from recovering items lying on the seabed around it. The prop, a section of shaft and the bearing support were lifted, and the recovery reported to the Receiver of Wreck in Aberdeen. The prop and shaft were offloaded onto the pier at Peterhead when the vessel arrived there on completion of the works. It lay there for more than a year until it was sent to Orkney, where it remains on display at the Scapa Flow Visitor Centre & Museum at Lyness on the island of Hoy.

Figure 123: The broken flange joint of the starboard side prop shaft housed at Sapa Flow Visitor Centre

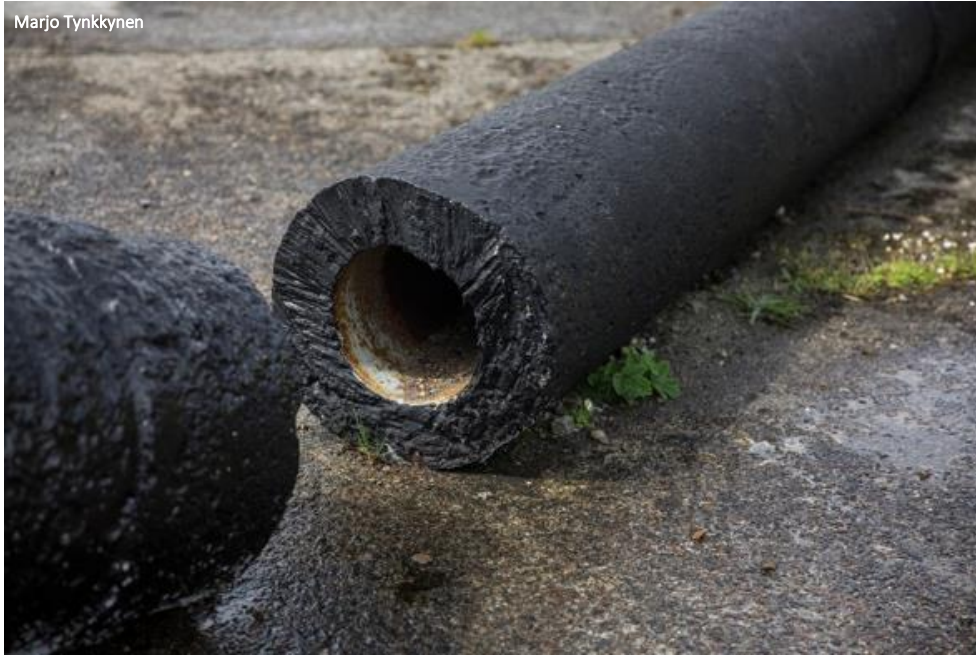
Figure 124: The starboard shaft was cut just aft of the propeller post-salvage

- The starboard shaft has been cut just forward of where the cutlass bearing would have been. This cut has been made post salvage, as archive images of the landed artefact show the shaft and propeller as a composite unit. It is suggested that the cut may have been made in order to ship the items to Lyness.

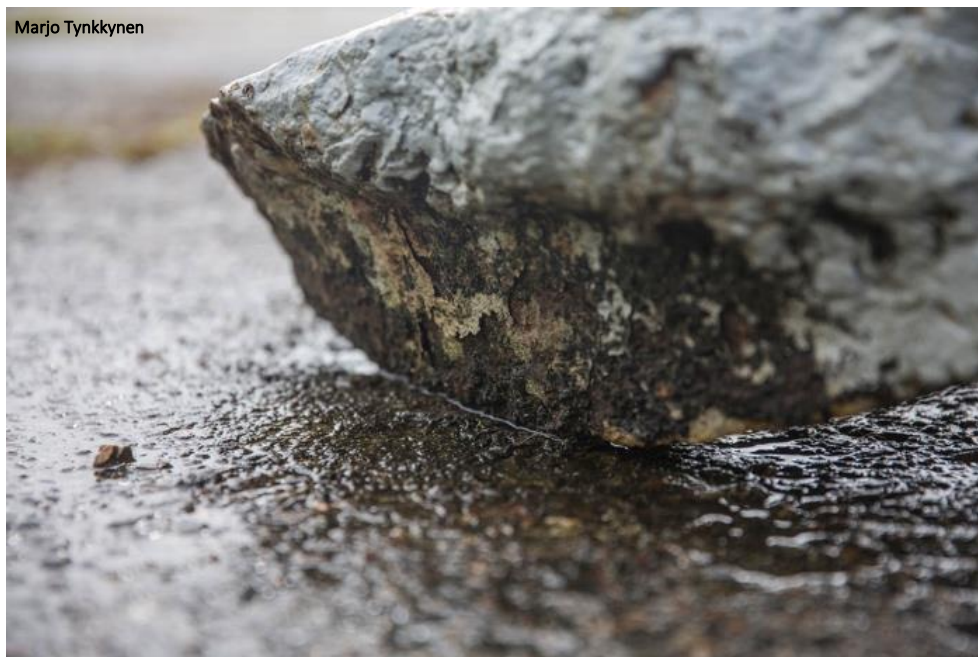
Figure 126: Fracture surface of A-frame

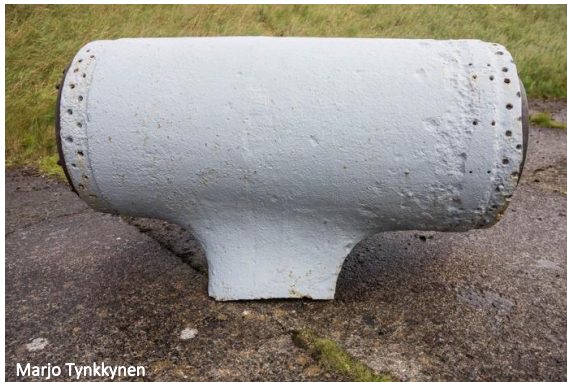
Figure 127: Starboard side A-frame bracket showing the severed short arm
