# IMPACTS OF SURFACE FAULT RUPTURE ON RESIDENTIAL STRUCTURES DURING THE 2016 $M_w$ 7.8 KAIKŌURA EARTHQUAKE, NEW ZEALAND

## ABSTRACT

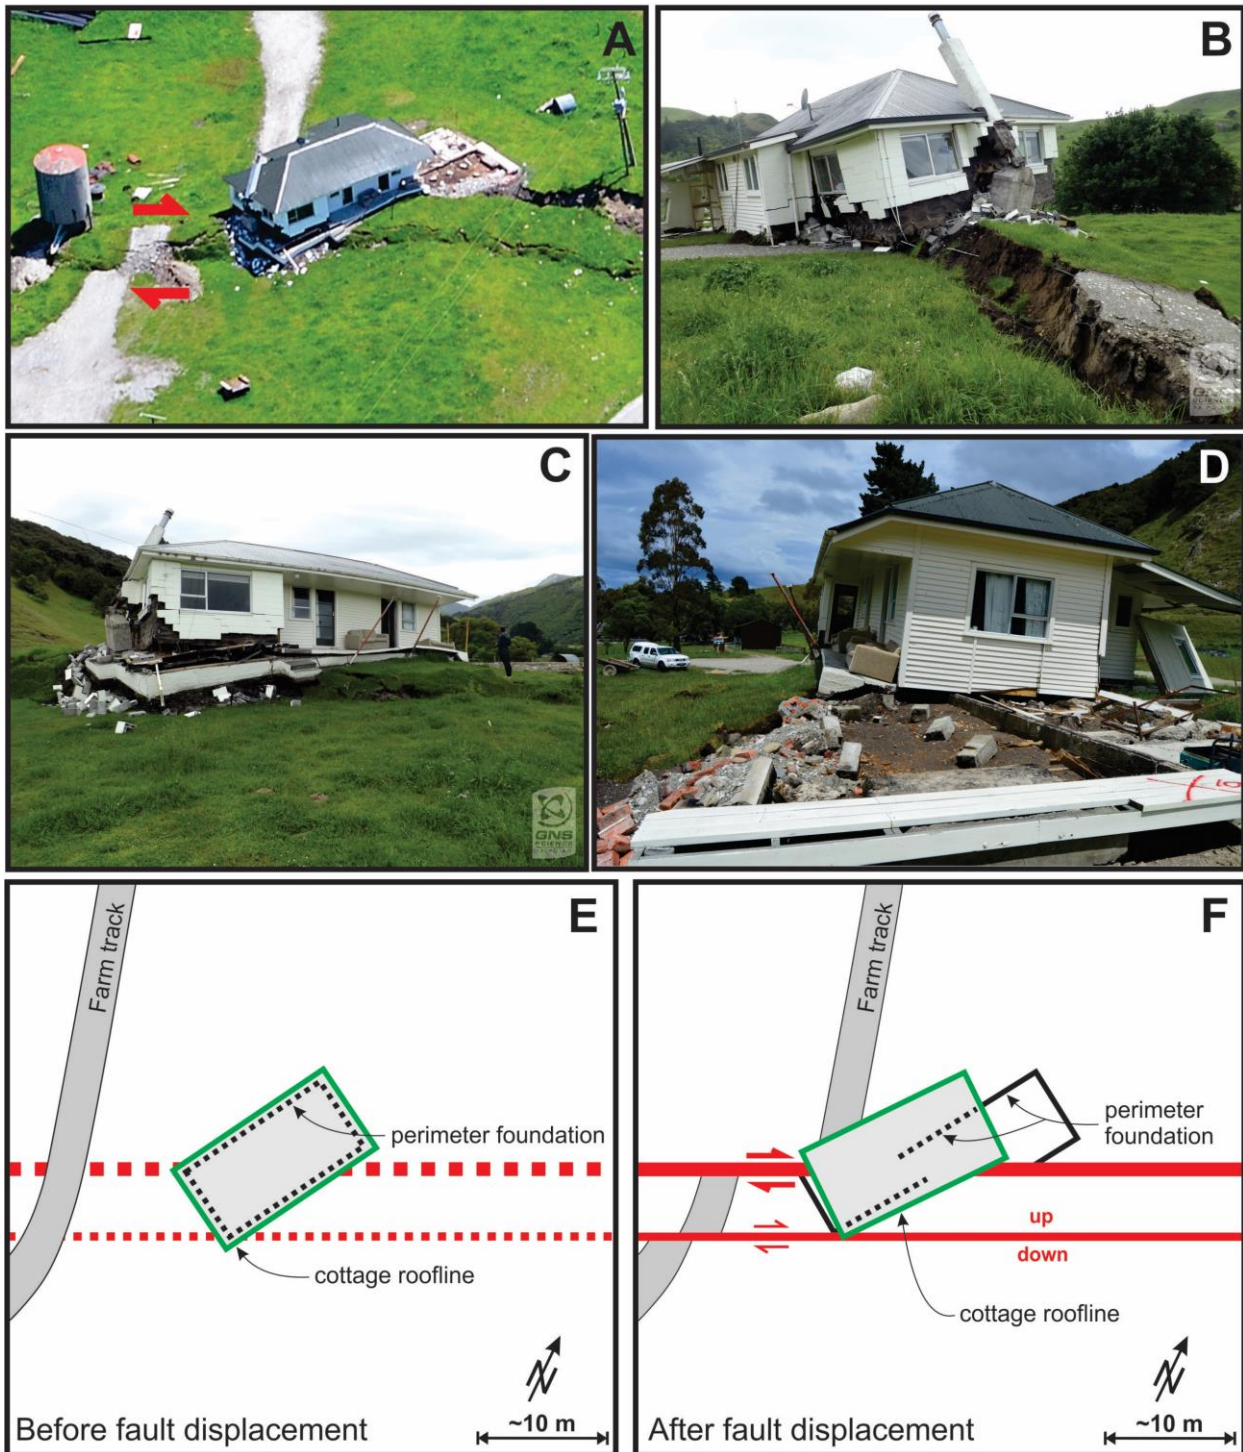
Approximately 10 m of discrete (i.e., concentrated – as opposed to distributed) horizontal and 1-2 m vertical surface fault rupture displacement extended through the foot-print of Bluff Cottage on the Kekerengu Fault (Figure 3) [18]. Offset fence lines within ~450 m either side of the cottage also document lateral displacements of ~10-11 m and narrow fault deformation zone widths (Figures 2 & 4). The foundation of Bluff Cottage was cut in half and displaced by fault rupture. The superstructure of the house was low mass, flexible, regular in shape, timber floored and relatively weakly attached to the foundation. These properties allowed the superstructure to detach from the mainly laterally displacing foundation, and to isolate it from the extreme ground deformation taking place beneath. The house suffered severe structural damage, but it did not collapse. From a life-safety perspective, and considering the large displacement and small fault zone width at this site (i.e., metre-scale strike-slip displacements and shear strains in the order of 10<sup>0</sup>; Table 2), this house performed admirably.

**Figure 3: Bluff Cottage and Kekerengu Fault surface rupture; see Figure 1 for location (Lat:  $-41.9796$ , Long:  $173.9976$ ).** (A) Oblique aerial view looking northwest. Red arrows show the sense of slip of the Kekerengu Fault that generated  $\sim 10$  m of right-lateral surface rupture displacement at this locality. Photo by Dougal Townsend taken in November 2016. (B) View of Bluff Cottage looking northeast along the strike of the surface rupture of the Kekerengu Fault. Right-laterally offset farm track to left of cottage in Figure 3A is the same farm track visible in lower right and middle left of Figure 3B. Photo by Nicola Litchfield taken in November 2016. (C) View looking northwest. Photo by Nicola Litchfield taken in November 2016. (D) View looking southwest. Note that the concrete perimeter foundation and piles that were once under the cottage have now been torn from the superstructure of the cottage and laterally displaced towards the viewer relative to the cottage. Photo by Robert Zinke taken in November 2016. (E) Schematic map of Bluff Cottage and farm track prior to surface rupture of the Kekerengu Fault. (F) Schematic map of Bluff Cottage and farm track after fault displacement.

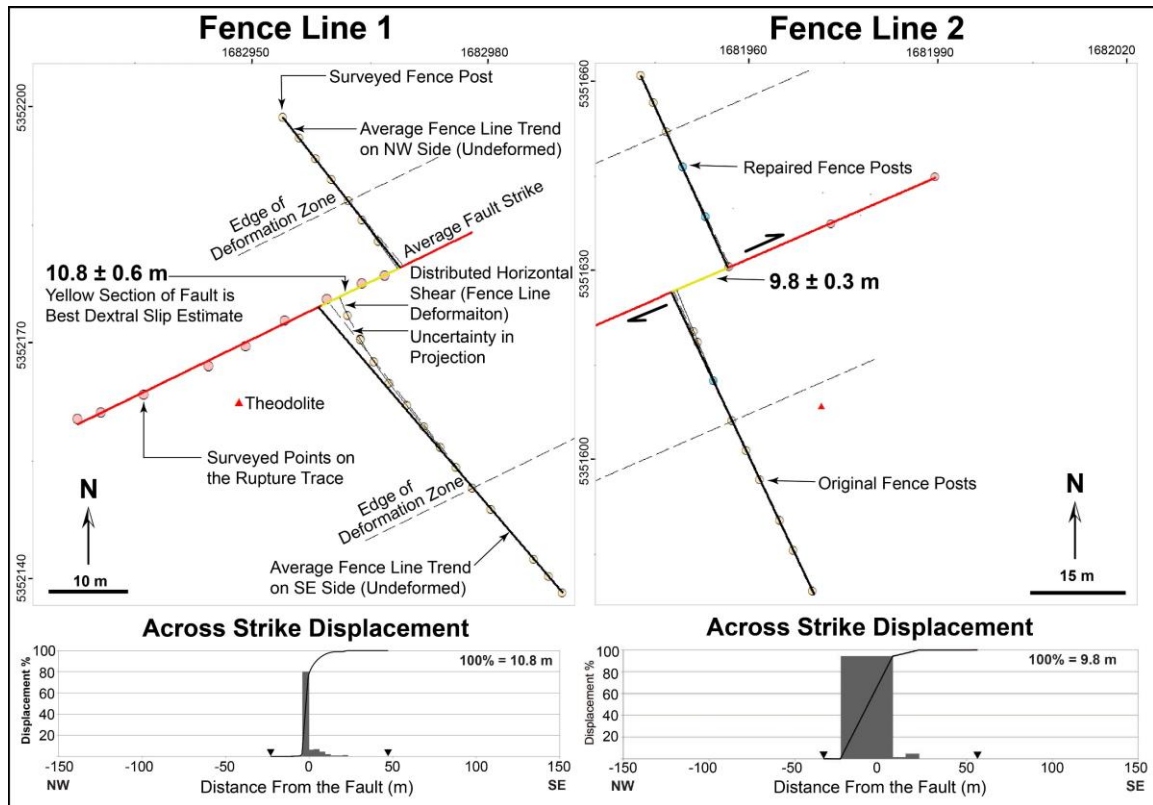
**Figure 4:** Examples of fence line displacements along the Kekerengu Fault near Bluff Cottage documenting both the amount of right-lateral displacement, and how that displacement is distributed as a function of distance perpendicular to fault strike (see Kearse et al. [18] for more detail). See Figure 2 for locations. Coordinates are New Zealand Transvers Mercator 2000.

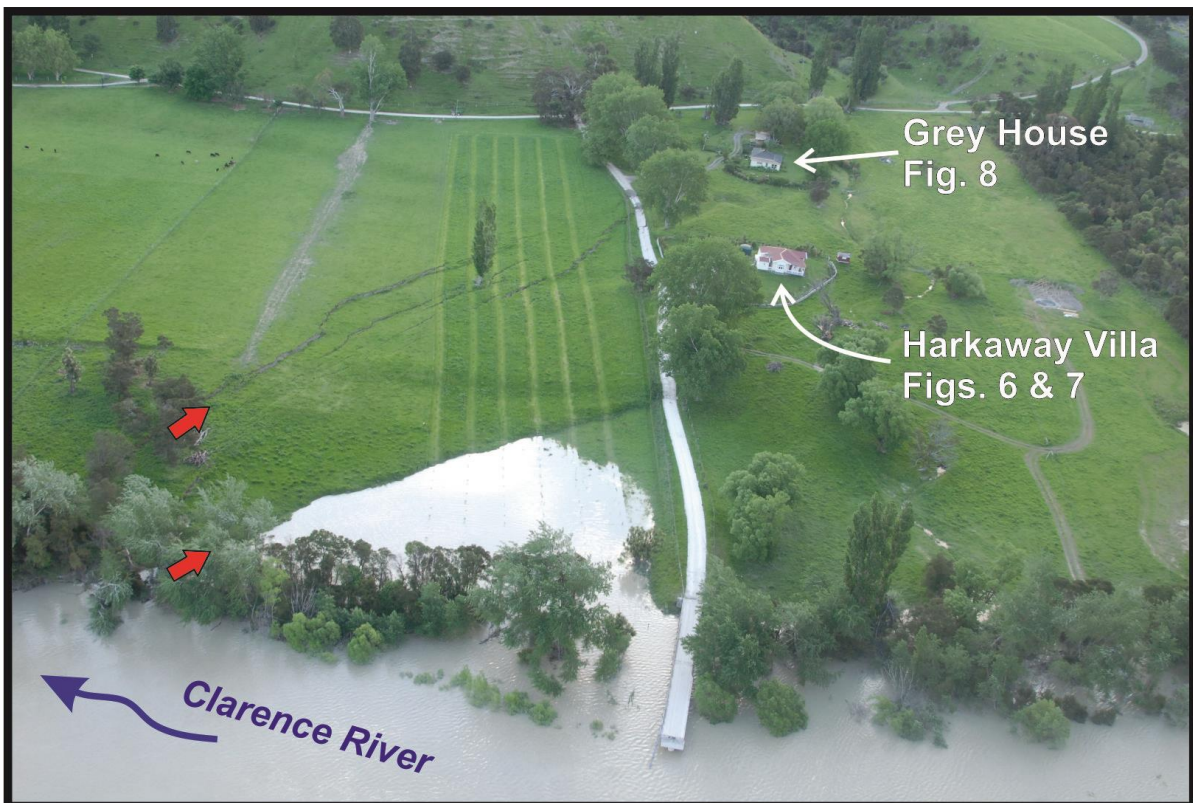
**Figure 5:** Harkaway Villa (Lat: -42.1105, Long: 173.8384), Grey House (Lat: -42.1105, Long: 173.8372), and the Papatea Fault surface rupture; see Figure 1 for location. Oblique aerial view looking west with red arrows denoting position of prominent discrete ruptures in the surface rupture deformation zone of the Papatea Fault. Photo by Will Ries taken in November 2016.

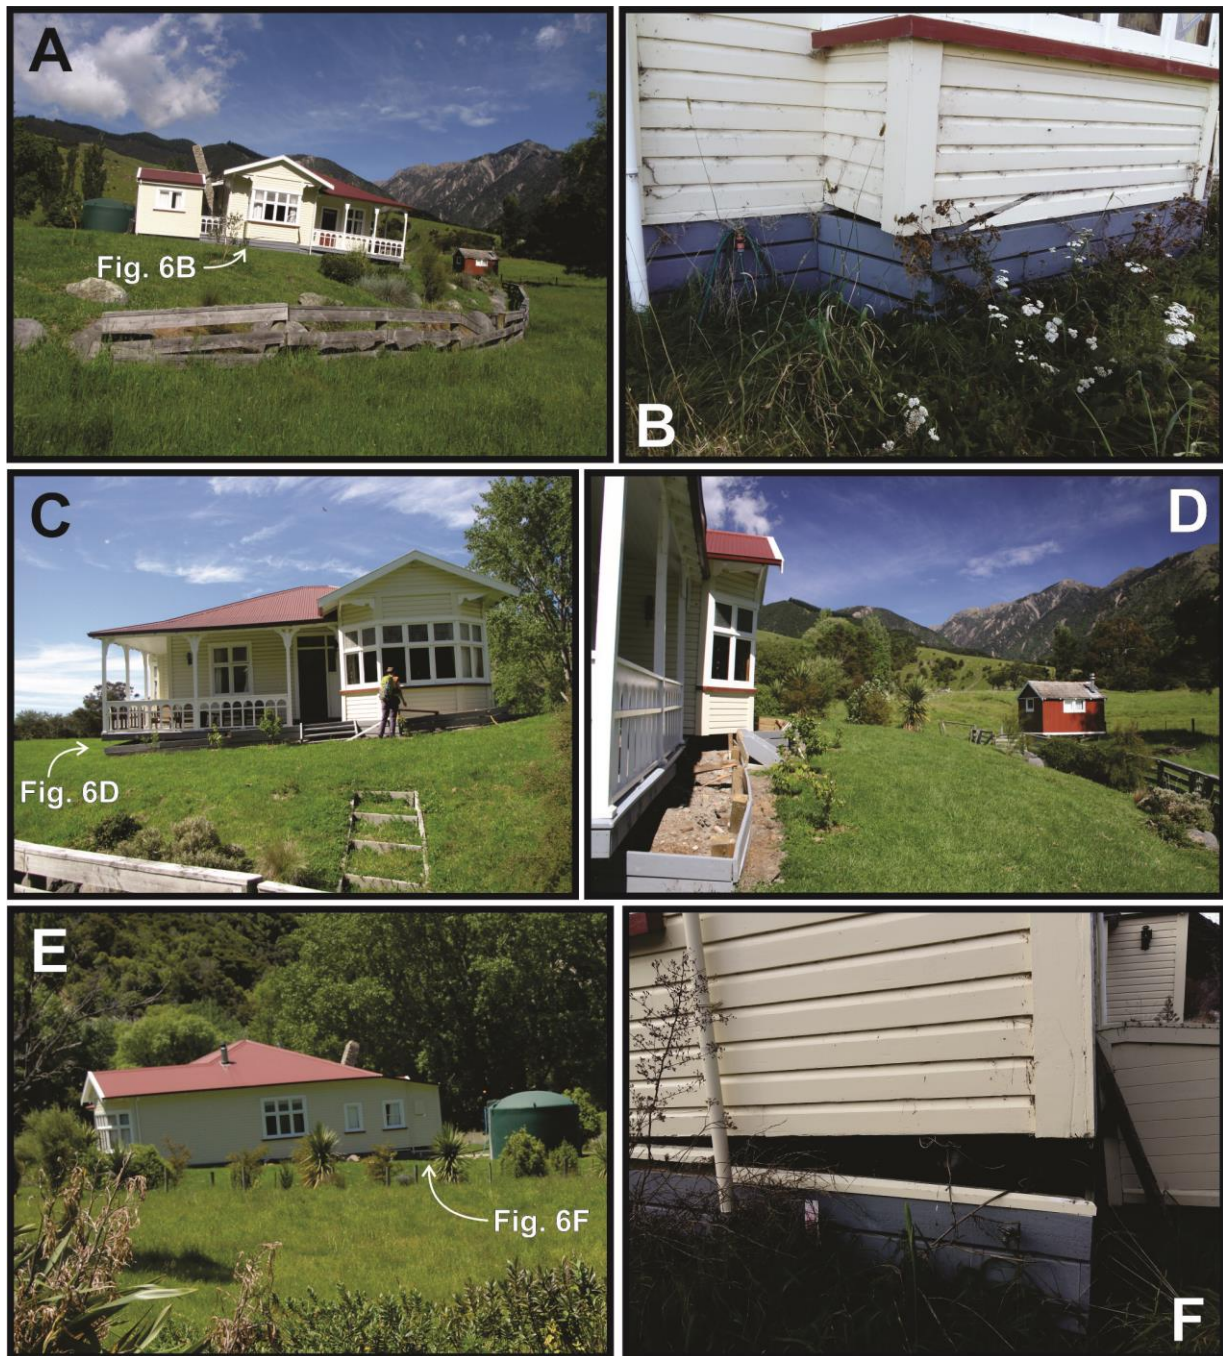
Harkaway Villa is located within the surface rupture deformation zone of the Papatea Fault which, at this site, is ~90 m wide, comprising both discrete fault rupture and distributed deformation, and accommodating ~5 m of vertical deformation (reverse, SW side up) and a comparable (or lesser) amount of left-lateral horizontal slip (Figures 5-7) [19]. The villa is situated ~200 m west from the true-right bank of the Clarence River on the hanging-wall side (SW side) of the Papatea Fault in the hinge zone between the higher vertical displacement gradient fold/fault scarp to the NE and the lower vertical displacement gradient “back limb” to the SW (Figure 7). The ground encompassed by the foot-print of the structure experienced decimetre-scale folding, horizontal sinistral flexure (i.e., fault drag), and up to ~80 cm of distributed N-S oriented extension (Figures 6 & 7). The villa was also tilted ~5° in a down to the NE sense. Fortunately, the superstructure of the house is low mass, flexible, regular in shape, timber floored and relatively weakly attached to the pile foundation, all of which allowed the superstructure to detach from the foundation thus isolating much of the ground extension from the superstructure. Despite this house suffering damage significant enough to be “red tagged”, it - from a life-safety perspective - performed commendably. It experienced very strong ground shaking, local decimetre-scale surface fault rupture deformation and is located within the hinge zone of a reverse fault scarp that has been classified in other earthquakes as a zone of ‘severe building damage’ [20], yet the villa did not collapse. And, not only did the villa not collapse, it appears that it could potentially be re-piled and re-levelled, suggesting the possibility of post-event reinstatement (as opposed to demolition and reconstruction).

**Figure 6: Harkaway Villa and Papatea Fault surface rupture. (A) View looking west showing northeastward tilt of the villa on the upthrown (hanging-wall) side of the Papatea Fault. Photo by Julie Rowland taken in November 2016. (B) View looking northwest showing detail of damage to the east-side of the villa. Photo by Julian Garcia-Mayordomo taken about 18 months after the 2016 Kaikōura earthquake. (C) View looking south of the north-side of the villa. Photo by Rob Langridge taken in November 2016. (D) View looking west of the north-side of the villa showing offset of the foundation piles from the superstructure. Photo by Julie Rowland taken in November 2016. (E) View looking east of the west-side of Harkaway Villa. Photo by Rob Langridge taken in November 2016. (F) View looking east showing detail of damage to the west-side of the villa. Photo by Julian Garcia-Mayordomo taken in May 2018.**

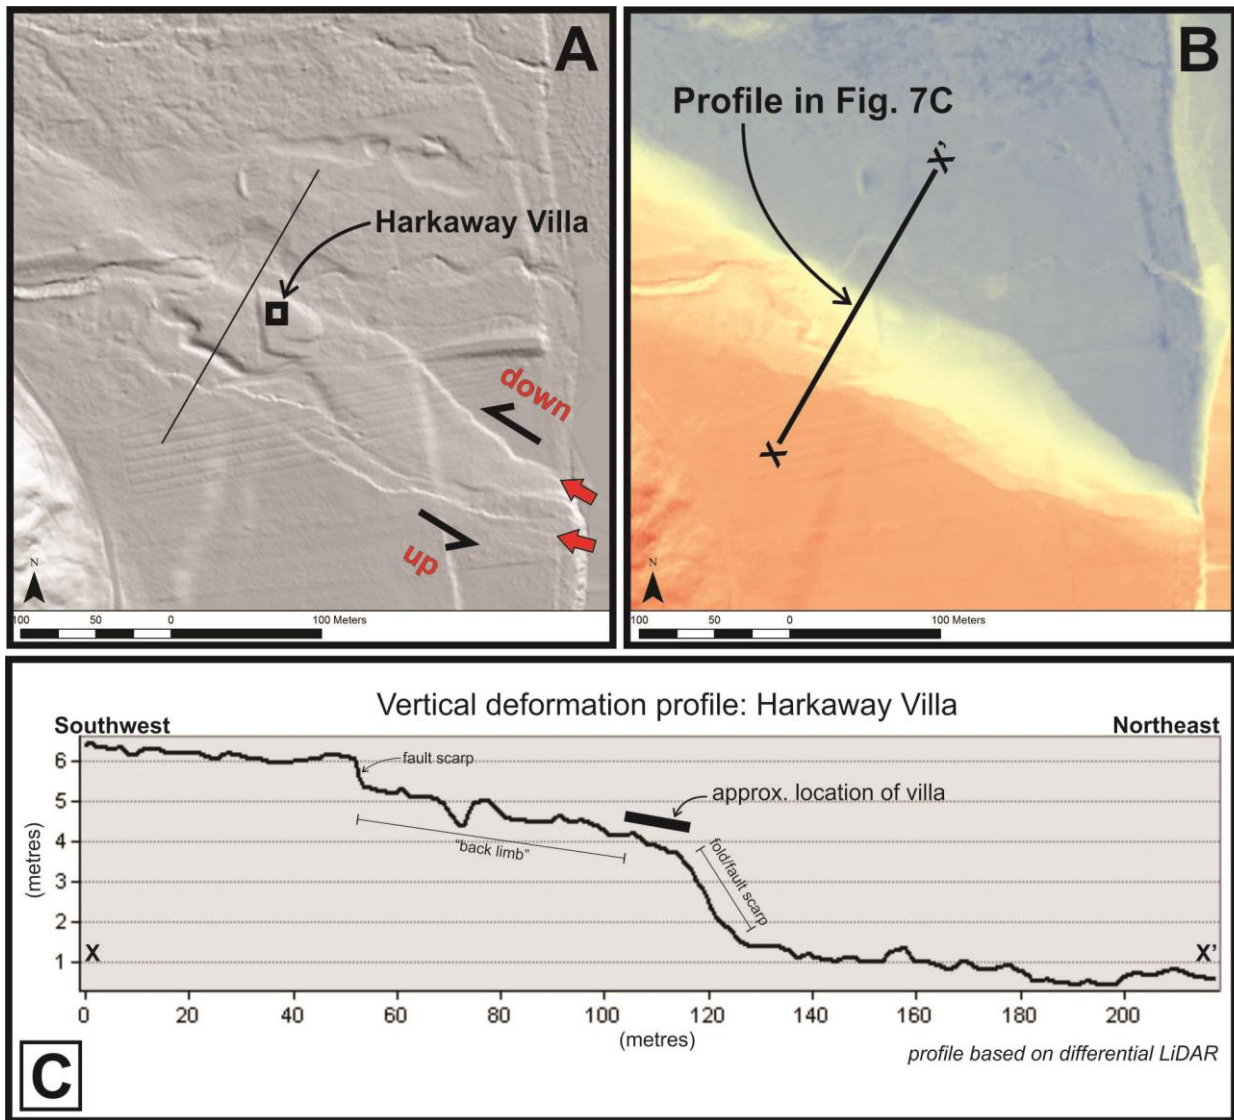
As stated above, and illustrated in Figure 7, Harkaway Villa is located in the transition zone between the higher strain fold/fault scarp to the NE and the lower strain “back limb” to the SW. Utilising a combination of field observations, a differential Light Detecting and Ranging (LiDAR) digital elevation model (DEM; 2013 LiDAR subtracted from post-earthquake 2016 LiDAR) at the site (Figures 7B & 7C), and assuming simple shear, ground strains at the villa site can be approximated.

based on ~1.5 m of elevation gain over 7 m of fault-perpendicular horizontal distance (Figure 7C), an estimated/observed fault dip of 45°- 90° [19], and assuming simple shear. Strike-slip shear strains of  $\leq 0.2$  can be estimated based on an observed horizontal to vertical ratio of displacement of  $\leq 1$  [19], ~1.5 m of elevation gain over 7 m of fault-perpendicular horizontal distance, and assuming simple shear. Based on the above dip-slip and strike-slip shear strain considerations, net shear strains oriented parallel to the plane of the fault of ~0.2-0.4 (rounded to  $10^{-1}$ ) are approximated in the region of the fold/fault scarp.

**Figure 7: Harkaway Villa and Papatea Fault surface rupture. (A) 2016 post-earthquake LiDAR hill shade DEM with black square denoting villa's location, and red arrows showing location of prominent discrete ground surface ruptures. (B) Differential LiDAR DEM with blue colours denoting little vertical change and red colours denoting significant positive vertical change (see Figure 7C for more detail regarding scale). (C) Vertical deformation profile derived from the differential LiDAR DEM. Vertical exaggeration = 7.5.**

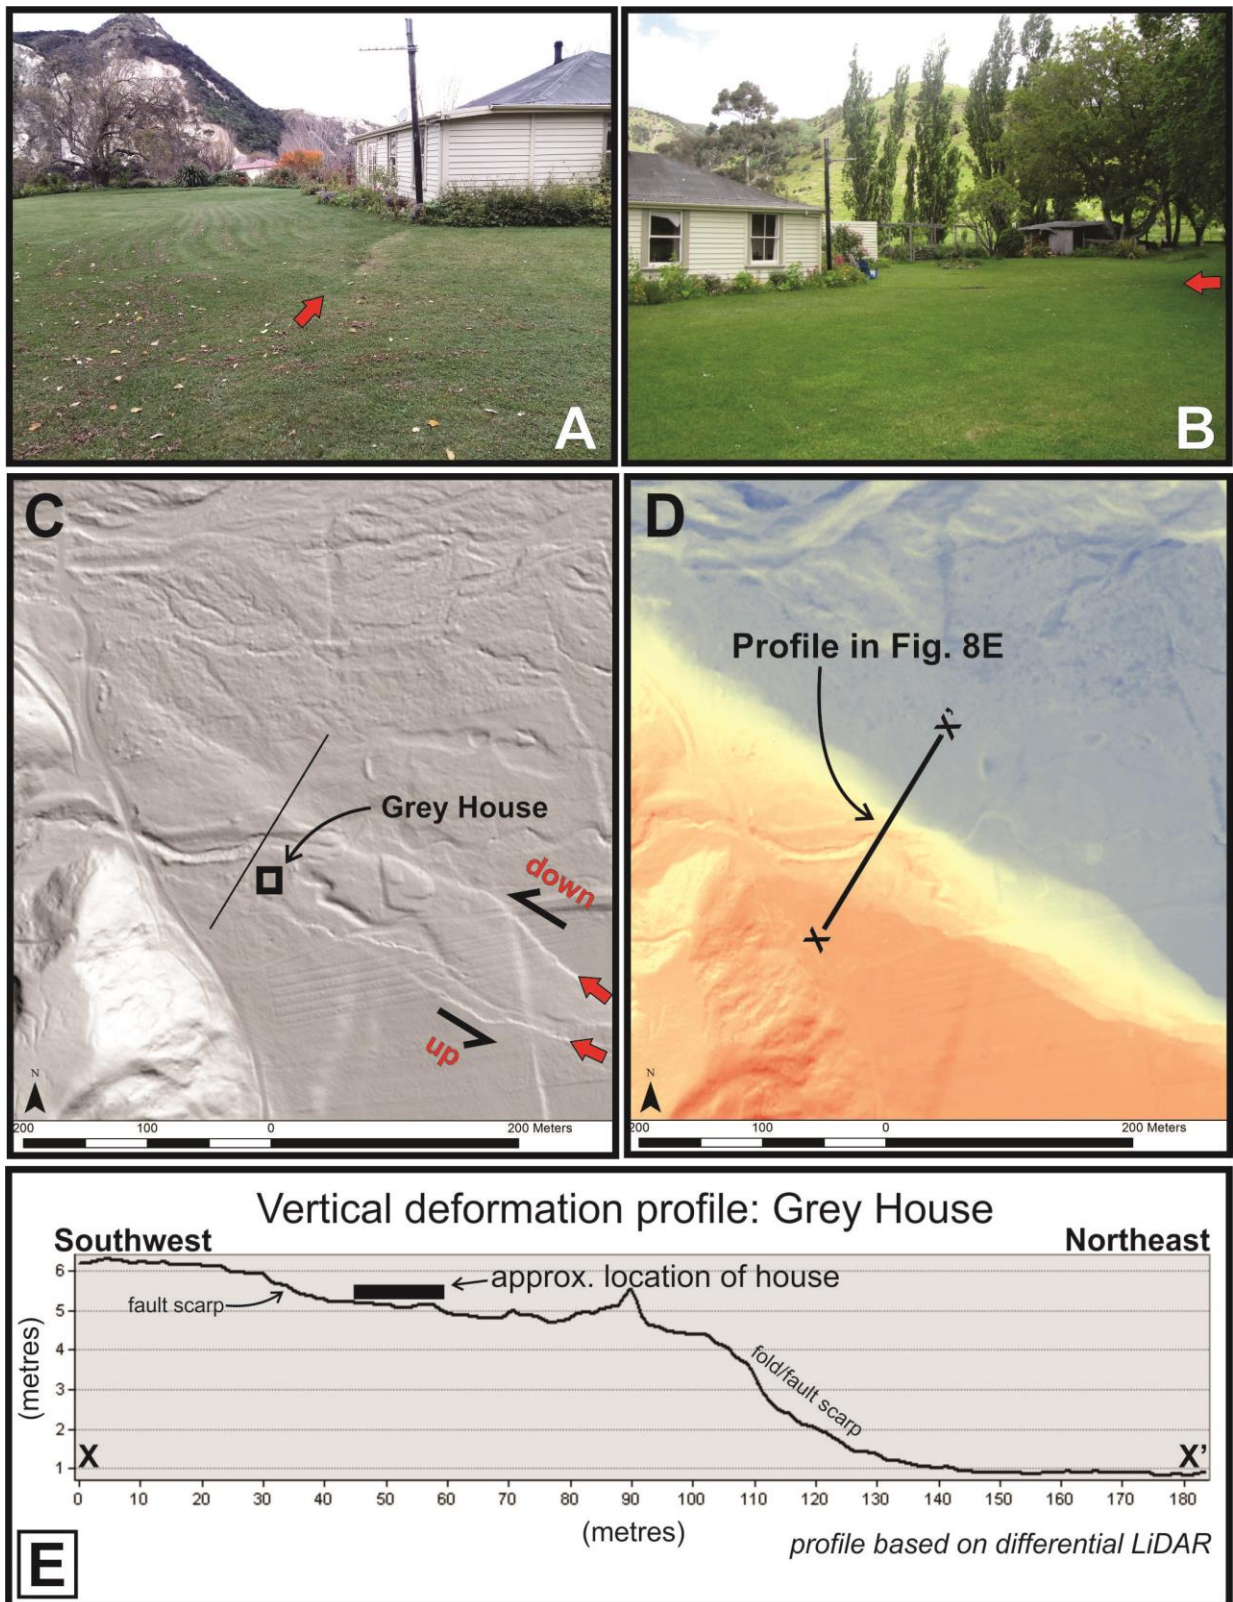
**Figure 8: Grey House and Papatea Fault surface rupture.** (A) View looking east-southeast with red arrow showing location of centimetre-scale discrete rupture that intersects northwest corner of the house. Harkaway Villa (Figures 5 & 6) is visible in the middle distance. Photo by Julia Garcia-Dayomo taken about 18 months after the 2016 Kaikōura earthquake. (B) View looking southwest. Red arrow denotes the location of centimetre-scale discrete rupture that intersects the northwest corner of the house. (C) 2016 post-earthquake LiDAR hill shade DEM with the black square denoting the house's location, and red arrows showing the location of prominent discrete ground surface ruptures. (D) Differential LiDAR DEM with blue colours denoting little vertical change and red colours denoting significant positive vertical change (see Figure 8E for more detail regarding scale). (E) Vertical deformation profile derived from the differential LiDAR DEM. Vertical exaggeration = 6.4.

Fault. At this locality, the Papatea Fault accommodates approximately 6 m of vertical deformation (reverse, SW side up), and a comparable (or lesser) amount of left-lateral horizontal slip [19], and defines an ~100+ m wide surface fault rupture deformation zone comprising both discrete fault rupture and distributed deformation (Figure 8). The house is located on the hanging-wall side (SW side) of the Papatea Fault with metre-scale surface fault rupture passing within ~45 m NE of the house, metre- to decimetre-scale surface fault rupture passing within ~10 m SW of the house, and centimetre-scale surface fault rupture intersecting the foot-print of the house (Figures 8A & 8B). Nevertheless, the house came through the earthquake in good shape. It did not suffer significant structural damage, and following the earthquake it was adjudged suitable for habitation, and is currently occupied. In addition, the house is located within a portion of the surface rupture deformation zone that experienced minimal tilt, and this too no doubt facilitated post-event occupation.

Utilising a combination of field observations, a differential LiDAR DEM at the site (Figures 8D & 8E), and assuming simple shear, ground strains at the Grey House site can be approximated. At the location of the house, dip-slip shear strains of ~0.02-0.03 can be estimated based on ~0.5 m of elevation gain over 25 m of fault-perpendicular horizontal distance (Figure 8E), an estimated/observed fault dip of 45°-90° [19], and assuming simple shear. Strike-slip shear strains of  $\leq 0.02$  can be estimated based on an observed horizontal to vertical ratio of displacement of  $\leq 1$  [19], ~0.5 m of elevation gain over 25 m of fault-perpendicular horizontal distance, and assuming simple shear. Based on the above dip-slip and strike-slip shear strain considerations, net shear strains oriented parallel to the fault plane of ~0.03-0.04 (rounded to  $10^{-2}$ ; Table 2) are approximated at the Grey House site.

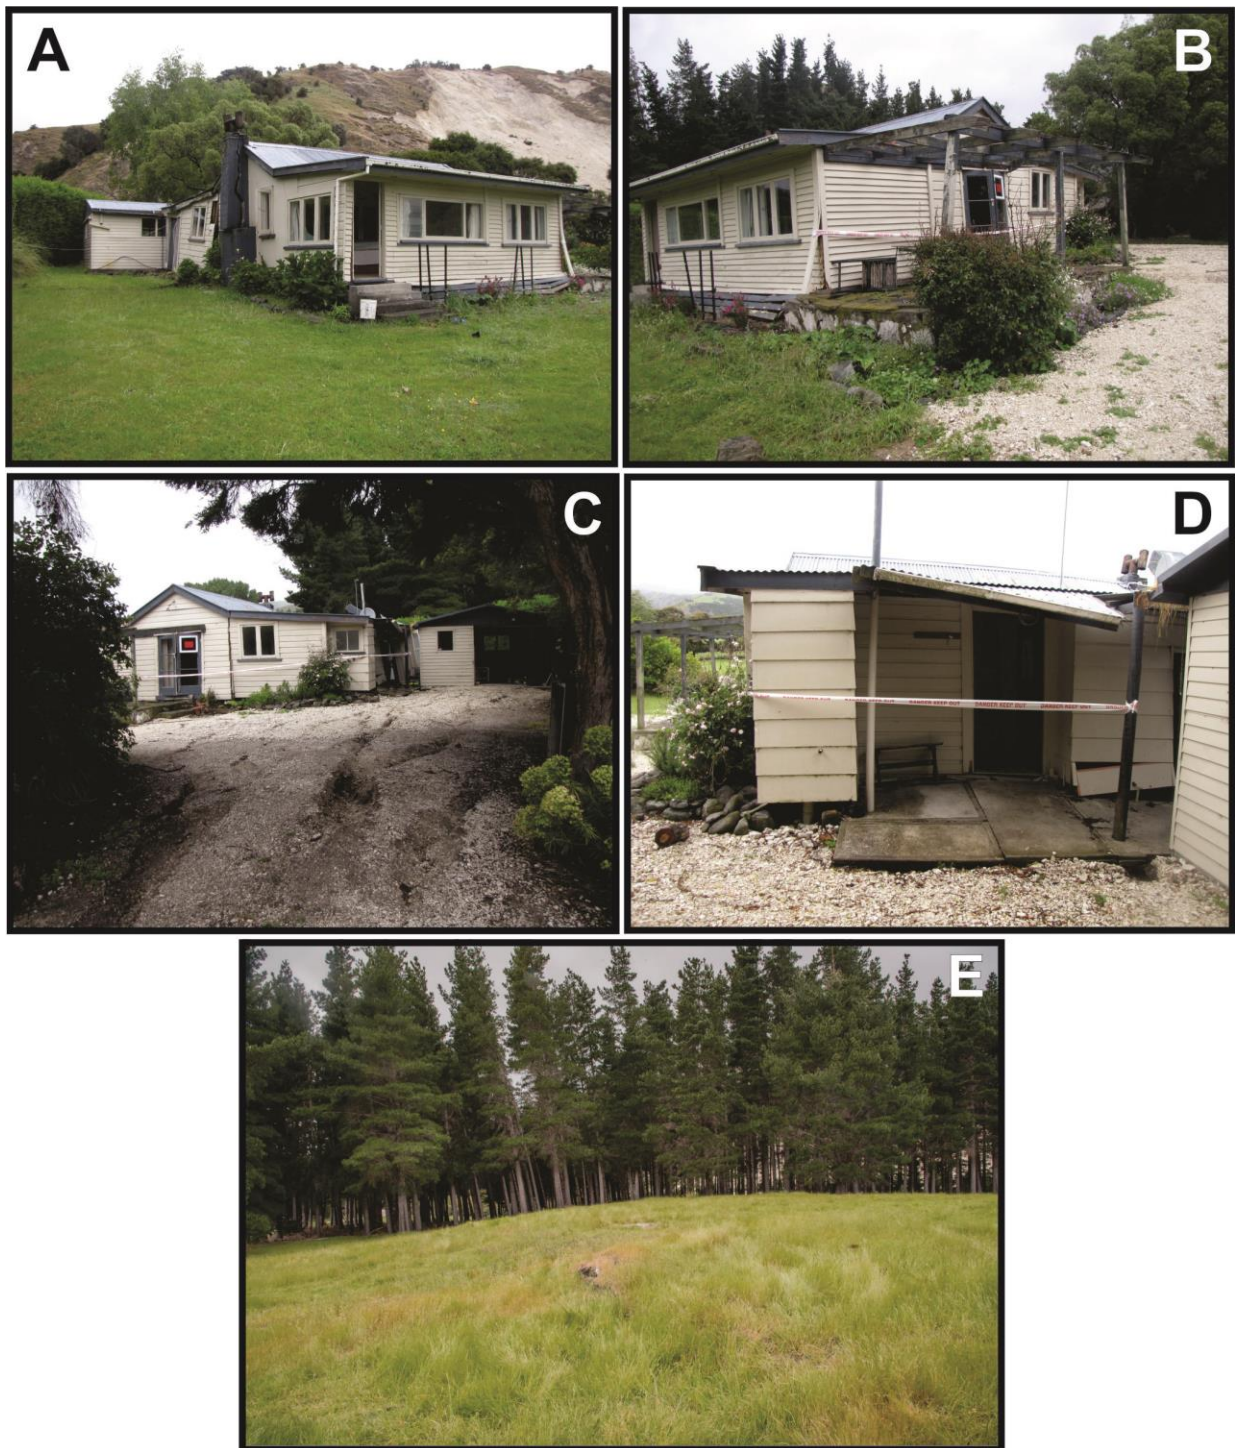
Middle Hill Cottage was located within the surface rupture deformation zone of the Papatea Fault which, at this site, is ~100 m wide, comprising both discrete fault rupture and distributed deformation, and accommodating ~7.5 m of vertical deformation (reverse, W side up) and a comparable (or lesser) amount of left-lateral horizontal slip (Figures 9 & 10) [19]. The Cottage was located on the hanging-wall side of the Papatea Fault, close to the crest of the broad fold/fault scarp that is cut by extensional fissures (Figure 9C). The ground encompassed by the foot-print of the structure experienced decimetre-scale folding, horizontal sinistral flexure (i.e., fault drag), tilting, and distributed E-W oriented extension. As a result of the Kaikōura earthquake, this house suffered damage significant enough to be “red tagged”, and it has since been demolished. However, from a life-safety perspective, this house performed creditably - it experienced very strong ground shaking, tilting and decimetre-scale surface fault rupture deformation, but it did not collapse.

**Figure 9: Middle Hill Cottage and Papatea Fault surface rupture; see Figure 1 for location (Lat: -42.1536, Long: 173.8667).**  
 (A) View looking west. Photo by Rob Langridge taken in December 2016. View looking south-southwest. Photo by Rob Langridge, December 2016. (C) View looking southeast along the strike of extensional fissures located in the crestal region of the primary fold/fault scarp that extend towards, and intersect, the cottage. Photo by Rob Langridge, December 2016. (D) View looking northeast. Photo by Rob Langridge, December 2016. (E) View from the cottage looking south-southeast along strike of the Papatea Fault's surface rupture deformation zone. Prior to the 2016 rupture of the Papatea Fault, the ground surface in this photograph was approximately flat and horizontal, and the trunks of the pine trees were all sub-vertical. Photo taken about a year after the earthquake by Stefano Pucci.

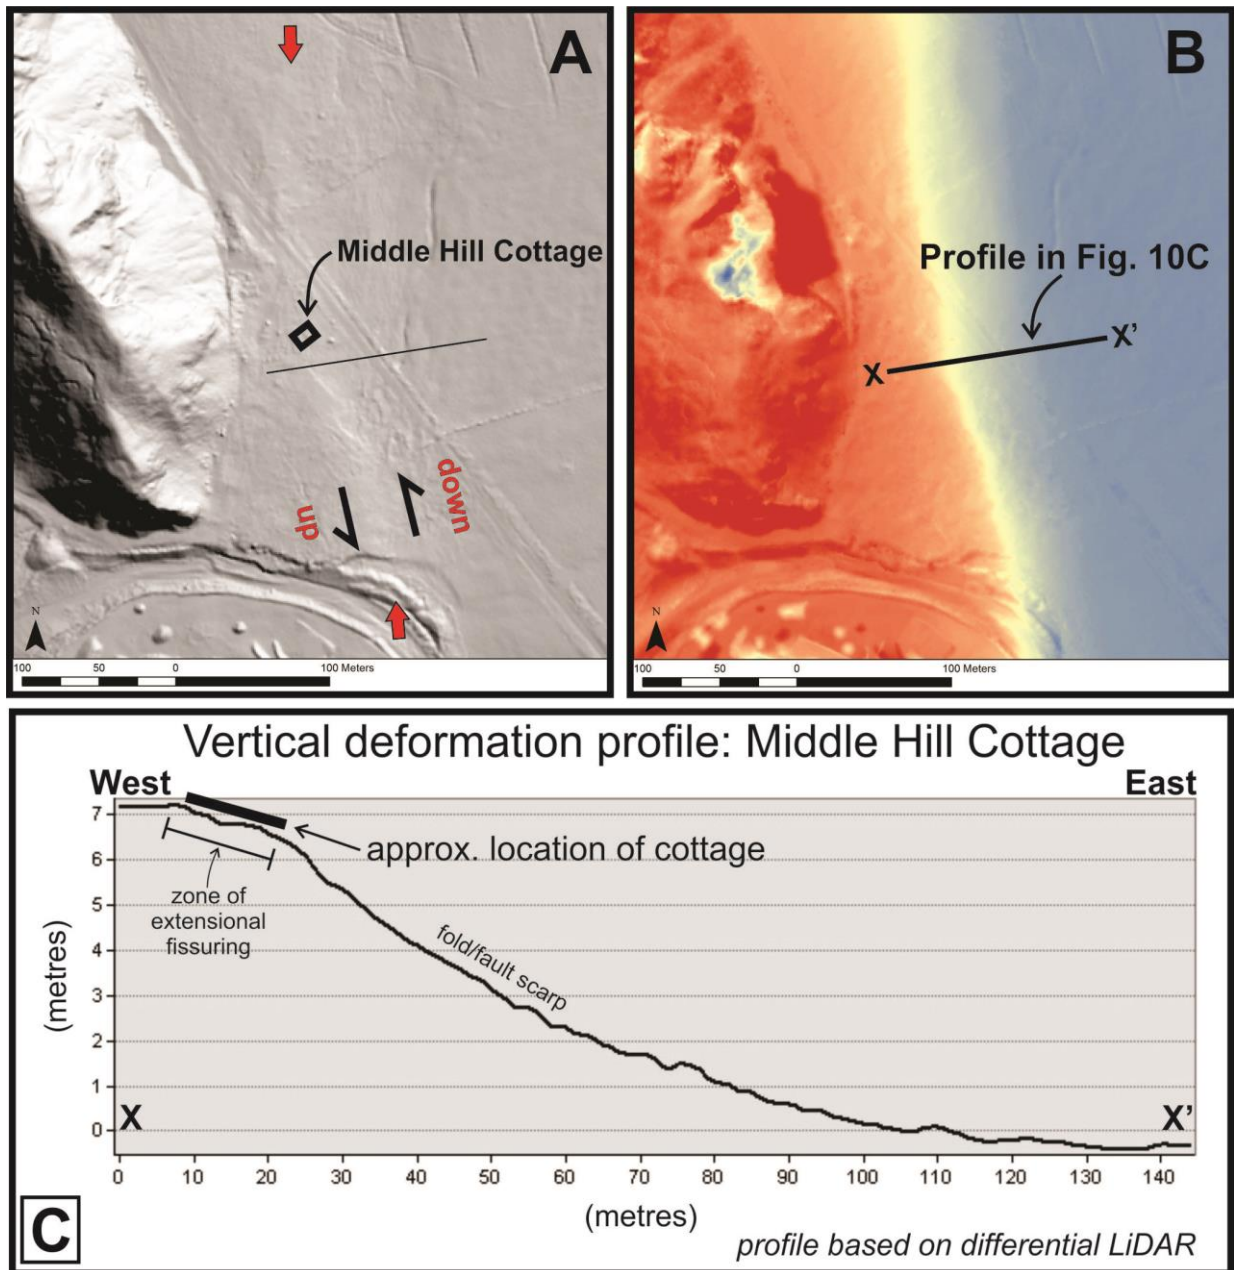
**Figure 10: Middle Hill Cottage and Papatea Fault surface rupture.** (A) 2016 post-earthquake LiDAR hill shade DEM with the black square denoting cottage's location, and red arrows showing the location the surface fault rupture scarp. (B) Differential LiDAR DEM with blue colours denoting little vertical change and red colours denoting significant positive vertical change (see Figure 10C for more detail regarding scale). (C) Vertical deformation profile derived from the differential LiDAR DEM. Vertical exaggeration = 6.1.

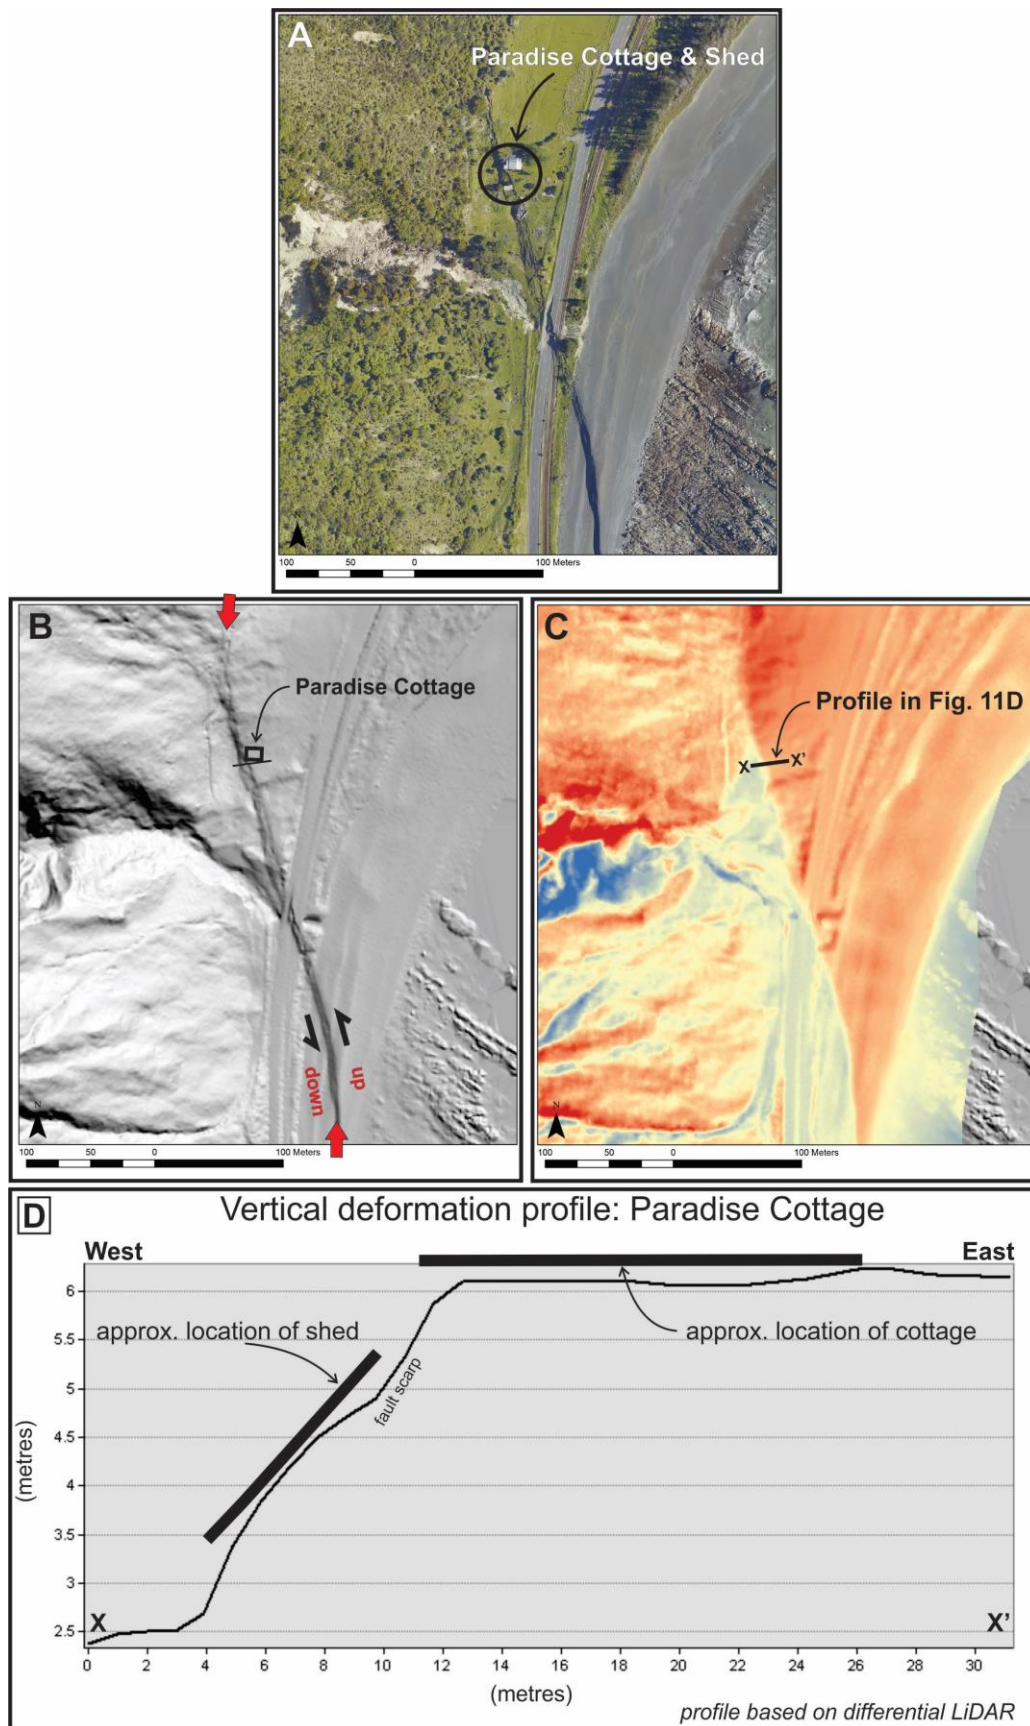
**Figure 11: Paradise Cottage and Papatea Fault surface rupture; see Figure 1 for location (Lat: -42.2010, Long: 173.8753). (A) 2016 post-earthquake vertical aerial orthophotograph. Black circle denotes location of cottage and shed to the south. (B) 2016 post-earthquake LiDAR hill shade DEM showing location of cottage (black square) and prominent discrete ground surface ruptures (red arrows). (C) Differential LiDAR DEM with blue colours denoting little vertical change and red colours denoting significant positive vertical change (see Figure 11D for more detail regarding scale). (D) Vertical deformation profile derived from differential LiDAR DEM located half-way between the cottage and the shed. Vertical exaggeration = 3.3.**

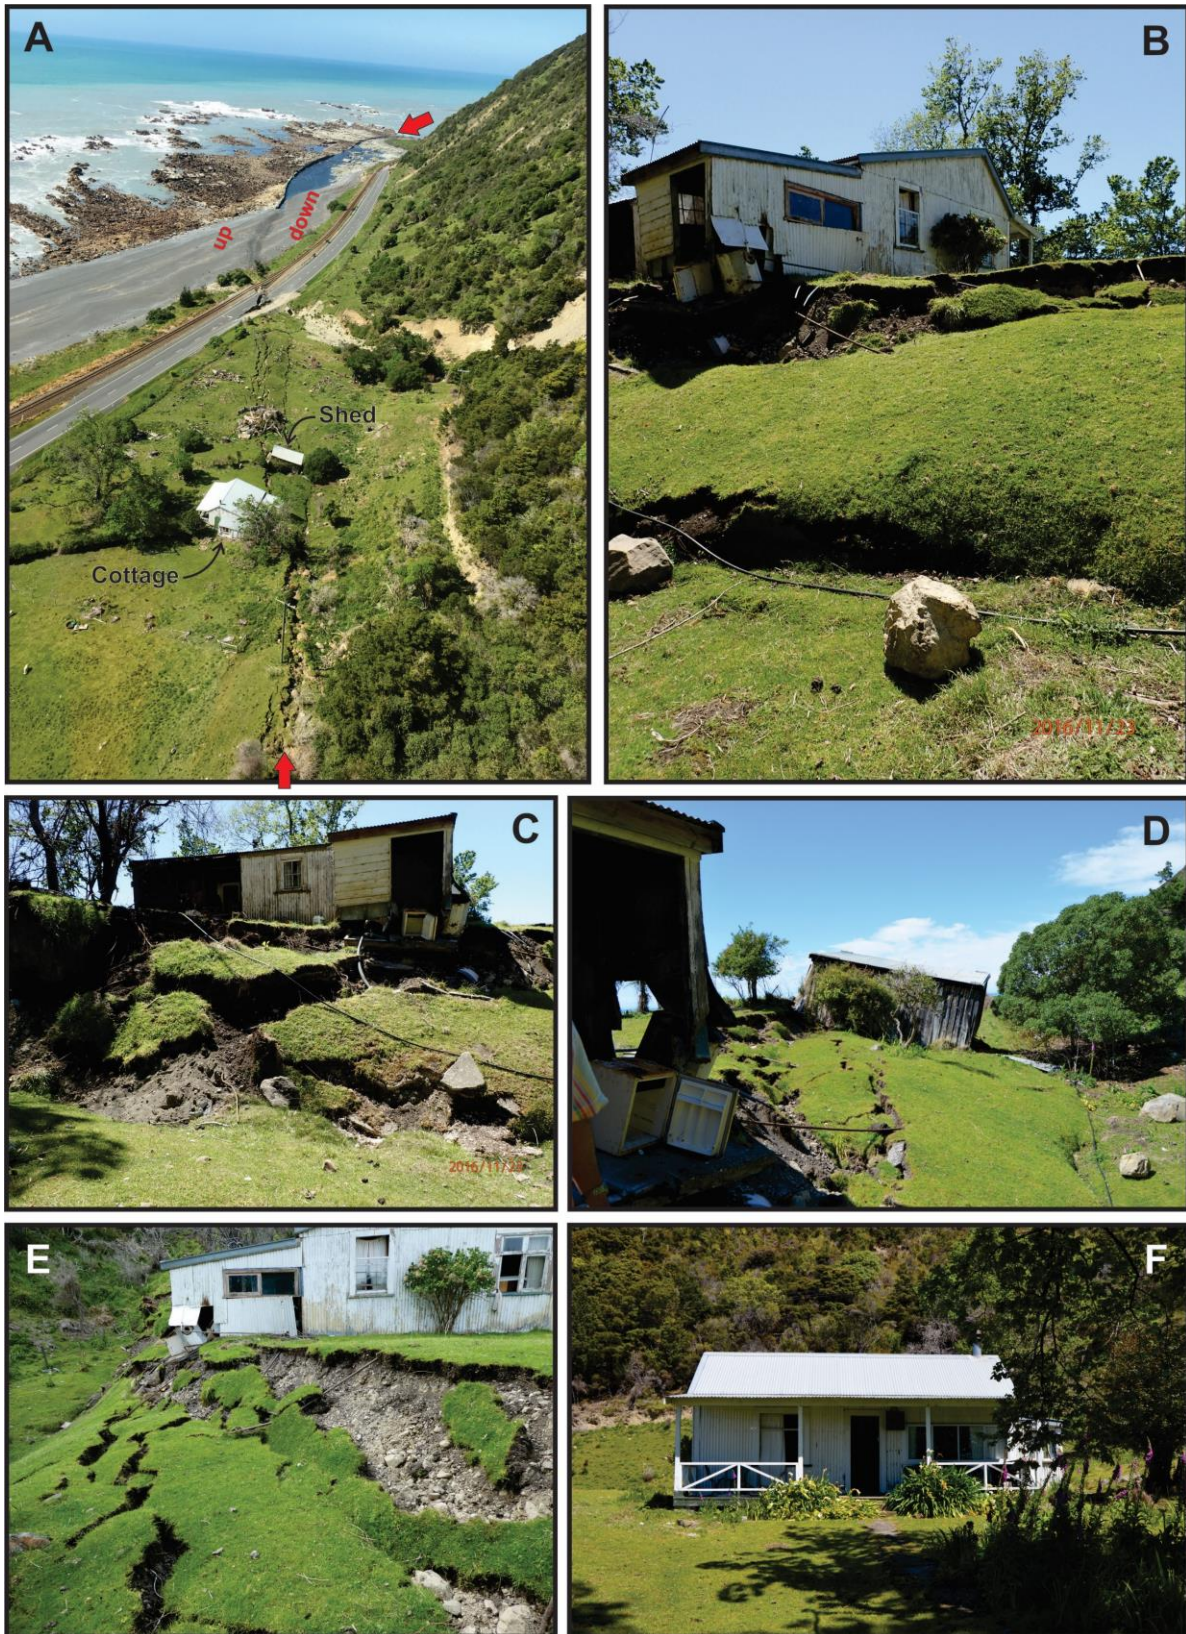
At the coast, where Paradise Cottage is located, the Papatea Fault comprises several main strands; the cottage is located across and immediately adjacent to the western most of these [19]. Here, the western strand of the Papatea Fault accommodates approximately 3.5 m of vertical deformation (E side up) (Figure 11D), a subordinate amount of left-lateral horizontal slip [19], and defines an 8-10 m wide surface fault rupture deformation zone primarily comprising discrete fault rupture. The cottage is located on the upthrown side of the fault, at the eastern edge of the surface rupture deformation zone, and has had its back-side ripped out by surface fault rupture. The nearby timber shed is located entirely within the fault scarp, and has been severely tiled and deformed. Neither the house nor the shed collapsed.

**Figure 12: Paradise Cottage and Papatea Fault surface rupture; see Figure 1 for location. (A) Oblique aerial view looking south-southeast along the strike of the western strand of the Papatea Fault. Red arrows denote the position of prominent discrete rupture. Photo by Will Ries taken in November 2016. (B) View looking northeast. Photo by Alex Hatem taken in November 2016. (C) View looking east. Photo by Alex Hatem taken in November 2016. (D) View looking south-southeast towards the shed. Photo by Robert Zinke taken in November 2016. (E) View looking north-northwest along strike of the surface fault rupture. Photo by Tim Little taken in November 2016. (F) View looking east towards the front-side of the cottage. The front of the cottage appears to be little damaged and belies the havoc out back. Photo by Robert Zinke taken in November 2016.**

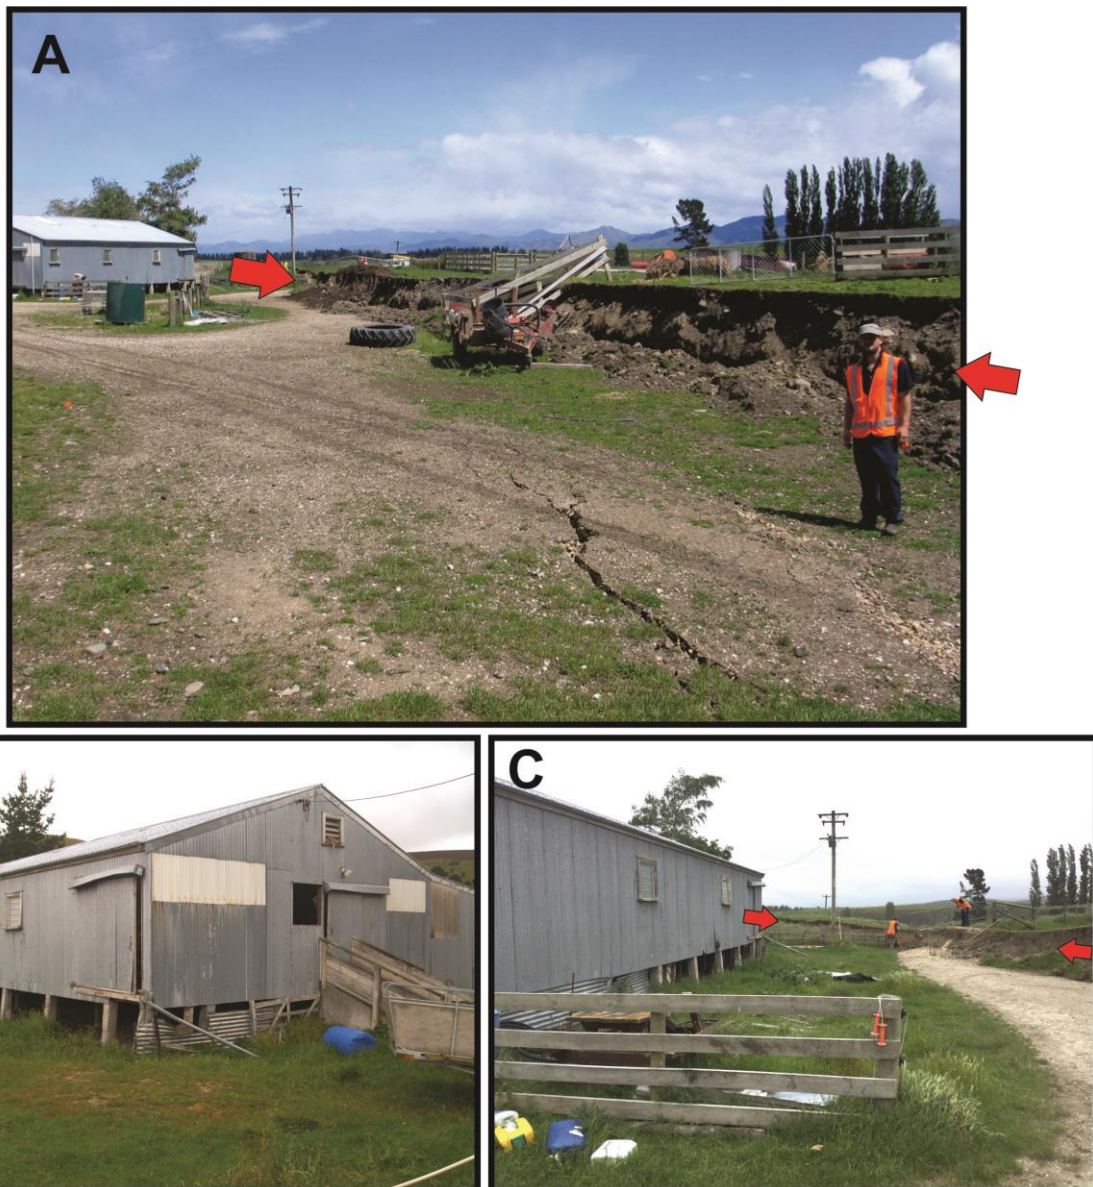
20 m wide zone of decimetre-scale ground subsidence that encompasses minor fracturing and small faults with vertical displacements of 1-10 cm (Figure 13A). This zone of ground subsidence extends from the stockyard adjacent to, and southwest of, the woolshed to the northeast for over 50 m. Fault rupture induced damage to the Glenbourne woolshed appears to be limited to rotation of some of the shallow-seated concrete piles (Figure 13B). The super structure itself is relatively undamaged and intact. We suspect that rotation of the piles isolated the super structure from the decimetre-scale fault rupture ground deformation underneath. It is pertinent to note that a similarly constructed, and piled, woolshed sited across the 2010 surface rupture of the Greendale Fault displayed similar performance with rotation of shallow-seated piles isolating, to a large extent, the super structure from the underlying fault rupture ground deformation [21].

**Figure 13: Glenbourne Woolshed and The Humps Fault surface rupture; see Figures 1 & 14 for location (Lat: -42.6152, Long: 173.1058). (A) View looking southwest along the fault rupture towards the woolshed. Note distributed centimetre-scale cracking in the foreground (in front of the high-vis geologist), adjacent to the main trace (red arrow, and behind the high-vis geologist). The distributed centimetre-scale cracking persists along strike for many tens of metres. Photo by Jarg Pettinga taken in November 2016. (B) View looking south at the woolshed (main fault scarp is behind the camera). Tilt and rotation of the shallow-seated concrete piles is the only recognisable damage. Photo by Clark Fenton taken in December 2016. (C) View looking southwest along the side of the woolshed and towards the main fault scarp at this site. Photo by Tim Stahl taken in November 2016.**
