# IMPACTS OF SURFACE FAULT RUPTURE ON RESIDENTIAL STRUCTURES DURING THE 2016 $M_w$ 7.8 KAIKŌURA EARTHQUAKE, NEW ZEALAND

## ABSTRACT

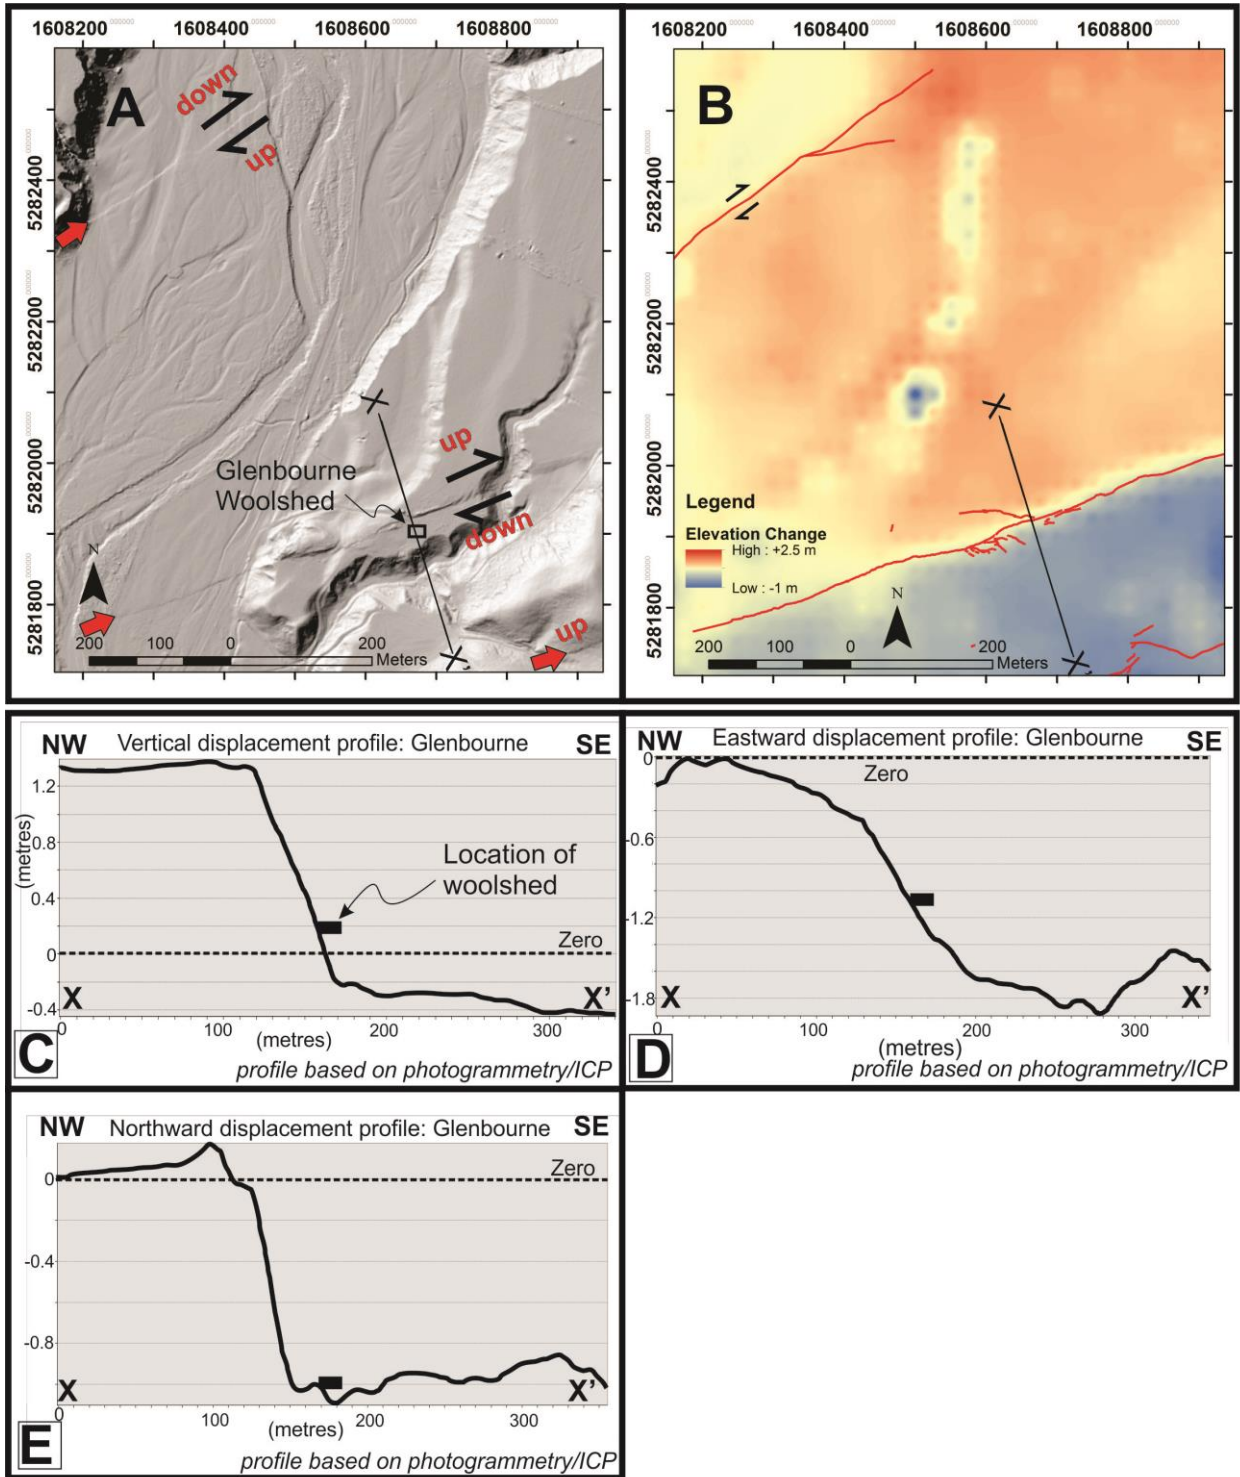
**Figure 14: Glenbourne Woolshed and surface rupture of The Humps Fault. (A)** LiDAR hill shade DEM showing location of the woolshed and two prominent discrete fault traces (red arrows), one of which is within ~5 m of the woolshed (see Figures 13A & 13C). **(B)** Raster of vertical displacements in the same area as (A), using ICP method outlined in the text. **(C), (D), and (E)** are the vertical, eastward, and northward displacement profiles from X to X' on the top two images. The location of the woolshed is shown on each profile. Note that while relative motions were mapped in the field, the absolute sense of displacement is more complex, with the downthrown side of the fault moving southwestward and the up-thrown side of the fault remaining relatively stable except in the vertical direction. Y-axis exaggeration in (C) & (D) = 85. Y-axis exaggeration in (E) = 130.

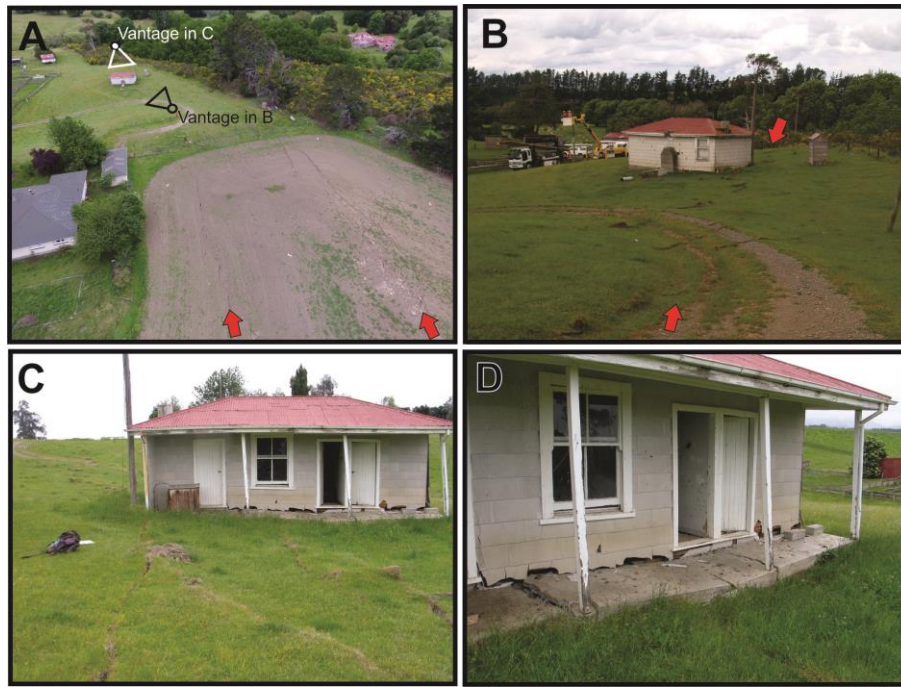
depression that transitions to the east into a narrow zone of Riedel shears and tension fractures (Figures 15 & 16A). In the field, an adjacent fault-offset fence yielded RTK-derived offset measurements of 0.9 m dextral and 0.5 m vertical [4]. The cottage experienced a chimney collapse (Figure 15B), and multiple fractures to the concrete foundation (Figures 15C & 15D). Timber supports for the roof/veranda at the front the

cottage experienced minor amounts of shear, and were deformed out-of-plumb (Figures 15C & 15D). Several cladding planks at the base of the exterior of the cottage were broken (Figure 15D). Although surface rupture caused structural damage to the cottage, the cottage appears to be far from collapse. Using a combination of the ICP-based analysis (see

**Figure 15: Hillview Cottage and surface rupture of The Humps Fault; see Figures 1 & 16 for location (Lat: -42.6287, Long: 173.0154). (A) Oblique aerial view looking east towards the cottage, along discrete dextral-normal surface fault ruptures (red arrows). Photo courtesy of Sam McColl taken from a drone in November 2016. (B) View looking northeast. At this location, the cottage is impacted by decimetre-scale discrete fault rupture (in this case Riedel shears) and centimetres to decimetres of distributed deformation between the shears. Note the collapsed chimney. Photo taken by Clark Fenton in November 2016. (C) & (D) Details of damage to the cottage caused by decimetre-scale surface fault rupture. Photos taken by Jarg Pettinga in November 2016.**

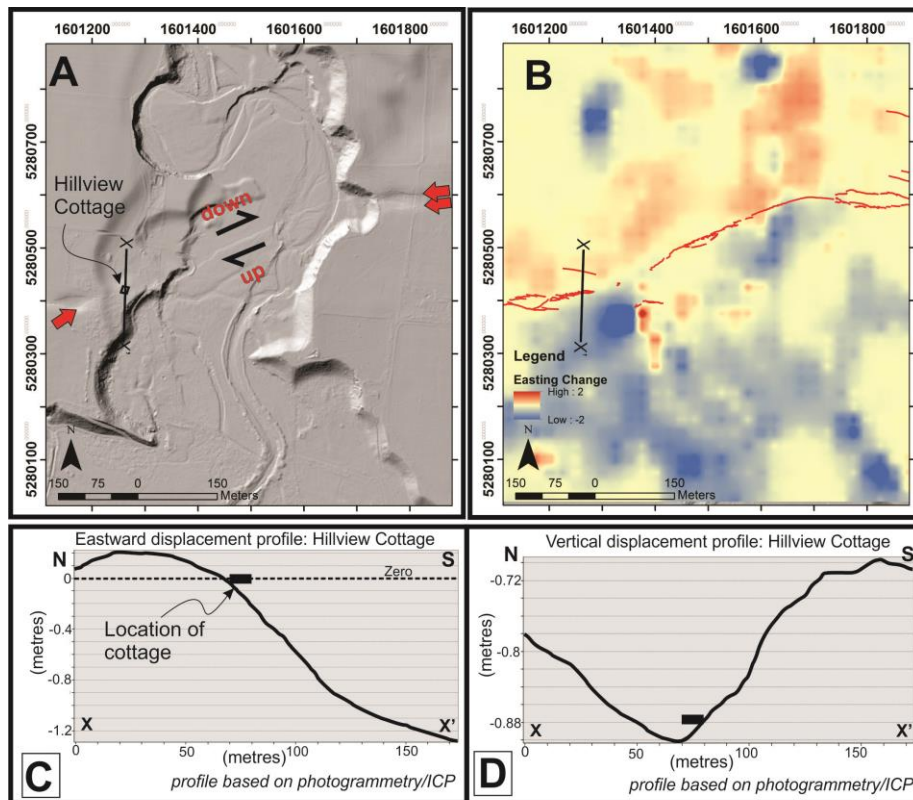
**Figure 16: Hillview Cottage and The Humps Fault surface rupture. (A) LiDAR hill shade DEM showing location of the cottage within a relatively narrow fault rupture deformation zone (red arrows). (B) Raster of displacement in the east direction (positive is east, negative is west) calculated using ICP method described in text. Some anomalies and artefacts of the grid exist within the dataset but the overall pattern is one of predominantly dextral displacement. West of the cottage is a small pull-apart, while the 100 m-scale fault geometry is that of a restraining bend. (C) & (D) The eastward and vertical deformation profiles from X to X', respectively. Y-axis exaggeration in (C) = 60. Y-axis exaggeration in (D) = 385.**

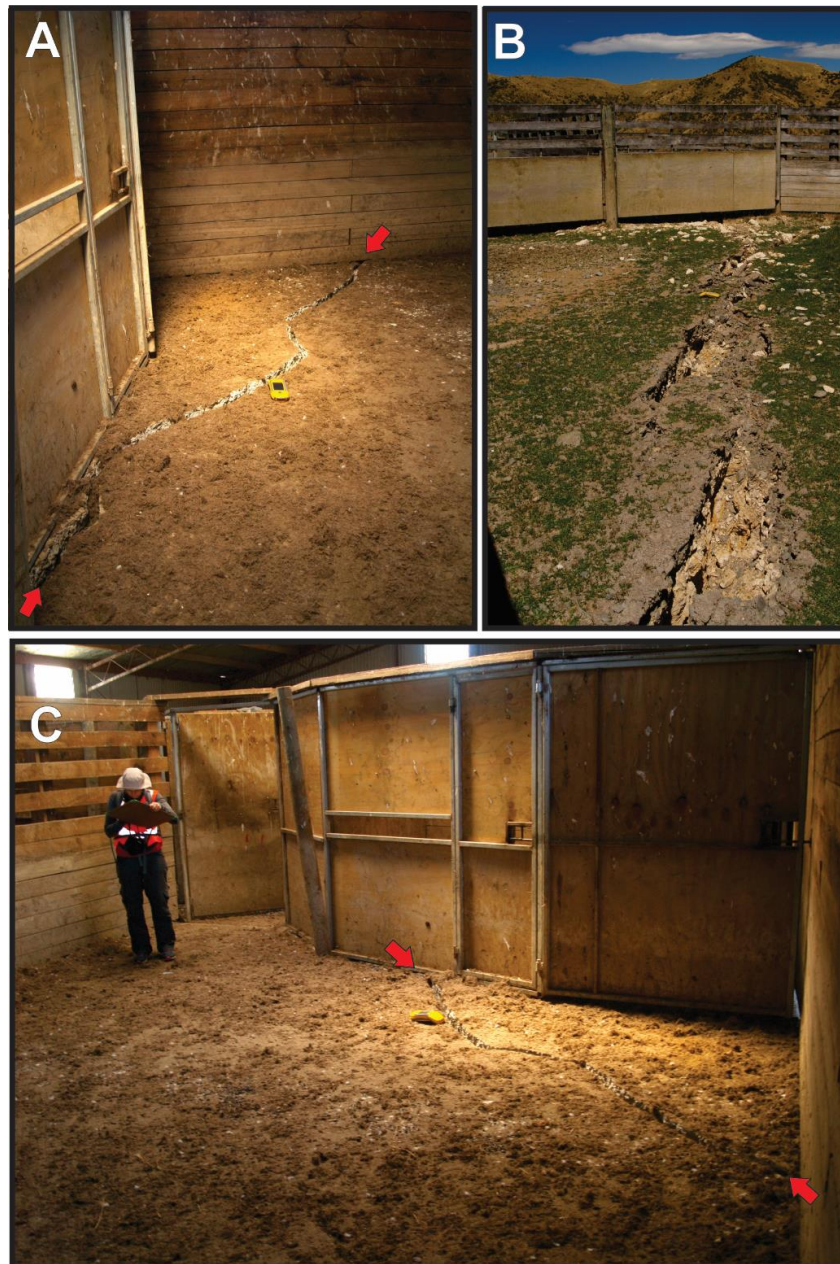
**Figure 17: Mendip deer shed and northern Leader Fault surface rupture; see Figures 1 & 18 for location (Lat:  $-42.5740$ , Long:  $173.2825$ ). (A), (B), & (C) Field photographs of normal faulting running through the deer shed. (B) is looking to the southeast, across the stock yard and towards the intersection of the two fault sets (see text for discussion). Photos taken by Clark Fenton in January 2017.**

faults were tracked through the deer shed floor and into the adjacent stock yards (Figure 17).

Damage to the deer shed was relatively minor and limited to some cracking of the concrete floor, and separation of the walls from the floor (Figure 17). Most of the damage is linked to the relatively minor, discrete displacements on the northwest trending secondary faults, as distributed deformation from the main thrust (~25 m to the southeast) is limited. This does,

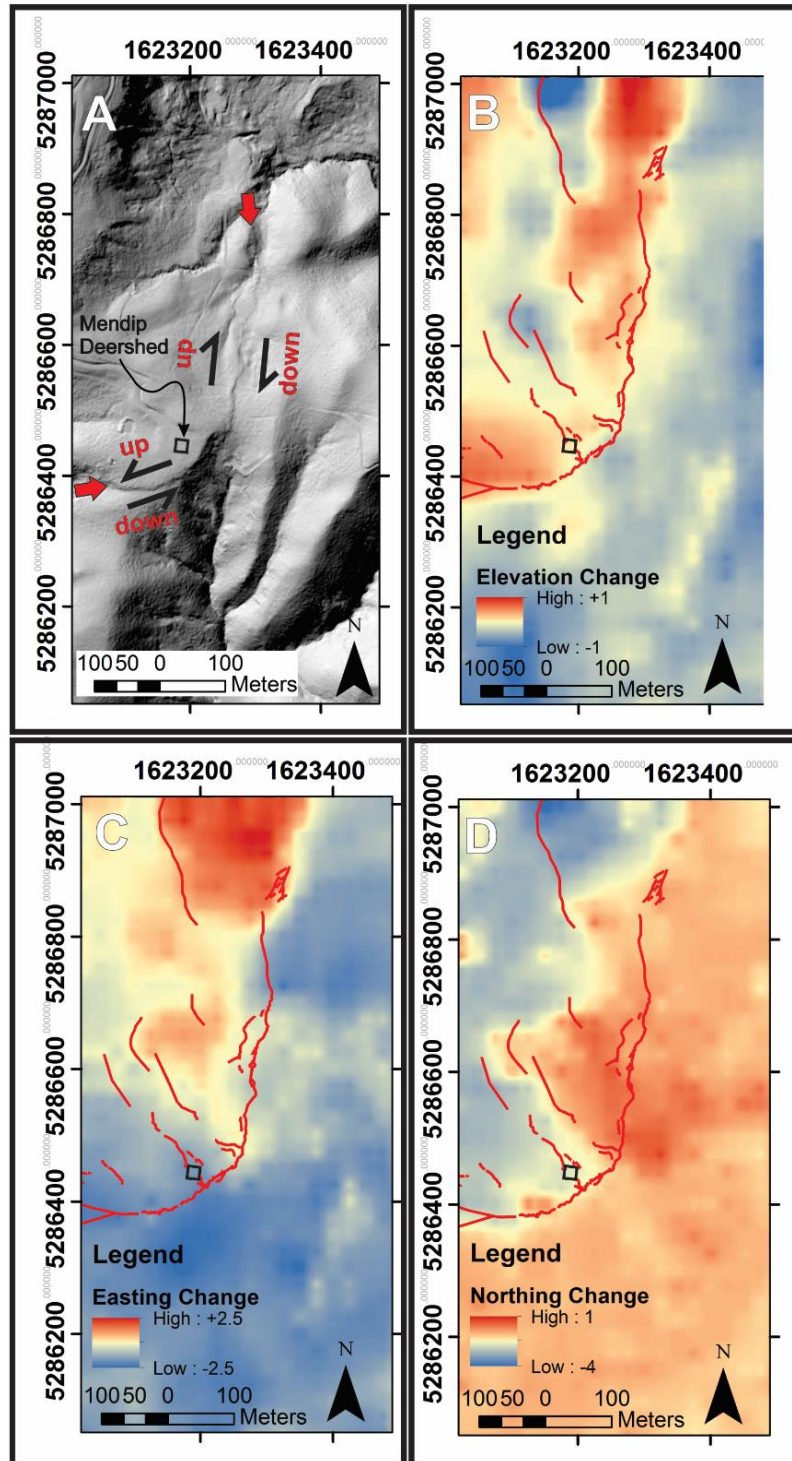
**Figure 18: The Mendip deer shed and surface rupture along the northern Leader Fault. (A) LiDAR hill shade with location of the deer shed indicated. The primary fault trace (red arrows) and sense of slip are indicated. (B) The fault traces with elevation change raster determined using ICP method described in text. (C) Same as (B), but for easting change (positive values moved east). (D) Same as in (B), but for northing change (positive values moved north). Note that compression and associated reverse faulting predominates, with components of sinistral and dextral sense west and north of the deer shed, respectively. However, discrete faulting on secondary NW-SE striking faults was the main contributor to deer shed damage.**
