Experimental Study of Various Techniques to Protect Ice-Rich Cut Slopes

Lin Li, M.S., Research Assistant
Department of Civil and Environmental Engineering
University of Alaska Fairbanks

August 2014

Number: 4000(113)B

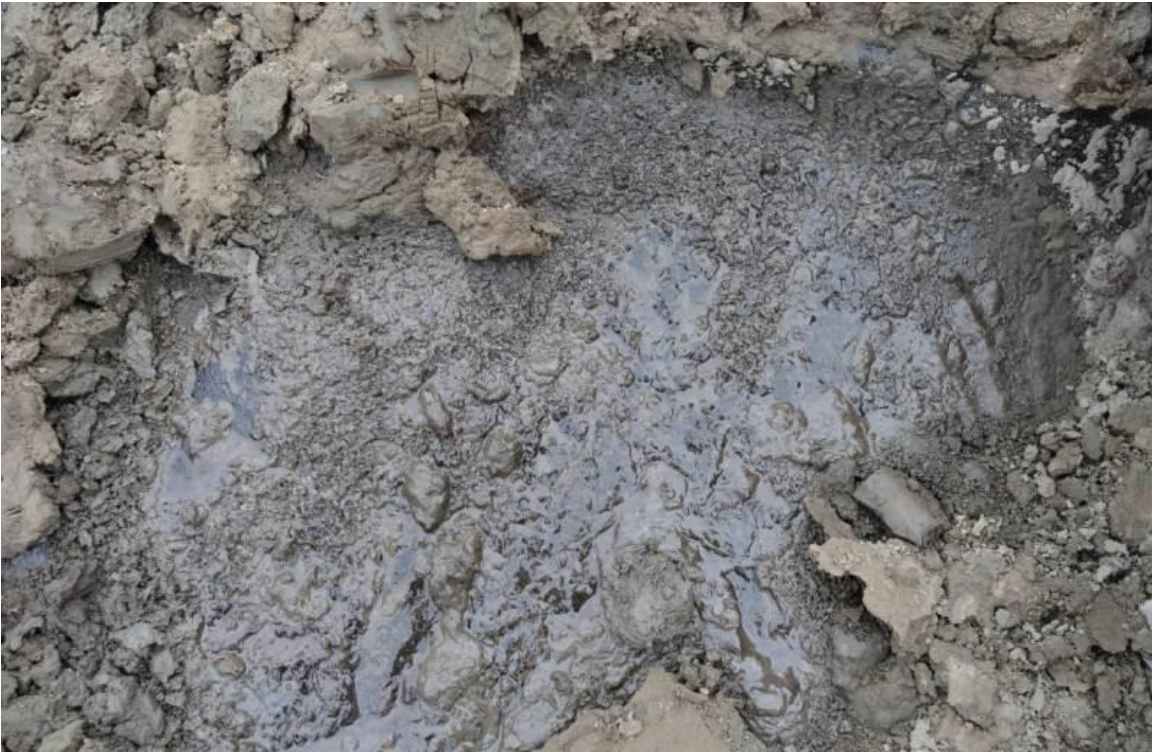
Figure 4.9 Ice exposed in the cut slope

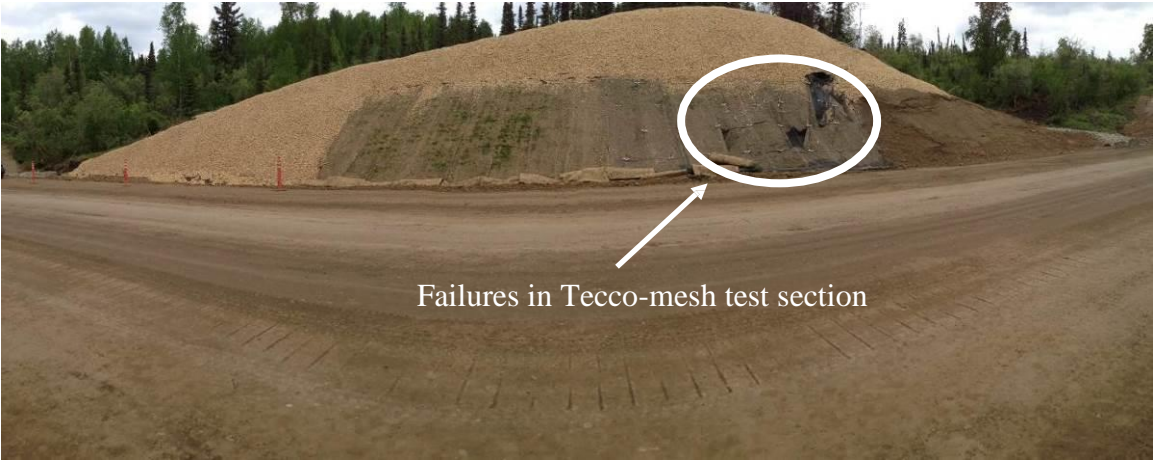
Figure 6.1 Panorama view of Experimental Feature showing failure in Tecco-mesh section

The panorama photo labeled Figure 6.1 shows the entire face of the Experimental Feature and the circled failure areas within the Tecco-mesh section. Observation at the site revealed an obvious loss in volume of original cut slope soil from the slope face. This loss of volume could be seen easily through the Tecco-mesh—an observation that was confirmed by probing and peering through the Tecco-mesh at many locations along the mesh surface.

suspended one to several ft above the present soil/ice surface. At that time, none of the Tecco-mesh and only small areas of the coconut matting within Section C had failed.

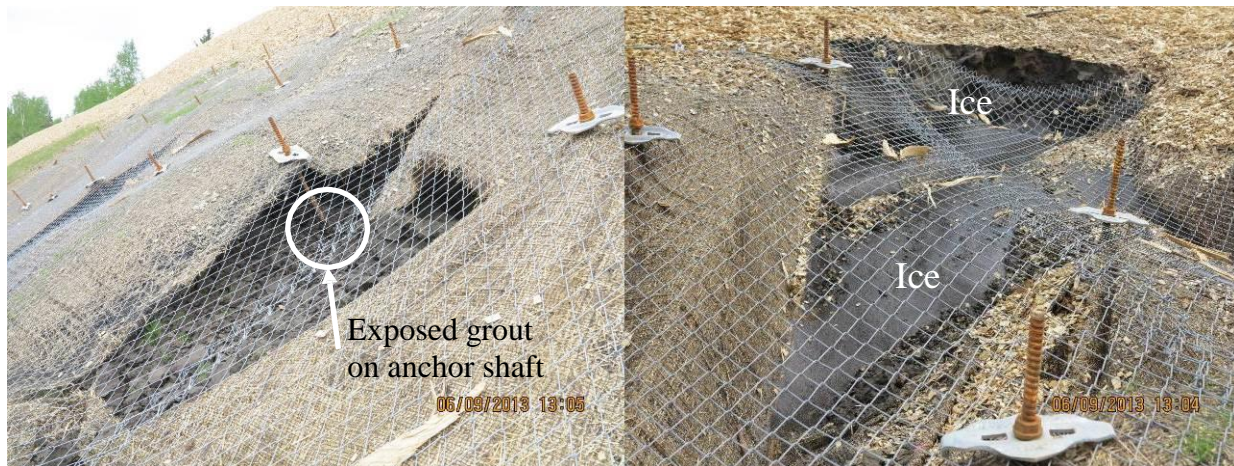
The significant loss of material from the original cut slope is evident in the left side of Figure 6.3, where the anchor grout is exposed. The depth from cut slope face to top-of-grout was 3 ft. The lighter gray material labeled in the right side of Figure 6.3 is some of the massive ground ice that caused serious problems with the Tecco-mesh experimental section.

Figure 6.3 Close views showing exposure of soil anchor grout (left) and portion of massive ice feature under Tecco-mesh (right)

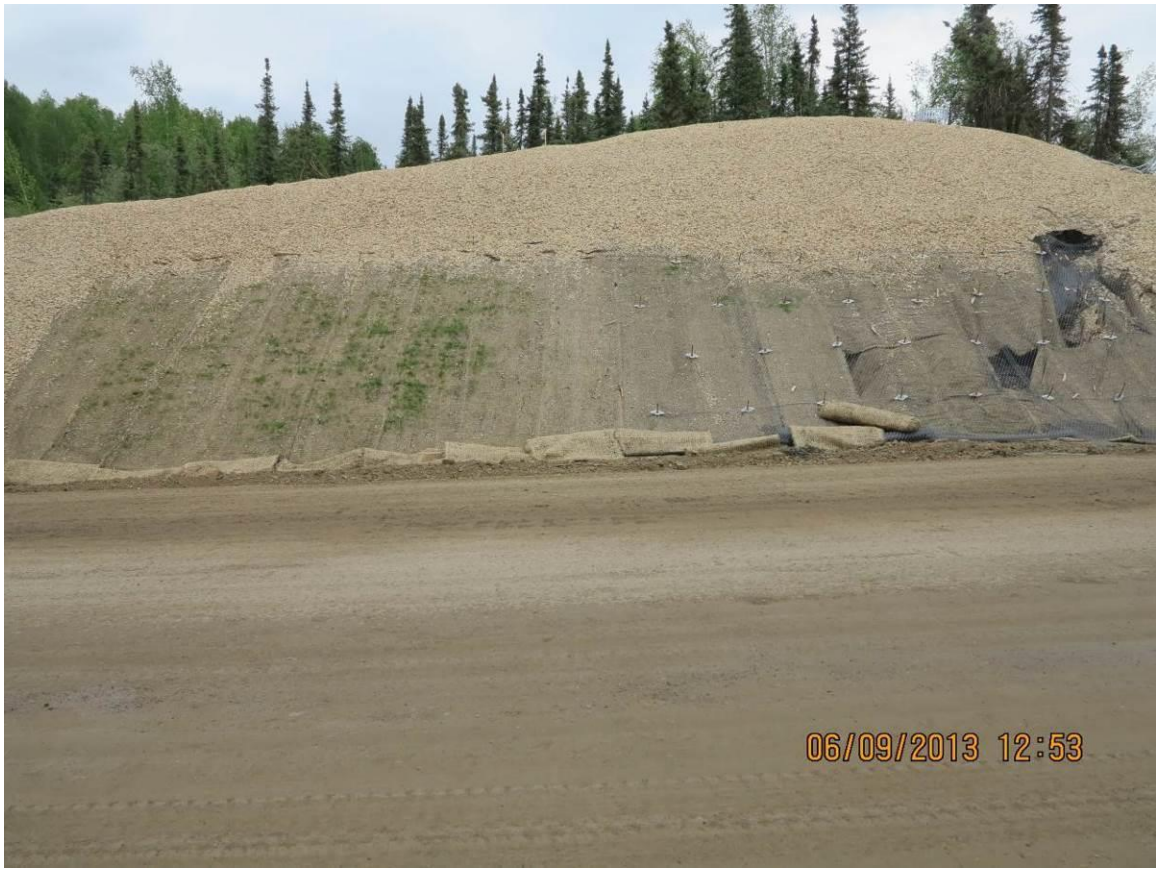
In Figure 6.4, the areas where the ground surface is *not* in contact with the Tecco-mesh or the adjoining coconut matting are those areas where no grass had yet appeared. As Figure 6.4 shows by the appearance of grass, only the very top portion of the Tecco-mesh section still has soil/Tecco-mesh contact.

Figure 6.4 Surface protection matting in area showing no grass growth is not in direct contact with ground surface

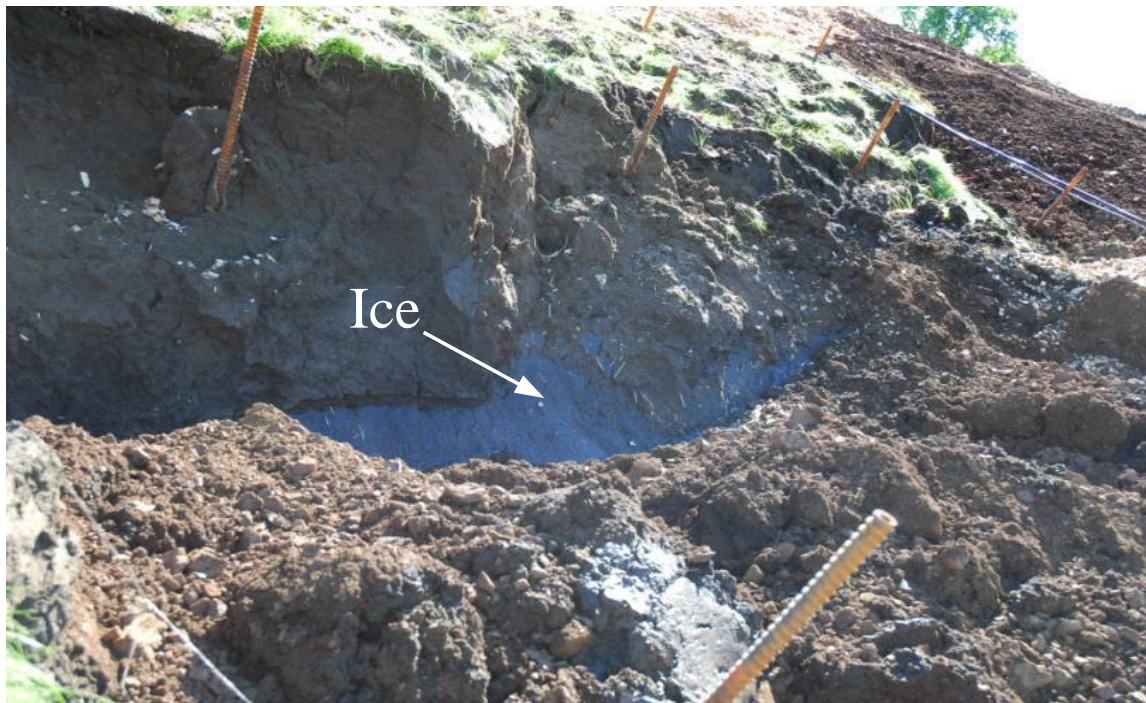
Figure 6.6 Massive ice in Section C

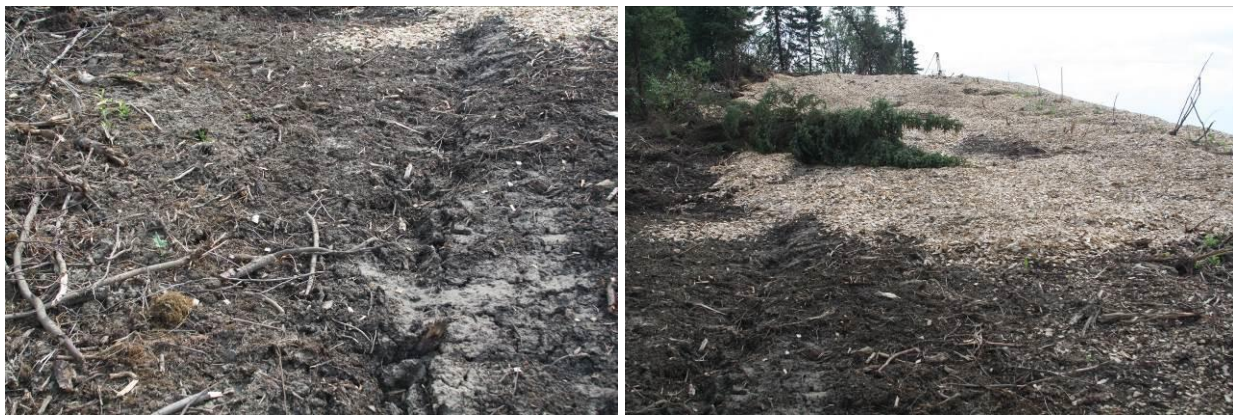
Figure 6.9 Start of thaw related damage at top of Experimental Feature cut slope

This work remains to be done at the time of this report's preparation (August 2014).
