Use of H2Ri Wicking Fabric to Prevent Frost Boils in the Dalton Highway Beaver Slide Area, Alaska Final Report

Xiong Zhang, Ph.D., P.E.

December 2012

INE/AUTC 12.23

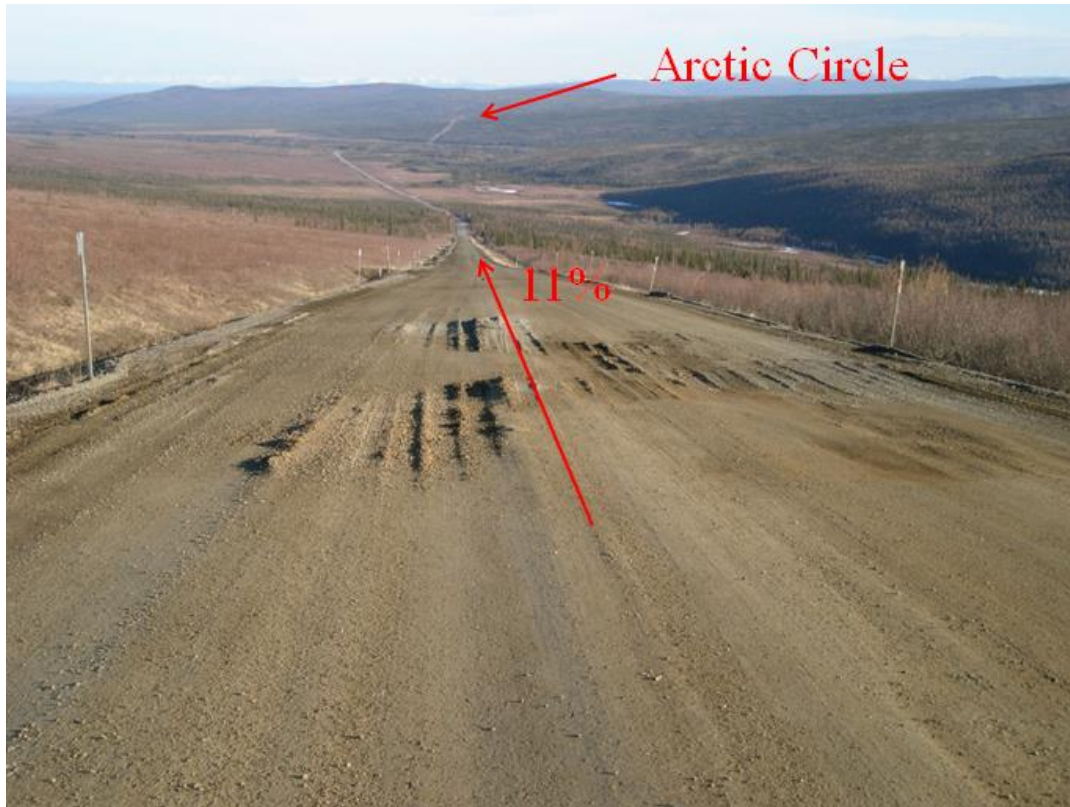
Figure 2. Frost boils at Beaver Slide on May 12, 2012 (looking north)

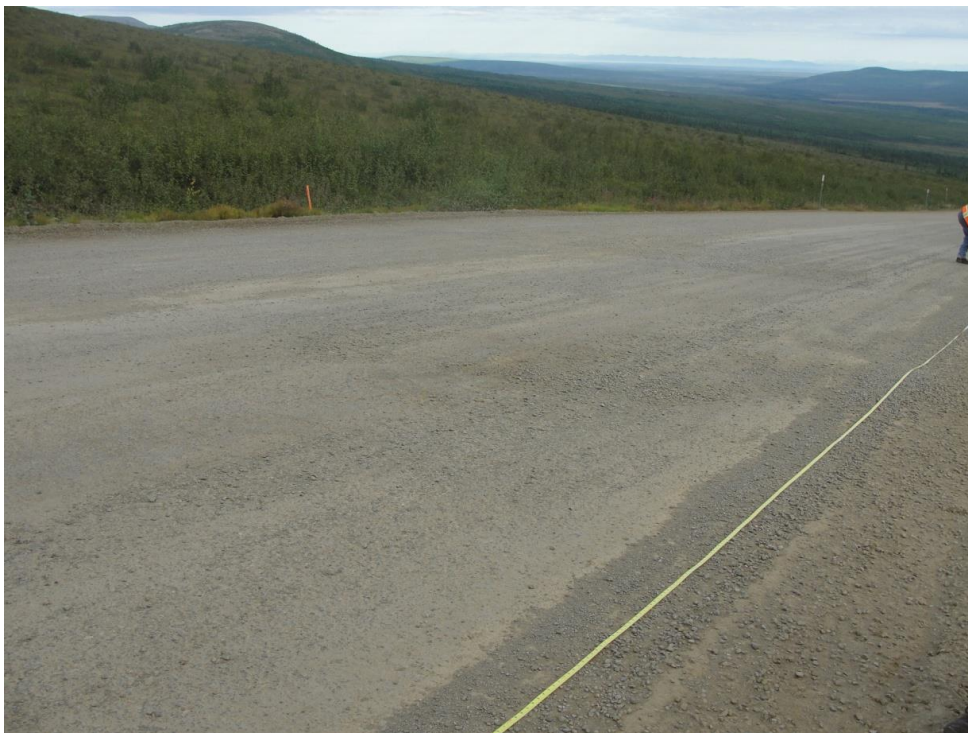
The construction of the test section started on August 3, 2010. A 60 feet long road section that had the most frost boils was selected for testing (Figure 20). First, the eastbound half of the existing road was excavated to a depth of 3.5 feet (Figure 21), and the bottom of the excavation was graded using a bobcat (Figure 22). The soils were generally brown to yellow sand with gravel, according to visual classification. The first 4 in. of soil was cemented and dense, most likely due to heavy traffic. Next, three pits were dug—at the center of the road, at the edge of the original road (20 feet to the center), and approximately at the edge of excavation (29 feet to the center of the road)—for installation of sensors 13, 6, and 2, respectively (see Figure 19).

Figure 20. Selection of test section (looking north)

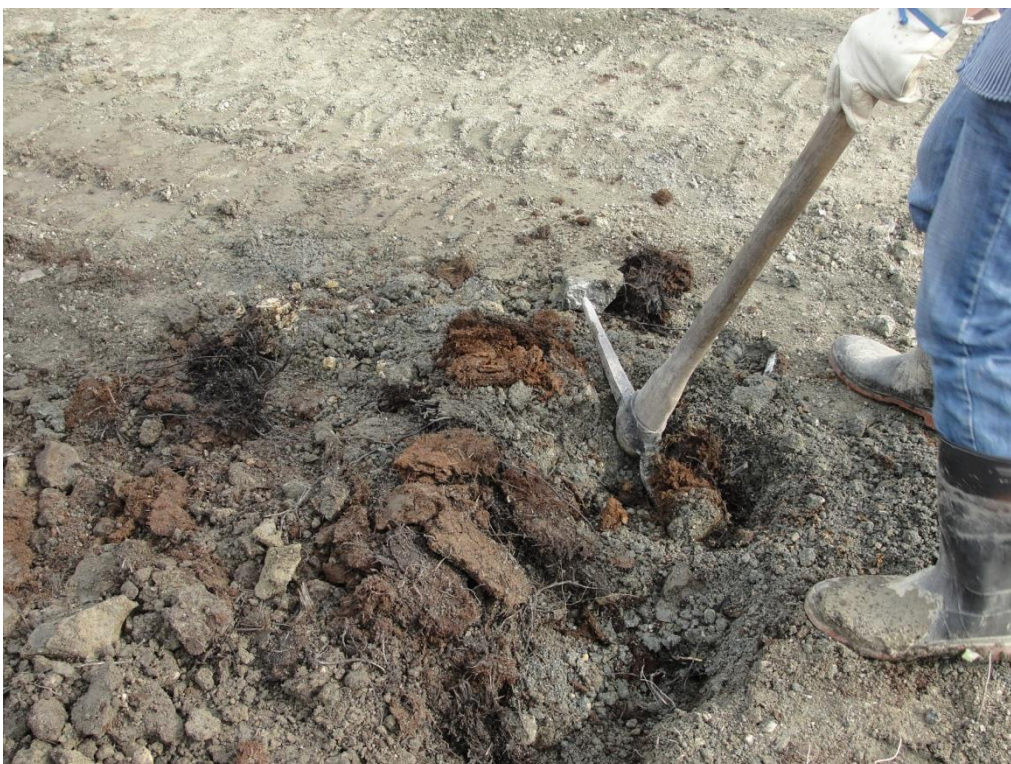
vegetation layer was encountered 4 feet below the original road surface (0.5–1.0 feet below the excavation bottom). Sand with gravel was on top of the degraded vegetation layer. Under the degraded vegetation layer were crushed rocks with sand. The soils excavated from pits at sensor locations 2 and 6 were generally sand with gravel, the same as soils excavated from the first 3.5 feet of soils. No degraded vegetation layer was found in these two excavation pits.

Figure 33. Degraded vegetation layer found on the bottom of the excavation

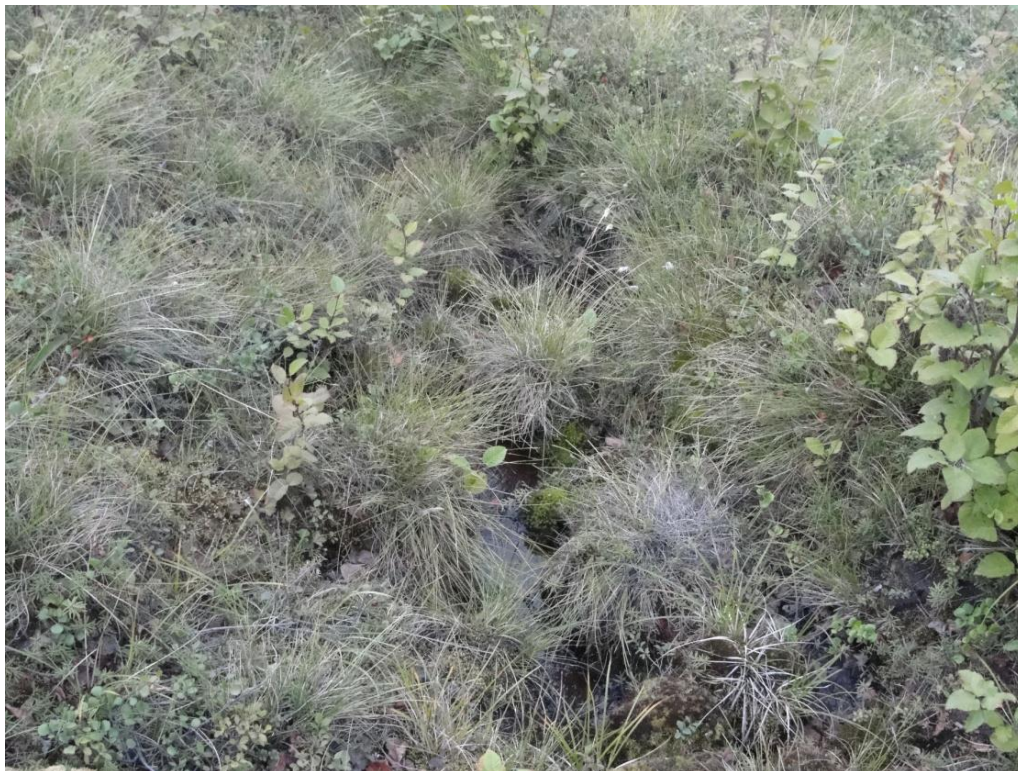
Figure 51. Water found in the tundra on the slope near the data collection box

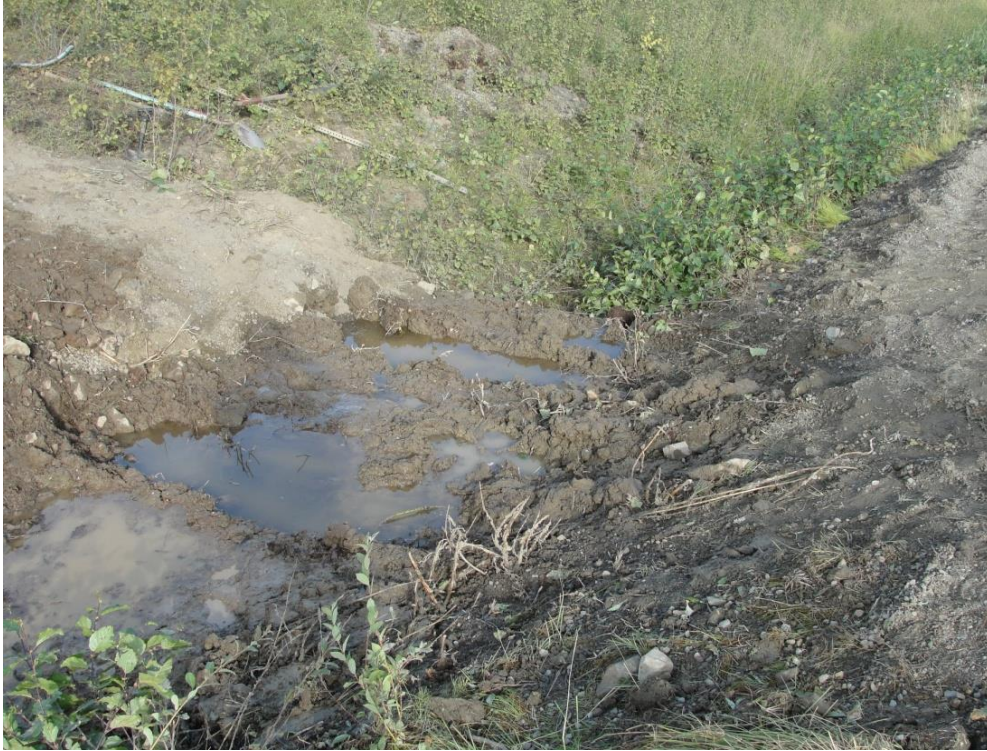
Figure 52. Water found in the existing ditch along east side of the road on August 5, 2010

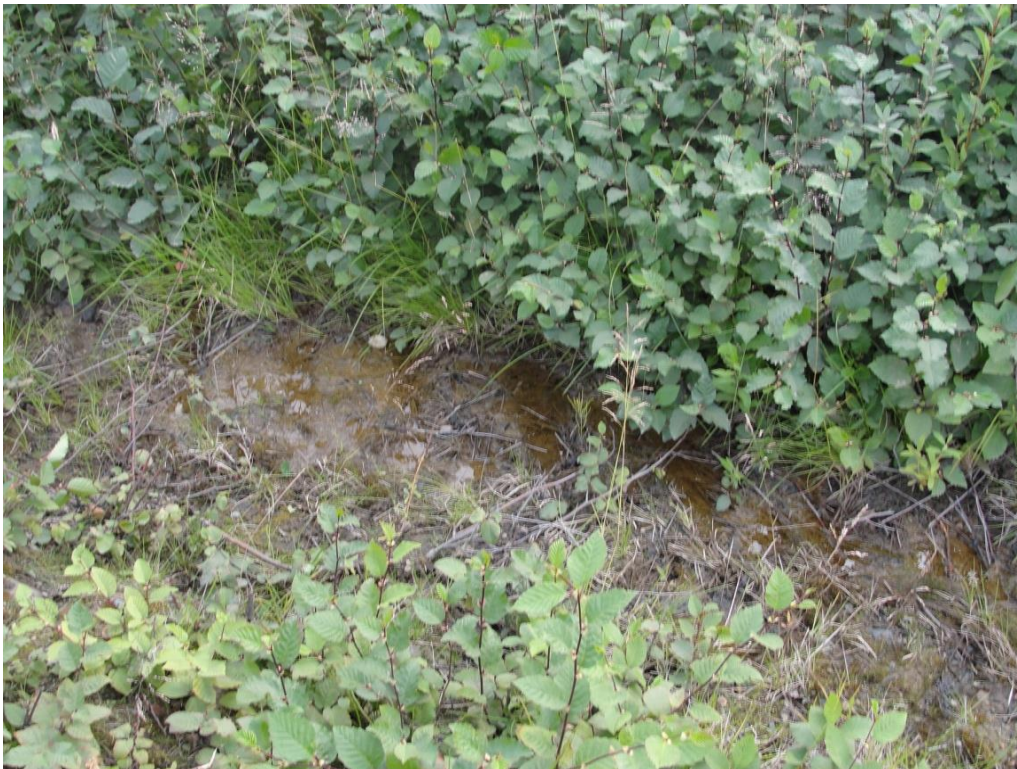
Figure 53. Water found along the tree line sporadically, on the west side of the road

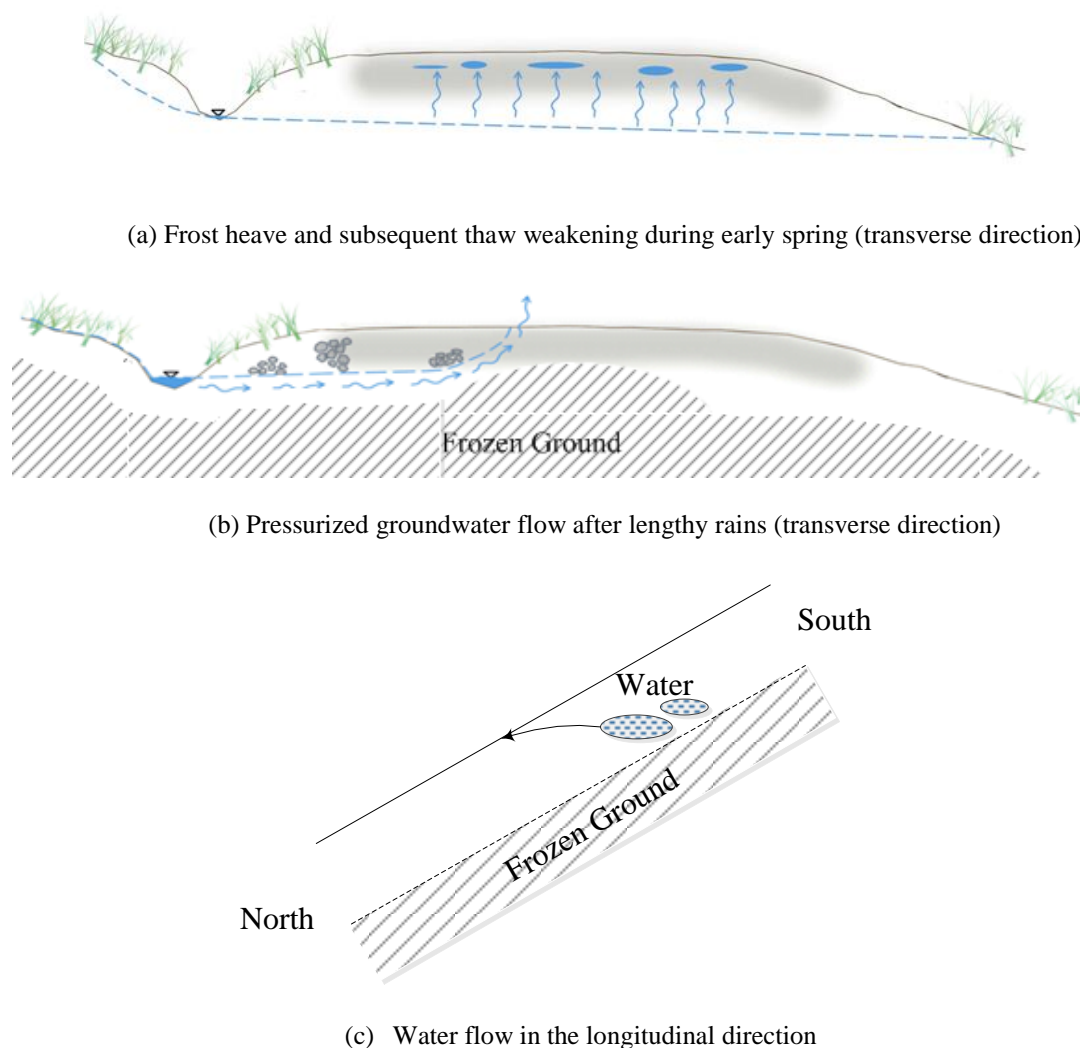
The obtained data indicate that there are two mechanisms for the formation of frost boils (also referred to as "soft spots") at Beaver Slide: (a) frost heave and subsequent thaw weakening, which occur in early spring, and (b) upward pressurized water flow to the road surface during lengthy rainy periods, similar to Artesian water, from mid-summer to fall. The test section was built at a site where soft spots had occurred most frequently in previous years. Surface observations made by the Alaska Department of Transportation and Public Facilities Maintenance and Operations (M&O) road crew for the Dalton Highway indicate that use of H2Ri eliminated the damage caused by both formation mechanisms. The test section performed well over the two-year study. During this time, no soft spots or frost boils occurred in the test section treated with H2Ri, though they were observed past both the upper and lower ends of the test section during early spring or a particularly rainy period. The M&O road crew reports that it is clear where the road was treated with H2Ri based on the road surface performance.

Figure 123. Mechanism of frost boils/soft spots
