# The Use of Geofibers and Synthetic Fluids Kwigillingok Airport

FINAL REPORT

**Report # RR08.14**

February 2011

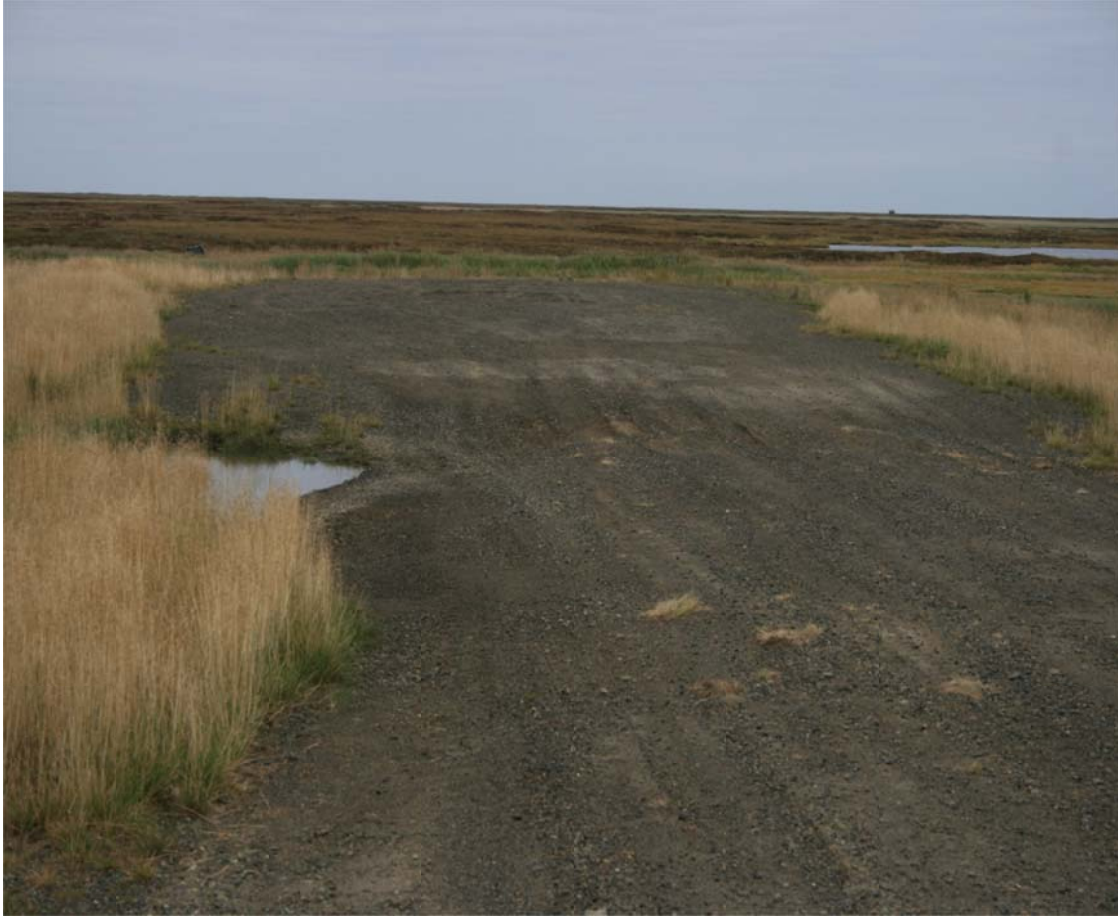
There is a 500 foot section on the northern portion of the runway that is not used. The pilot explained that this portion of runway is not used because it is difficult for pilots to slow down before a large bump is reached which can make the plane re-launch. Upon further investigation into the northern end of the runway it was evident that there is some melting permafrost in this area. The thaw-pond forming from this is shown as [Fig.1](#). The northern end of the runway was apparently slightly higher in elevation than the rest of the runway, this is evident in [Fig.2](#) which was taken approximately 800 feet from the northern end. Also, shown in [Fig.2](#) are the cones which mark the section of runway that is avoided.

Figure 1: Melting Permafrost puddle on the northern end of runway

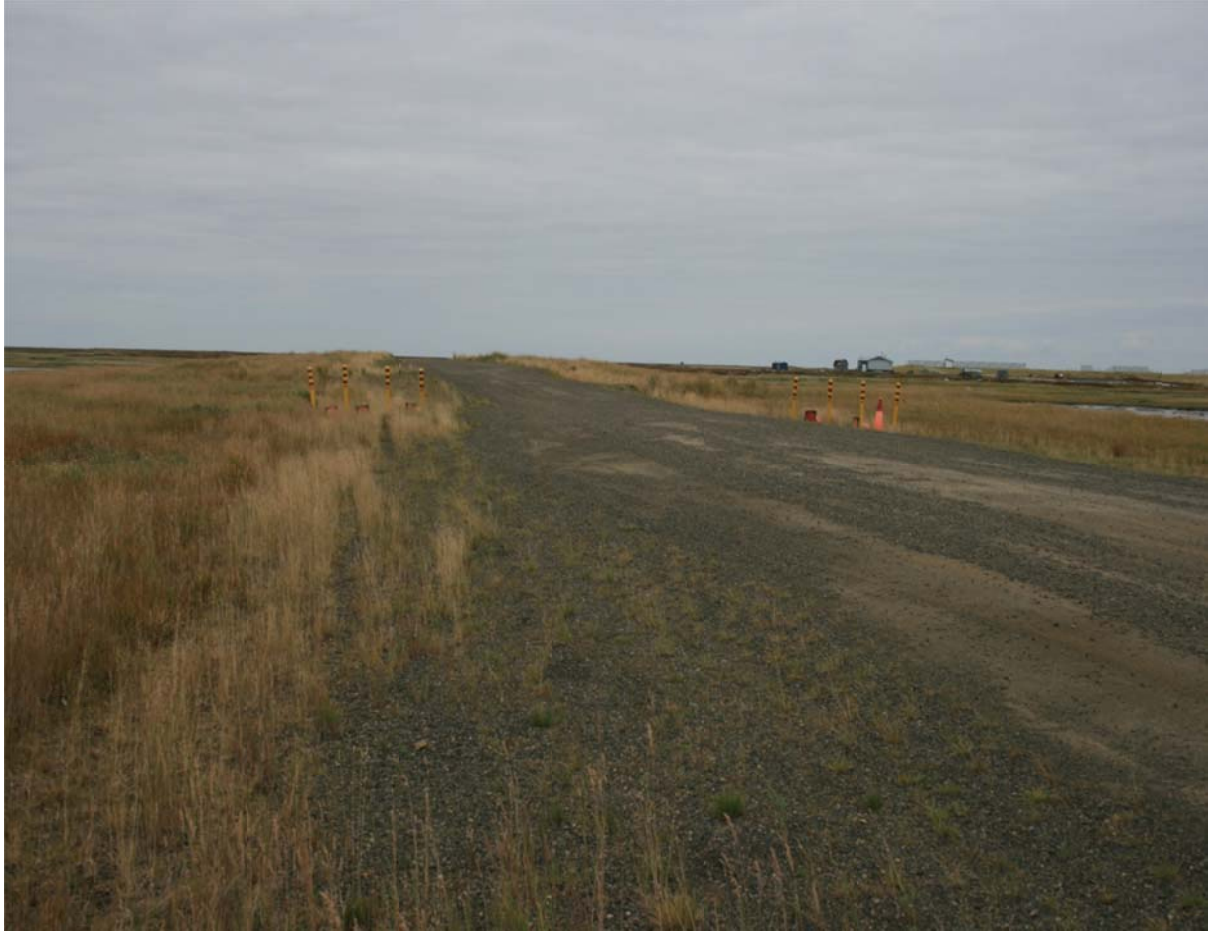
Figure 2: Elevated northern section of runway unused for airline traffic

The best alternative at this time is to add granular material to the existing surface without disturbing it. The greatest problem to be overcome is to move the material from the docks to the runway. The roadway connecting the two is incapable of handling heavy traffic required.

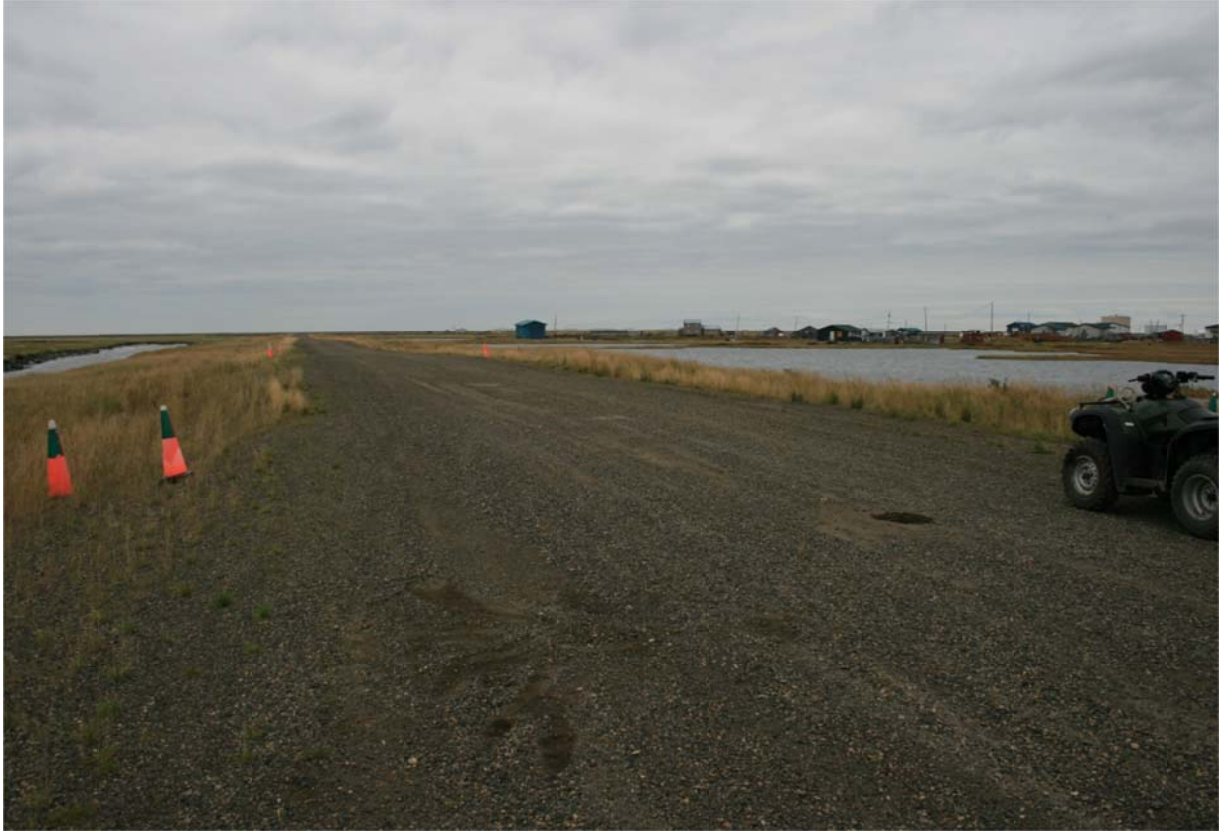
The depth of the gravel on the runway surface was checked on the northern and southern sections of runway, also on the sides of the runway. The depth of gravel at both the north and south ends of the runway was approximately eight inches; no further digging could be done after this depth was reached because it was heavily compacted and only a spade shovel was used, the image showing where the hole was dug is shown as [Fig.3](#). One hole was dug on the side of the runway to find the depth of gravel throughout the runway; this showed the gravel to be nearly one inch thick on the side of the runway which is shown in [Fig.4](#). It is apparent that the many years of grading had resulted in the variable thickness of the gravel surface. However, it is not clear whether this is due to differential settlement. Unfortunately, we did not have the equipment to determine this.

Figure 3: Area disturbed in front of picture is where eight inches gravel was found

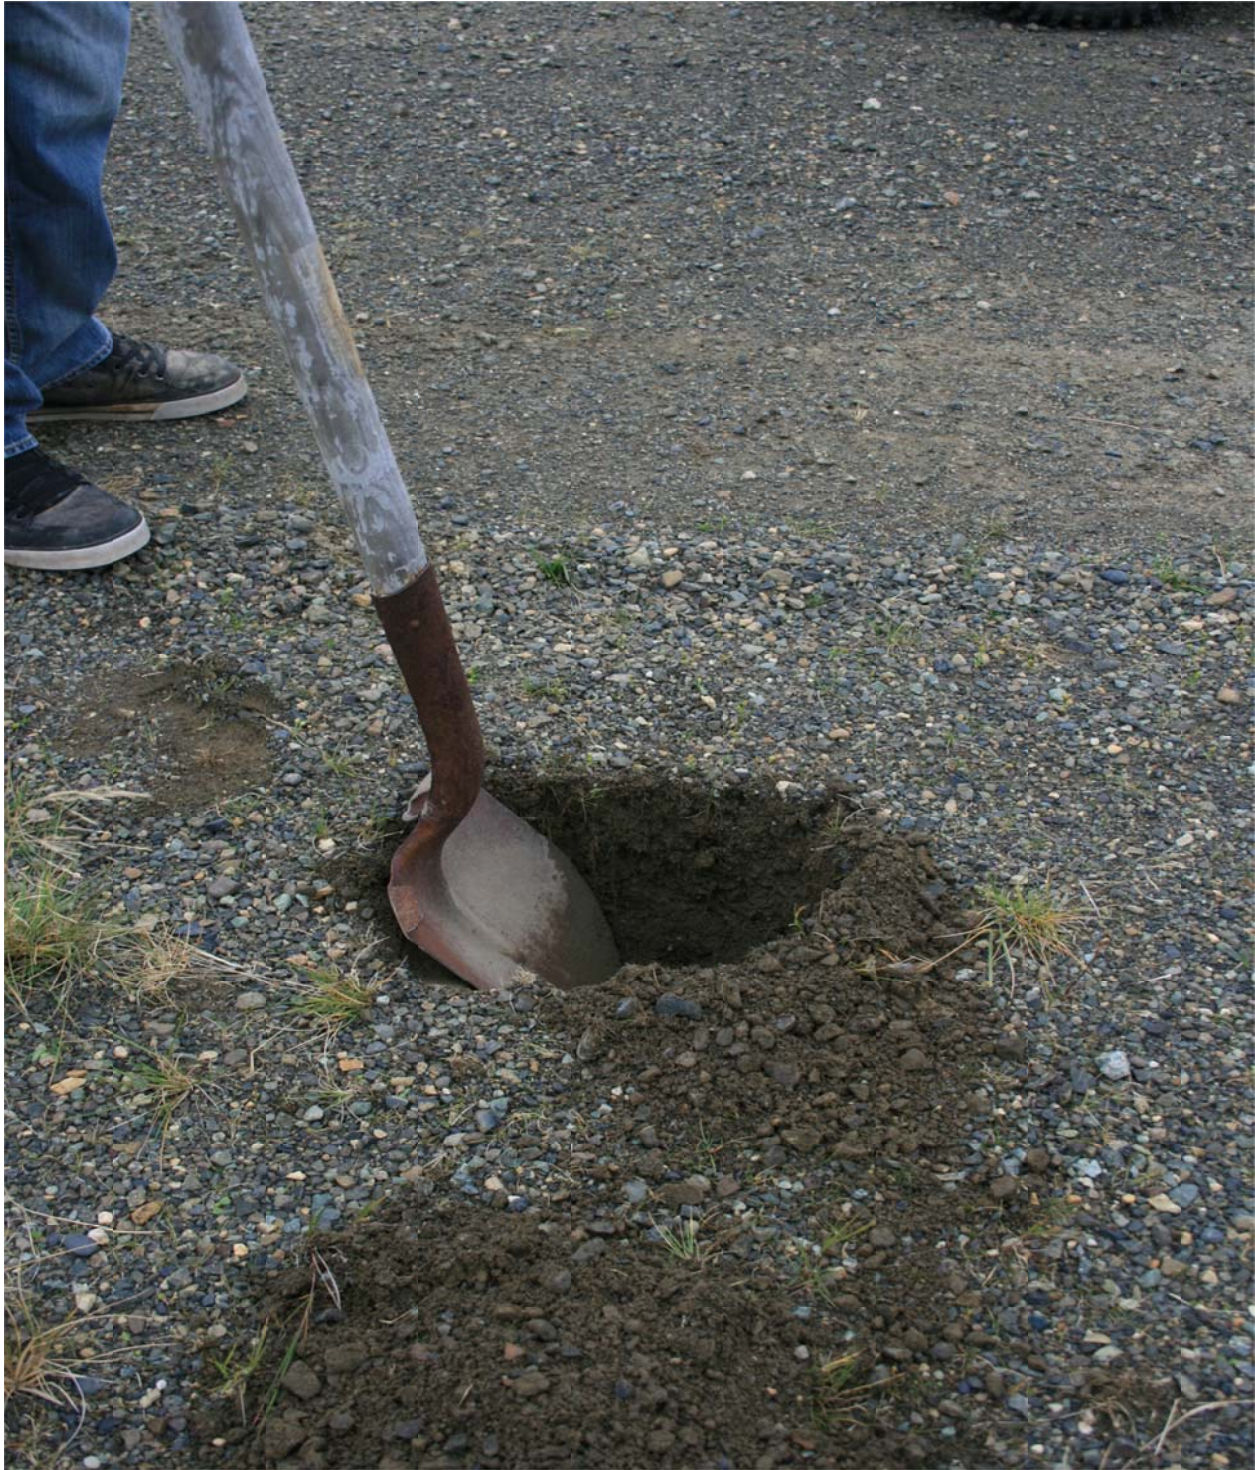
Figure 4: Hole on side of the runway showing a shallow depth of gravel

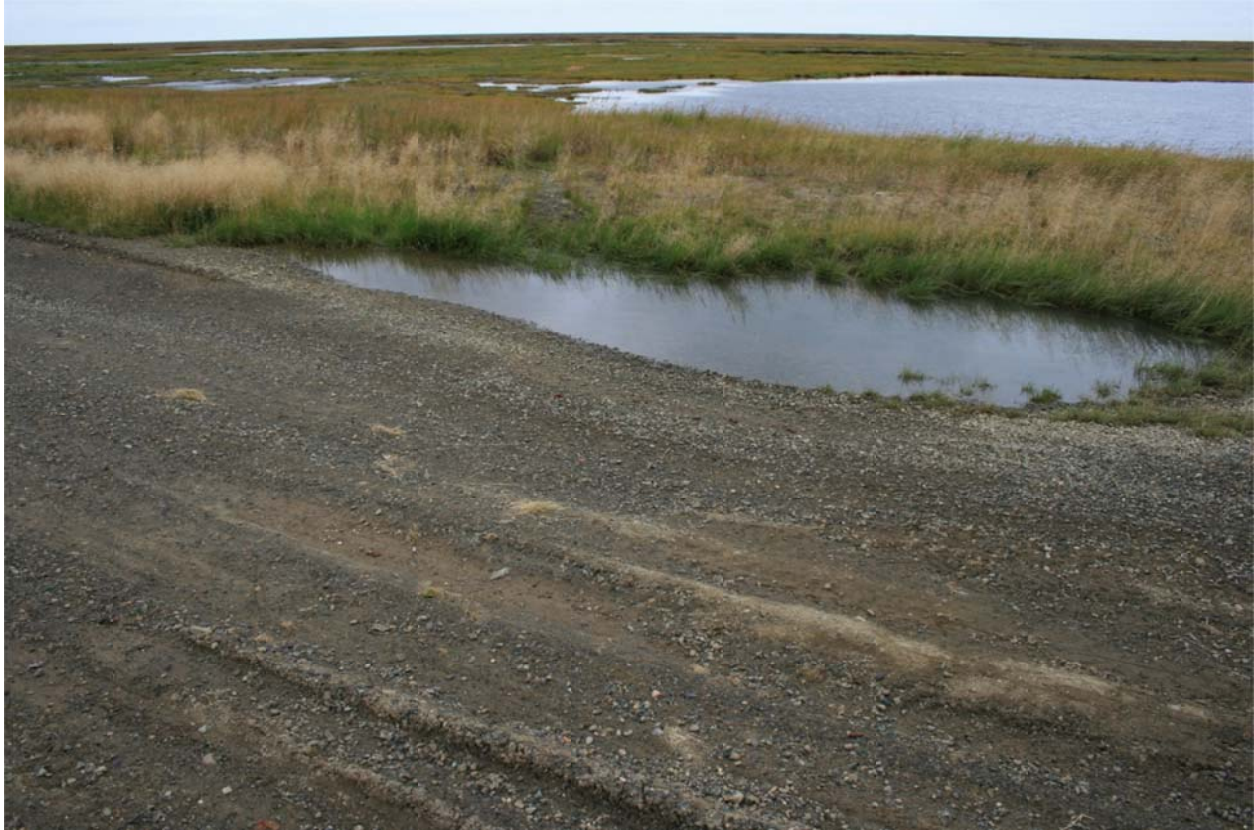
There are few ruts and potholes on the Kwigillingok runway. However, the northern end of the runway where the permafrost has melted the subgrade has become very soft [Fig.5](#).

Figure 5: Ruts caused from melting permafrost on northern end of runway

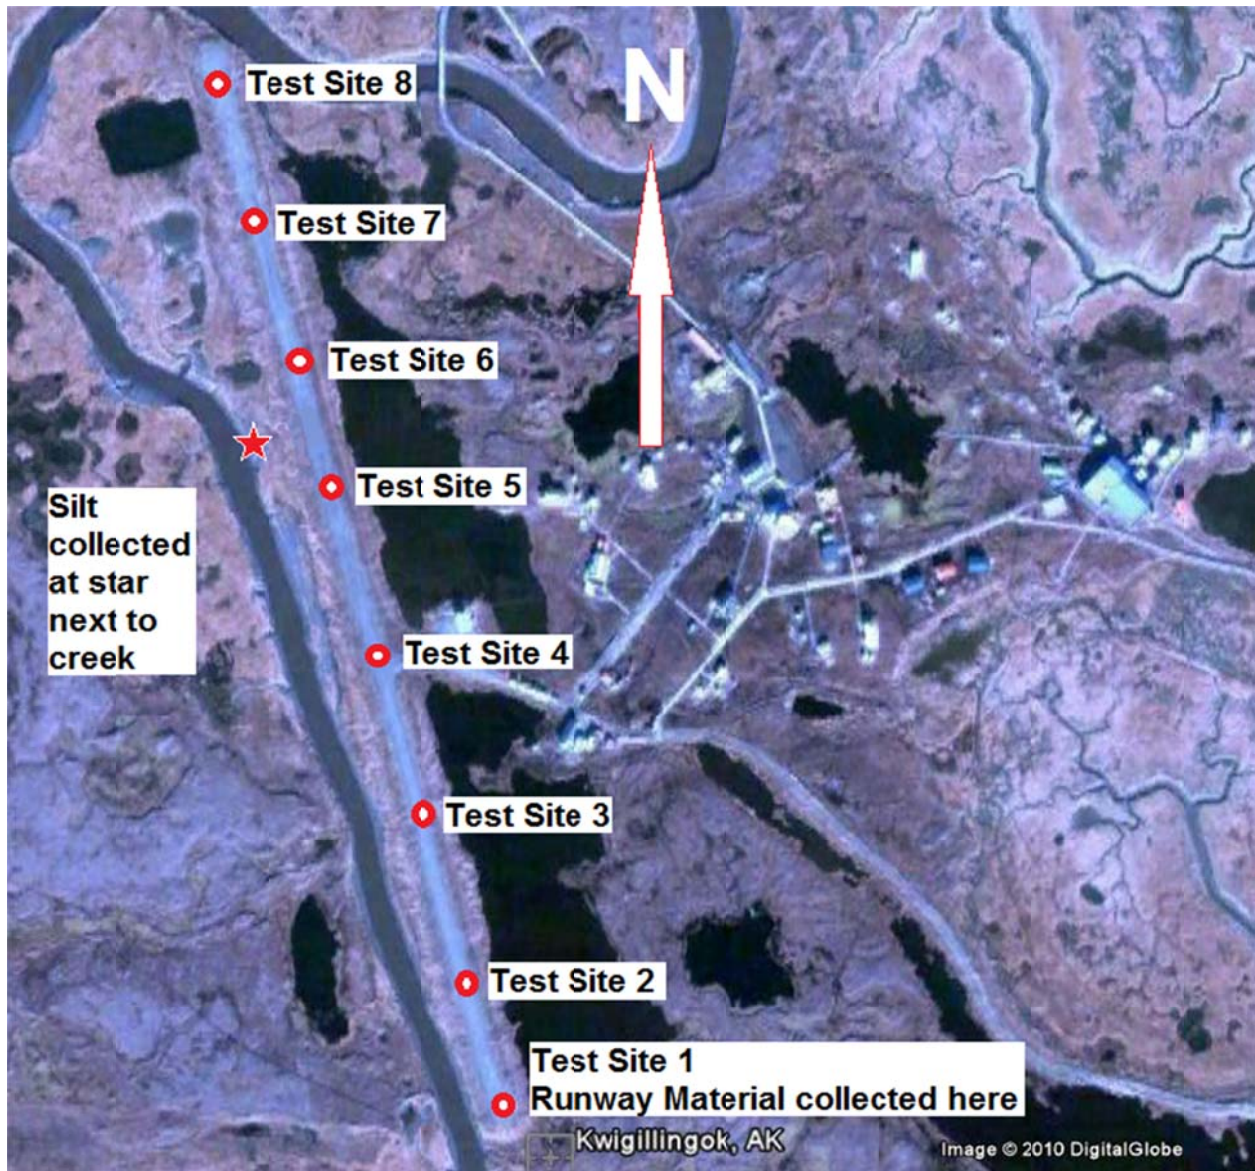
Figure 6: Map of Kwigillingok runway with points of interest marked

Stiffness measurements were taken at eight locations along the runway. The Geogauge measures to a depth of nine inches. The first measurement was taken on the south end and readings were taken at nearly even distances to the north end of the runway. At least two measurements were taken in each location. In a few locations, three were taken because the first two did not agree with each other. A table summarizing the results of the Geogauge testing is presented as [Table 1](#). An aerial photo of the Kwigillingok runway is shown as [Fig.6](#) shows the test locations.

The results of the stiffness measurements indicate the surface of the runway is sufficiently stiff without any added stabilization. Further, disturbing the surface could cause the underlying clays to weaken requiring costly remediation.

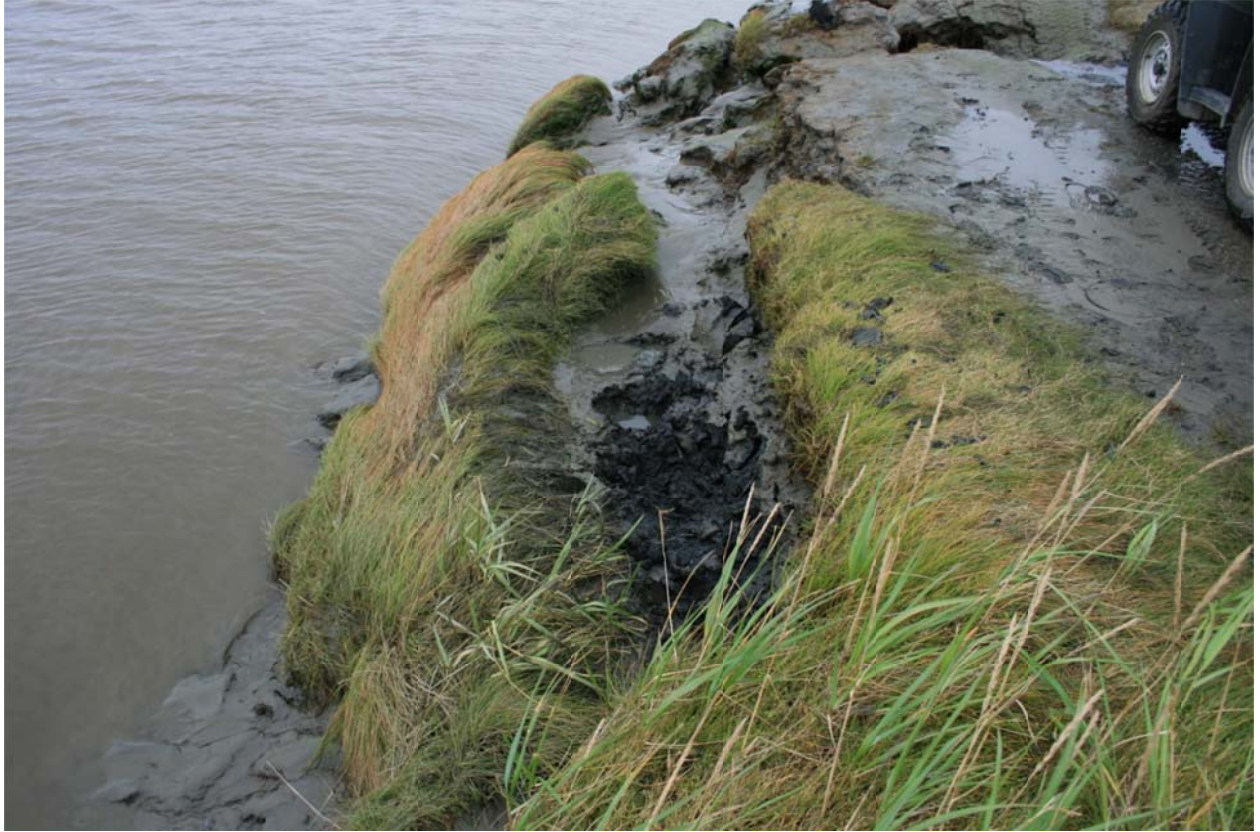
Material was needed for use in laboratory testing. This will be treated with geofibers and synthetic fluid in an attempt to improve the strength and stability of the soil. The material collected is clay from the riverbank. This is representative of the soil found throughout Kwigillingok. A picture showing the site the clay was collected from is presented as [Fig.7](#). The site is also indicated by a star on [Fig.6](#).

Figure 7: Area where clay was collected

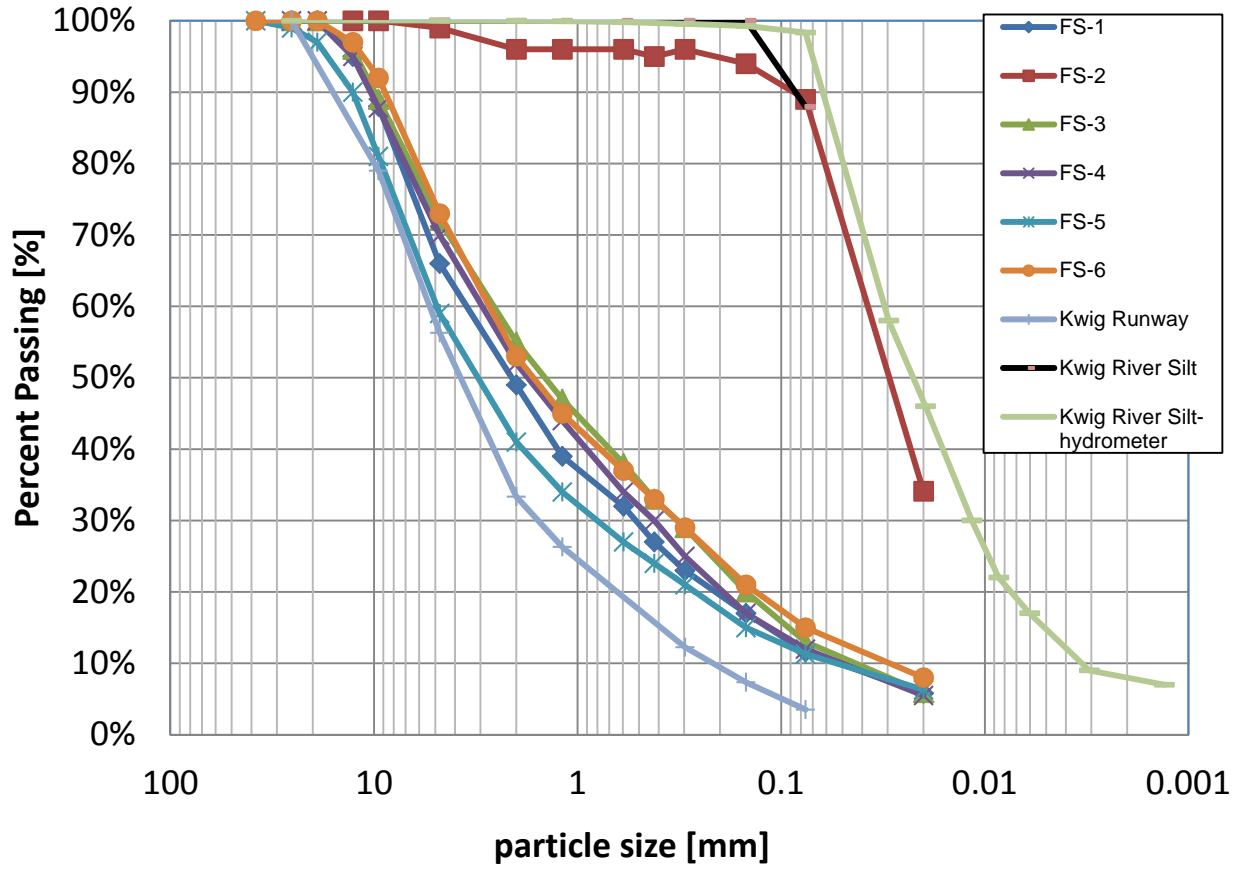
The gravel material found on the runway, and the clay material underlying Kwigillingok was compared with sieve analysis results provided by AKDOT [Fig.8](#). The uniformity coefficient ( $C_u$ ) and the coefficient of curvature ( $C_c$ ) is 70.8 and 2.2 for the gravel material and 9.7 and 1.3 for the clay material. The gravel is classified as well graded gravel (GW) according to the United Soil Classification System (USCS).

Figure 8: Particle Size Analysis of Kwigillingok Soil

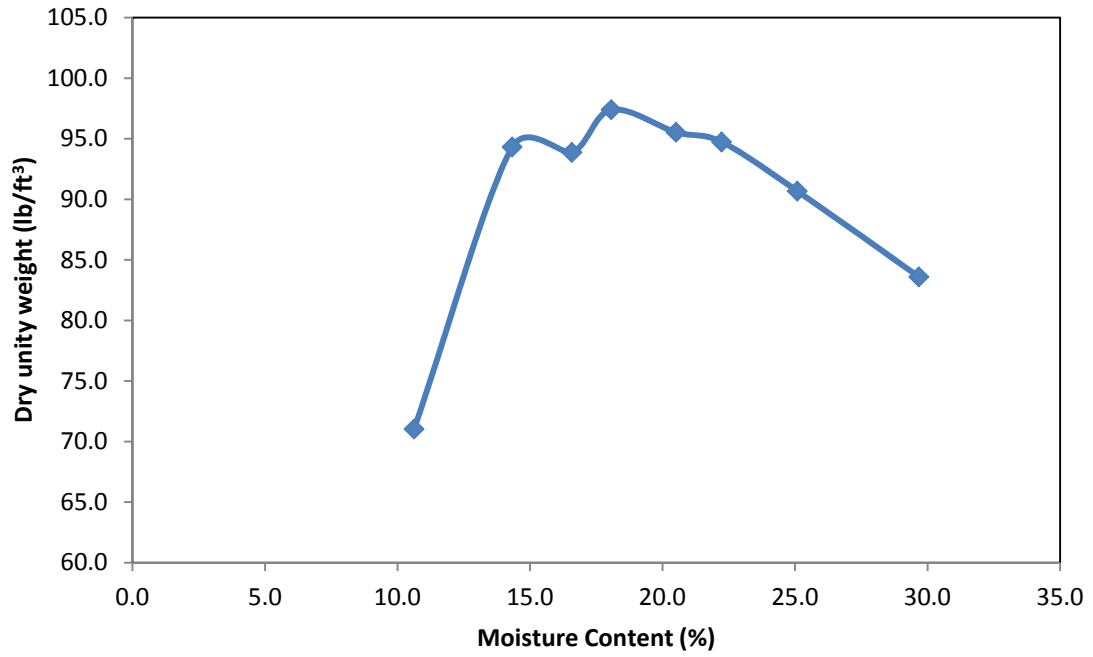
The maximum dry density curve was found using mechanical compaction. The optimum moisture content of the Kwigillingok soil is 18% with a maximum dry density of 97.4 lb/ft<sup>3</sup>. The moisture density curve is presented as [Fig.9](#).

Figure 9: Moisture Density curve for Kwigillingok Clay

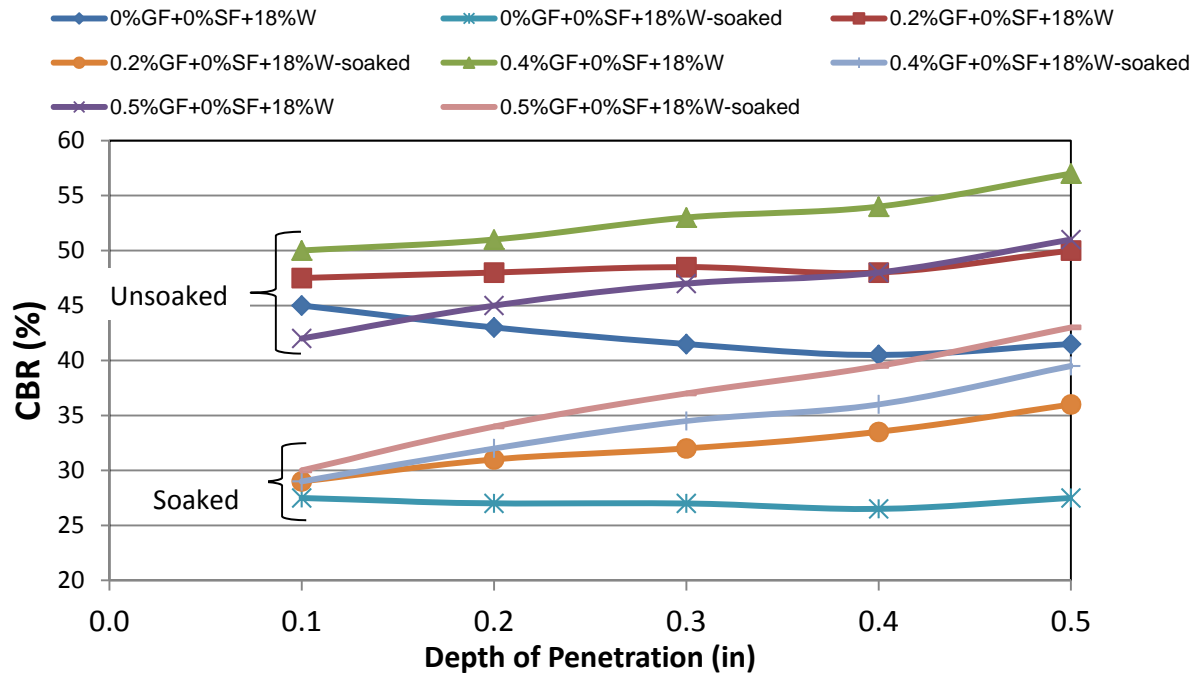
As shown in Figure 10, the unsoaked CBR was 45% while the soaked CBR was 30%. The 33% reduction in CBR indicates the material is moisture sensitive. The addition of fiber shows little improvement in the design CBR. However, further inspection shows the untreated silt is strain softening which is consistent with our experience and the literature. The fiber treated material is strain stiffening which is also consistent with our experience and the literature.

Figure 10: Soaked and Unsoaked CBR test results for samples treated with geofiber

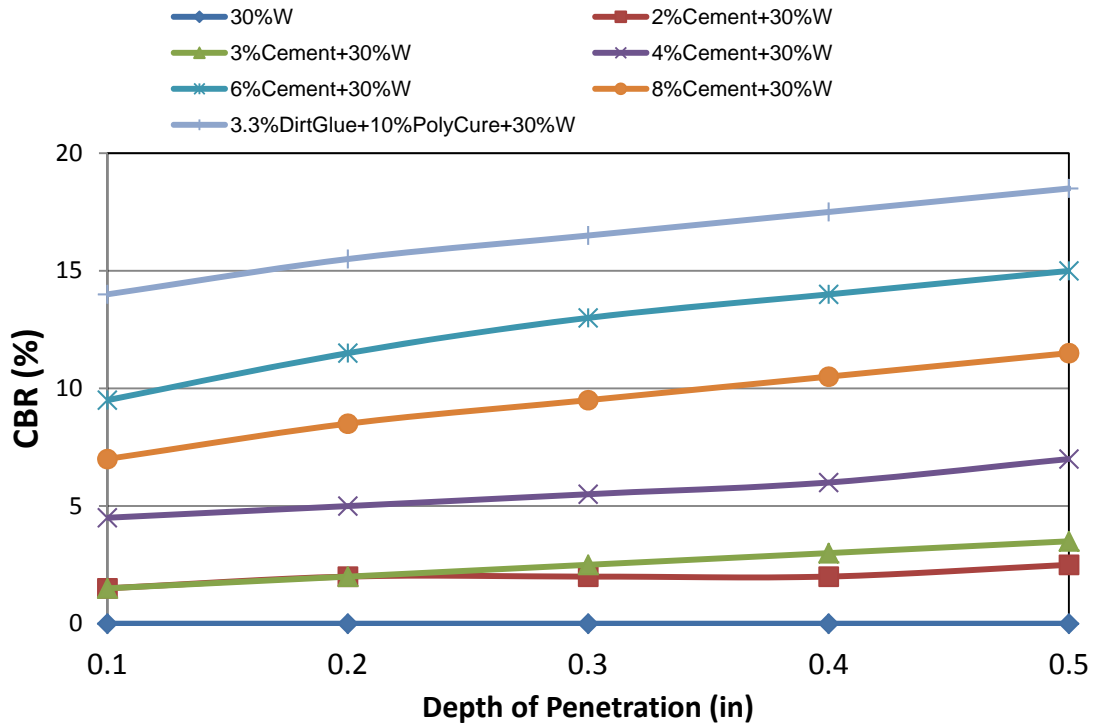
The addition of Portland cement does seem to have an influence on the CBR value; however there is little influence on the moisture contents of the samples. The control sample when tested in the CBR apparatus had zero bearing capacity. The results of the CBR testing are presented in [Fig.11](#), where the CBR value is shown versus the depth of penetration for the samples. There are two things of interest in this figure, the first and most obvious is the increase in CBR performance with increasing up to 6% cement content, the sample with 8% cement did not perform as well as the 6% sample. It should be noted that as the cement percentages increased there was increased difficulty in mixing the samples homogenously, this probably explains the

decrease in bearing capacity for the 8% sample. The second interesting piece of information that comes from [Fig.11](#) is the strain hardening achieved with increasing amounts of Portland cement.

Figure 11: Depth of Penetration versus CBR value for samples treated with cement and DirtGlue

The use of fibers and synthetic fluids are not recommended for use at Kwigillingok at this time. The addition of Portland cement did provide some improvement. However, the improvement was not great enough to suggest its use.
