# Monitoring and Analysis of Frozen Debris Lobes, Phase I

December 2012

INE/ AUTC 12.25

FHWA-AK-RD-12-17

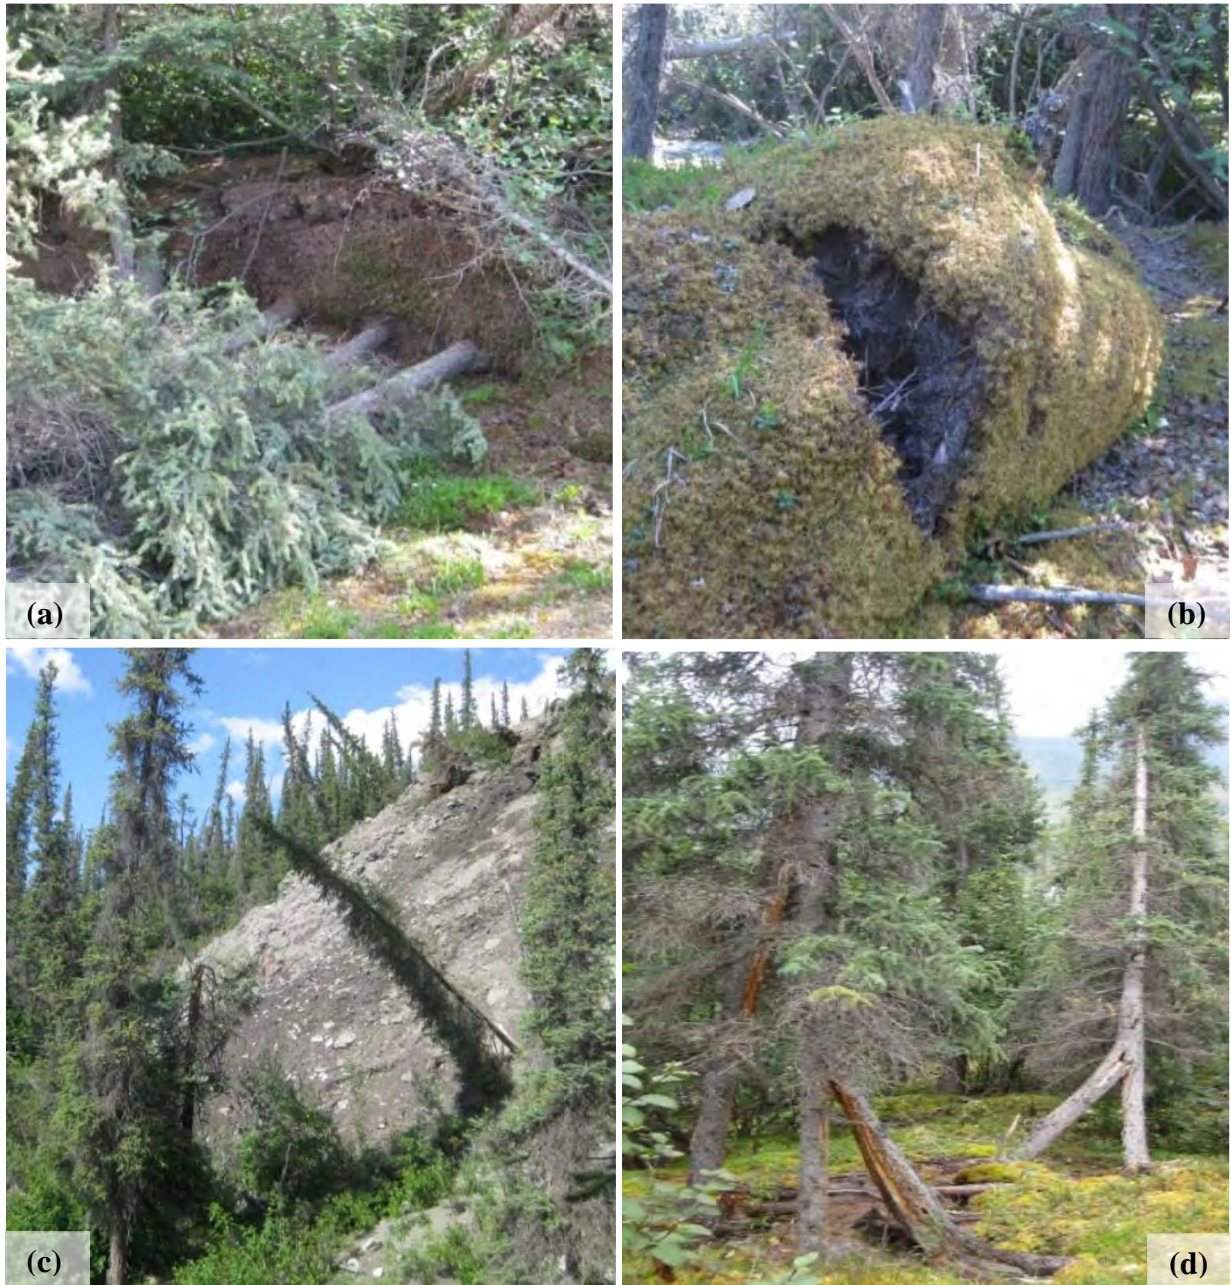
Figure 2. Indicators of frozen debris lobe (FDL) movement. (a) Trees are “bulldozed” and incorporated within the approaching FDL. (b) The toe of FDL-A rolled up the vegetative mat like a carpet. (c) The toe of nearby FDL-D (~3 mi. to the south of FDL-A), showing the approaching wall of debris. As the toe over-steepens, it is prone to debris flows during the summer months. (d) Trees growing on the surface of an FDL experience tension as the surface cracks and moves in multiple directions. The tree to the left has been split five-ways. (Photographs by M. Darrow)

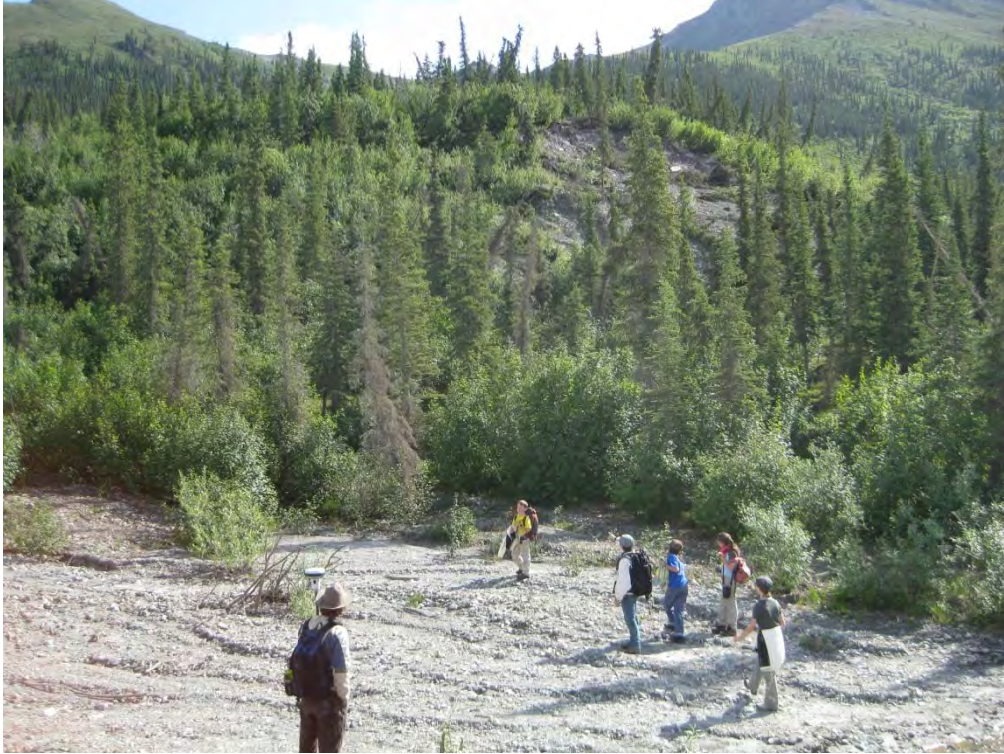
Even before entering the right-of-way, FDL-A is affecting the Dalton Highway. As shown in Figure 3, runoff, debris flows, and possibly internal meltwater from FDL-A have deposited a large volume of sediment ahead of the lobe toe. This sediment has banked up against the highway embankment, completely burying one culvert inlet and partially burying another (see Figure 4). This represents a maintenance issue in itself, and may result in damage to the highway embankment during periods of high discharge through the existing culvert.

Figure 3. The toe of FDL-A as seen to the east from the Dalton Highway in June 2011. The people in the foreground stand on recent sedimentation produced by FDL-A. (Photograph by M. Darrow)

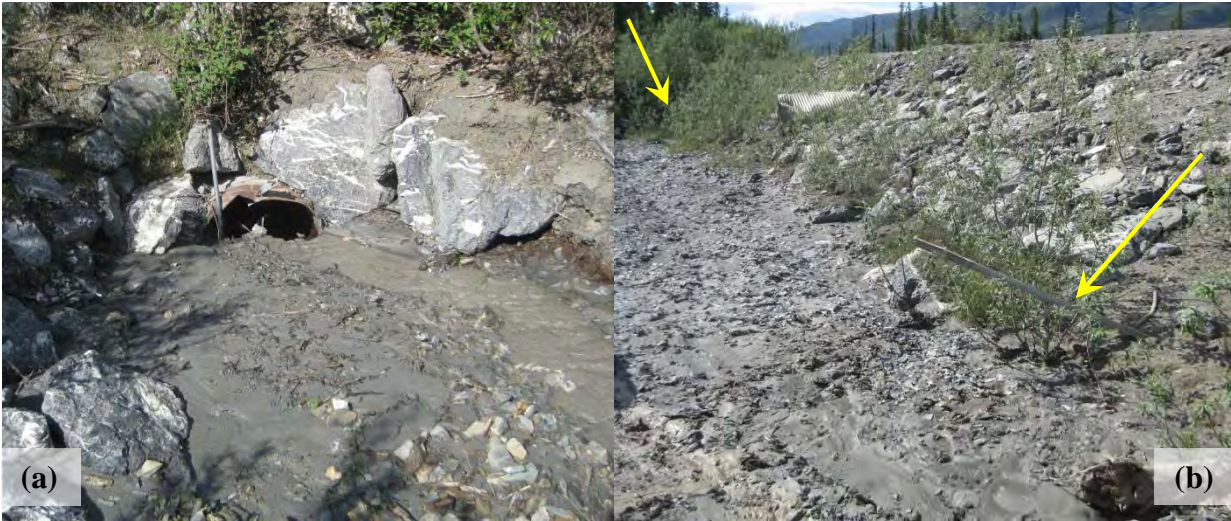
Figure 4. Evidence of sedimentation from the outflow of FDL-A. (a) A culvert inlet nearly buried with recent deposition. (b) A second culvert inlet is already buried by the sediment (see right arrow). The location of the culvert in (a) is indicated with the arrow to the left in (b). (Photographs by M. Darrow)

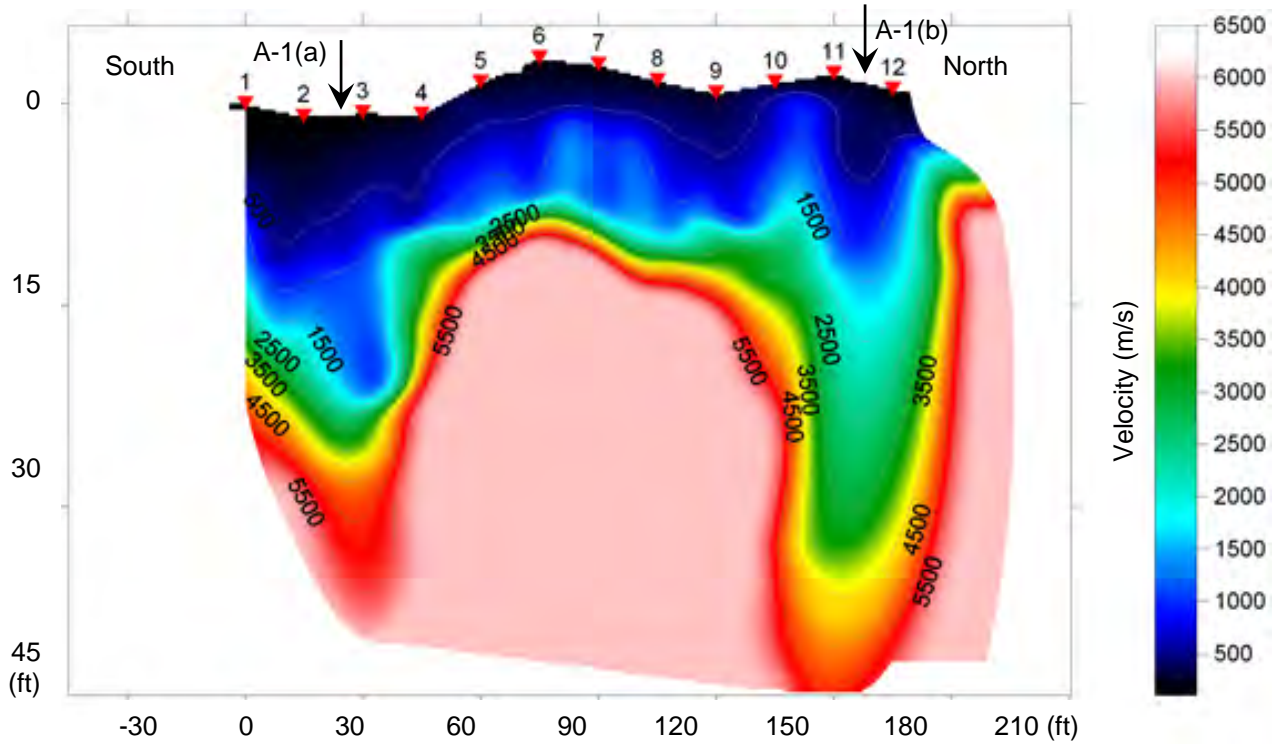
Figure 6. Seismic survey results for L1. Elevation and distance provided are relative to Shot 1 along this line. Velocity is provided in m/s from the seismic program. Arrows and identifiers correspond to those figures in Appendix A.

As mentioned above, the seismic velocity is far from uniform with depth. Instead, there are several areas where lower velocities are present dipping down into the subsurface. These low velocity areas seem to correlate with the location of cracks observed at the surface; photographs of examples of cracks documented along the seismic lines are included in Appendix A. As these cracks may function as conduits for liquid water, it follows that the water thaws the adjacent debris, which results in deep zones of lower seismic velocity.

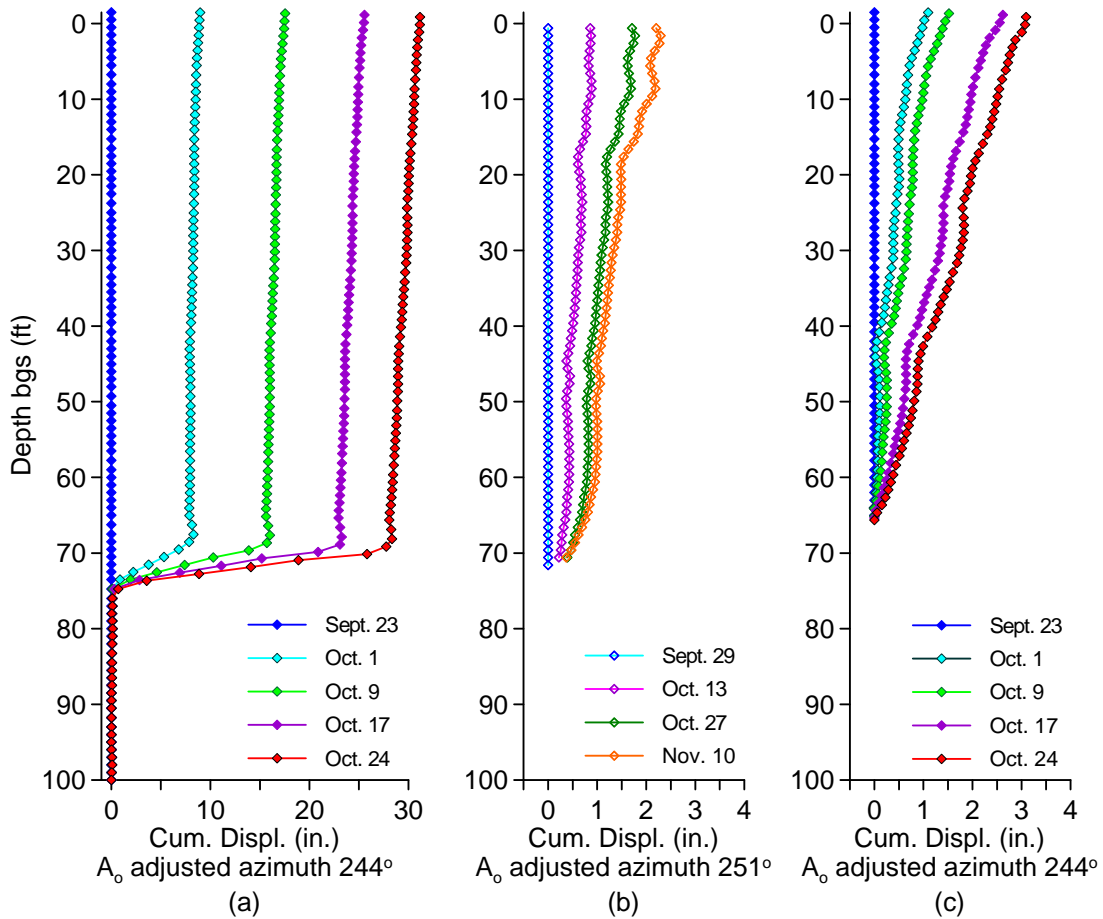
The plots of cumulative displacement in Figure 22a demonstrate fairly consistent movement over the measurement period, with a total of 31.2 in. of movement at the surface in about 31 days, or approximately 1.0 in. of movement per day. Early in the morning of October 24, the M-IPI began to record “retrogressive” movement upslope between 67 and 70 ft bgs. Considering the earlier failure of the thermistor string and the subsequent failure of the piezometer, we suspected that a few of the M-IPI sensors were damaged in the shear zone. The manufacturer of the device agreed, indicating that the sensors “probably deformed or rotated within the housing” (J. Lemke, pers. comm., Nov. 2012). Despite the damaged sensors, the entire M-IPI continued to record data, acquiring reasonable measurements of cumulative displacement below the depth of 70.5 ft. The sensor original at 69.5 ft bgs recorded the largest amount of shear (i.e., 30.4 in.) within this zone before failing. Then on October 31, the M-IPI sensors below 66 ft bgs ceased reporting data. Movement of FDL-A has continued, however, as indicated by the sensors above 66 ft bgs.

At first glance, it appears that only about 2 in. of movement occurred overall in TH12-9005 (see Figure 22b). Instead, these readings indicate that this boring is too shallow; when drilling, we did not penetrate through the shear zone and into the underlying bedrock as was suggested by drill reaction. Ideally, a slotted casing is installed 10 to 20 ft beyond the depth of movement (Cornforth 2005, Dunncliff 1993) so that systematic errors can be identified and corrected based on the zone of stable readings below the shear surface. This zone of stable readings is missing in Figure 22b; however, if the movement below 67 ft in TH12-9004 is factored out, the cumulative displacement appears to be about 3 in. (see Figure 22c), or about the same order of magnitude as seen in TH12-9005. Thus, since the casing in TH12-9005 does not penetrate the shear zone, it is only recording the deformation within the sliding mass. Although minor in comparison to the amount of movement within the shear zone, the upper portion of the lobe also is deforming, as indicated by the progressive “leaning” of the casing. This suggests that there is both internal shear and slow to moderate flow occurring within FDL-A.

Figure 22. Cumulative displacement measurements for (a) TH12-9004 and (b) TH12-9005. The data in (a) was adjusted to show only movement from above the shear zone at 67.5 ft bgs; the adjusted data is shown in (c).

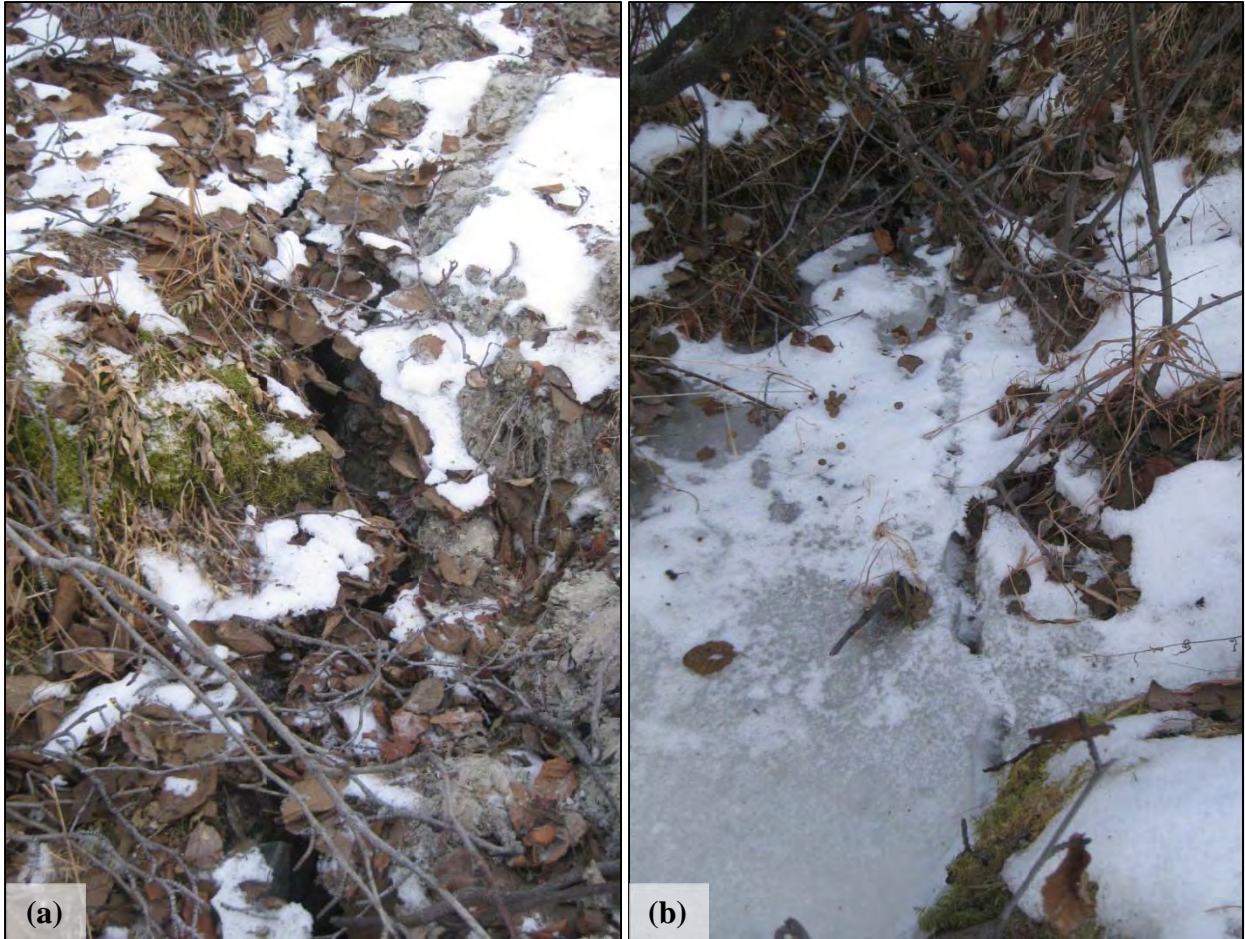
On subsequent trips to FDL-A, we continued to observe signs of ongoing movement on its surface. The late fall of 2012 was unusual as there was no appreciable snowfall (several residents in nearby Wiseman and Coldfoot comments on this unusual lack of precipitation). This allowed us to observe cracks in the ground surface that would otherwise have been covered with snow (see Figure 24 for examples).

Figure 24. Evidence of on-going movement in the early winter of 2012. (a) A crack separates the leaf litter and snowfall of late September. (b) Water that ponded on the surface in late September and subsequently froze is penetrated by a crack that continued beyond the extent of this photograph. (Photographs by M. Darrow)

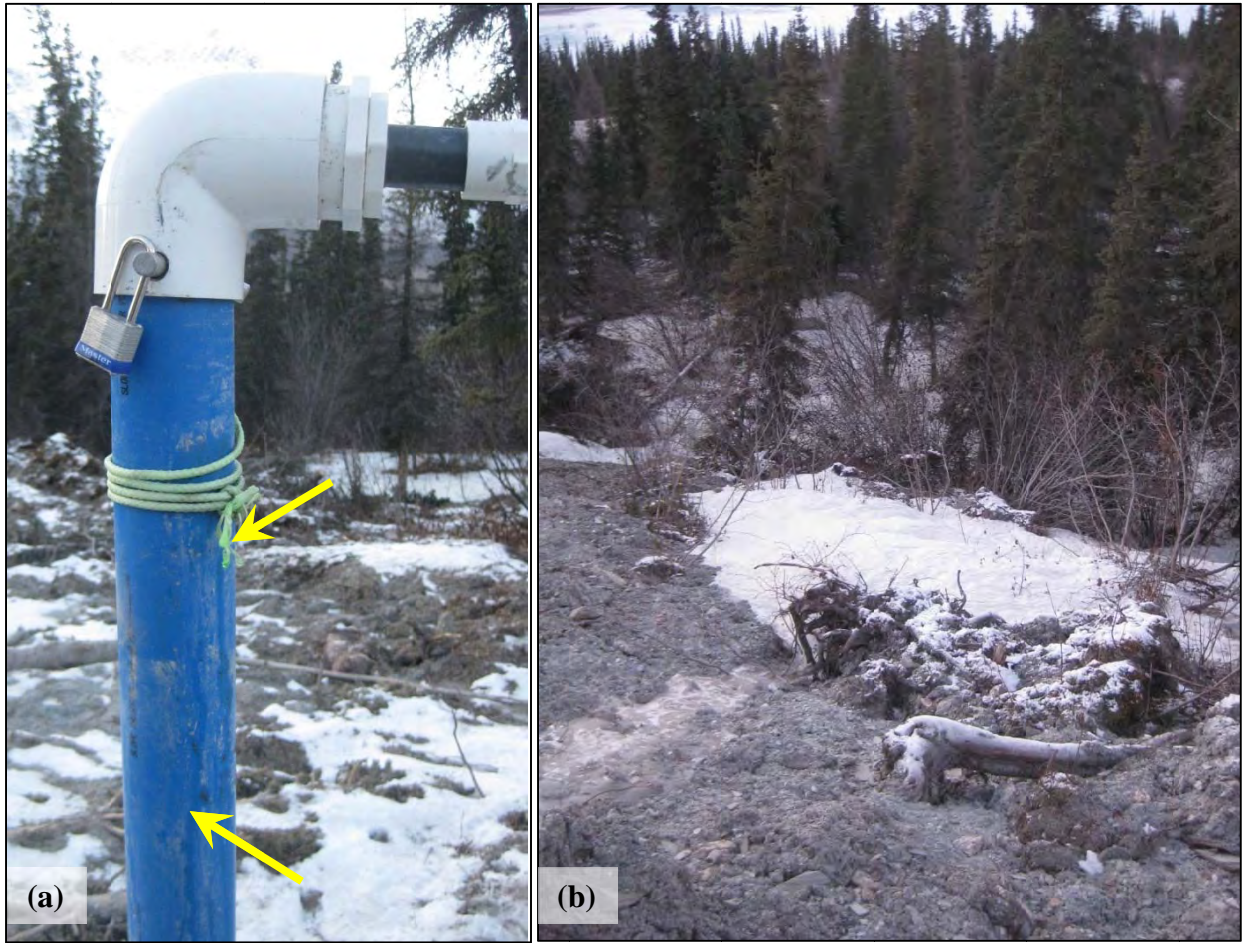
To ensure that the slotted casings remained free of ice for future readings, we filled each casing with propylene glycol. On October 27, we observed that the fluid level in TH12-9004 had dropped about 3 ft, confirming that the casing had sheared and some fluid had leaked out. On November 10, we observed that the fluid level had risen to fill the casing and was dripping out from the top. The high fluid level was again apparent on November 23, as indicated by drips running down the outside of the casing and accumulating on the M-IPI safety line (see Figure 26a). These fluid pressure observations suggest that groundwater has entered the casing through cracks within the shear zone, and is under enough pressure so as to flow up and out of the casing at the surface. We observed additional phenomena that indicated groundwater flow at FDL-A. Along the northern portion of the toe, water flowed out of the slope and into the forested area beyond (see Figure 26b). This ice-covered area was considerable in area and represented a significant volumetric discharge from FDL-A as the surface froze in early winter.

Figure 26. Evidence of groundwater flow at FDL-A. (a) Propylene glycol overflowing the top of the slotted casing in TH12-9004 drips from the M-IPI safety line and runs down the outside of the casing (indicated by arrows). (b) Ice formed along the toe of FDL-A; the Dalton Highway is visible near the top of the photograph. (Photographs by M. Darrow)

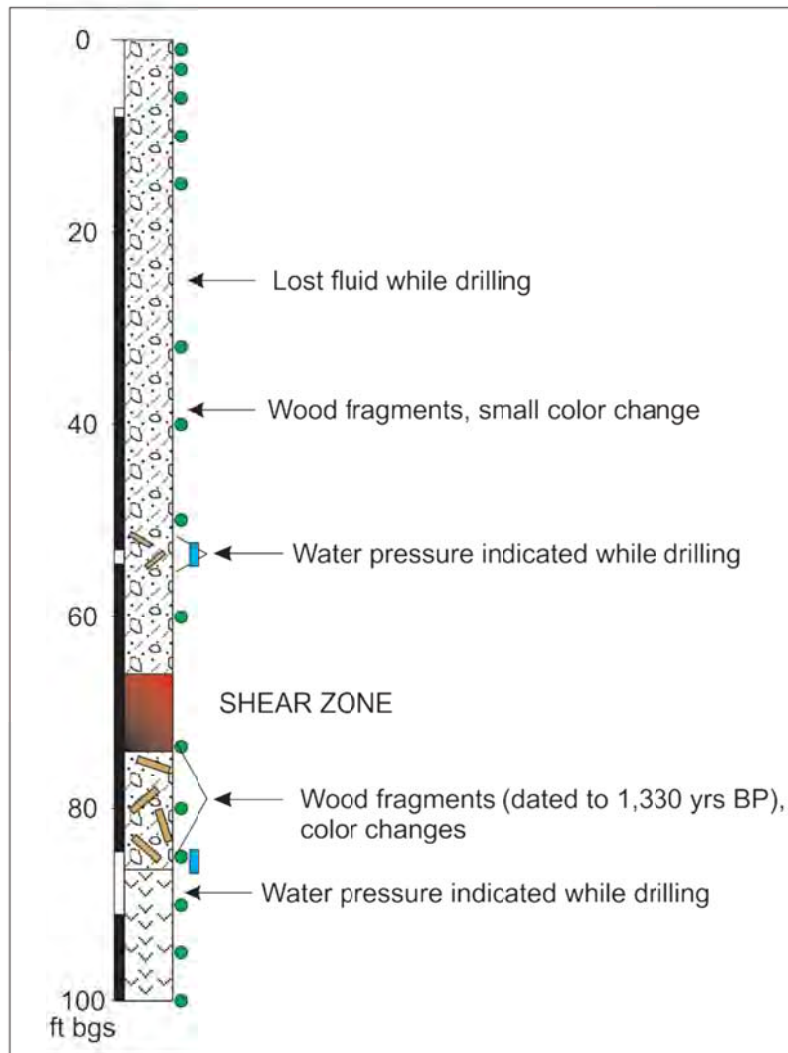
TH12-9004 was the most successful boring of the 2012 drilling program, as it intercepted both the shear zone and the bedrock surface, and the instrumentation installed within yielded much of our data. Figure 27 is a schematic summary of the major features of the subsurface and the drilling events. It also graphically summarizes the locations of thermistor beads and vibrating wire piezometers. The loss of drilling fluid and the presence of water pressure during drilling suggests a network of subsurface cracks through which water may flow. Indeed, the fact that water has entered into the sheared casing supports this idea.

Figure 27. Schematic of TH12-9004, showing locations of major features and events during drilling and borehole instrumentation. Thermistor beads are represented by green circles at depths of 1.5, 3, 6, 10, 15, 32, 40, 50, 60, 73.5, 80, 85, 90, 95, and 100 ft bgs. Vibrating wire piezometers are represented by blue rectangles at 53.5 and 85.5 ft bgs. Wood fragments are indicated by brown rectangles, and the bedrock surface is at 86.5 ft bgs. The shear zone is between 66 and 74 ft bgs. Frozen ground is represented by the black bar along the left of the boring schematic; white portions of the bar represent questionably frozen areas.

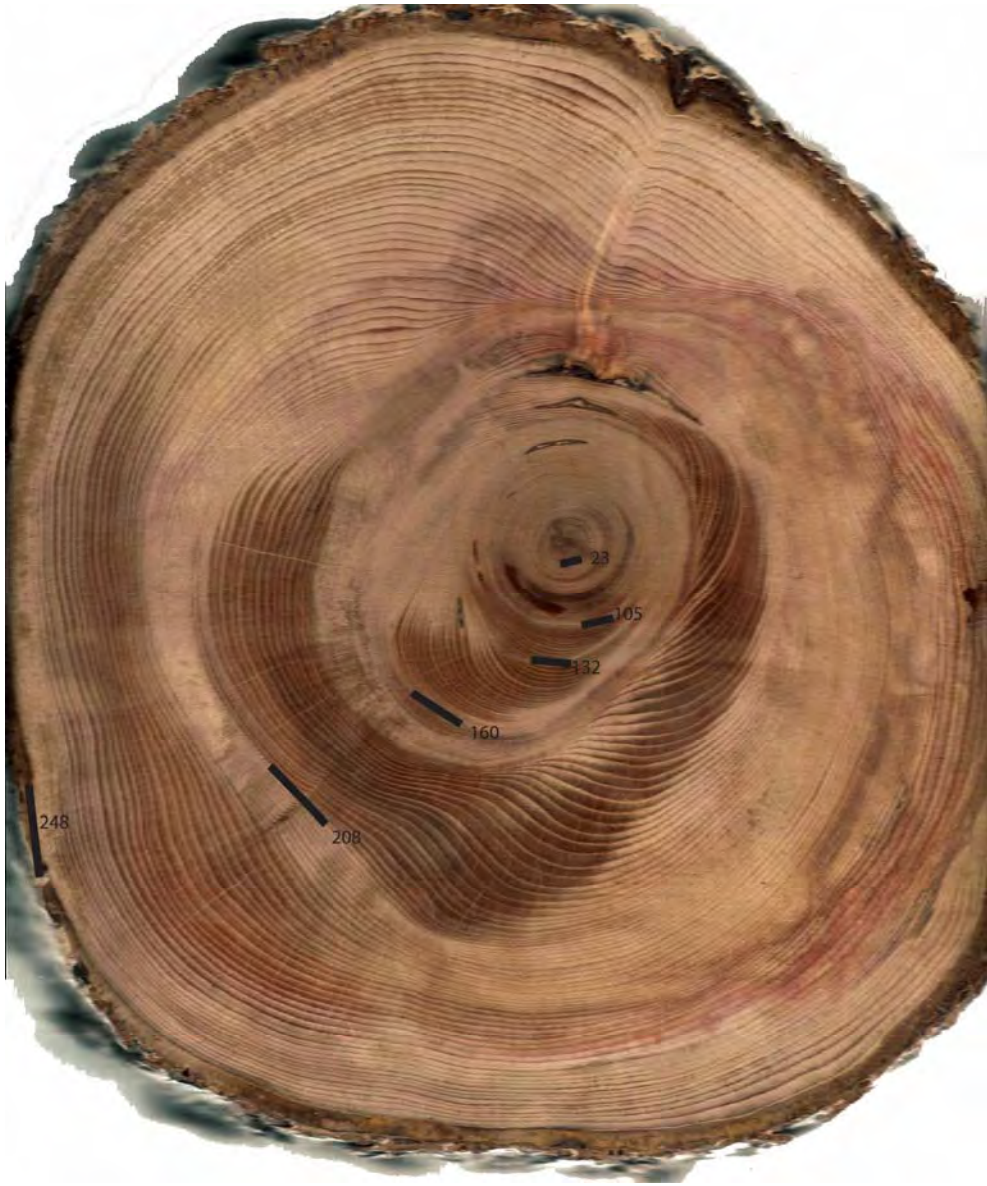
Figure 29 illustrates a particular tree ring pattern associated with one such tree that grew on the shifting surface of FDL-A for 248 years. The pattern reveals that the tree started its life growing vertically for about 23 years, after which time the ground shifted. Eighty-two years went by with very dense growth rings, possibly due to damage in the root system, but without a shift in the tree's growth direction. The next 27 years indicate that the tree grew in a different direction. The tree shifted again after another 28 years, followed by 48 years of continuous rotation, like a corkscrew. The last 40 years of growth on the tree shows a relatively stable period. More detailed growth information can be obtained by comparing the width of the rings to healthy trees in the area; stress caused from ripping roots would reduce the tree's growth, resulting in thinner rings. As part of future studies, we will develop a dataset of tree ring width and correlate it to movement of FDL-A.

Figure 29. Tree slab from the FDL-A surface, showing tree ring deformation as a result of changing tree orientation. The photograph contains annotations indicating the age of particular rings when change in the tree's orientation occurred. (Photograph by R. Daanen)

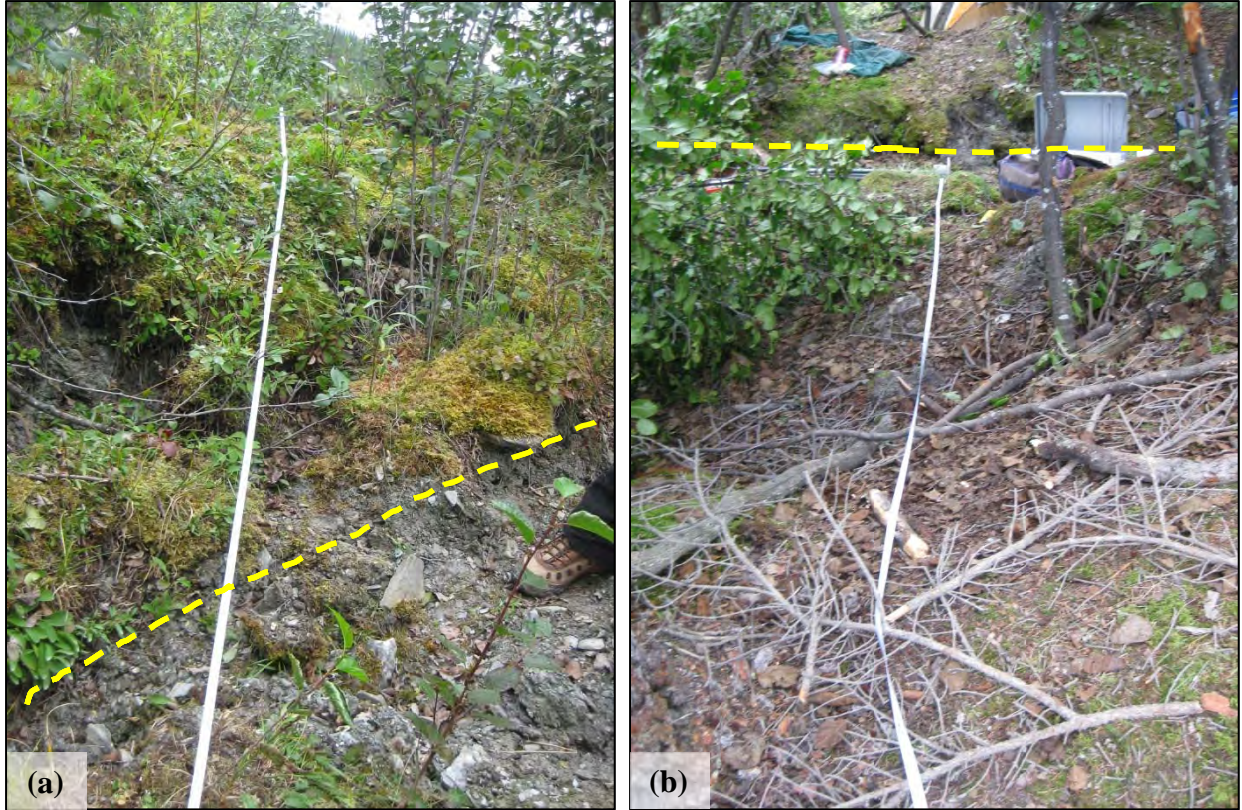
Figure A-1. Cracks (indicated by dashed yellow lines) along seismic Line 1 on FDL-A. (a) Crack between Shots 2 and 3; photograph was taken towards the south, facing the left-flank of FDL-A (photograph by M. Darrow); (b) crack between Shots 11 and 12; photograph was taken towards the south. (Photograph by J. Simpson)

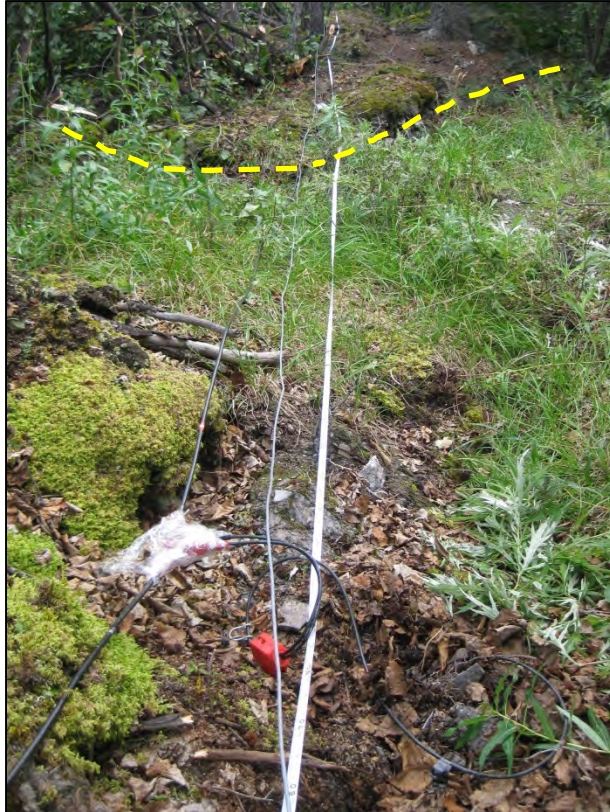
Figure A-2. Crack (indicated by the dashed yellow line) along seismic Line 4 between Shots 46 and 47. This photograph was taken towards the east, facing uphill on FDL-A. (Photograph by M. Darrow)

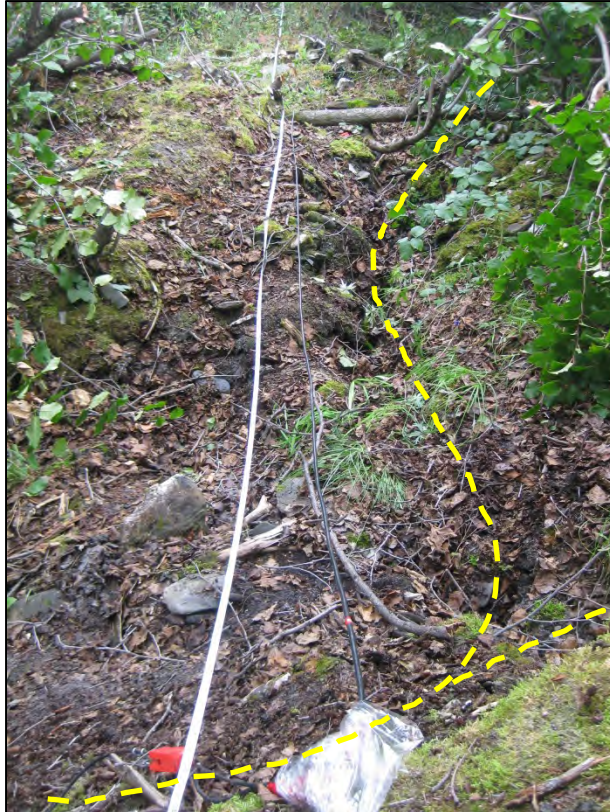
Figure A-3. Cracks (indicated by the dashed yellow lines) along seismic Line 6 between Shots 63 and 64. This photograph was taken towards the west, facing downhill on FDL-A. (Photograph by M. Darrow)
