**Observations from the EEFIT-TDMRC Mission to Sulawesi, Indonesia to Investigate the 28th September 2018 Central Sulawesi Earthquake**

Lagesse, Richard; Rossetto, Tiziana; Raby, Alison; Brennan, Andrew; Robertson, David; Adhikari, Rohit Kumar

*Published in:*  
SECED 2019 Proceedings

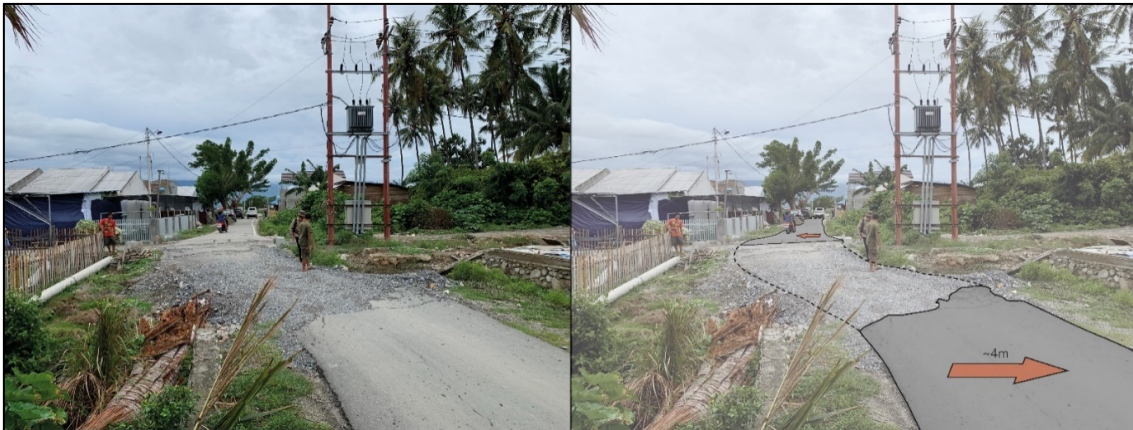
Numerous expressions of the fault surface rupture were identified throughout the area, typically by the offset of linear features such as roads (Figure 2), but also dramatic continuous surface ruptures through agricultural land. Left-lateral strike-slip displacement was measured by the Team to be a maximum of 5m at Pewunu (Figure 3), and typically between 3-4m. It is possible that, as the Pewunu area is in close proximity to the valley sides and steep terrain, the soil is thinner and thus the greater displacements in the bedrock are more closely represented at the surface.

Figure 2. Offset road due to strike-slip fault displacement.

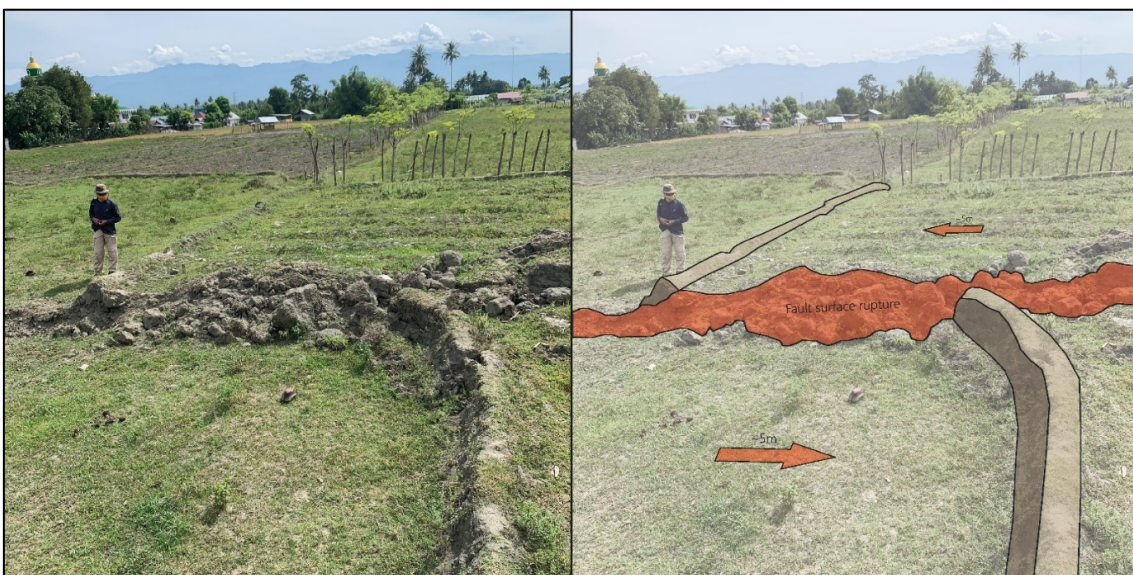
Figure 3. Displacement of approximately 5m along fault surface rupture shown due to offset rice paddy terraces.

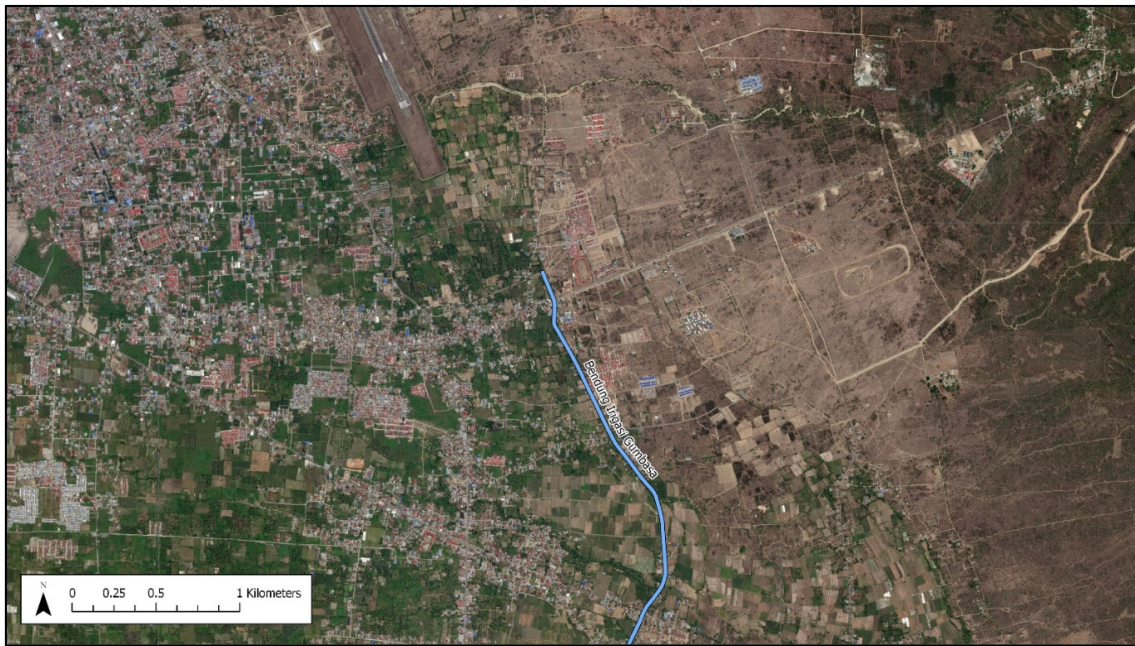
The three main landslides that occurred following the earthquake are considered to be low-angle liquefaction-induced debris flows that were extremely mobile due to significant water content. The causal factors are largely thought to be related to the hydrogeological regimes' interaction with the topography as well as possible anthropogenic factors. Most notably, a man-made irrigation channel running along the eastern side of the valley (Figure 1) appears to be the initiation point of the two largest landslides with evidence suggesting the underlying hydrogeological regime is significantly affected by its presence (Figure 4). Whether or not the irrigation channel alone directly led to the failures is cause for discussion, but it is likely at the very least that it contributed to the long runouts due to the significant volume of additional water introduced into the ground.

Figure 4. Difference in vegetation growth due to groundwater conditions on either side of the Bendung Irigasi Gumbasa. Green vegetation growth (left) indicates wetter ground conditions as opposed to brown land with lack of vegetation growth (right) indicating mostly dry ground.

Further investigation is needed to establish a clearer picture of the landslide causes and mechanisms, ideally with some detailed intrusive geotechnical investigation. This will provide information on which to design potential mitigation options, such as drainage infrastructure and modifications to irrigation systems.

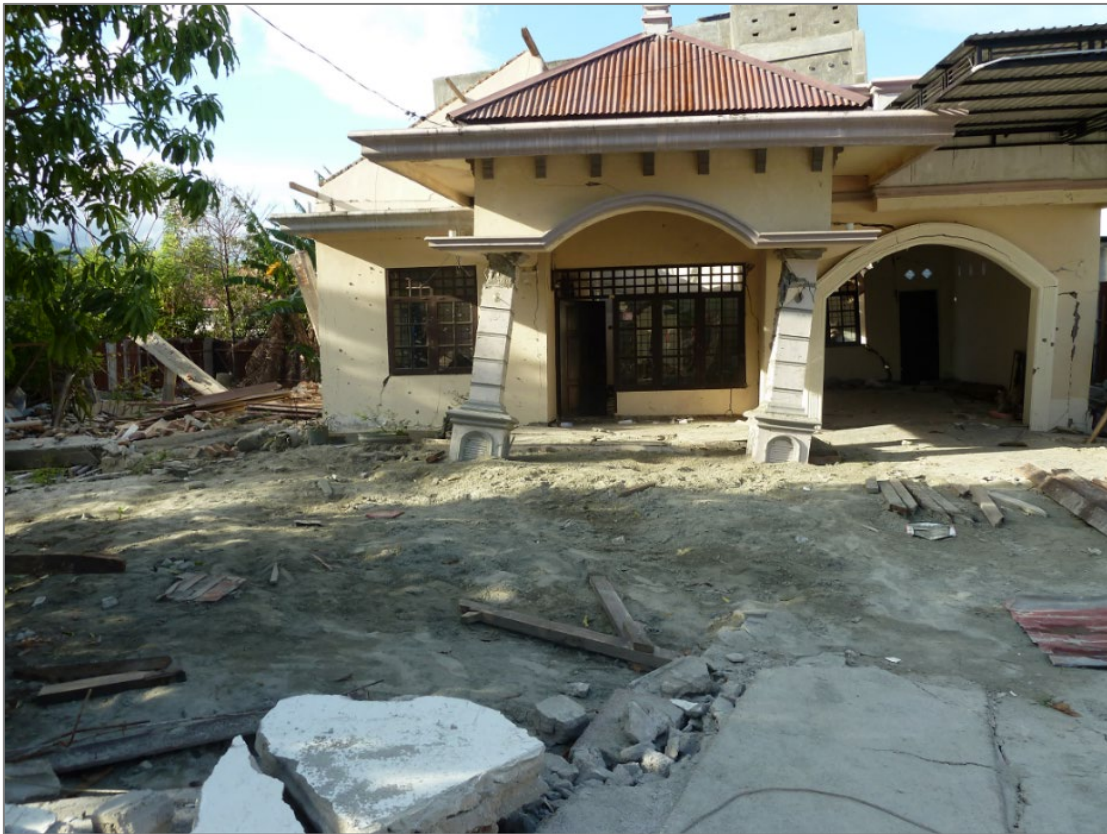
- “Conventional”, localised liquefaction-induced settlements and tilting of individual structures, with associated ejecta features (Figure 5). These seemed to affect a small number of isolated areas.
- Liquefaction of seafront areas near estuary mouths, resulting in significant areas of land mass slumping into Palu Bay (Figure 6). The Team identified areas on both sides of Palu Bay affected by this. It is possible that some of the reported coastal inundations were caused by backwash over these slumps.

Figure 5. Damage to a one-storey building in Lasoso due to differential settlement induced by liquefaction. Sandy ejecta in garden.

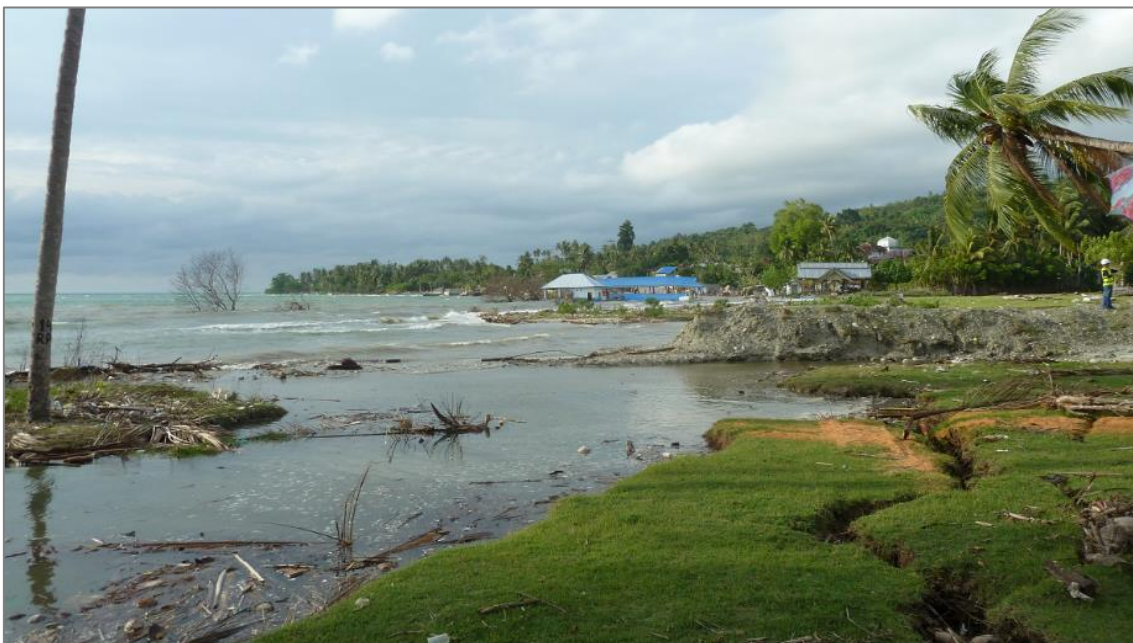
The team identified areas on both sides of Palu Bay affected by seafront loss due to liquefaction. The EEFIT-TDMRC observed this at Loli Tasiburi on the Western shore and at Lero on the Eastern coast. Locals at Loli Tasiburi reported that large areas of coastline had broken off and fallen into the sea, with one indicating Palu, visible in the distance around a headland, which he reported had previously been obscured by the land. An eyewitness described the soil “bubbling”, and two large upwards spurts of water on the beach. The soil type and inevitable high groundwater level suggest liquefaction was a clear possibility, and the eyewitness reports are consistent with soil liquefying. The team concluded that liquefaction had therefore occurred in the coastal soil, and either the resultant large settlements were sufficient to submerge the coastal land or (more likely) lateral spreading has taken the shoreline into the bay.

Figure 6. Area of land lost to coastal slumping due to liquefaction at Lero.

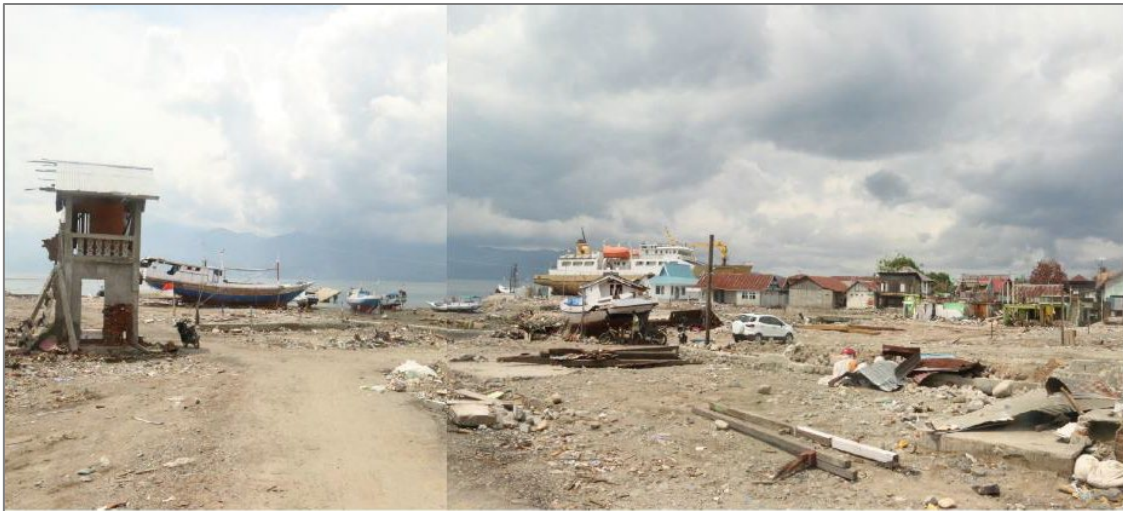
Despite causing considerable damage along the shoreline (Figure 8), the horizontal inundation of the tsunami was relatively modest. This is an indicative characteristic of landslide generated tsunamis. There was no evidence of the tsunami having travelled up the Palu river at the southern end of the bay, which is in contrast to what has been found on previous EEFIT missions e.g. Japan 2011. A possible reason for this is that the collapsed Palu Bridge IV created a barrier to the tsunami; the collapse of the bridge occurred due to the earthquake ground shaking.

Figure 8. Wani village on the east coast of Palu bay which experienced considerable damage.

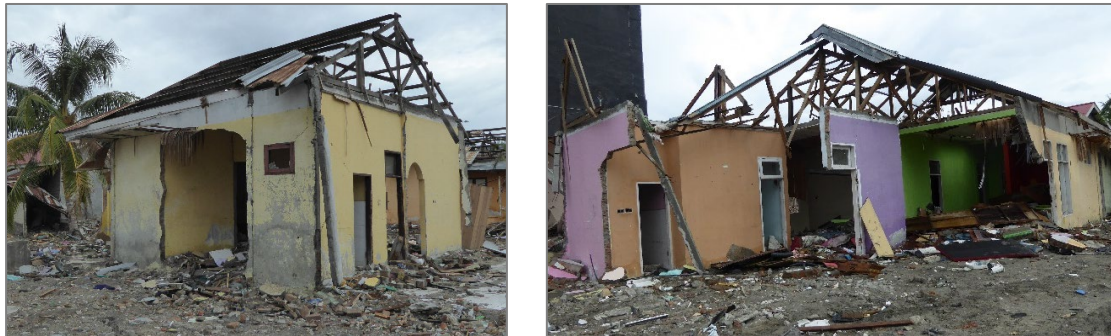
The most common non-engineered construction observed in Palu is confined masonry (CM). Typical damage sustained by CM houses along the coast line in Palu bay area is shown in Figure 9. The main damage pattern is the out of plane failure of walls directly hit by the tsunami waves. In the case of earthquake ground shaking the weak materials used for both the masonry and confining elements resulted in out-of-plane failure of the masonry and cracking and failure of tie-columns.

Figure 9. Heavily damaged CM houses in Palu bay area along the Jl. Rajamoili road, about 100m from coastline. The walls of this house were directly hit by the tsunami inundation.

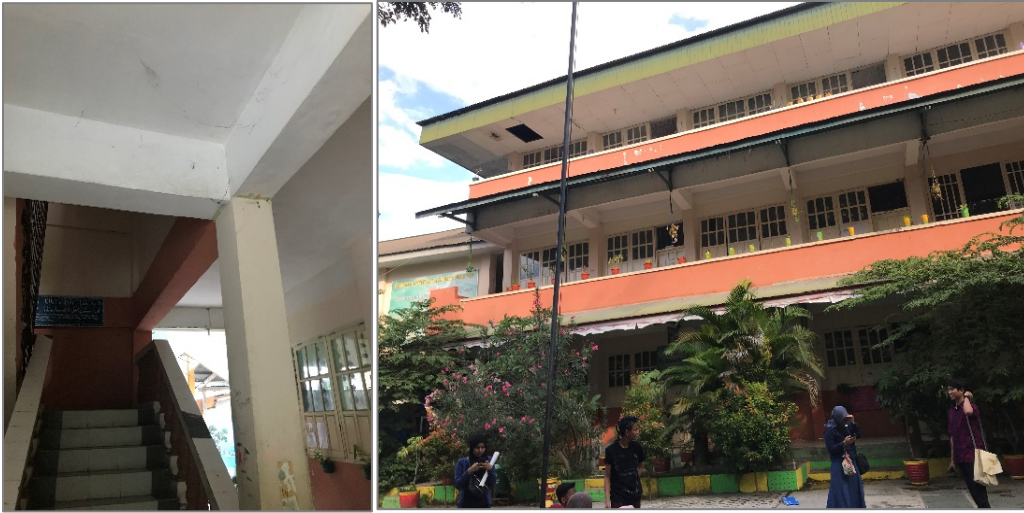
Figure 11. MTS Alkhairaat Pusa Palu School. Left – 3-torey RC frame building that sustained minor damage to infill panels. Right – Typical sizes of beams and columns in RC frame schools.

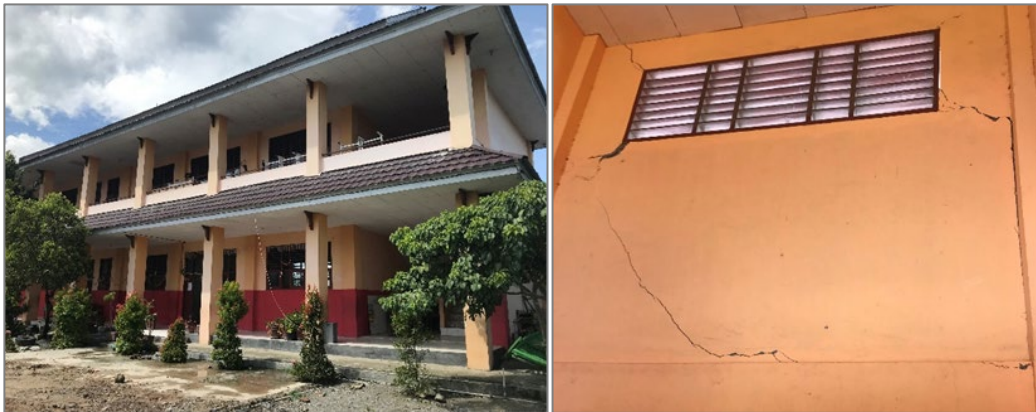
Some reinforced Concrete (RC) school buildings were also observed. These were 2 to 4 storey high, RC frames with brick masonry infill. These school buildings had had some level of seismic design and good material quality. Generally, reinforced concrete school buildings performed well during the earthquake ground shaking. For example, MTS Alkhairaat Pusa Palu School contained 9 two-storey RC school buildings, all of which suffered no damage. Only one 3-storey RC building at this school complex had suffered light damage to its infill walls (Figure 11). In fact, damage to masonry infill walls was the predominant damage observed in RC frame school buildings that were subjected to earthquake ground shaking only, and an example is shown in Figure 12.

Figure 12. Damage to infill walls in a 2-storey RC school building in SD Negeri Pengawu School in Palu (Building A in Fig. 7.24).
