# Evaluation of the Overheight Detection System Effectiveness at Eklutna Bridge

## Final Report

INE/AUTC 13.12

FHWA-AK-RD-13-01

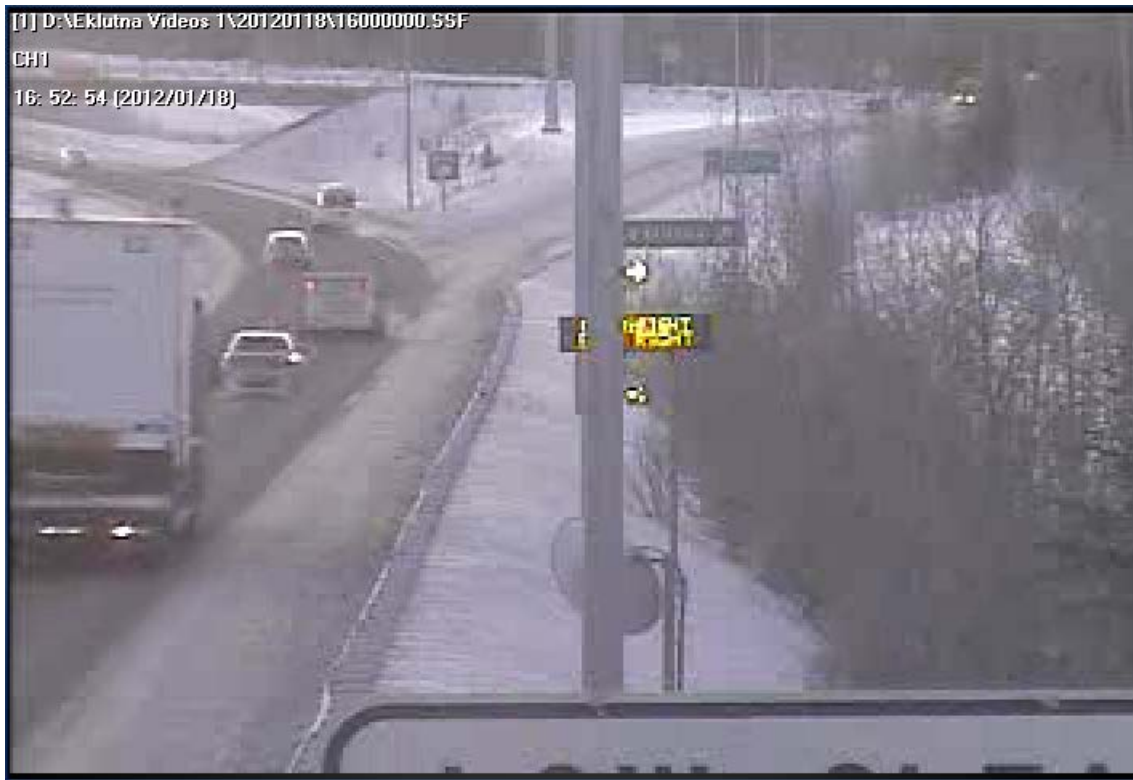
**Figure 9 The blankout sign captured by Camera#1 in Incidence#2**

By design of the original system, after the detector is triggered, the alarm speaker will go off and the blankout sign will display a warning message telling the driver to take the ramp exit. Camera#1 of the added monitor system is installed to capture the blankout sign to see if it is actually turned on after an overheight violation is detected. Figure 10 shows the video image of the blankout sign captured by Camera#1. With the exception of cases identified as system error false alarms (see Table 4), the blankout sign was successfully activated and flashed in all the cases when camera#1 was activated.

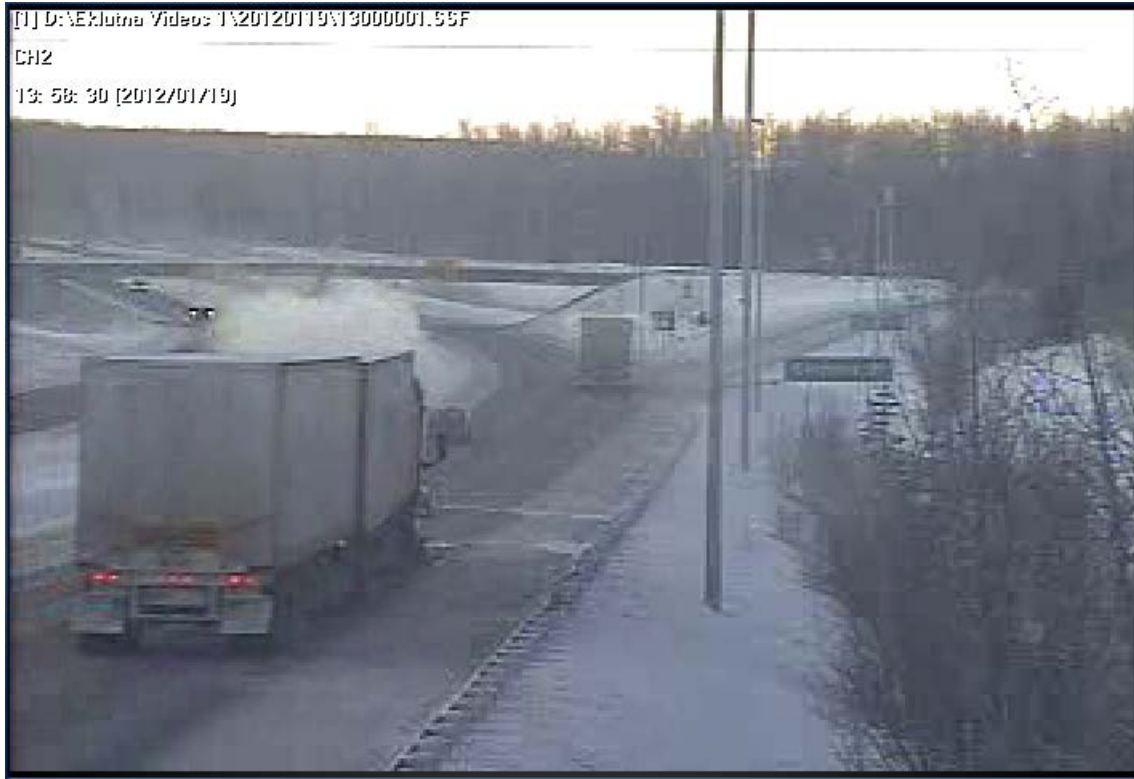
**Figure 15 The image of the truck recorded by Camera#2 in Incidence #4**

After examining the video footages from January of 2012, we found out that in all of the 15 false alarm cases this month the overweight detector beam was not blocked by the cargos of the trucks, but by the freezing fog coming from the exhaust pipes of the trucks. Figure 16 shows the video image of one of these incidents.

The truck in Figure 16 appears to be a typical tractor trailer with a standard height of approximately 13 feet. However, the dense fog coming from the exhaust pipes of the vehicle appears to add about 2 to 3 feet from the top of the truck. The overall height of the truck with the exhaust fog could easily reach the overheight detector.

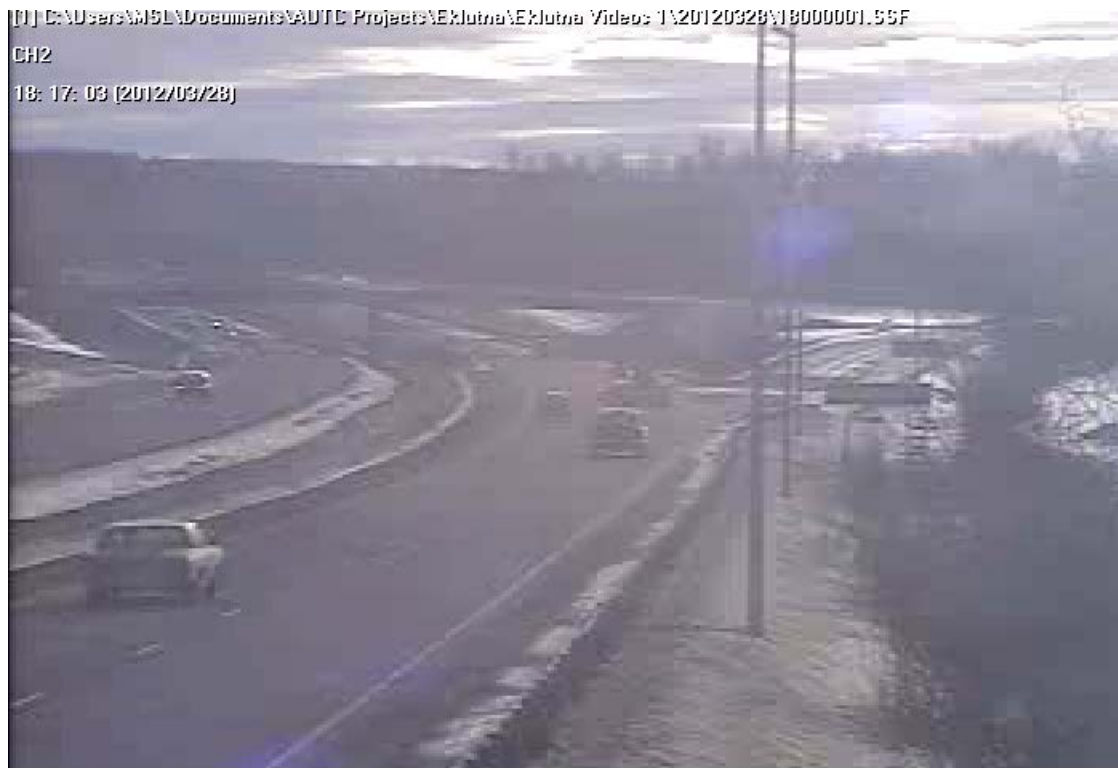
**Figure 17 The Video Image of Lighting Condition during Sunset on March 28, 2012**

The video images for the two cases identified as caused by sunlight reflection show glare of sunlight (see **Figure 18**). The incidence on March 28 occurred during sunset at 6 pm and the one on April 14 occurred during sunrise at 6 am. Note that the Glenn Highway at the bridge site runs in the general direction of east-west. The rays of sunlight during sunrise and sunset run parallel to the highway and perpendicular to the detector beam, thus increasing the chance for sunlight reflection/glare to intersect the detector beam. Since no other potential cause can be identified for the false alarms in these two cases, sunlight reflection is determined to be the most likely cause of the false alarms.

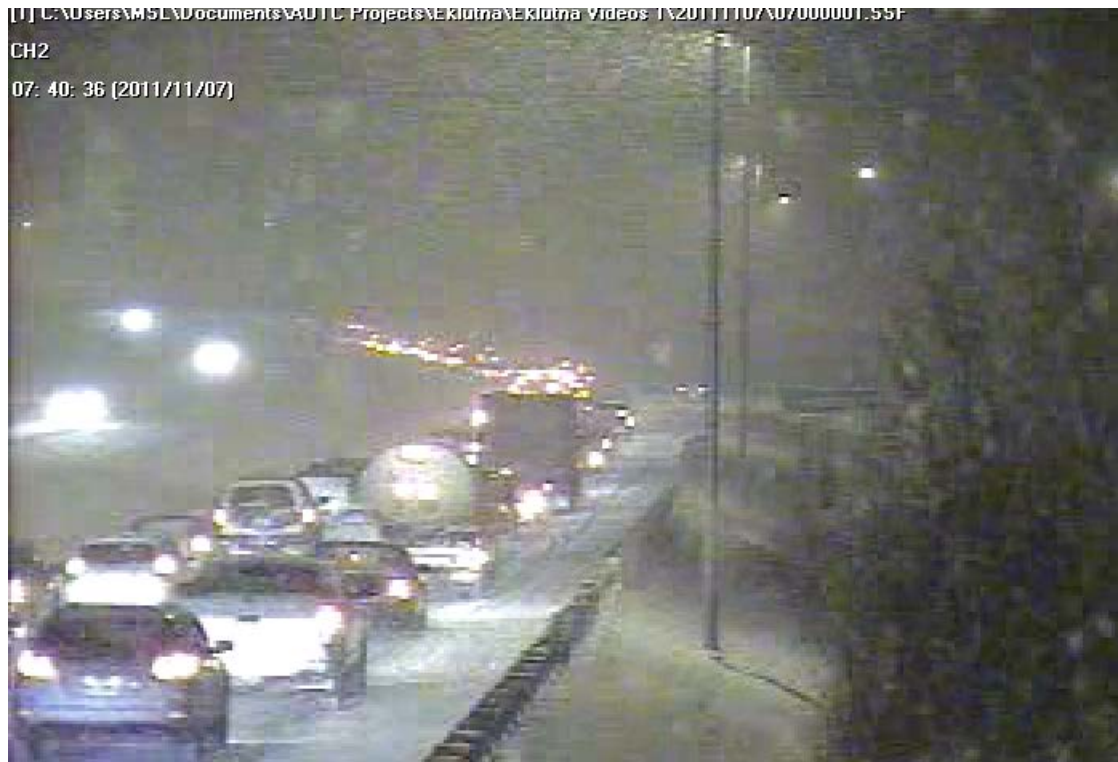
Figure 19 The Video Image of the Heavy Snow Even on November 7, 2011

detector beam and triggering the system. Thus, during heavy snow events, the system has a higher chance of being triggered for false alarms. A good example of this is the heavy snow event on the morning of 11/7/2011 (see Figure 20). In less an hour, the system was triggered twice for false alarms by the heavy snow fall.

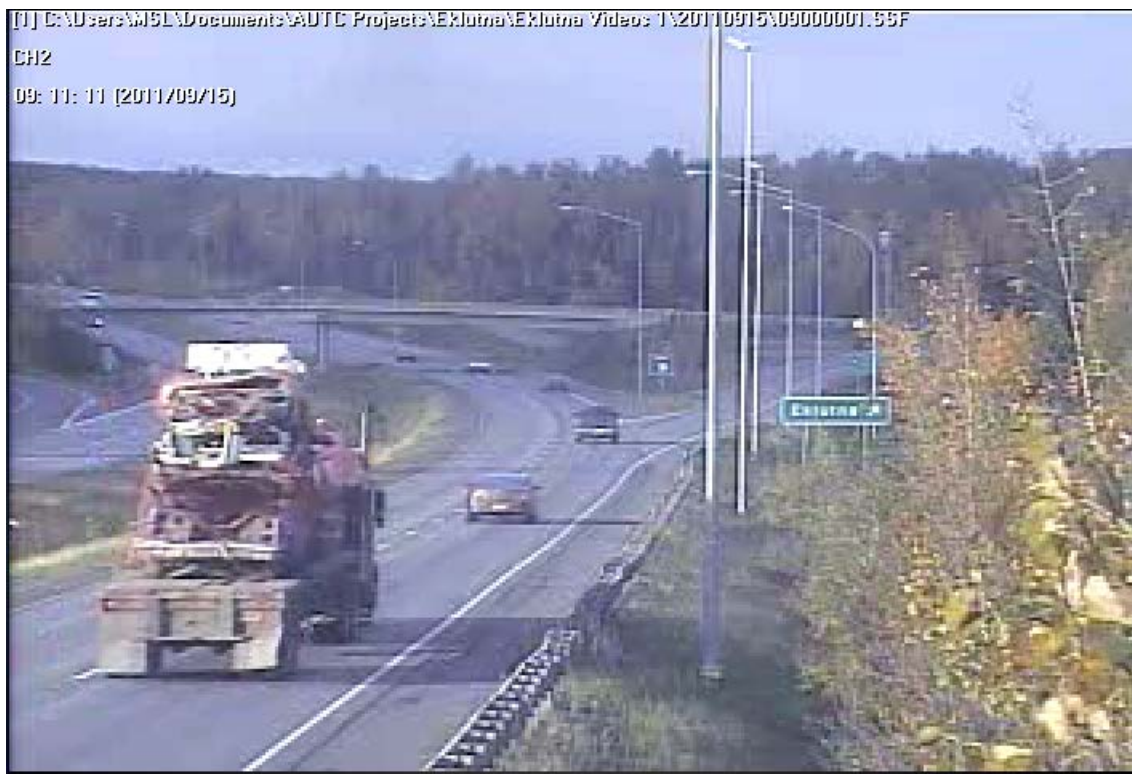
We also identified 15 cases of verified overheight violation that did not take the ramp exit. Most of these trucks carried cargoes of irregular shapes such as junk metals, double decks of cars, large containers, or large vehicles or equipment. These trucks appear in the videos to be taller than typical semi-tractor trailers. Figure 21 shows one of such an example. According to the recorded video, the truck in Figure 21 appears to have cleared the bridge underpass (Figure 22). However, it is noted that

**Figure 20** The image of an overheight truck recorded by Camera#2

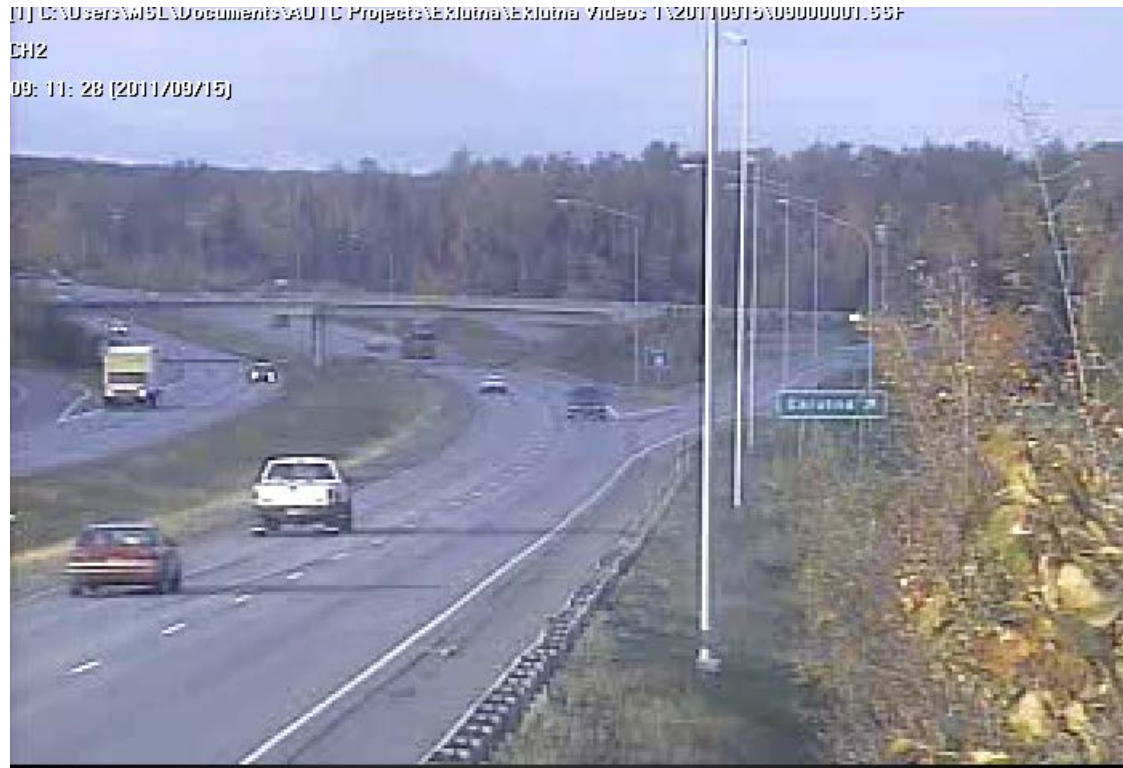
the image of the truck at the bridge underpass is too small to serve as convincing evidence for the occurrence of bridge impacts.

**Figure 21 The end of recording showing the vehicle in Figure 21 clearing the underpass**
