38th WEDC International Conference, Loughborough University, UK, 2015

Sustainability of hand-dug wells in Tanzania: results from a post-evaluation

L. Gill, & F. Flachenberg (Ireland)

BRIEFING PAPER 2088

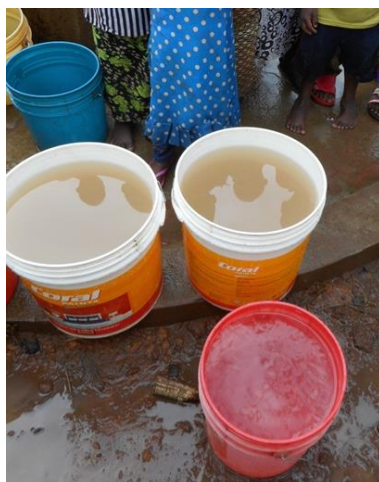
At 10 out of the 17 of the wells the users reported that the water changed colour after heavy rainfall events which indicates potential rapid pollution pathways. An example of this is shown in Photograph 1 which shows the difference in water clarity from water drawn in the morning following a couple of days without rain (the red bucket) compared to water pumped just after a rainfall event (the white buckets). This is of some concern from both a water quality perspective as well as the local community's perception. In addition, at two of the wells, users reported that worms sometimes appeared in the pumped water during the rainy season. The siting of some of the wells was very close (<30 m) to surface water (rivers or other traditional wells) which provides a contamination source and potential for very rapid pollutant transport into

Photograph 1. Change in turbidity of water following a rain event

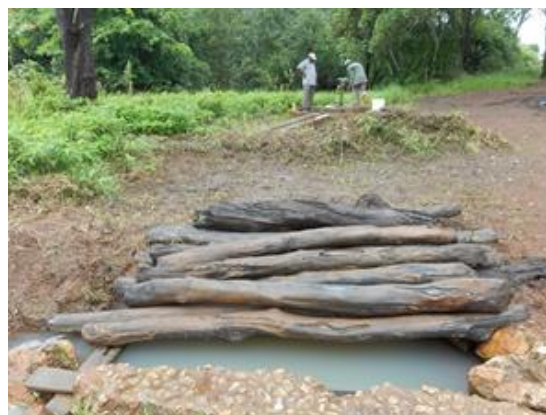
these shallow wells (see Photograph 2). In addition, many users reported significant problems with reduced yields in the dry season.

Photograph 2. Proximity of PE17 hand pump to traditional open water source
