Factors Contributing to Heat Affected Zone Damage in Grade 91 Steel Feature Type Cross-weld Tests

John A. Siefert¹, Dr. Jonathan D. Parker² and Rachel C. Thomson³

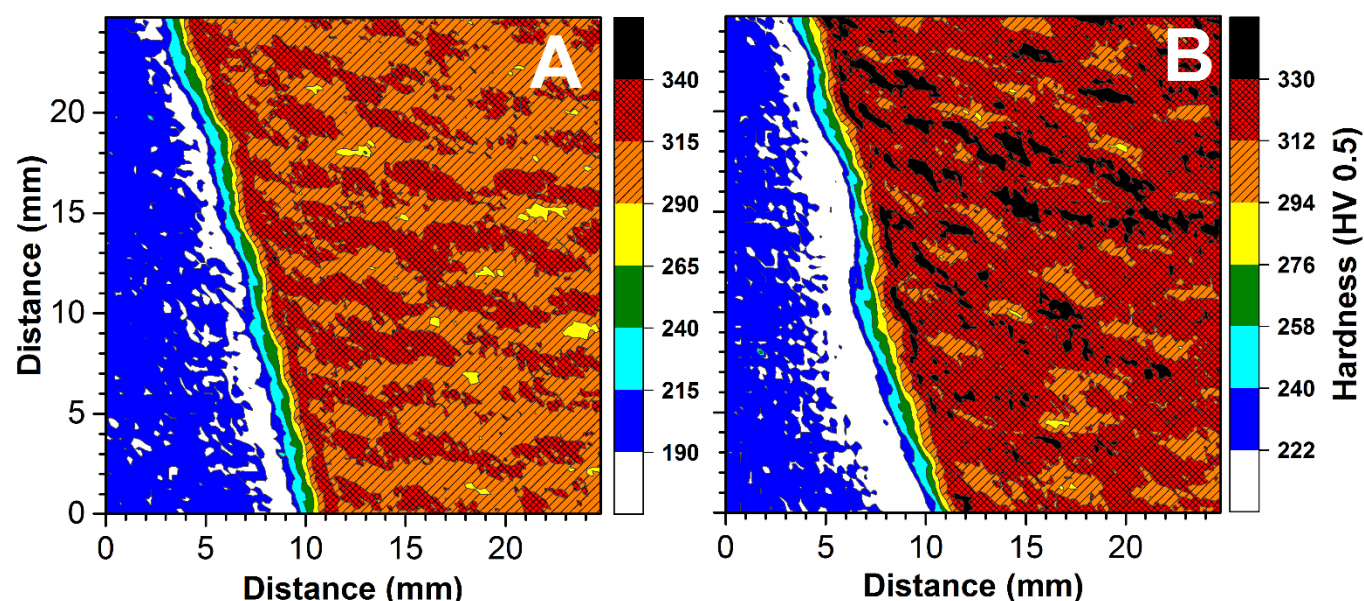
The results for hardness mapping are given in Figure 3. Note that with regard to each image, the unaffected parent material is on the left, then the heat affected zone and the deposited weld metal (all results are provided after post weld heat treatment [PWHT]).

Figure 3: Hardness Mappings for Weldment in TP1 (A) and RNT-B2 (B); Note that the hardness scales have been adjusted relative to each image.

Damage is often identified with an over-tempered region in the HAZ, e.g. such as the white region identified in Figure 3. However, and consistently for numerous samples including data not presented here, there is consistent association of peak damage and failure in the HAZ region adjacent to this over-tempered region and as exemplified in Figure 7. In the HAZ then there must exist subtle details in the microstructural zones with respect to deformation and damage. This situation is exacerbated, e.g. the tendency to damage-dominated failures, by the feature test cross-sectional area which results in a multiaxial stress state. The multiaxial stress state results in high triaxiality and enhances the evolution of damage in a process analogous to in-service component behavior. It is important to note that damage observations made in the HAZ for small, round bar samples more typical of cross-weld creep evaluations in the literature may not result in the same conclusion presented here as the sample geometry (e.g. that damage and failure occur adjacent to the over-tempered zone and not in this zone). Small samples with gauge diameters conventionally on the order of <6.5 mm are insufficient to induce a sustained triaxial stress state through the thickness of the HAZ.

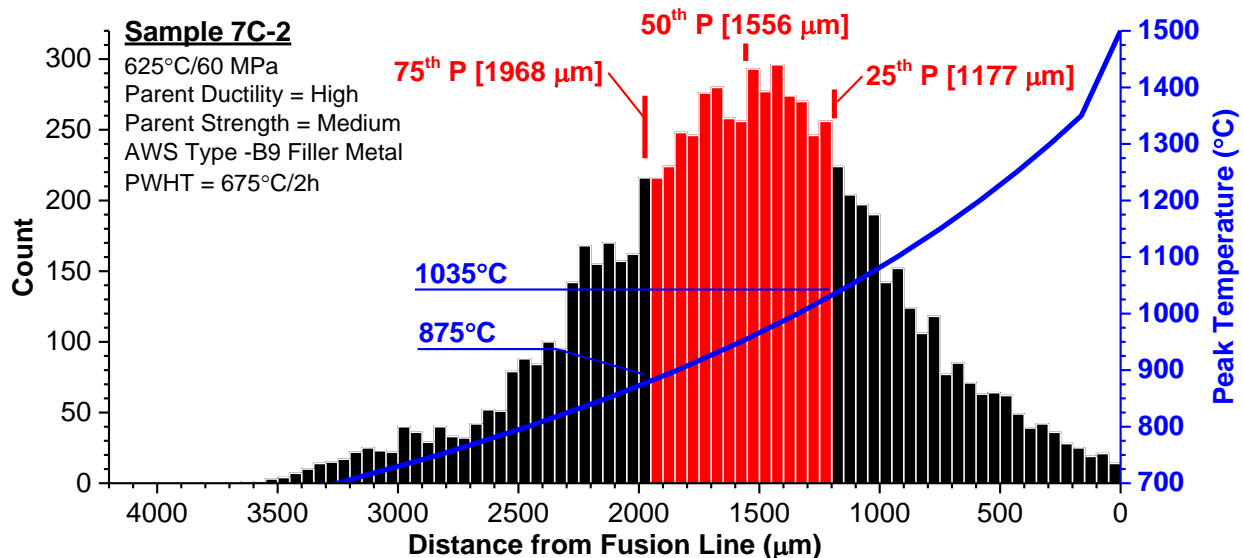
A plot of the damage analyzed in the HAZ for samples 7C-2 and RNT-B2-2 are given in Figures 4 and 5, respectively. The region in each plot highlighted in red corresponds with the area in the HAZ to the highest, statistically evaluated region of damage and as explained in more detail in [13]. With respect to the feature cross-weld tests conducted at 625°C and 60 MPa, sample 7C-2 was terminated after 13,201 hours and for sample RNT-B2-2 after 2,596 hours. A representative image in a high damage field in the HAZ for each sample is provided in Figure 6 as an adjusted brightness and contrast image (creep cavitation damage represented by the black features in each image).

Figure 4. Distribution of Damage in Sample 7C-2 (parent metal TP1) after Testing at 625°C, 60 MPa and 13,201 hours

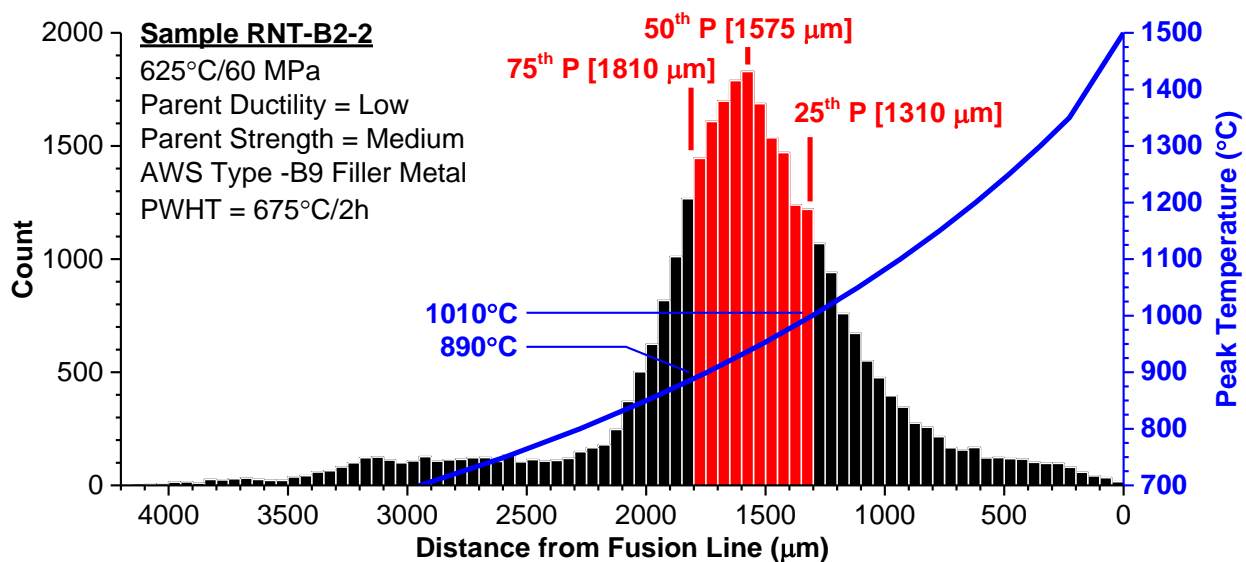
Figure 5. Distribution of Damage in Sample RNT-B2-2 (parent metal B2) after Testing at 625°C, 60 MPa and 2,596 hours

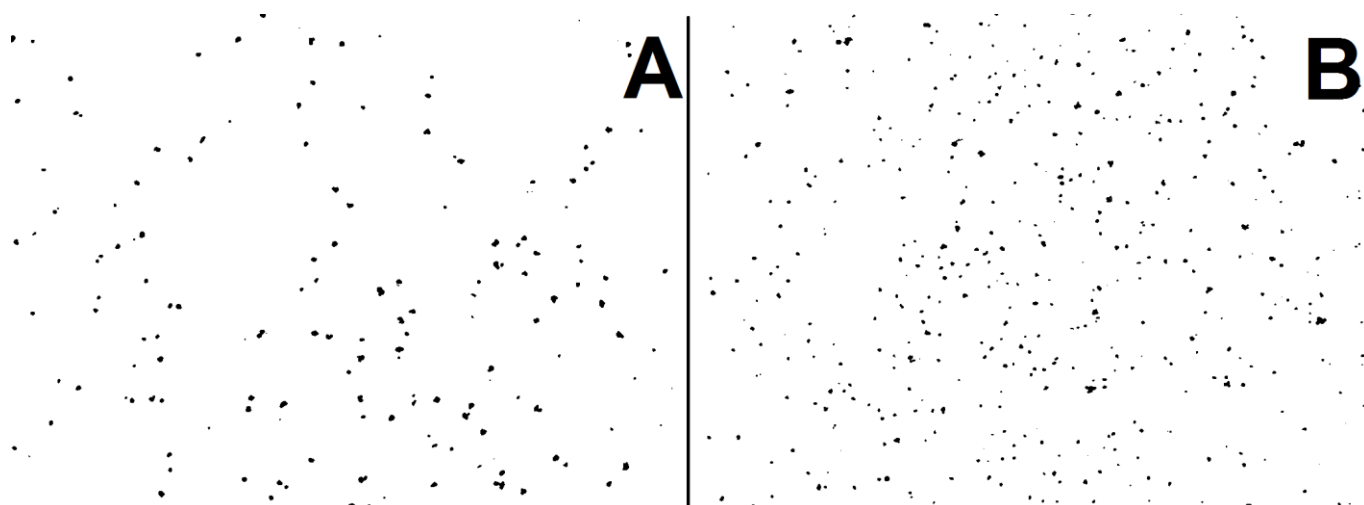
Figure 6. Creep Damage in the Heat Affected Zone where a High Density of Cavities is Noted, Sample 7C-2 435 voids/ mm^2 (parent metal TP1) [A] and Sample RNT-B2-2 1,255 voids/ mm^2 (parent metal B2) [B]

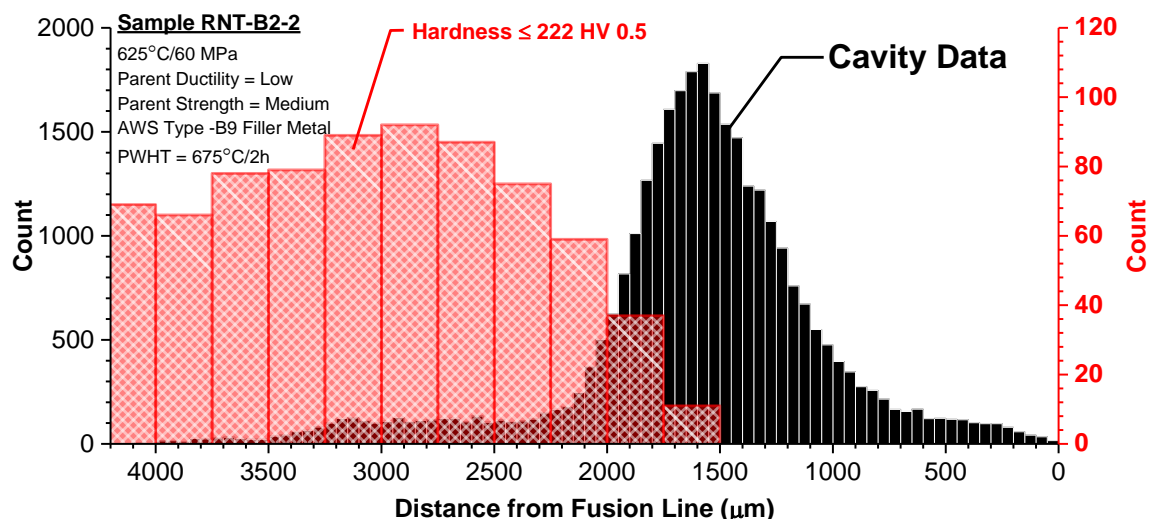
A comparison of the hardness map data to the analyzed damage is provided in Figure 7 for sample RNT-B2-2 which exhibited a very high level of damage in the HAZ. Backscatter images for two types of damage are provided for sample RNT-B2-2 in Figures 8 and 9. In Figure 8, damage that is not clearly associated with inclusions and appears to be isolated at grain boundaries are provided. Figure 9 provides a second population of damage which is clearly associated with inclusions. The detail of these inclusions is described in Figure 10 for a set of cavities around Al- and Mn- rich particles.

Figure 7. Comparison of the Hardness Data in the Low Hardness Region (Red Histogram) to the Distribution of Damage (Black Histogram) for Sample RNT-B2-2 (parent metal B2). Note that the distribution of hardness indents ≤ 222 HV 0.5 are identified in Figure 3B by the white region in the HAZ

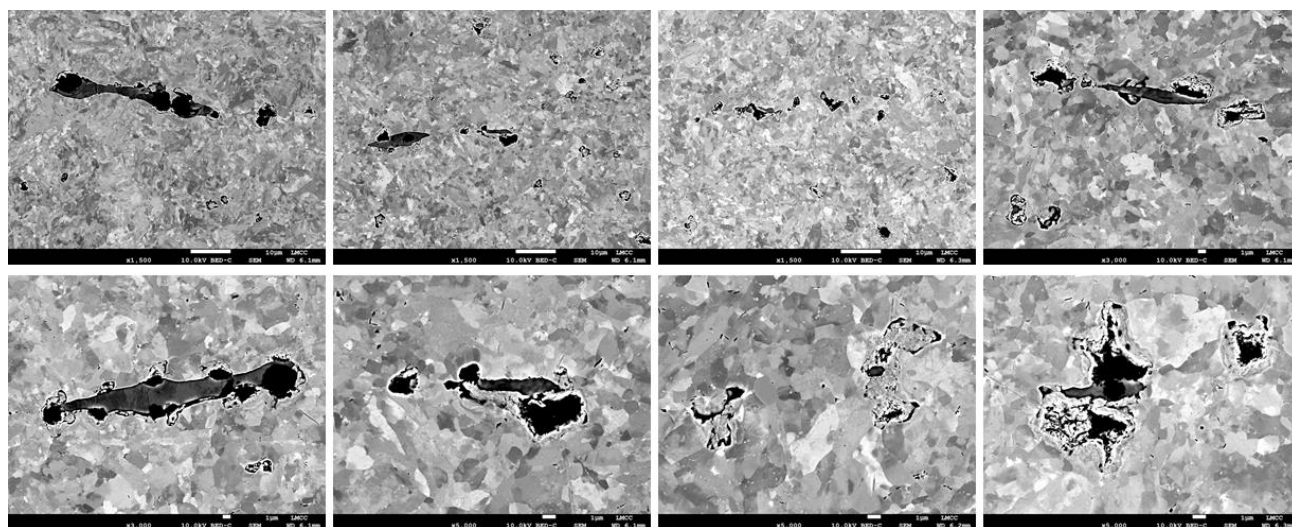
Figure 9. SEM Backscatter Images of Creep Cavities which are Associated with Inclusions in the Heat Affected Zone in Sample RNT-B2-2 (parent Metal B2), Note variable magnification in each image

A direct comparison of the damage present in the HAZ for the analyzed cross-weld samples is provided in Figure 12 shows that the damage in the RNT-B2-2 sample is dramatically higher than that for the 7C-2 sample. Evaluation of damage in the HAZ in Figures 8 and 9 suggests that two populations of damage exist in the HAZ; one set with grain boundary features and a second set with inclusions/particles in the HAZ. For the population which does not appear to clearly be linked to inclusions, it is important to note that the reliance of the provided observations are 2D, e.g. there may or may not be an inclusion which exists either below the evaluated plane (and hidden from view) or above the evaluated plane (and removed by polishing).

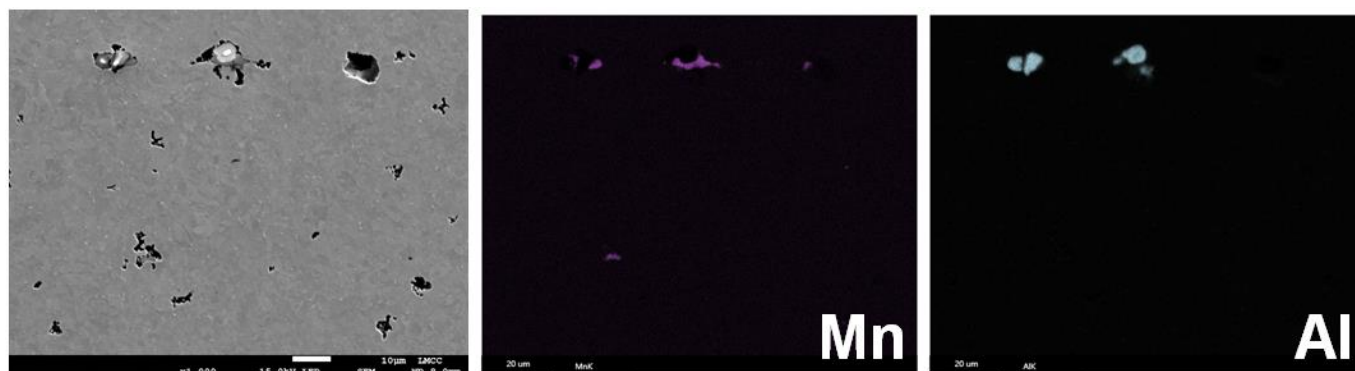
Figure 10. SEM-EDS Analysis for Damage at Inclusions in Sample RNT-B2-2 (parent Metal B2) and for Al and Mn

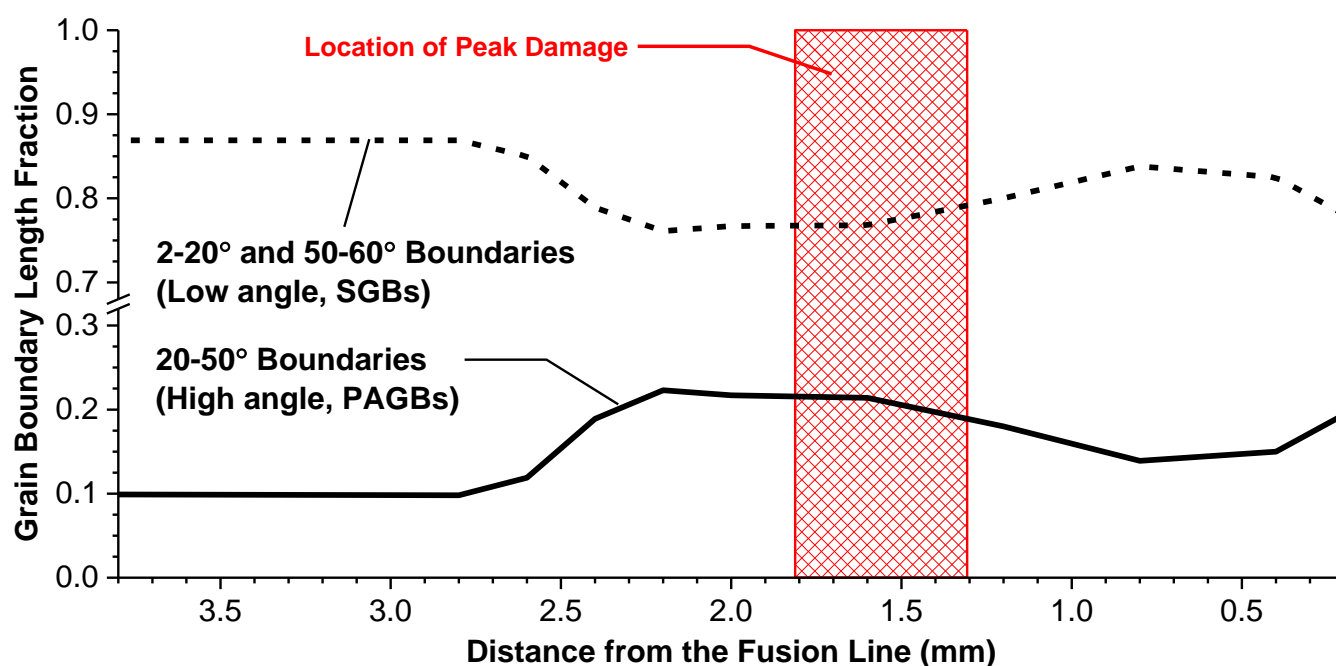
Figure 11 provides results for the SEM-EBSD analysis in the as-fabricated condition and as linked to the distribution of peak damage in sample RNT-B2-2. Although in each of Figures 7 to 11 the emphasis is on a single sample (RNT-B2-2) a similar set of observations were noted for sample 7C-2.

Figure 11. SEM-EBSD Analysis of Low and High Angle Grain Boundary Distribution through the Width of the HAZ and as Linked to the Distribution of Peak Damage in Sample RNT-B2-2 (parent Metal B2)

The contribution of the HAZ grain structure to the evolution of damage is detailed in Figure 11. The overlap of maximum, peak damage to a local increase in the HAZ for grain boundaries with a misorientation of 20 to 50 degrees is well-explained by the temperature distribution in Figure 5. In the location of the HAZ where damage is identified, there is a compounding effect from the peak temperatures which are below the conventional minimum normalization temperature for Grade 91 steel of 1040°C. For the stated temperatures where damage is noted, e.g. ~875 to 1035°C and for the non-equilibrium heating and cooling the HAZ material is expected to be highly non-homogeneous. Although the poor grain structure in the HAZ contributes to poor performance in cross-weld samples for 9%Cr steels, the effect is similar for both parent materials evaluated in this study, e.g. both weldments were fabricated with similar procedures (Table 2). Thus the heterogeneous grain structure cannot on its own account for the poor performance observed in the RNT-B2-2 sample as compared to the 7C-2 sample (e.g. failure times in cross-weld creep of 2,596 versus 13,201 hours, respectively).

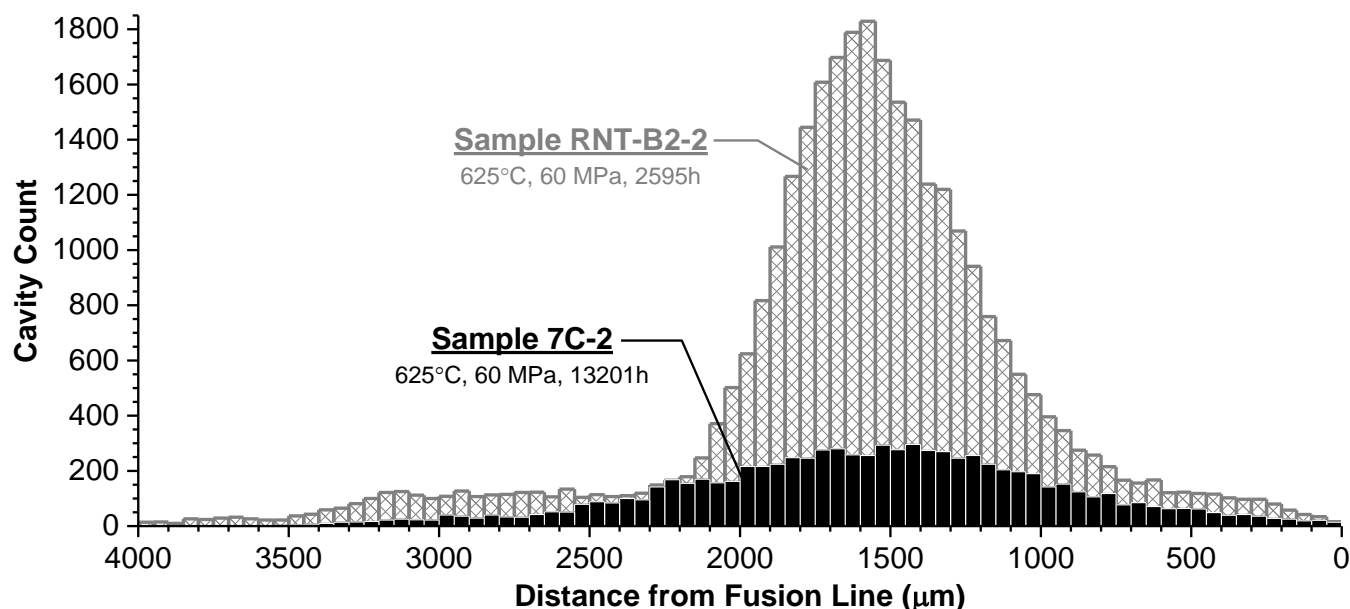
Figure 12. Comparison of the Damage in the HAZ provided in Figures 4 and 5

The composition and inclusion content in Tables 3 and 4 at least partially explains the observations in Figure 12. There is a markedly higher content of tramp elements in the B2 material evaluated in test RNT-B2-2 as well as a population of inclusions which is ~10X high than that for the TP1 material (sample 7C-2). The density of analyzed inclusions in sample RNT-B2-2 (~150/mm²) cannot alone account for maximum distribution of damage which is measured at >1,000 voids/mm², Figure 6. It should be noted that the inclusion analysis is limited to the physics of the process, e.g. the EDS spot size which is ~1 µm in diameter and it may be rationalized that some inclusions are unable to be properly accounted for in the analysis.

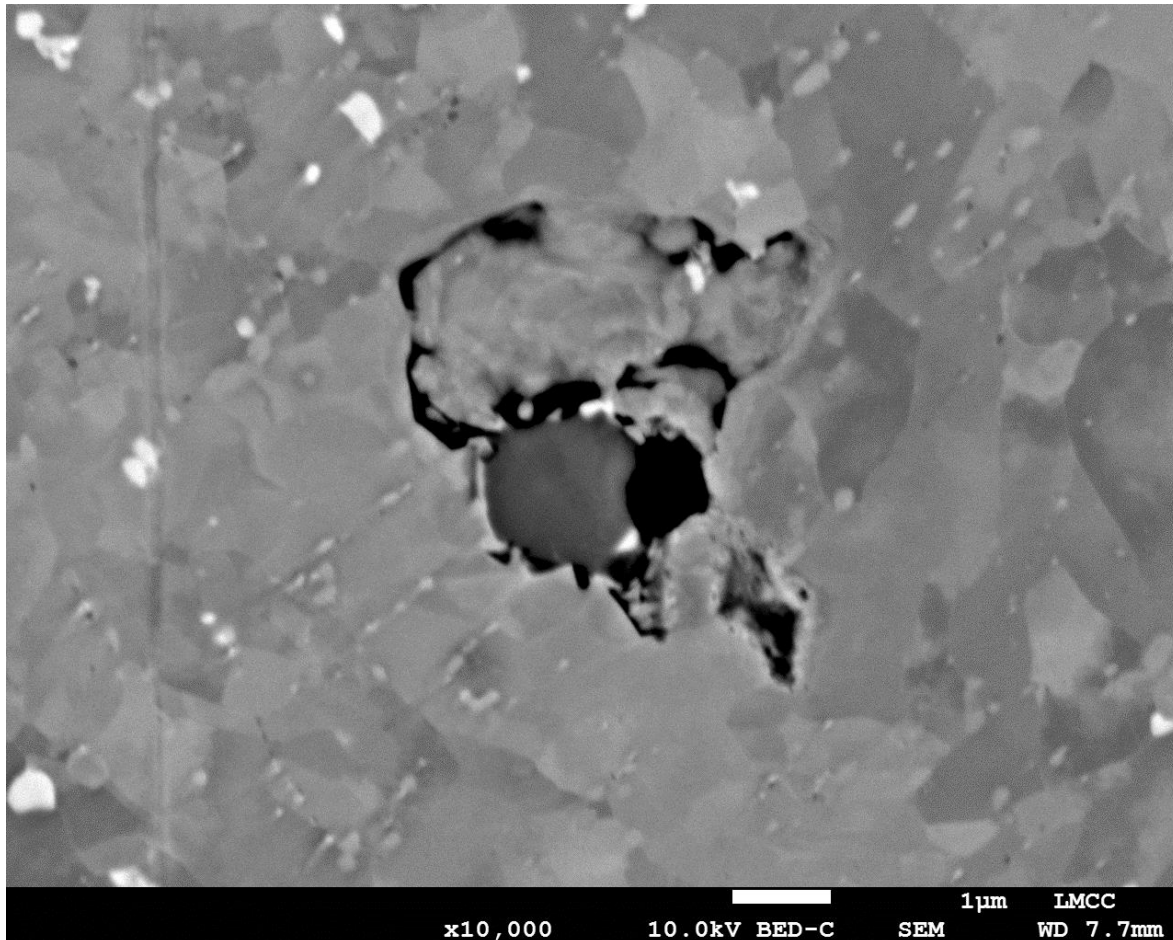
size as MnS, the MnS will intersect newly formed grain boundaries in the HAZ and may result in elemental segregation along grain boundaries. Whether tramp elements reside at MnS or on grain boundaries, the local surface energy at these interfaces will be reduced and result in a reduction in the stress required for nucleation [14]. The presence of a particle in these locations (e.g. inclusions) can cause an enhancement of the stress and intensify strain. Support for this phenomenon is given in Figure 14 where a region above and below the MnS inclusion is apparently recrystallized.

Figure 14: Recrystallization at a MnS Particle in the Heat Affected Zone
