Causal factors in construction accidents

Prepared by **Loughborough University** and **UMIST**
for the Health and Safety Executive 2003

RESEARCH REPORT 156

**Departments of Human Sciences and
Civil and Building Engineering**
Loughborough University
Leicestershire
LE11 3TU

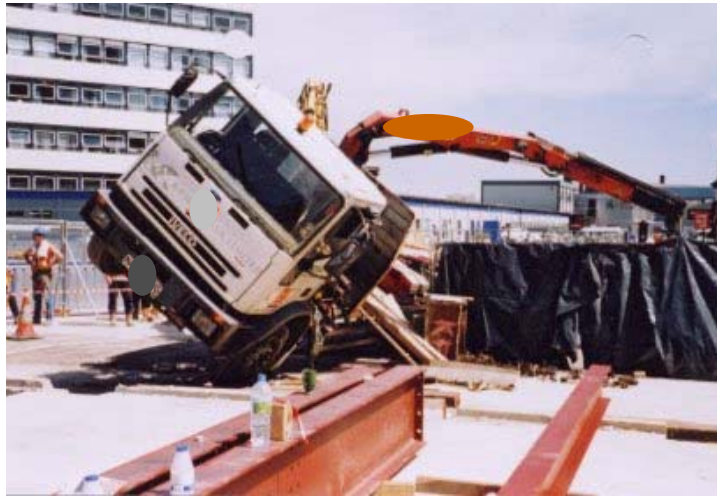
Insufficient working space was a problem reported in a number of the accident studies (2, 7, 11, 17, 25, 53, 62, 85). In one case it was felt that the space allocation was hindered by commencement of the build prior to the completion of demolition. This resulted in a number of later reorganisations of site layout to accommodate the changing plan of the build. More general discussion highlighted how space constraints restrict the allocation of floor area for workshop placement, footpaths, storage (especially important in winter when work is rained-off), parking provision, and adequacy of space for transport routes. It was reported that the latter manifests itself in constricted room for vehicle manoeuvrability and difficult access to drop-off points, Figure 5. This has a knock-on effect on the ease of receiving deliveries and can result in a subsequent need for double handling of materials. Problems with transport routes between different levels were described, involving narrow routes for lorry access or lack of lifting equipment to hoist smaller items between levels (11, 50).

Figure 5 Dangerous occurrence involving access and space constraints (11)

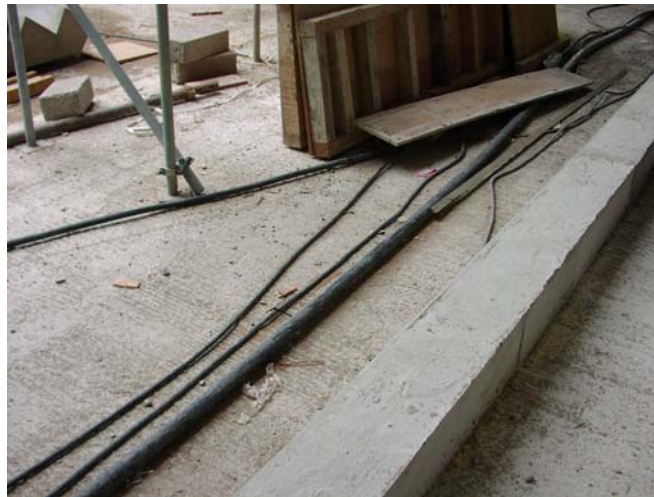
Problems mentioned included partial obstruction of access areas or footpaths with debris, deliveries or traffic cones (17, 62, 64). Allied to concerns about pedestrian movement was the effect that ground conditions have on the safe movement or stability of mobile equipment, such as lorries, hoists or scaffold towers (11, 50, 60). Surface hazards such as spilt oil, mud, cement or wetness were also reported (22, 40, 52, 62).

Figure 6 Presence of trip hazards (17)

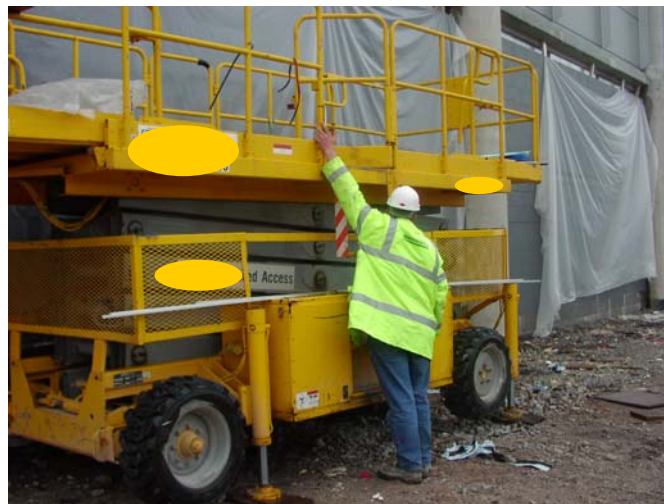
Inappropriate physical dimensions of some equipment resulted in user interaction, such as physical or visual access, being hampered. In accident 6, for example, a jump was required to climb off a scissor lift. Inspection of the equipment revealed that there were no distinct handholds on this equipment to support the user in this action, Figure 7.

... We're taught to come down the scissor lift steps backwards, but the last step is about 2ft from the ground, so you have to jump the last bit ...

Figure 7 Poor foot and handhold provision on scissor lift (6)

The safety cage on top of the scissor lift offered the most convenient points to grasp (at 2.2m from the ground), yet fixing bolts here were left exposed, compromising the only handhold available. A related problem existed in accident 21, in connection with the length of ladder attached to the side of a rail wagon (Figure 8). Elsewhere, use of split or cut down ladders was reported (25).

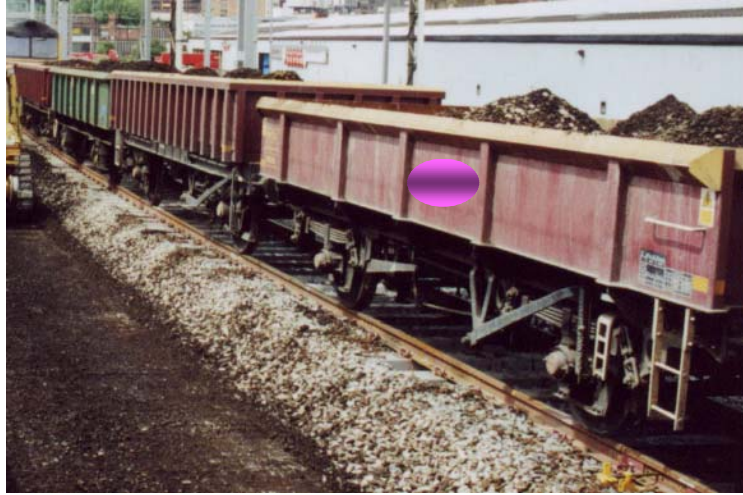
Figure 8 Ladder access to rail wagon (21)

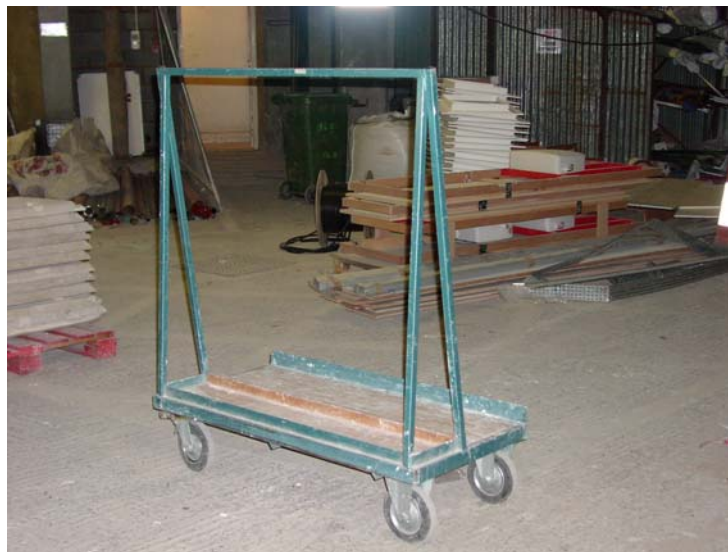
22, problems occurred manoeuvring a laden plasterboard trolley (Figure 9). The trolley had directional wheels at one end only (the other end having fixed forward facing wheels). While it was not known which end of the trolley was leading, difficulties were to be expected moving a full load with this particular trolley design.

Figure 9 Plasterboard trolley (22)
