# **COMPLIANCE TESTING OF IOWA'S SKID-MOUNTED SIGN DEVICE**

## **MIDWEST ROADSIDE SAFETY FACILITY**

MwRSF Research Report No. TRP-03-86-99

July 23, 1999

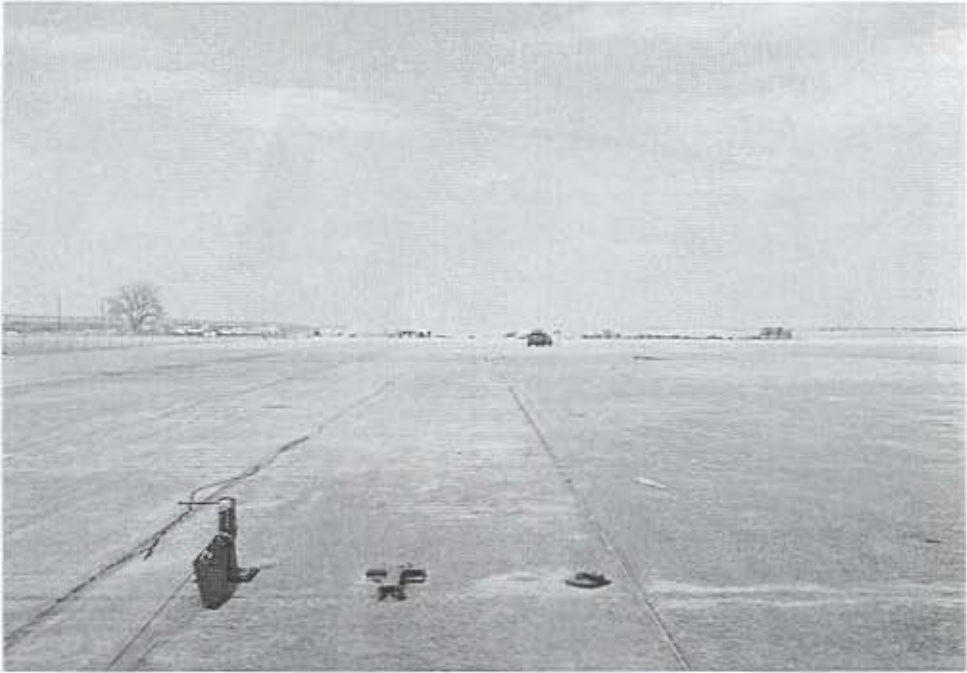
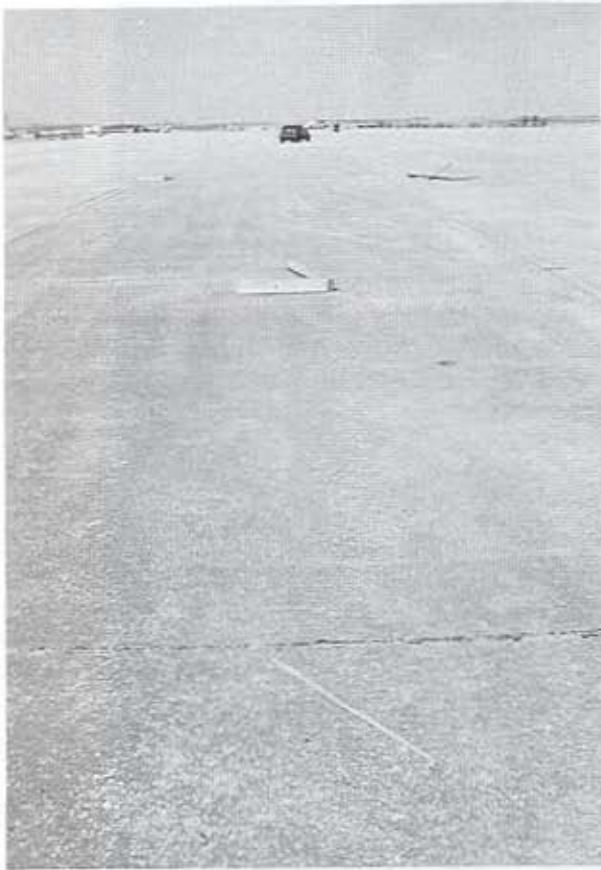
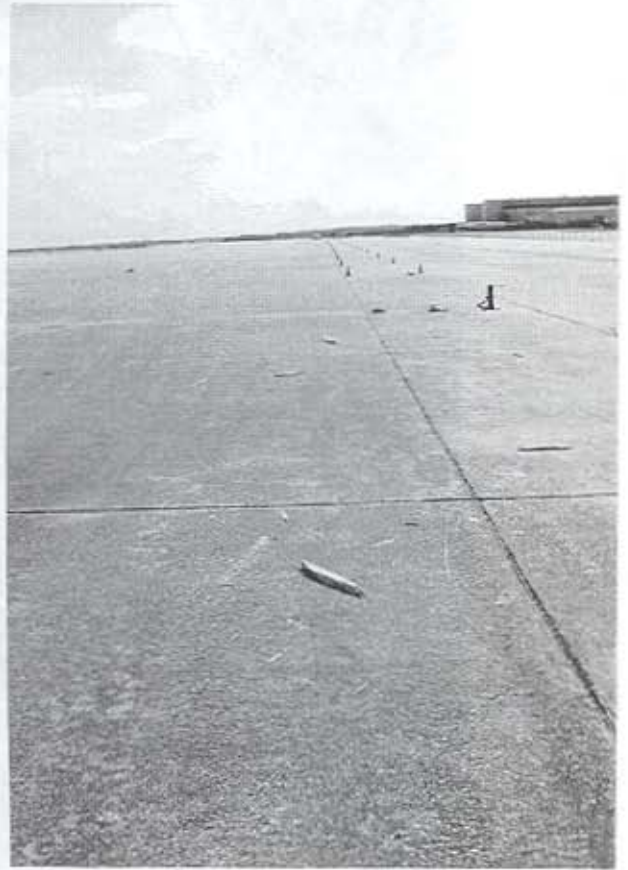
Figure 14. System No. 1 Overall Damage, Test I-1

Damage to System No. 1 is shown in Figures 14 and 15. System No. 1 encountered moderate damage to the sign support. The wooden base broke into two larger pieces and many smaller pieces. The pipe base, vertical tubing, mast, support rod, and sign panel all remained intact, but encountered deformations. Each leg of the pipe base bent to a 30 degree angle in opposite directions. The vertical tubing was bent in the shape of the nose of the vehicle. The support rod was bent into a 90 degree angle about the top third of the rod. The sign panel encountered scrape marks near the bottom front of the impacted side. The two bolts furthest away from the impact were slightly pulled through the plywood. No major damage was found to have occurred to the mast.

After discussion with the sponsor, it was concluded that there were potential minor modifications of the sign support that may prevent intrusion into the occupant compartment. It was decided that a test of the sign at 0 degrees was warranted prior to investigating further effort into modification to address the performance from test no. 1.

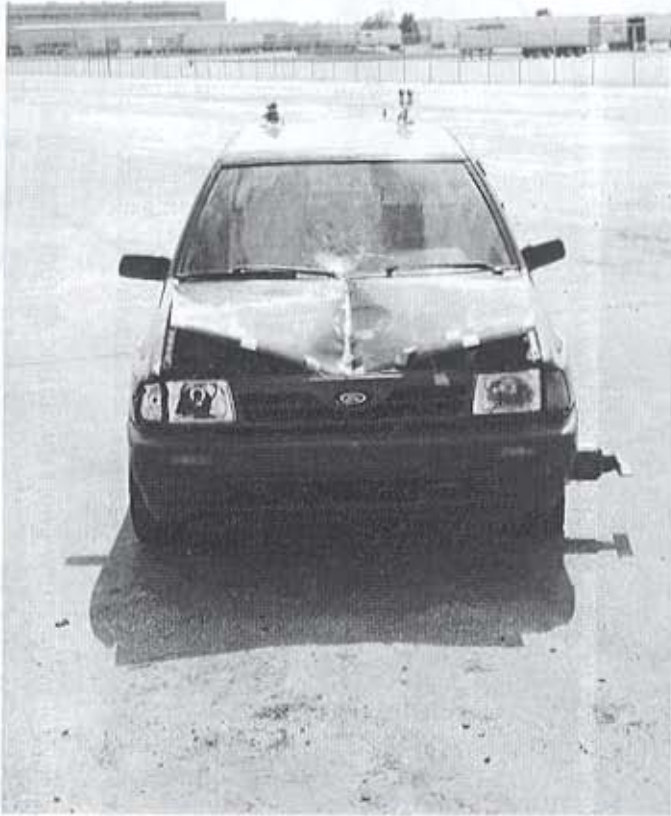
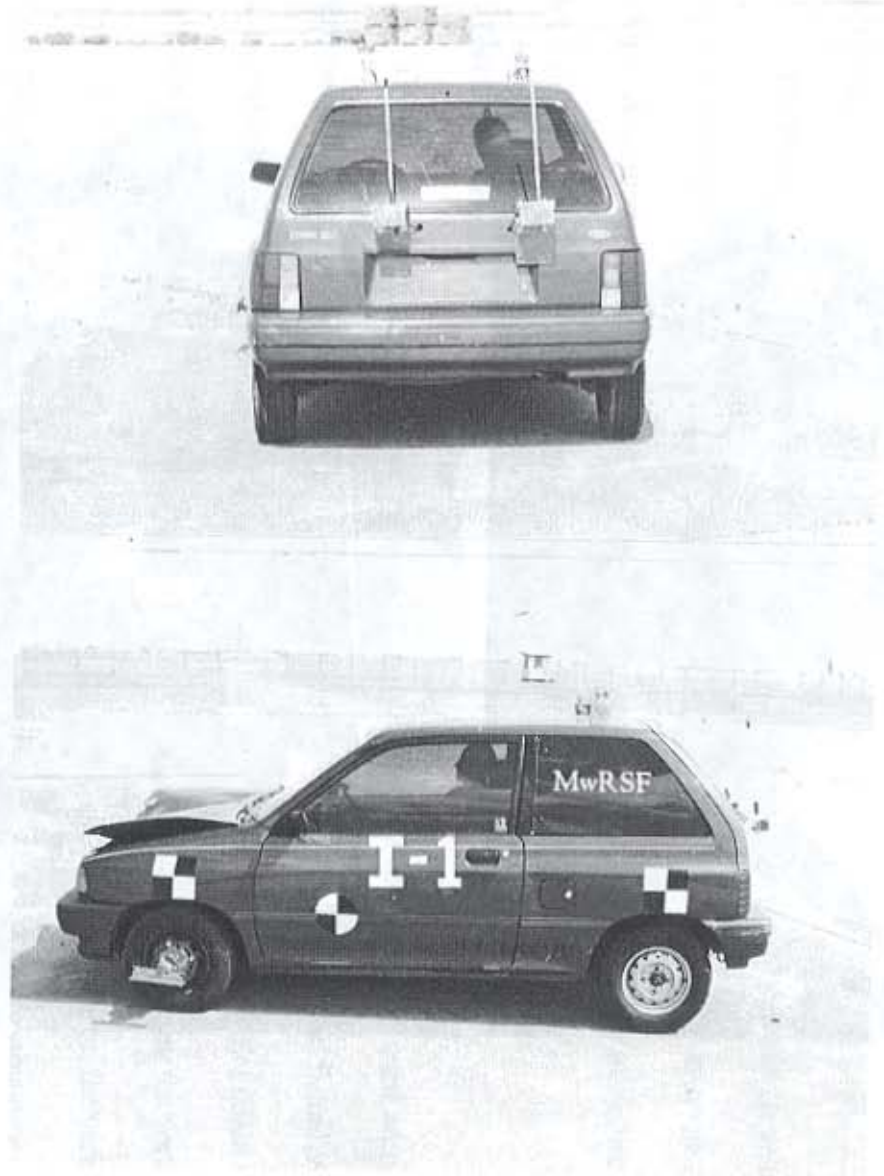
Figure 16. Vehicle Damage, Test I-1

Exterior vehicle damage was moderate, as shown in Figures 16 and 17. A hole through the windshield was located 203 mm from the bottom and slightly to the right of the center. The windshield also had “spider web” cracking around the hole. The hood creased down the center and the edges of the hood folded upward. The left-front side of the hood also encountered scrape marks. The center point of the bumper cover had a slight indentation. A small crack was found at the top midpoint of the grill. Scrape marks and dents were found just above the target on the right-side door. The right-side headlight and blinker light were broken. No other damage to the vehicle was found. There were no interior occupant compartment deformations to the vehicle.

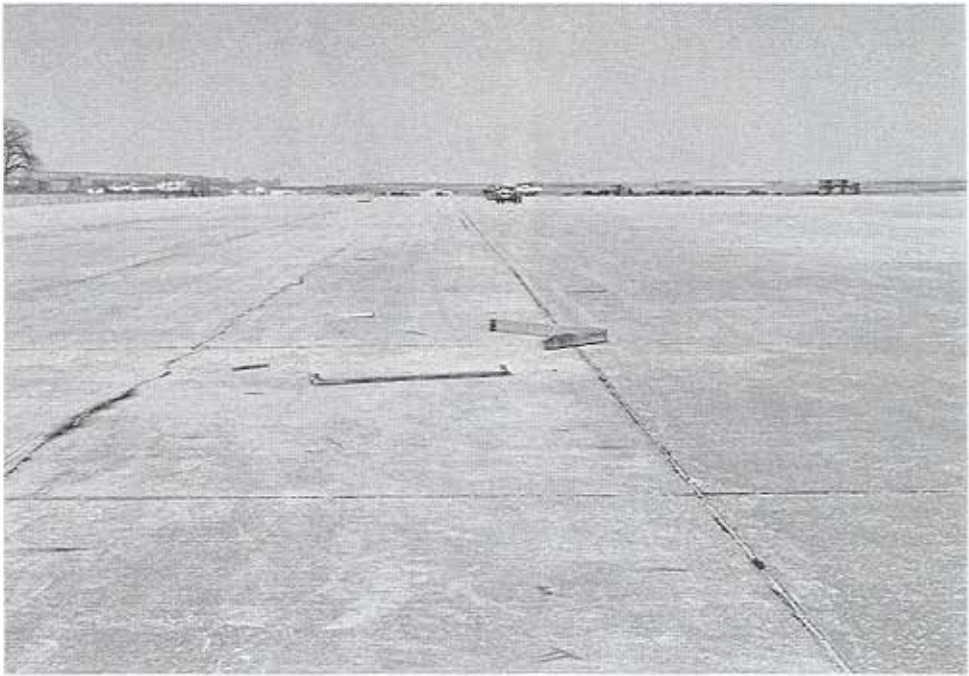
Figure 21. System No. 2 Overall Damage, Test I-2

Damage to System No. 2 is shown in Figures 21 through 23. System No. 2 has moderate damage to the sign support. The wooden base broke into three larger pieces and many smaller pieces. One of the larger pieces, the back piece with the support rod connected to it, was bent into a 120 degree angle about the rod's midpoint. The pipe base, vertical tubing, mast, and sign panel all remained intact but encountered deformations. Each leg of the pipe base bent evenly about the attached triangular gussett plate. The vertical tubing bent at 381 mm above the triangular gussett plate and was slightly dented at the support rod's connection point. Weld failures were found at the flat plate and gussett connection and the lower crossbrace and vertical tubing connection. The lower crossbrace was bowed slightly away from the sign panel. The sign panel was cracked on the left side near the lower crossbrace, and the bottom tip of the sign panel was also broken. No major damage was found to have occurred to the upper crossbrace.

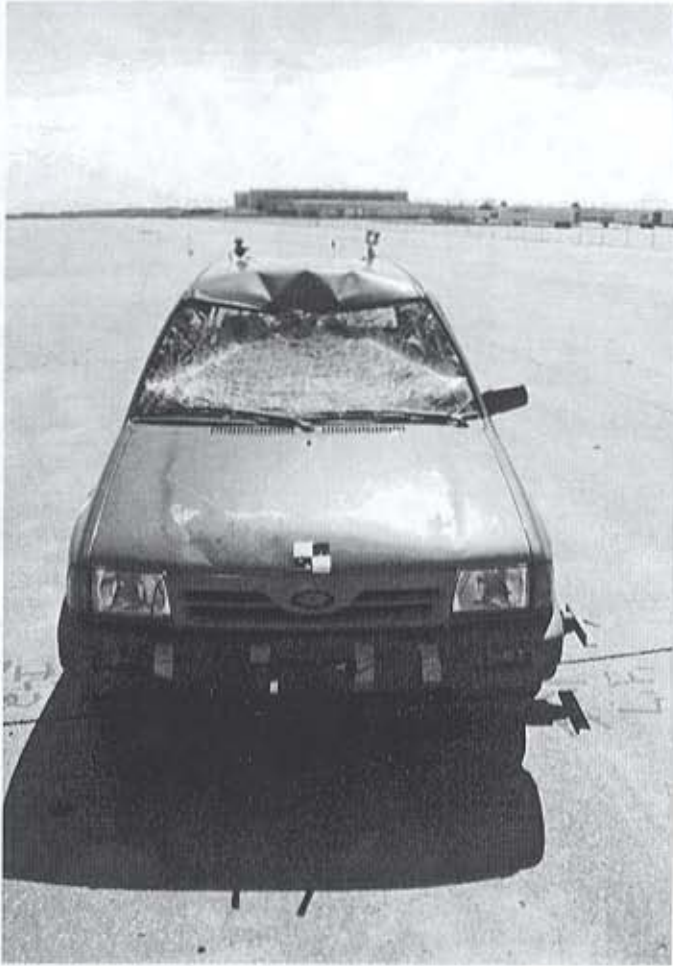
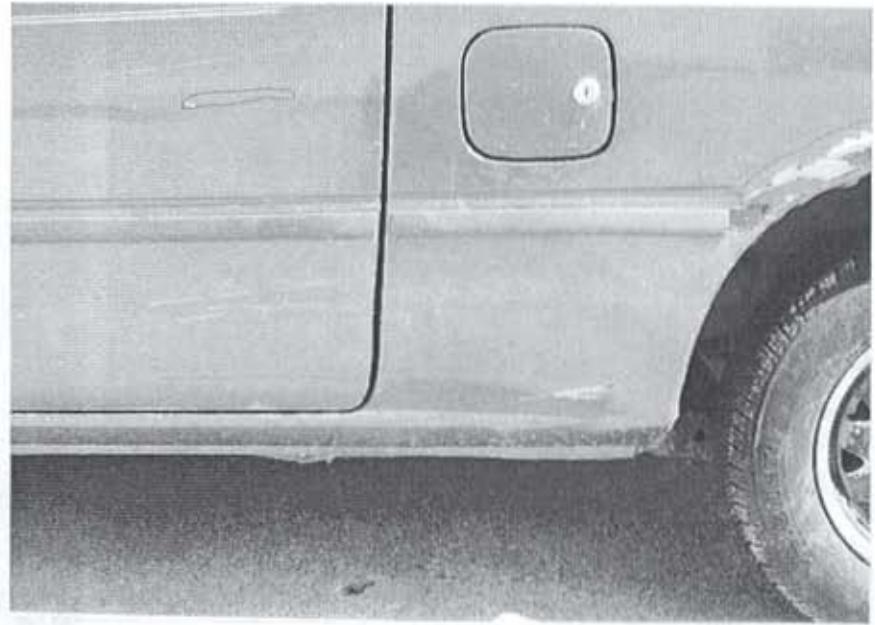
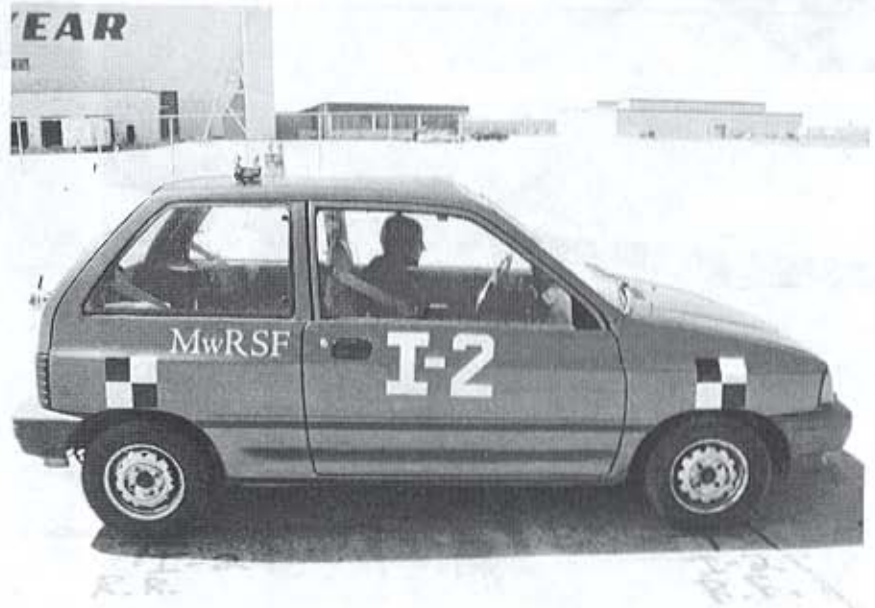
Figure 24. Vehicle Damage, Test I-2

Exterior vehicle damage is shown in Figures 24 and 25. Light scuff marks were found on the hood.

The center point of the bumper cover encountered a slight indentation. Scrape marks and small dents were found on the lower left-side door and the lower left-rear quarter panel. The windshield cracked due to contact with System No. 2. The windshield sustained major “spider web” cracking throughout, with both layers of the windshield being cracked. Most of the structural integrity of the windshield was lost. The roof at the top of the windshield was crushed downward toward the occupant compartment. The vehicle’s right-side, back-end, headlights, fog lights, and parking lights were undamaged.
