# Combining ground penetrating radar and seismic surveys in the assessment of cultural heritage buildings: The study of roofs, columns, and ground of the gothic church Santa Maria del Mar, in Barcelona (Spain)

Combined non-destructive techniques are applied in the study of a historical building in Barcelona. Santa Maria del Mar is a magnificent Mediterranean gothic church built between 1329 and 1383. Two of the most important characteristics of this building are the slender columns and the almost flat rooftop. This structure, used to create a visual impression of a unique space, transmits high loads to the tall columns. Previous to restoration, vaults, roofs, and columns were extensively assessed with non-destructive tests, in order to improve the knowledge of those structures. This information will be used in further simulations to analyse load distributions at each part of the structure. Ground and floor were also studied. The analysis of the columns was based on ground-penetrating radar (GPR) surveys and on seismic tomography. Finally, the dynamic behaviour of the structure was determined by seismic monitoring of the main nave and the bell tower. Results obtained at the radar s

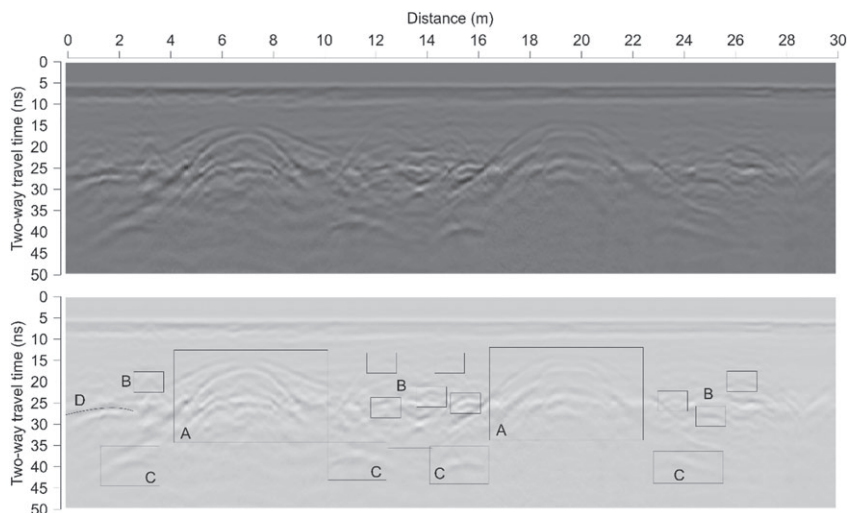
The first one corresponds to the structure of the arches (A in Figure 5). The radargrams show several reflections in the vaults that could correspond to three possible layers with different radii of curvature. The deepest anomaly could be produced by the reflection on the keystone of the vault. The other two anomalies could be associated to the intrados and the extrados. The intrados is the inner curve of the arch, whereas the extrados is the outer curve of the arch. In the radar data, the two anomalies are most likely associated at these two surfaces of the arch, separated by the thickness of the stones. Between the anomalies, the image is clearly uniform. Therefore, materials in this zone are most likely homogeneous, probably composed by ashlars and without irregular filling material.

The second interesting characteristic appeared around the zone over the columns, the widest assessed part. Radargrams obtained in that area are characterized by small hyperbolas (B in Figure 5). These anomalies appear in the area of the thicker roof structure and are produced presumably due to the presence of ceramic pieces. In previous studies of mediaeval churches, this type of material is used as a light infill that contributes to the reduction of loads. Usually, these ceramic pieces are between 0.7 and 1 m thick and are disposed as a layer embedded in rubble masonry mixed with lime mortar.

The third characteristic zone in the radargrams corresponds to the junction between arches and columns. The strong reflections could be produced on the capitals of the columns supporting the vaults (C in Figure 5).

Finally, the fourth feature is a flat and homogeneous anomaly related with the load-bearing walls and the arches junction. In this part of the radargrams, no significant hyperbolas are recorded, denoting that the structure is probably built with homogeneous stones (D in Figure 5). Radar data reveal important differences between heterogeneous zones with ceramic vessels between columns and more homogeneous zones near the walls.

**FIGURE 5** Detail of the radar image obtained (only with a bandpass filter applied) in the roof with the 400-MHz centre frequency antenna (part of Profile P4 in Figure 2) and possible interpretation. (a) Reflections on the arch structures. (b) Reflections on heterogeneous filling around the zone over the columns. (c) Reflection on capitals of the columns supporting the vaults. (d) Reflection on homogeneous materials between the vaults and the walls

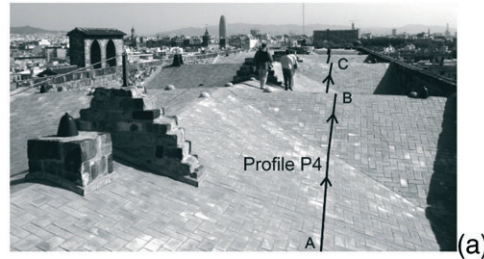
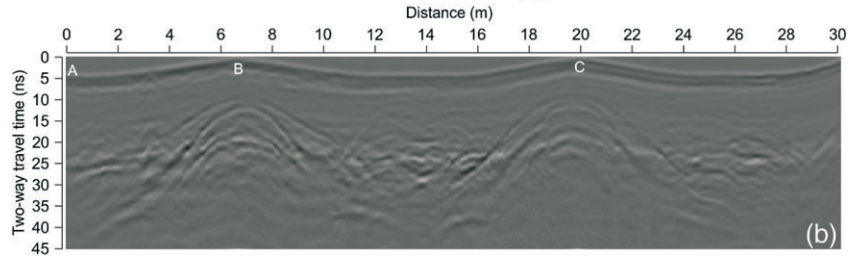
As the surface of the roof was uneven in all the sectors, the topography was corrected to determine the volume of material supported by the columns. Figure 6 shows the correction and the surface of the roof. In this section, an undulating shape of the roof corresponds to the different vaults.

**FIGURE 6** (a) Radar line P4 over nonflat roof surface. (b) Topographic correction of part of the radargram obtained along P4. Two arches and three columns are detected in this section

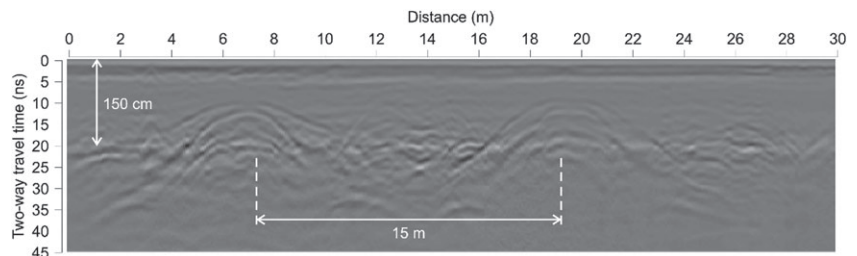
**FIGURE 8** Detail of the anomalies around zones over columns, corresponding to ceramic elements, most likely amphorae or ceramic bottles. The distance between vaults is 15 m. The thickness of the roof structure in the zone close the load-bearing walls indicates a wave velocity of about 15 cm/ns in the most homogeneous mortar

of the heterogeneities in the mediaeval concrete used in the structure. Considering that this velocity corresponds to the mediaeval concrete and ashlar, the depth to the upper part of the vessels could be found at about 75 cm.

Figure 8 shows an image of a section from Profile 4, in which heterogeneous anomalies are associated to hollow elements. The existence in the structure of those hollow targets is due to the use of slender columns to support a wide roof structure. The distribution of the columns inside the church produces a visual impact creating a diaphanous space. Although the inside of the church is a three-nave building, as other gothic churches, the effect is a unique space because of the high distance between columns (15 m) and a design that equals to the elevations of the three naves. Besides, the rooftop surface is quasiflat, in opposition to European gothic style that was built with very pitched roofs.

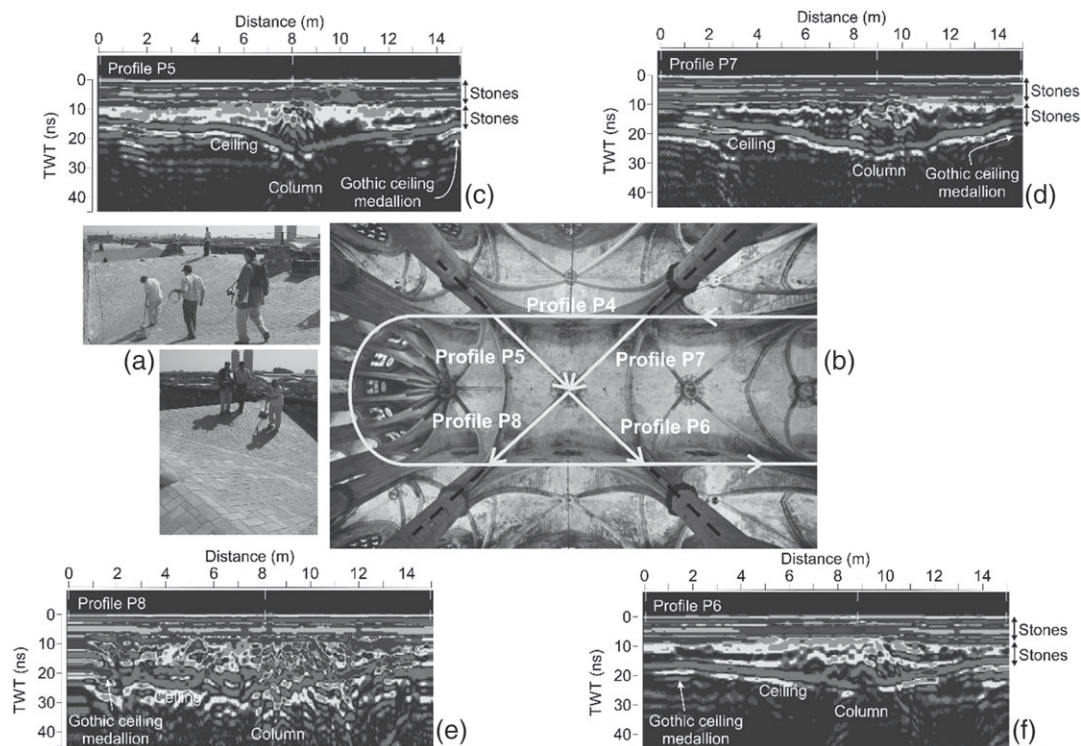
Four profiles (P5 to P8 in Figure 2) crossed the roof of the main nave, each one of them over one column and the corresponding arch. The results (see Figure 9) highlight the existence of the already discussed reflections in the heterogeneous targets around the column junctions. The reflection on a practically continuous target denotes the existence of two levels of stones in the homogeneous zone.

Notwithstanding, the most representative element in this group of radar images is the radargram obtained in Profile 8. This image is highly irregular, and even though it presents similar patterns than the other three radargrams, the heterogeneity appears in the whole image. A possible interpretation points to a more damaged zone, or perhaps a restored zone, using more irregular elements and filling. No actual restorations are documented in this part of the building. It is

**FIGURE 9** Four profiles crossing the roof of the main nave, obtained with a 900-MHz centre frequency antenna. (a) Radar data acquisition. (b) Location of the profiles over the roof. (c–f) Radar data from radar lines P5, P6, P7, and P8, respectively

a reasonable hypothesis, mainly considering the structural damage after the 1428 earthquake and the fire in 1397. The differences in this zone are decidedly important to understand the structural behaviour of the building and to design the most appropriate restoration and the preservation planning.

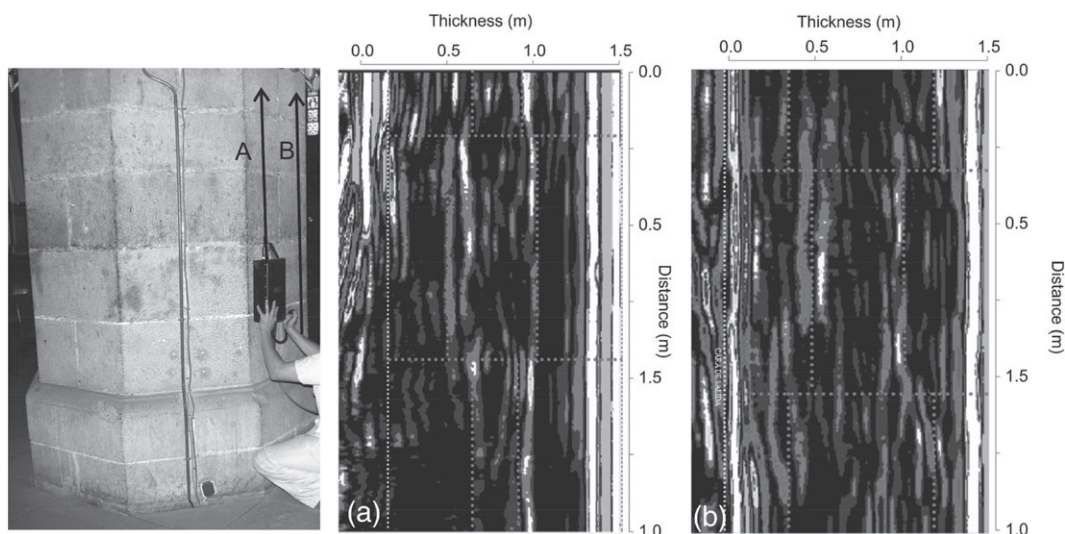
The external arrangement of the ashlar in the columns is similar to that observed in other gothic churches with octagonal columns. The GPR images (Figure 10) present analogous characteristics to the columns of other Spanish gothic cathedrals, being similar to those obtained in Mallorca Cathedral.<sup>17</sup> The columns are composed by rows of regular ashlars. In one row, a shallower reflection appears in both opposite sides of the columns, whereas in the following row, reflection is deeper because the ashlar is rotated 45° with respect to the first row. The contact between stones is clearly evident. The absence of other important reflections highlights the good state of conservation (Figure 10). Anomalies in radar data correspond mainly to reflections on the ashlars joints. Therefore, it could be considered that the columns are only built with large carved stones separated by thin joints filled with mortar. Despite of the clear images, radar data from isolate profiles are insufficient to determine the inner structure of the columns. Combining the GPR survey with a high resolution seismic assessment could reduce the uncertainty. Therefore, the seismic tomography was applied to determine the inner arrangement of the ashlars. Connections between stones are mortar, characterized by smaller seismic wave velocities than the stones, and might be detected, highlighting the shape of the internal contacts. The damage in the stones could produce lower velocities, indicating areas for deeper analysis.

**FIGURE 10** Assessing the columns with the 900-MHz centre frequency ground-penetrating radar antenna. The results obtained in two parallel radar lines demonstrate that the columns are composed by ashlars

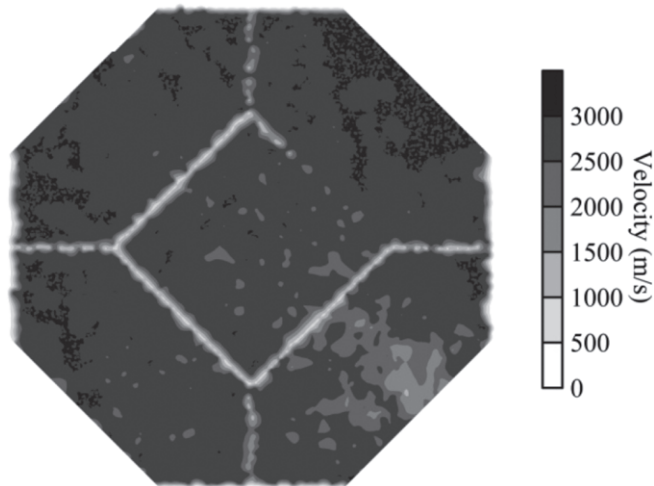
**FIGURE 11** Seismic tomography of the column

Seismic tomography provides a more detailed image of the inner arrangement. Results present the seismic velocity distribution (Figure 11). Main velocities range from 2,500 to 3,000 m/s. These velocities correspond to a high-quality limestone. However, results exhibit few zones with very low velocity (about 500 m/s); these zones are located in the ashlar junctions and in the surface of four sides, corresponding to a more irregular surface. The tomography also reveals a deepest zone inside one of the ashlars in which intermediate velocities (between 1,000 and 2,000 m/s) are measured.

The image of the inner column obtained with the tomography facilitates the interpretation of the radar images. The deepest reflections correspond to the row in which the inner squared stone presents the surface parallel to the surface of the column, whereas shallowest reflections correspond to the 45° rotated stone.

Referred to possible damage in columns, from the GPR assessment of nine columns and the seismic tomography in one of them, no evident cracks were detected inside the structures. However, seismic tomography exposes the existence velocities between 500 and 1,500 m/s inside one of the stones, suggesting some damage in the stone. GPR images, without important anomalies, point to damage without cracks. Other ashlar have velocities between 2,500 and 3,000 m/s, which corresponds to high-quality limestone. The most superficial decrease of velocity in four sides of the column can be associated with the most irregular surface and also with the external damage in the stone as consequence of fire effects.

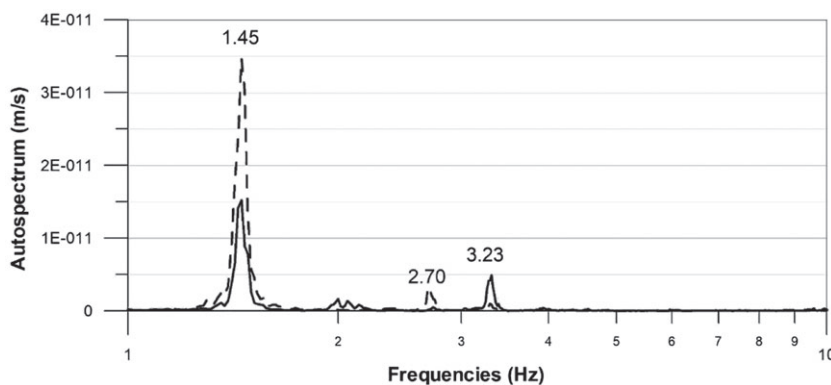
In Santa Maria del Mar church, the transversal component shows a very ease comportment with only one global frequency of 1.45 Hz. There are also few local frequencies with low energy compared with the global one; the most interesting are the 3.23 Hz at the façade and 2.70 Hz at Point 4 (Figures 4 and 12). Figure 12 also reveals that the façade presents a similar behaviour than the nave, comparing results at Points 4 and 6 showed in Figure 4.

**FIGURE 12** Transversal autospectrum at Point 4 (dashed line) and at Point 6 (continuous line)

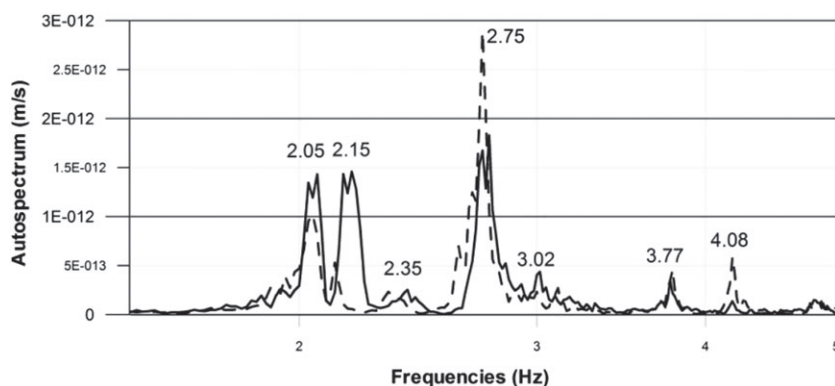
Longitudinal comportment is more complex, presenting global frequencies of about 2.05, 2.15, 2.35, 2.75, and 3.77 Hz; a 4.10-Hz local frequency at the ambulatory zone; and a 3.02-Hz frequency value at the façade zone (see Figure 13).

The results of the façade and the tower bell show a very similar pattern compared with the main nave (Figures 13 and 14). However, the spectrum shows a characteristic crack of the peak named breathing effect.<sup>28</sup> Also, modes 2.05, 2.35, and 2.75 Hz, in Point 7 (Figures 4, 14, and 15), are transformed from pure longitudinal to bidirectional components probably due to any asymmetry of the towers. Draws of particle motion for each mode<sup>5</sup> show different comportments.

**FIGURE 13** Longitudinal autospectra at Point 1 (dashed line) and Point 6 in the façade (continuous line)

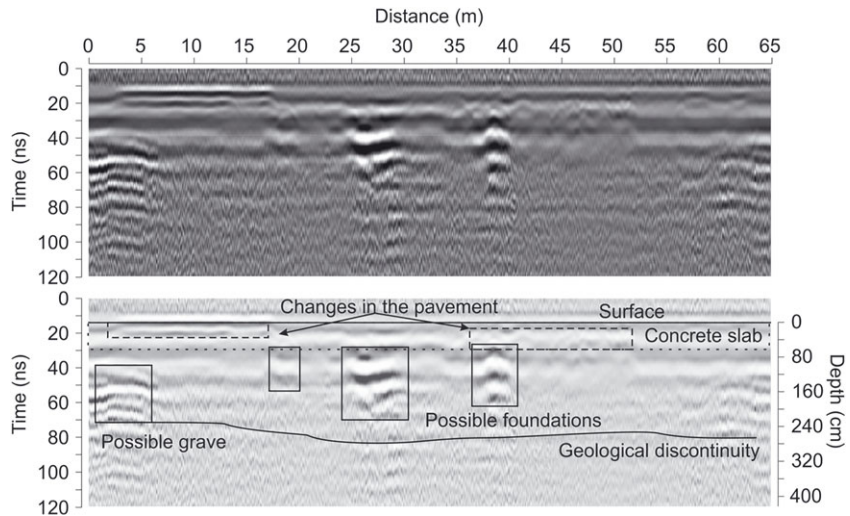
The floor and ground were only investigated with GPR. Results related with ground survey inside the main façade show the existence of a slab in the basilica. This slab is most likely not completely homogeneous, given the changes detected in GPR images probably related to historical repairs. In fact, some zones seem to be formed by reinforced concrete.

Under the slab, ground seems to be homogeneous with a possible geological change at about 2.5 m deep. However, at both sides of the front door, just next to the two columns, important anomalies probably caused by reflections on

**FIGURE 16** Radar data inside the church, acquired with the 200-MHz centre frequency antenna showing significant anomalies that could be associated to foundations

church foundation appear. Other anomalies could be associated to graves and buried structures (Figure 16). Outside radar data acquired in front of the basilica also contain some anomalies possibly associated to walls remains of ancient structures (Figure 17).

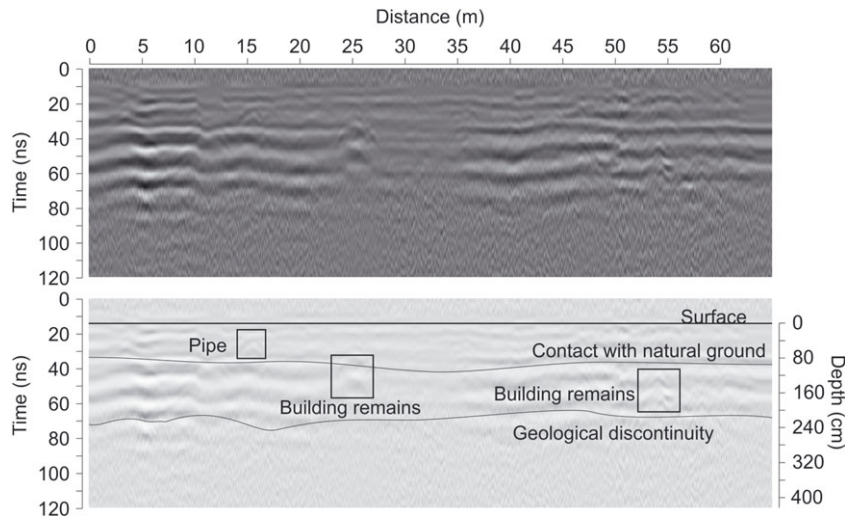
**FIGURE 17** Radar data obtained with the 200 MHz centre frequency antenna in front of the main façade, outside the church
