Fernandina old Wall of Lisbon – Characterization towards its preservation

Leandro Gomes¹, Paulina Faria², Vitor Silva¹, António Santos Silva³

GOMES L., FARIA P., SILVA V., SANTOS SILVA A. (2019), Fernandina old Wall of Lisbon – Characterization towards its preservation. HMC2019 - 5th Historic Mortars Conference, 19-21 June 2019, Pamplona. RILEM Proceedings PRO 130, José Ignacio Álvarez, José María Fernández, Íñigo Navarro, Adrián Durán, Rafael Sirera (Eds.), ISBN: 978-2-35158-221-3, e-ISBN: 978-2-35158-222-0, 681-694.

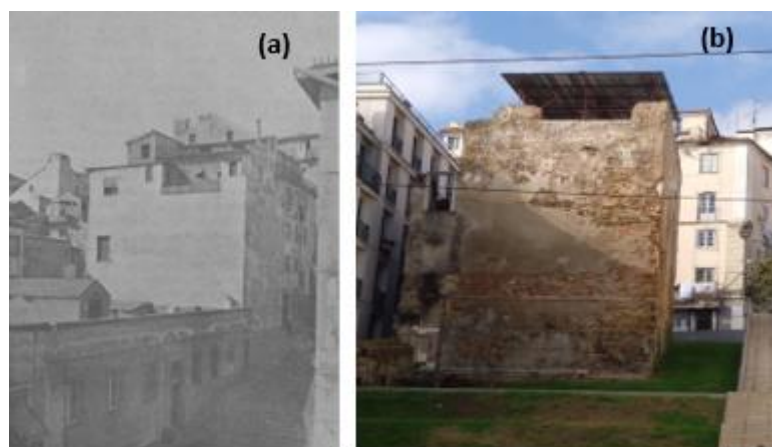
This Tower is one of the few remaining towers that composed this Wall (Figure 2). It is located very closed to Martim Moniz Square (Figure 1 (1)), and on the West section of the Wall. Its transversal dimensions are 6 m x 8 m with a height of 11.30 m. Figure 2 presents an example of the changes occurred in this Tower in last 70 years. In the past, shops and a factory have been installed there. In the last years, the annexed volumes had been demolished and a provisional coverage was placed by the Lisbon city council heritage, that has developed interventions of geological and archaeological nature [3-4] that helped this research.

On the top of the Tower there is a void, with about 2.5 m x 3 m, that is rendered, were some samples were extracted horizontally and vertically to know the stratigraphy of this rubble stone masonry. The visual analysis of the core samples extracted (Table 1) revealed that the inner nucleus of the tower is composed by a rubble limestone masonry with a lime mortar with red ceramic aggregates, apart from siliceous sand. Different limestone types could be observed (Table 1).

Figure 2 – Jogo da Pêla Tower: (a) in 1949 and (b) in 2019

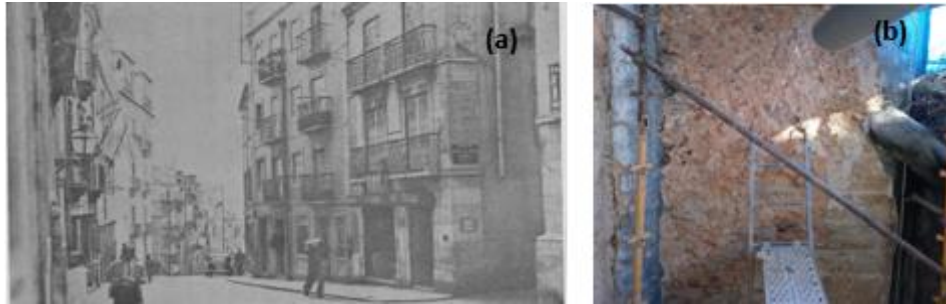
Figure 3 – (a) Santana's Street in 1949 [1] and (b) wall masonry of the tower inside the building

The tower façade visible in the building (Figure 3 (b)) was built in rubble stone masonry and has regular stone masonry in the visible corner. A horizontal sample core was extracted at a height corresponding to the first floor of the building (Table 1).

The sample observation confirms the use of rubble stone technique. There is an intervention going on, with supervision of the Municipality, on the only private apartment with access to the top of the small tower.

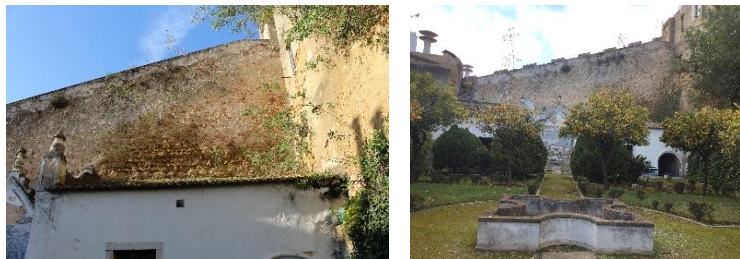
This Palace is classified as a national Portuguese monument and is located at São Domingos Square (Figure 1 (3)) very closed to the popular Rossio Square. Presently, it is the headquarters of Historical Society of the Independence of Portugal. In the back part of the palace there is a garden and a section of the Fernandina Wall with around 20 meters long (Figure 4). This wall section have been subjected to intensive weathering exposure and to several interventions, such as a staircase on its top and the repair with different mortars - Figure 4. Although it was not possible to extract any core sample from this section, the façade that is visible seems to be a rubble limestone masonry.

Figure 4 – Wall section at the north of Independence Palace garden: (a) general view and (b) detail of the wall

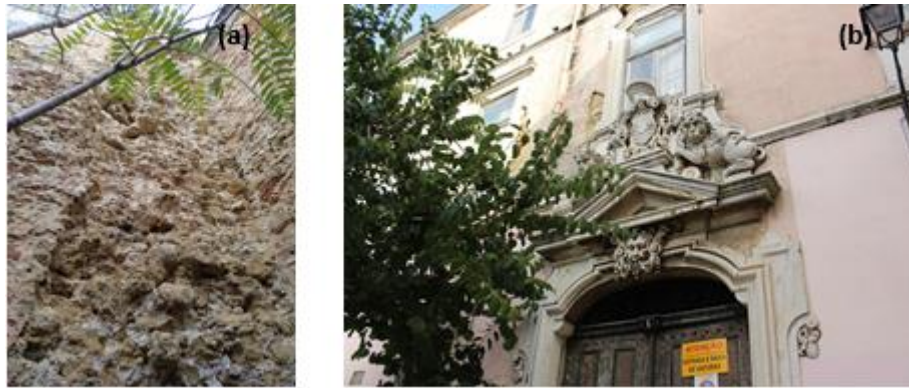
This palace is located at the beginning of the western section of the Fernandina Wall, very closed to the St. George Castle (Figure 1 (5)). In this section it is possible to find some different construction characteristics, including the foundations on geological substrate and a tunnel excavated inside of the Wall. Figure 6 (a) shows a section of the Wall and Figure 6 (b) the palace façade facing south. Due to the masonry characteristics (a rubble stone masonry) it was not possible to extract core samples from Rosa Palace. The palace, with a very impressive area, will soon be transform into a historical hotel.

Figure 6 – Rosa Palace: (a) Wall section and (b) south façade of the palace

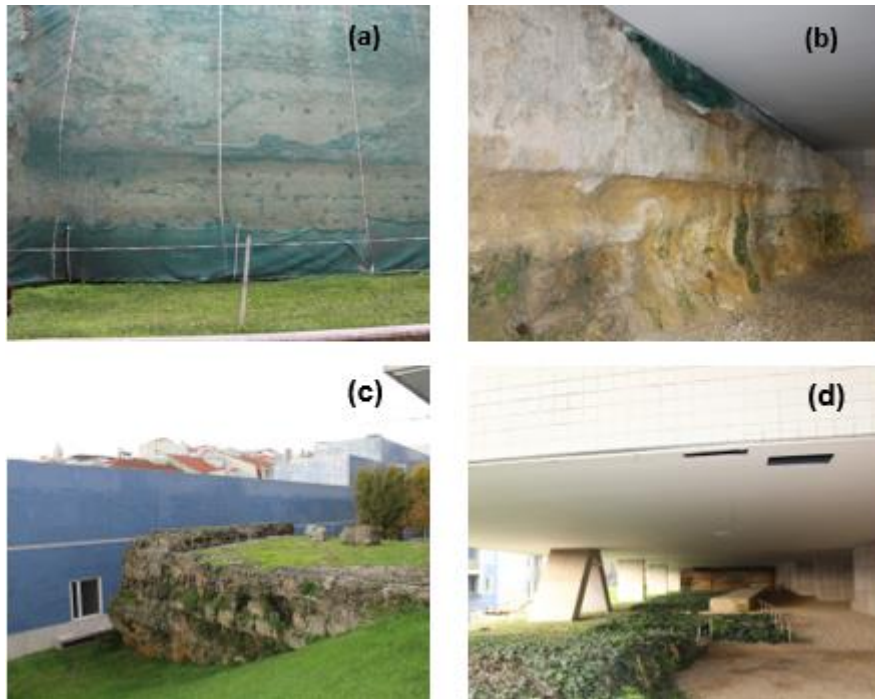
These residences belong to an apartment complex designed by the famous Portuguese architect Siza Vieira, located in the old city centre of Lisbon, very close to Cais do Sodré Square (Figure 1 (6)). This complex built in 2003 in the surrounding area of the old fortress, has one of the best places to see sections of the Wall in two distinct structures: main walls (Figure 7 (a)) and one tower called “Conde Vimioso Tower” (Figure 7 (c)). The tower presents a base where the ground foundation is being exposed. The upper levels of the Tower present stone masonry. The Wall sector facing west is long (more than 20 m) and could not be accessed due to a building that is being retrofitted in its back. The Wall sector facing south (with about 10 m long) presents lack of cohesion, significant thickness lacunae (Figure 7 (b)), efflorescence’s and biological development. This is partially covered by the new buildings, being always in the shadow, and since the last couple of years it seems to have the rear surface waterproofed by construction works that have been performed in the adjacent building. Therefore, the microclimate of the Wall section has completely changed, being this part very damaged nowadays. There is also a low high remain of the Wall exposed to east and west with more than 10 m long. After the conclusion of the construction of this apartments complex, a replica of an original Wall sector was made following the continuity of the east-west exposed wall and the original plan of the Fernandina’s Wall, with more than 10 m long, using hydrated air lime-stabilized rammed earth technique [7] (Figure 7 (d)), and being also covered by the building. Two core samples were extracted vertically from the top of the tower and another two from the Wall sector facing south (Table 1). The tower seems to be mainly filled with rubble stone, including ceramic fragments and different types of limestones,

namely Lisbon's Miocene fossiliferous limestone. The wall samples observation confirmed that it was built with rammed earth technique.

Figure 7 – Fernandina Wall in Bragança Terraces Residence: (a) rammed earth wall section facing West showing the holes of the originally used formwork; (b) rammed earth wall section exposed to south but presently under a building; (c) part of the tower with stone masonry; (d) remains of an old Wall section and its replica

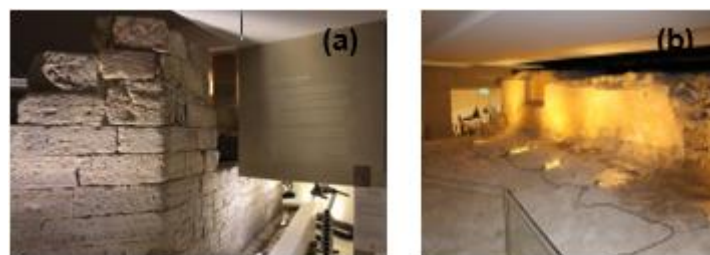
According to Vieira da Silva [2], this part of the city is lacking in studies about the Fernandina Wall. Nevertheless, when Corpo Santo Hotel start being built, an archaeological and restoration campaign was performed and important data was collected [8-9], having the Hotel won an international prize for this preservation. This part of the Wall was built to protect attacks from pirate ships entering the Tagus river (Figure 1 (7)). Nowadays, the hotel offers a large room where remains of the João Bretão Tower and a section of the adjacent Wall are visible (Figure 8). Two core samples were extracted from the top of João Bretão Tower. These samples allowed to observe the top layers of the rubble stone masonry walls of the tower.

Figure 8 – Corpo Santo Hotel: (a) João Bretão Tower and (b) nucleus of the tower

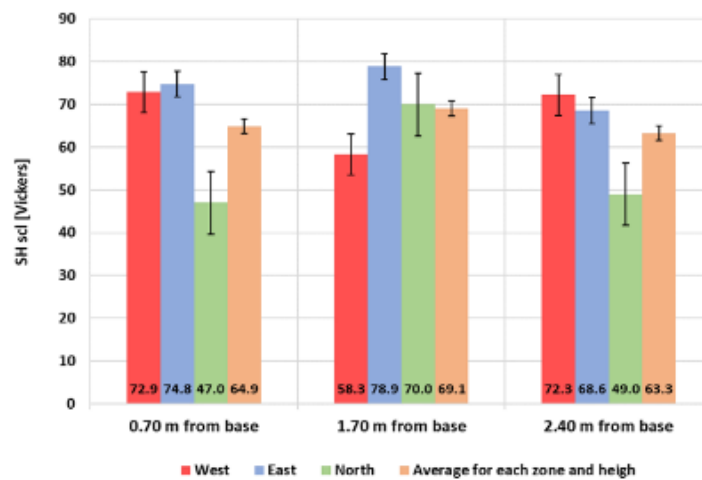
Figure 10 - Pendular sclerometer results in Jogo da Pêla Tower

The surface hardness values in Jogo da Pêla Tower revealed different trends, depending on the render zone tested, being the average values between 63-69 Vickers (Figure 10). For Bragança Terraces Residence, it can be observed that surface hardness of both original and replica of the East Wall section are quite similar - 56 Vickers. The same for base and upper level of South Wall section, with 70-73 Vickers, presenting the recently rendered sample a lower value (56 Vickers), inducing compatibility with the original Wall (Figure 11).

Although the Jogo da Pêla Tower sections were rendered rubble stone masonry, results are not significantly different from rammed earth wall sections of Bragança Terraces Residence. The results presented by [12] applied on earth plasters reveals average values between 35-45 Vickers.

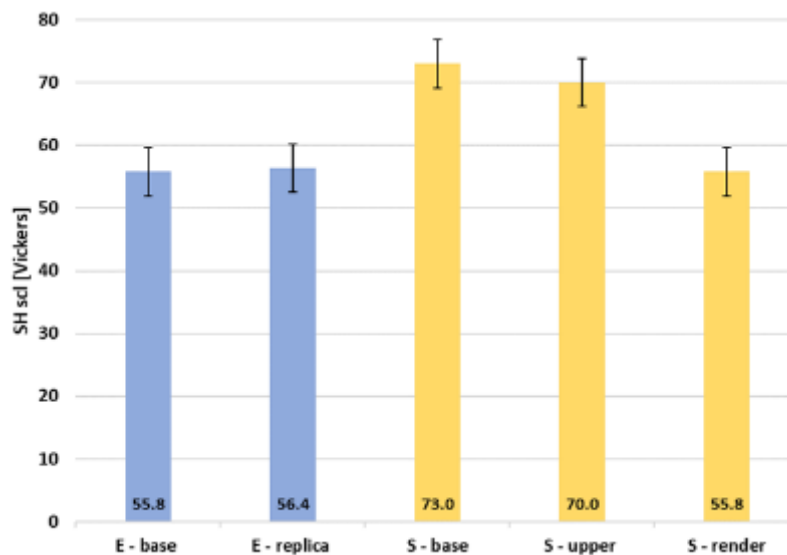
Figure 11 - Pendular sclerometer results in Bragança Terraces Residence

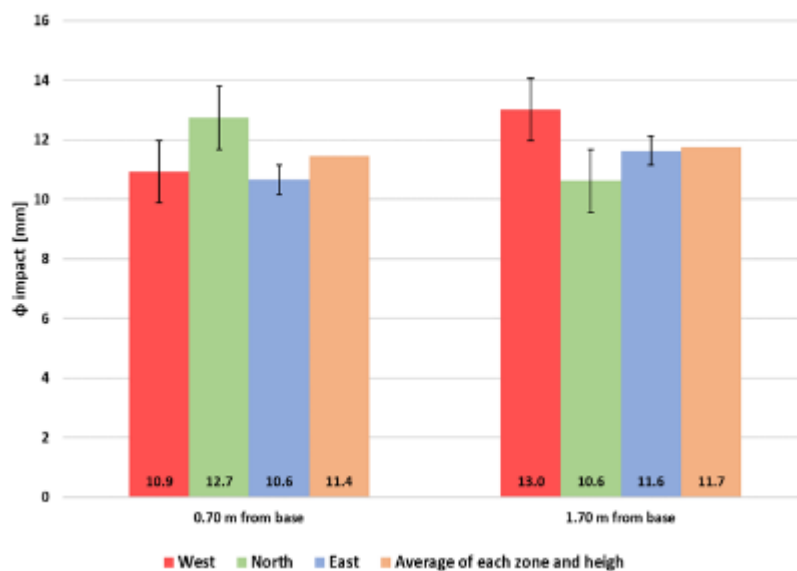
The values of diameter of the concavity resulting from the sphere impact test, using the Martinet-Baronnie equipment, can be observed in Figure 12. At Bragança Terraces Residence it was only possible to test the lime-stabilized rammed earth replica, 20 cm and 60 cm from the ground, obtained 14.6 mm and 13.8 mm respectively. These values, unlike to the results presented by [12], that reveals larger diameters, between 18-21 mm, and lower mechanical resistance. In [13] Veiga et al. analysed by the same methods the surface hardness of two panels of different renders and obtained a sphere impact diameter of 15 mm and 12 mm for hydraulic lime and white cement, respectively.

Figure 12 – Sphere impact results in Jogo da Pêla Tower

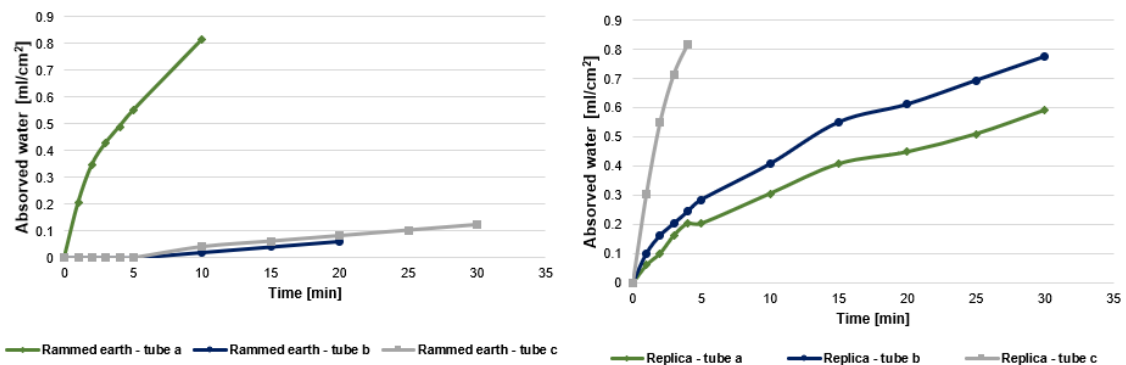
Figure 13 – Water absorption by three Karsten tubes at Bragança Terraces Residence: (a) south exposed rammed earth wall; (b) rammed earth replica

In both cases of Figure 13 two tubes register a low absorption with time and one tube a much faster absorption. There were no visible cracks but, in both cases, eventual microcracking may justify the behaviour of one of the tubes absorptions. For the other two tubes, the water absorption of the replica was faster in comparison with the original rammed earth wall (Figure 13). Presently it is not known if the original rammed earth is lime stabilized and with which lime content; but the stabilization of the replica rammed earth seems to be high. Therefore, the faster water absorption of the replica may be justified by that lime stabilization that interrupts the clay lamella connections. Therefore, clay lamella seems to be more efficient on blocking the water migration in comparison to a lime stabilization of the rammed earth. Another possible reason for the slow absorption rate in the original rammed earth is that it may be partially saturated, due to rising water migration, the humid environment (under the building and without direct sunlight and with a waterproofing membrane located in their back. Tubes b and c for the old Wall section (Figure 13 (a)) revealed that the water absorption only started after a 6 or more minutes compared to similar tubes on the replica (Figure 13 (b)). The results in Figure 13 (a) could have been improved and made as in [15] which the water

capillarity coefficient obtained for earth rammed material was performed during more time.
