Identification of Bridges with Fracture-Prone Details

Report Number: KTC-19-35/SPR18-553-1F

Research Report
KTC-19-35/SPR18-553-1F

October 2019

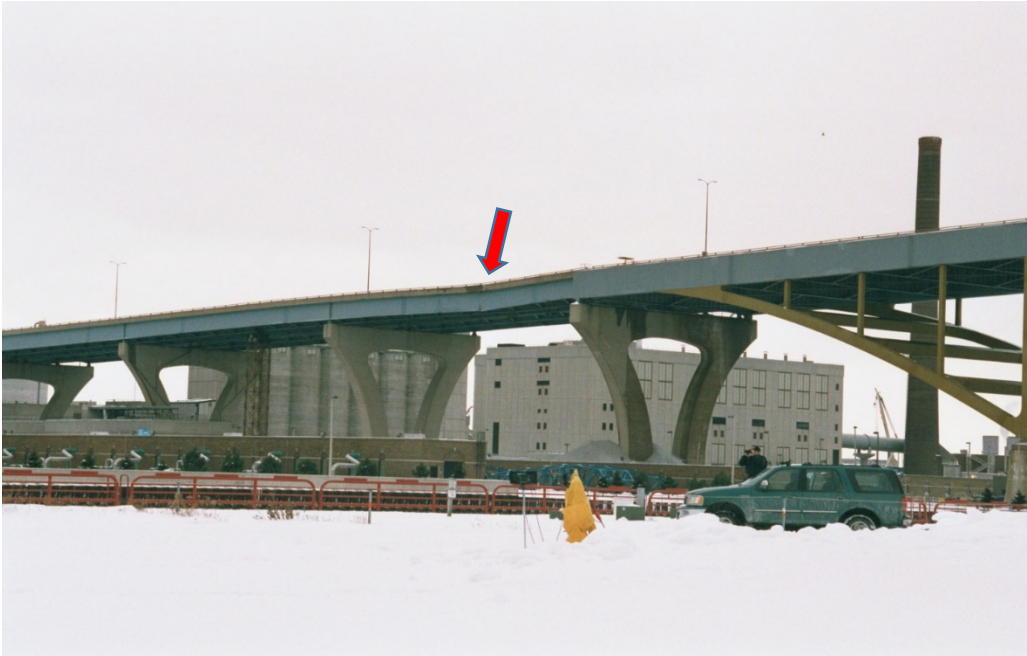
The seminal event related to CIFs was the I-794 Hoan Bridge fracture in Milwaukee, Wisconsin, on December 13, 2000. At that time, Winter conditions were present and the temperature was below freezing. Early that morning several trucks crossed the bridge, causing the third span of the southbound approach to sag. The bridge was promptly closed, and inspectors found that two of the three girders supporting the roadway were completely fractured along with a 30-inch long crack in the bottom portion of the web of the third girder (Figures 1, 2).

Figure 1 The I-794 Hoan Bridge in Milwaukee, Wisconsin, after the girder fracture event (December 2000). Note the sag in the barrier wall and girder (arrow).

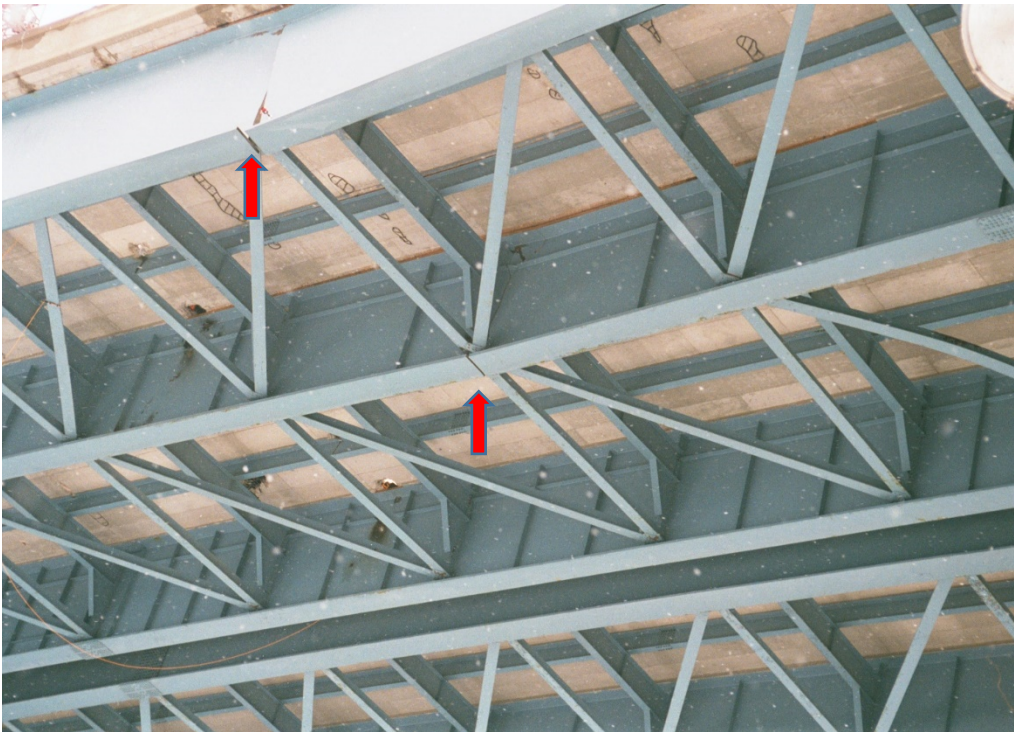
Figure 2 Complete girder fractures in two of the three approach span girders (arrows).

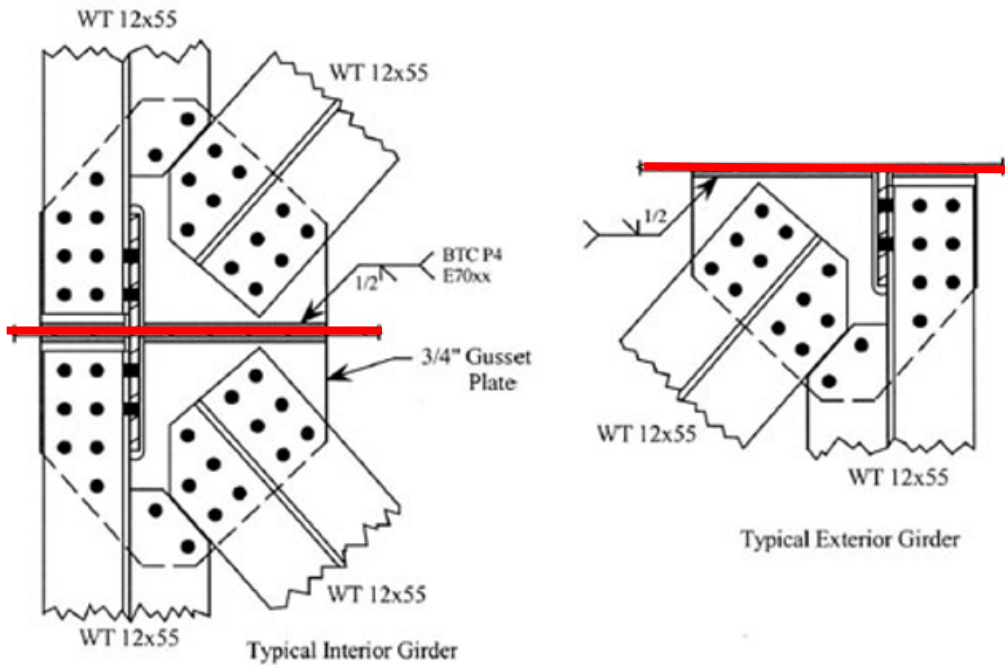
A follow-up investigation concluded that those fractures originated at the gusset plate area connecting lateral bracing to the girder webs (1). Two of these attachment details were involved in the fractures (Figure 3). Previously, the Wisconsin Department of Transportation (DOT) had detected arrested cracks at other approach span locations ranging in length from 6 to 36 inches. Those previously detected cracks were initially attributed to fatigue. A typical mock-up of similar lateral bracing connections is shown in Figure 4. With the lateral bracing removed, the mock-up shown in

- All fractures originated in the web plate at the joint where the lower lateral bracing system framed into the web. The initiation site was located in the gap between the gusset plate and the stiffener plate.

- A narrow gap between the gusset plate and the transverse connection/stiffener plate created a local triaxial constraint condition and increased the stiffness in the web gap region at the fracture initiation site. This constraint prevented yielding and redistribution of the local stress concentrations in this region. As a result, the local stress state in the web gap was forced well beyond the materials' yield strength. Under triaxial constraint, the apparent fracture toughness of the material is reduced and brittle fracture can occur under service conditions where ductile behavior is normally expected.

Figure 3 Plan views of girder attachment details of connections of girder webs (red lines) with lateral bracing - WT 12 x 55s (2).

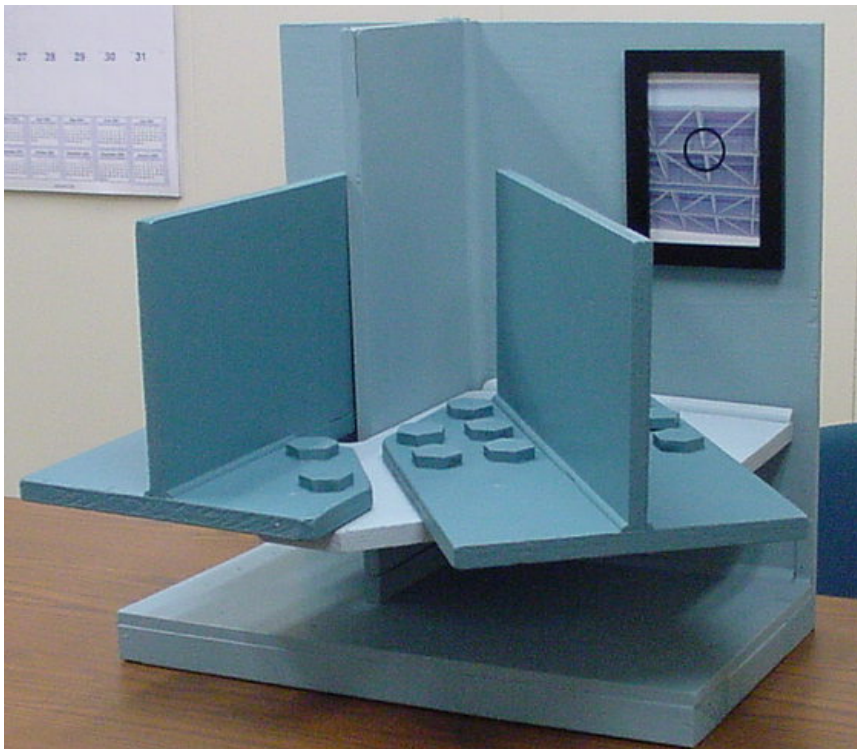
Figure 4 Mock-up of Hoan Bridge-type fracture detail (light green) showing lateral bracing attachments (green).

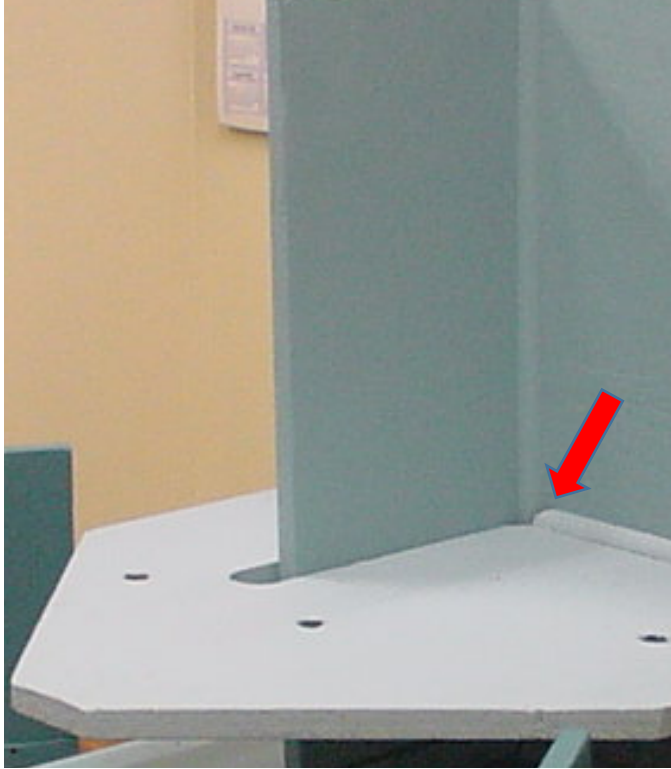
Figure 5 Mock-up of Hoan Bridge-type fracture detail (light green) with bracing removed. The problematic gap lies between the vertical stiffener and gusset plate fillet welds (arrow).

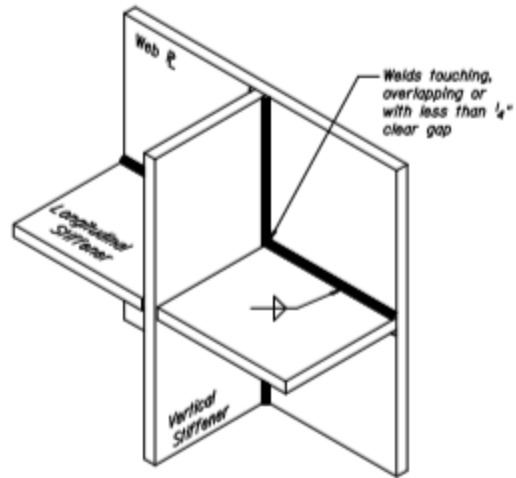
Longitudinal stiffener terminations in areas of the web subject to tension are vulnerable to constraint-induced fracture if there is insufficient weld clearance.

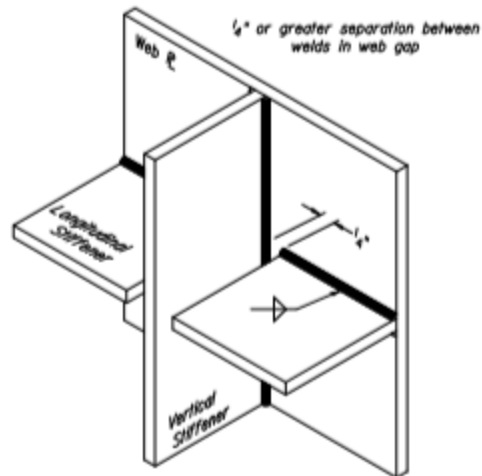
Longitudinal stiffener terminations with 1/4" or greater clear gap between welds present a low risk for constraint-induced fracture.

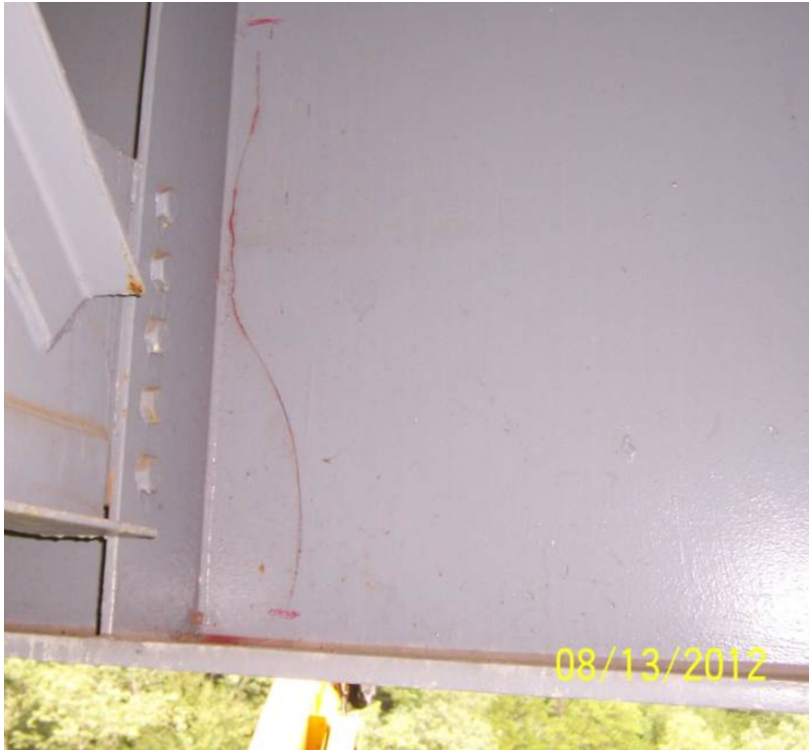
In 2012, KYTC discovered fractures on both the southbound and northbound I-75 bridges over Lynn Camp Creek in Whitley County (Figures 8, 9). They are continuous welded-plate girder structures with four girder lines. The fractures occurred in the girder webs near the center of the longest (200 ft.) spans. It appeared that the fractures emanated from potential CIF locations, similar to a detail shown in the Illinois DOT circular letter (see Figure 6, lower detail). The bridges were quickly repaired, however, there was no follow-up investigation. As the red arrow in Figure 9 indicates, the fillet welds attaching the horizontal and vertical stiffeners were in contact, indicating that a CIF fracture was possible.

Figure 8 Fracture in interior girder of the northbound I-75 bridge over Lynn Camp Creek in Whitley County (2012).

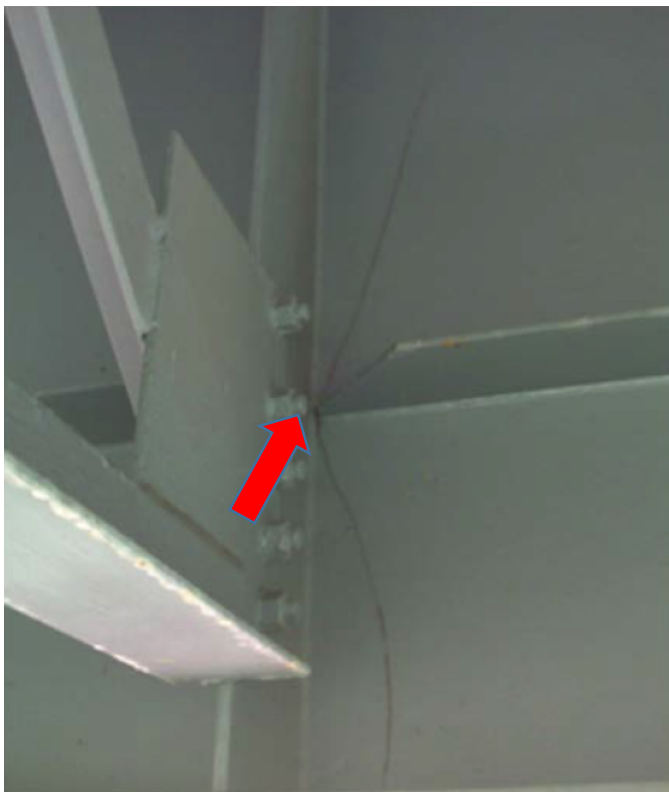
Figure 9 Fracture in interior girder of the southbound I-75 bridge over Lynn Camp Creek in Whitley County (2012). Note that the fillet welds attaching the horizontal and vertical stiffeners to the web appear to be in contact (arrow).

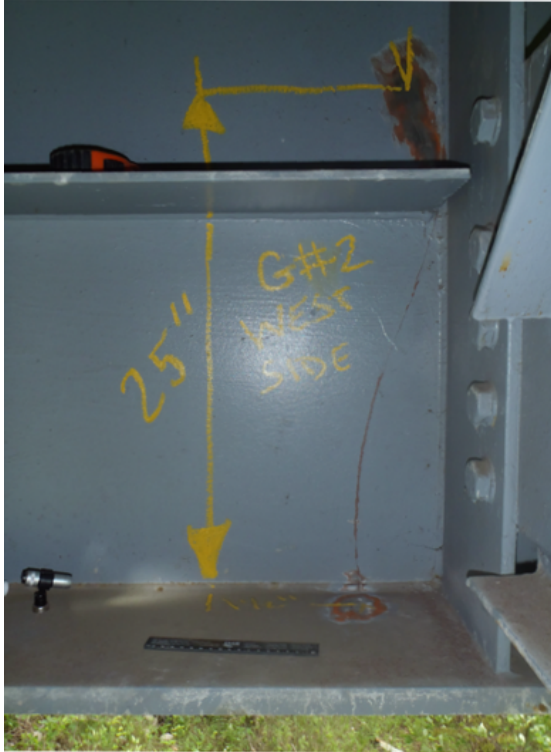
In June 2014 another fracture was found on the same girder (No. 2) of the northbound bridge that experienced a fracture event in 2012 one panel over (Figure 10). The 2014 fracture occurred in the same location as the 2012 fracture. Unlike the 2012 events, by the time this fracture was detected it had advanced into the lower flange and periodic monitoring revealed that it was growing by fatigue (Figure 11). KTC analyzed the girder at the time of its fracture (7).

Figure 10 Fracture in interior girder of the northbound I-75 bridge over Lynn Camp Creek in Whitley County (2014).

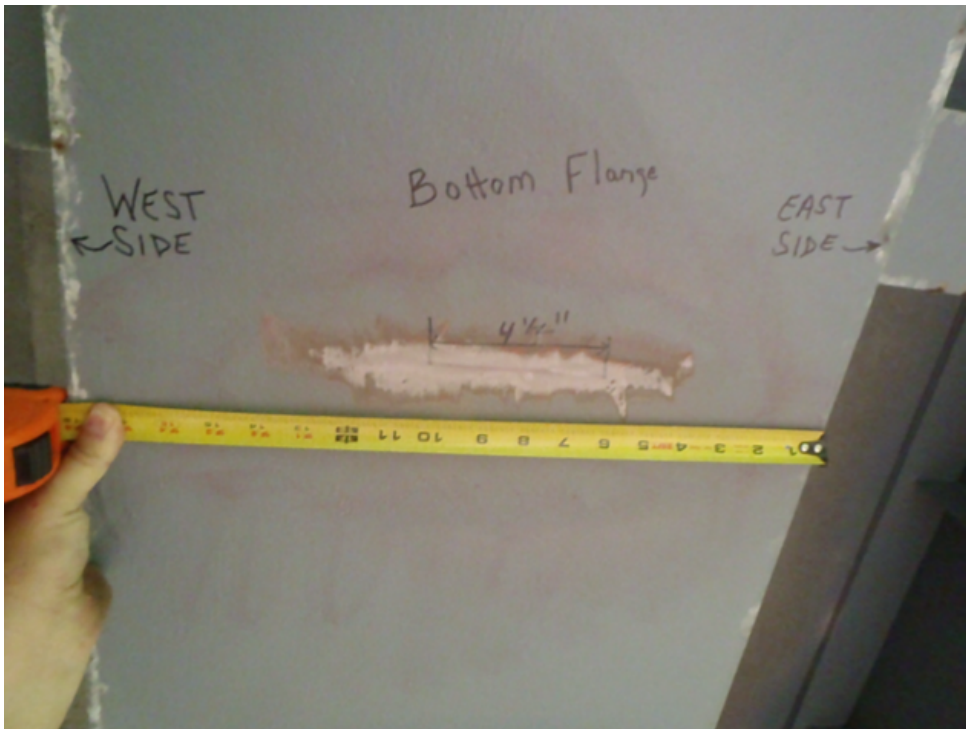
Figure 11 Fatigue crack growth in the lower flange of the girder after the initial web fracture.

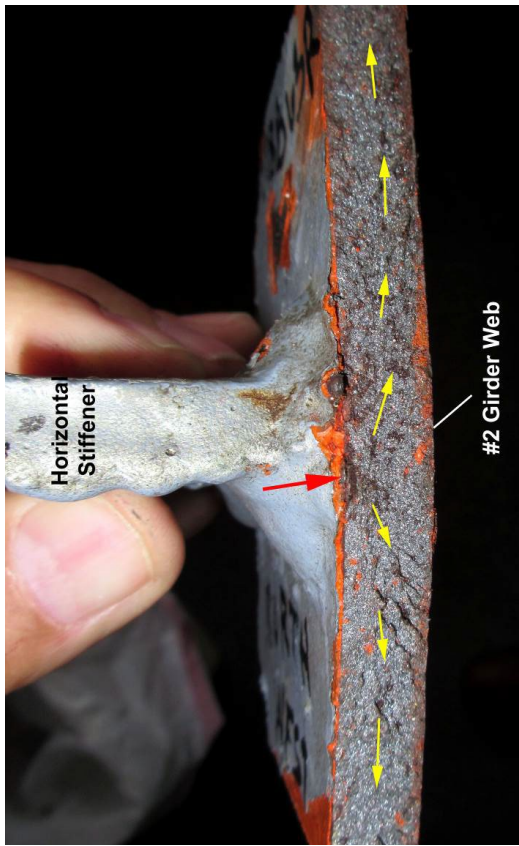
Pieces of the web and stiffeners were removed straddling the fracture, where the horizontal and vertical stiffeners were in close proximity. A fracture surface at that location indicated the web had experienced an unstable brittle fracture (Figure 12, yellow arrows) which originated near the termination of the horizontal stiffener-to-web fillet weld. Close study with a scanning electron microscope revealed a thumbnail-shaped fracture origin which KTC determined was a fatigue crack that subsequently drove the unstable brittle failure when it reached a critical size of only ~ 5 mm wide x 1 mm deep (Figure 13). While fatigue cracking precipitated the unstable brittle failure in the web, the presence of a CIF detail and small size of the fatigue crack at the point of instability led KTC researchers to speculate that constraint-induced fracture might have played a key role. It is unknown whether the 2012 events similarly involved fatigue cracking or simply brittle CIF fractures from crack pop-in.

Figure 12 Fracture specimen showing web fracture surface and horizontal stiffener filler weld termination. Note the direction of the spreading unstable brittle fracture in the web (yellow arrows) and the fracture origin (red arrow).

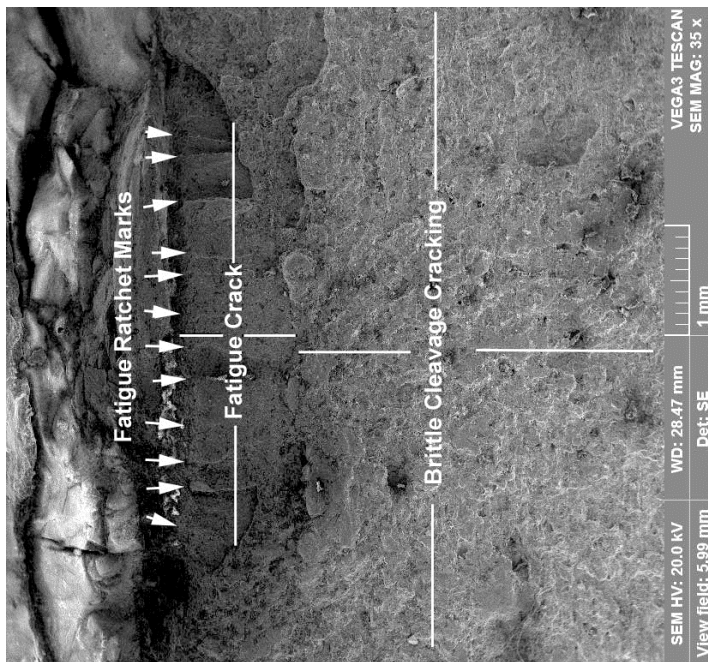
Figure 13 Scanning electron microscope image of the fracture surface in the area of the red arrow in Figure 12. Note the small (~ 5mm x 1mm) fatigue crack that precipitated the unstable brittle fracture of the girder web.

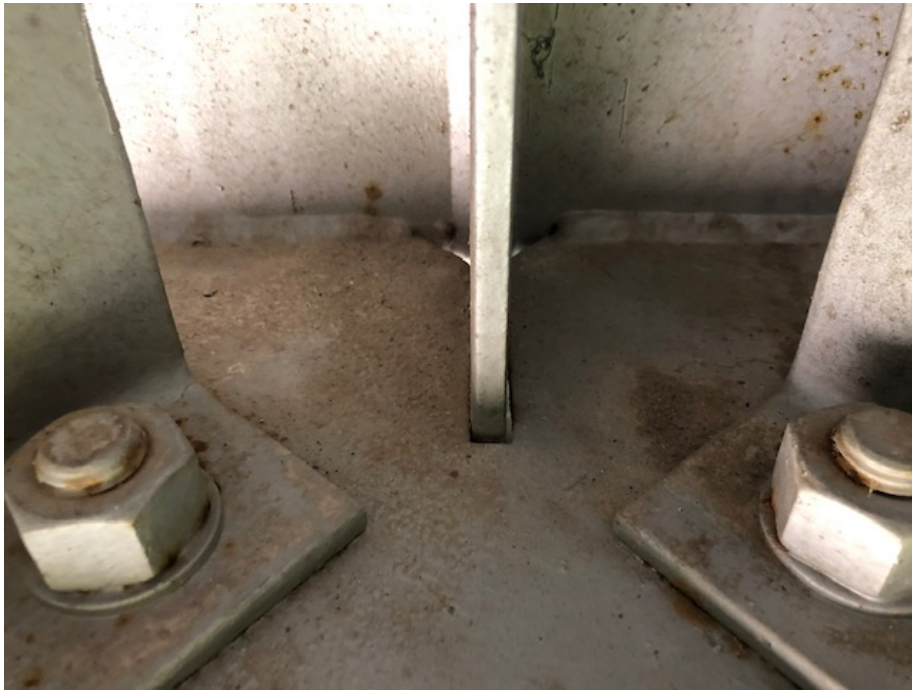
Figure 14 Bridge 045B00049N in Greenup County showing Hoan Detail which is typical throughout entire structure.

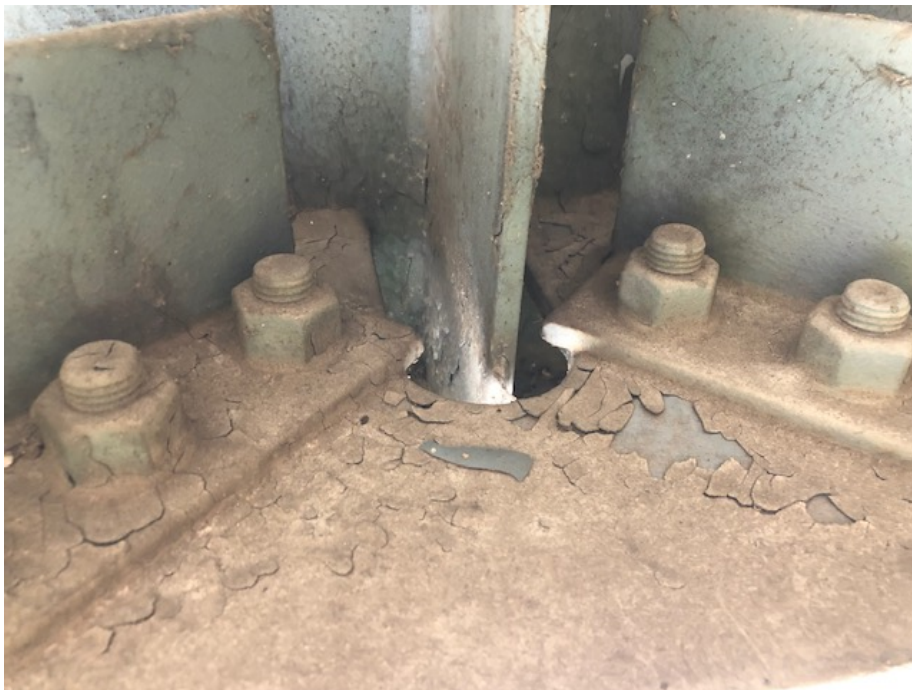
Figure 15 Bridge 073B00120R in McCracken County showing Hoan Detail which is typical throughout entire structure.

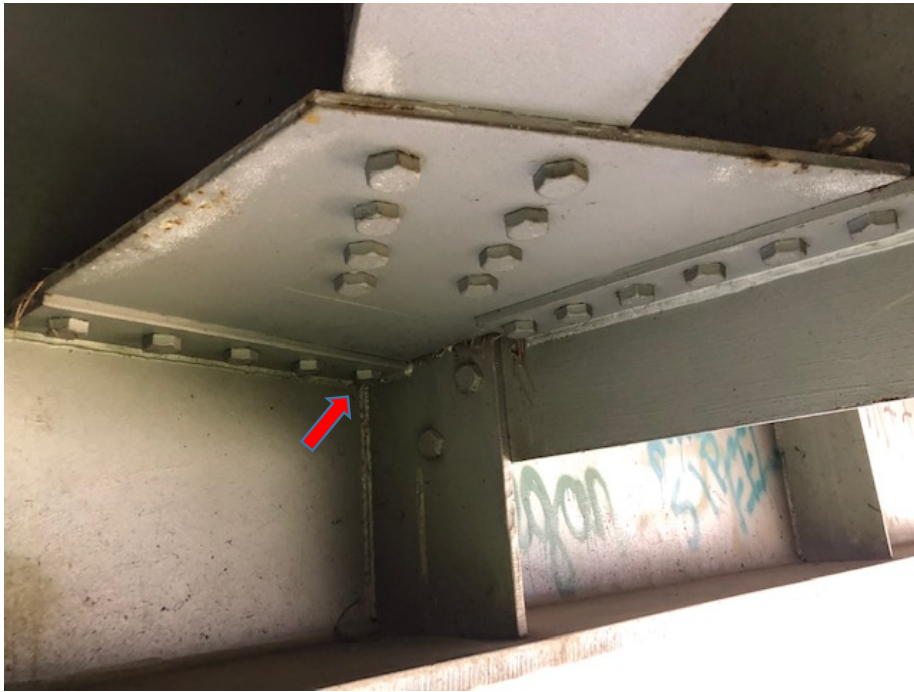
Figure 16 Bridge 040B00028R in Garrard County showing problematic CIF detail related to the gap between perpendicular fillet welds attaching gusset mounting bracket and vertical stiffener to web (arrow).

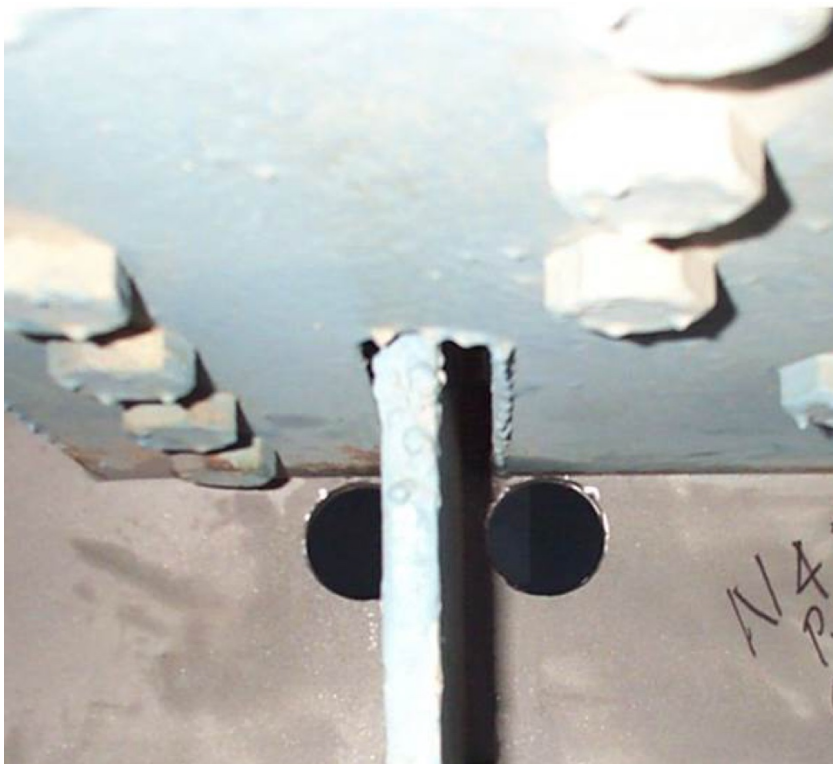
Figure 17 Check holes placed bracketing weld gaps on gusset in the I-794 Hoan Bridge.

The simplest form of mitigation is to place check holes adjacent to the weld gaps as this intercepts any cracks that might emerge and prevents large-scale damage to girders (Figures 17 and 18). Other recommendations for potential repairs were provided by the FHWA in the 2001 Technical Advisory (3). These are:

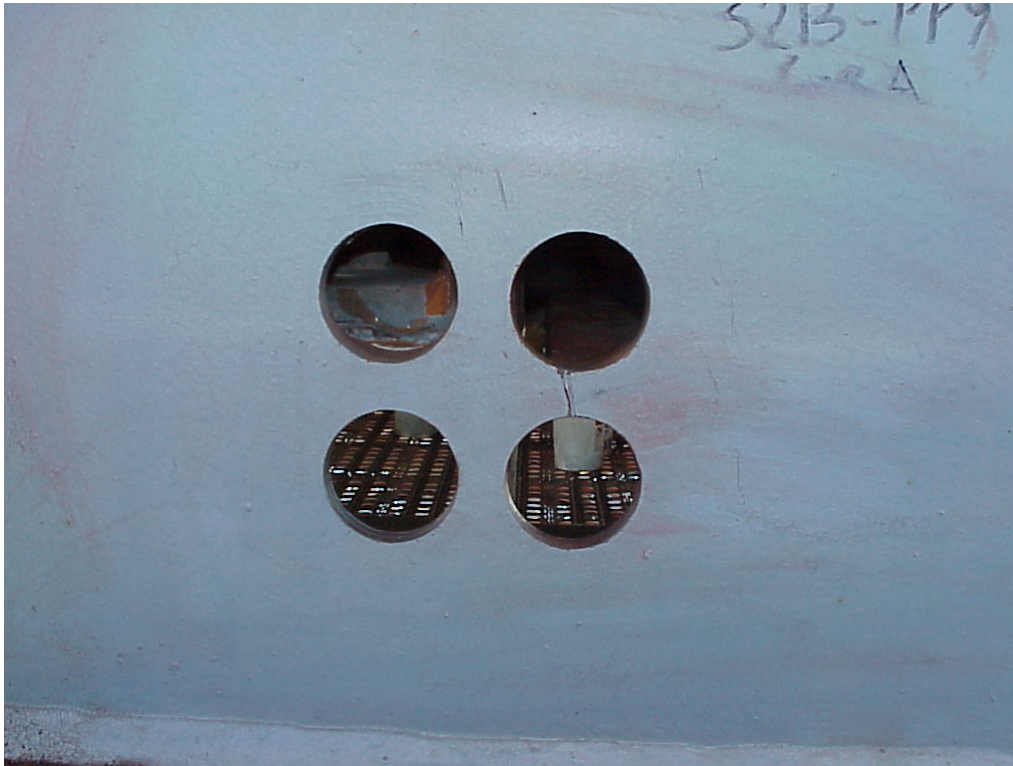
Figure 18 Check holes that arrested CIF crack in gusset weld gap on the I-794 Hoan Bridge.
