Repair of a Model Masonry Arch Bridge using FRP

Tao, Y, Chen, JF & Stratford, TJ 2009, Repair of a Model Masonry Arch Bridge using FRP. in Advanced Composites in Construction 2009. NetComposites Ltd., pp. 426-436, Advanced Composites in Construction (ACIC 09) , Edinburgh, United Kingdom, 1-3 September.

Y. Tao, J.F. Chen and T.J. Stratford

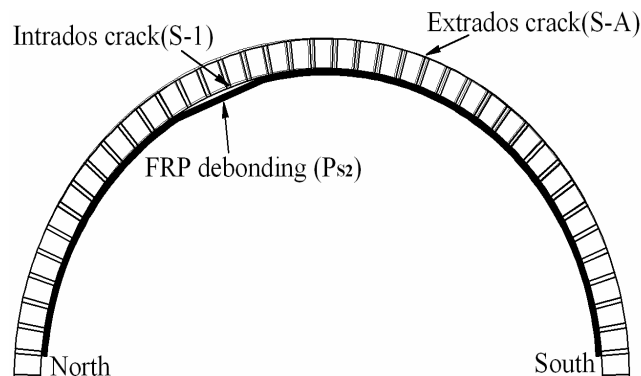
The initial FRP debonding failure occurred at the intrados hinge beneath the loading point at a load 250kN (Figure 4). The opening of the intrados crack (S-1) required high shear stress to be transferred across the adhesive, resulting in debonding of plate Ps₂ from the masonry. At this stage, the bond of the other five CFRP plates remained intact.

Figure 4. Plate P_{S2} on the southern arch after first debonding.

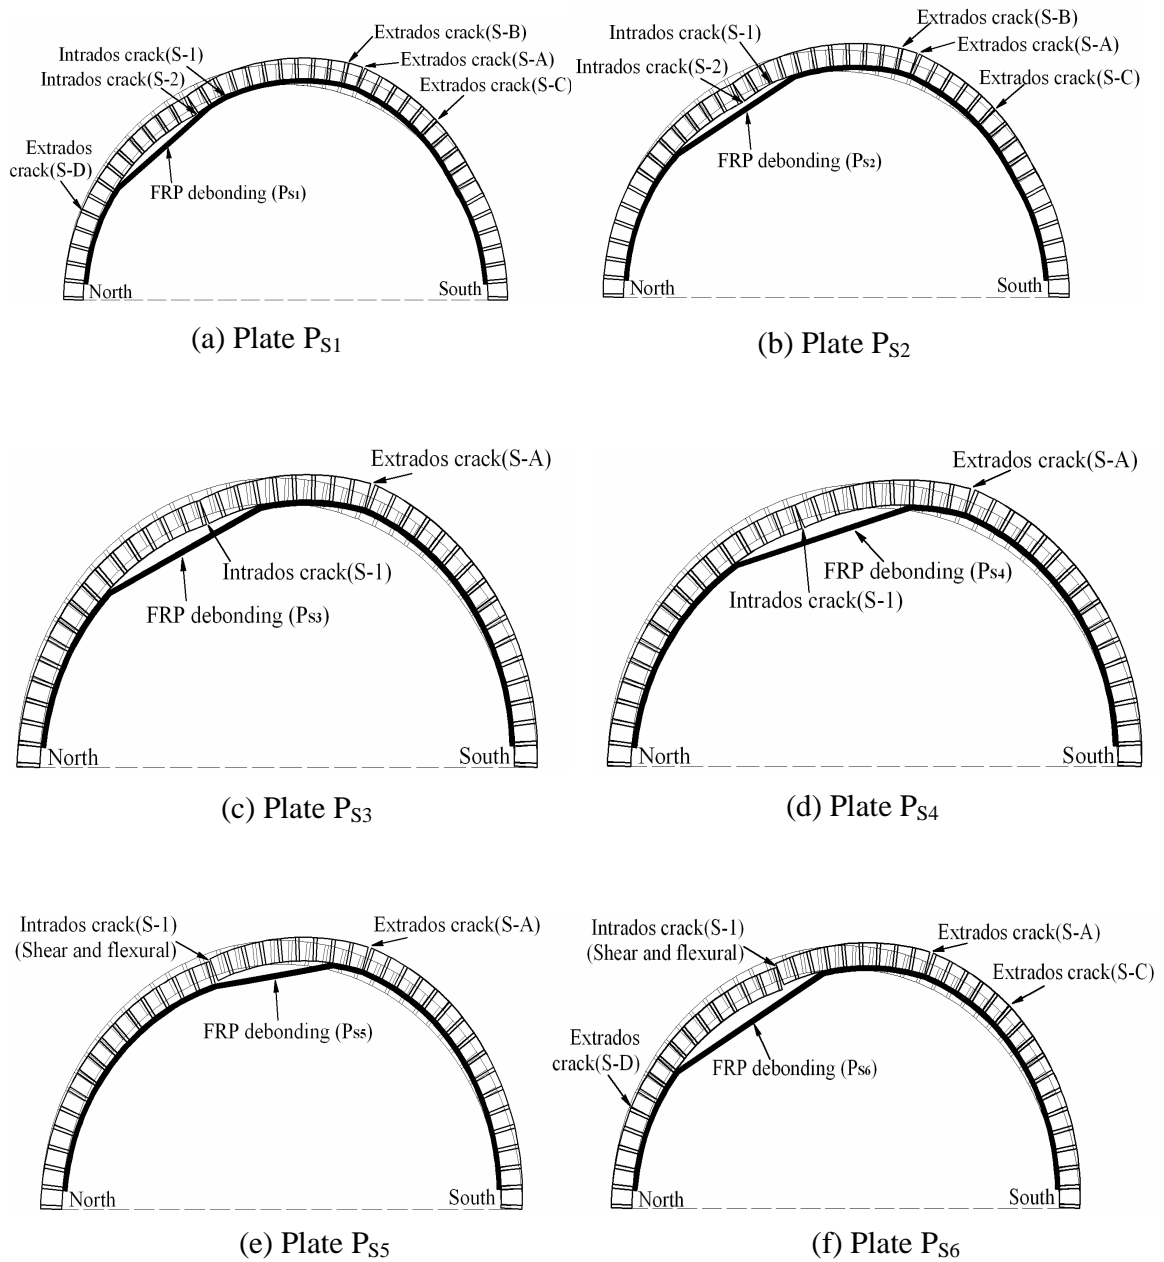
The type of masonry cracking and debonding varied across the width of the bridge as shown in Figure 5 where sections through the arch along each of the CFRP plates are shown. A new intrados crack (S-2) opened two bricks away from the original crack (S-1) at the east side of the bridge as shown in Figure 6. This new crack certainly crossed CFRP plate P_{S1} and P_{S2} , but it was not clear from photographs (direct observation underneath the bridge was not possible due to health and safety concerns) how far it penetrated into the central portion of the arch (P_{S3} and P_{S4}), but it was clear that this new crack did not extend to the west side of the bridge so it did not cross CFRP plate P_{S5} and P_{S6} . At the west side of the bridge, a mixture of rotational opening and shear occurred at intrados crack (S-1) as shown in Figure 7.

Figures 5 and 8 show the extent of debonding of each CFRP plate. Debonding of plates P_{S1} , P_{S2} , P_{S3} and P_{S4} was clearly due to rotational opening of the intrados crack (Figures 5a, b, c and d). The debonding of plate P_{S6} also appears to have been dominated by rotational opening of the intrados crack, as the debonded region bridges the crack (Figure 5f). Plate P_{S5} , however, appears to have been dominated by shearing of the masonry joint, accompanied by peel debonding that started at the intrados crack (Figure 5e).

Figure 5. Deformed shape of the southern arch and position of FRP after final debonding, shown along each CFRP plate section and viewed from the west.

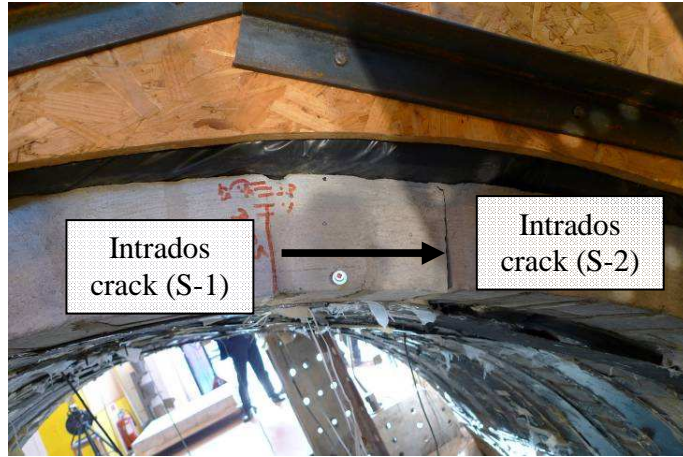
Figure 6. Development of second intrados crack near the loading position - viewed from the west

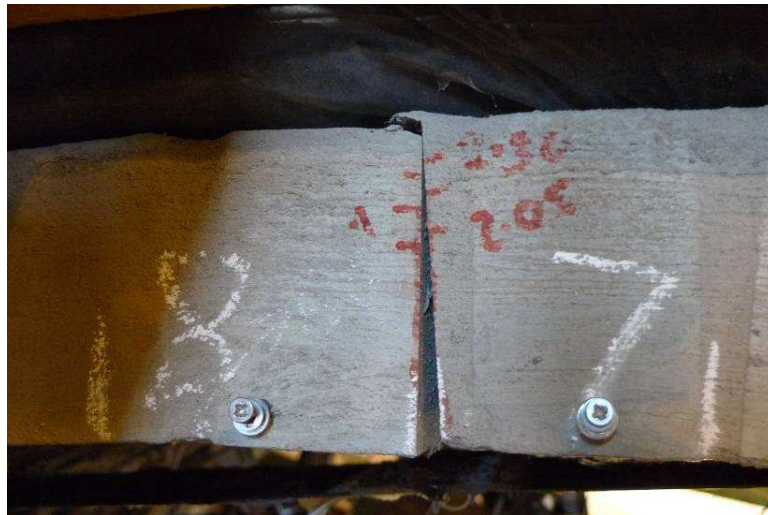
Figure 7. Mixed shear and flexural cracking failure at intrados crack (S-1) - viewed from the east

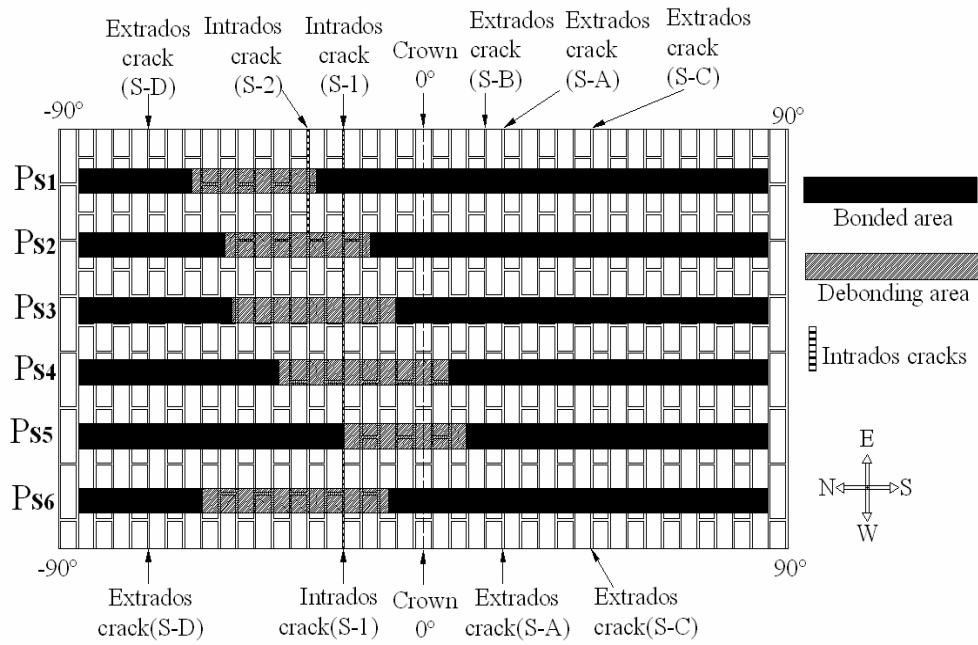
Figure 8. Plan view along the developed length of the southern arch after failure, showing the location of cracks and extent of debonding

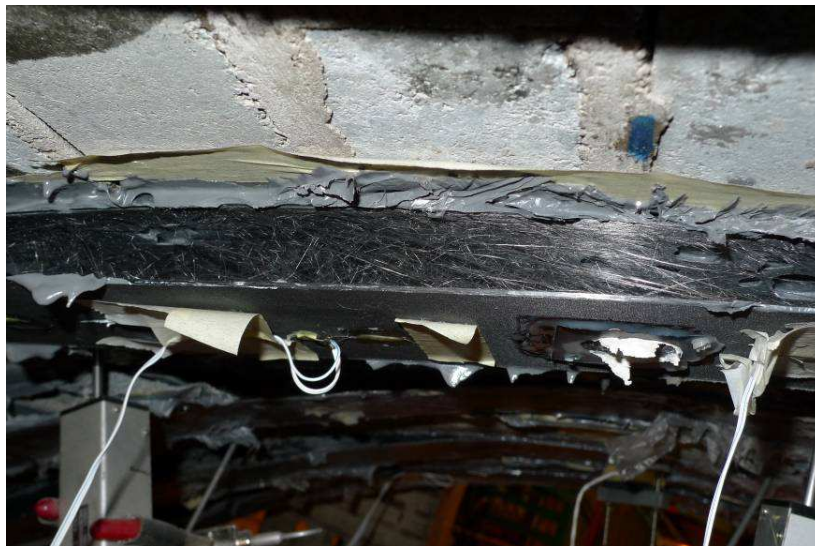
In all cases, separation of the CFRP from the masonry occurred slightly within the masonry, and left a thin layer of brick bonded to the plate to either side of the hinge. Further back from the hinge, however, the separation occurred within the laminate, leaving exposed fibres (Figure 9).

Figure 9. Debonding of the CFRP plate within the laminate, plate Ps₄
