### Behaviour of a concrete structure in a real compartment fire

# Behaviour of a concrete structure in a real compartment fire

**In July 2006, a full-scale compartment fire was set in an existing block of flats in Dalmarnock, Glasgow, Scotland. Prior to ignition, the structure was instrumented with deflection gauges, thermocouples and strain gauges. The growth of the fire was also carefully monitored. The resulting data provided a unique record of the behaviour of a concrete structure in fire through a heating–cooling cycle. The results show significant variation in structural temperatures within a relatively small compartment, demonstrating that the assumption of uniform temperature at any level within a fire compartment, which is implicit in many simple design fires, is incorrect. The response of the structure showed a corresponding complexity due to the combination of non-uniform spatial and temporal heating and the structural boundary conditions.**

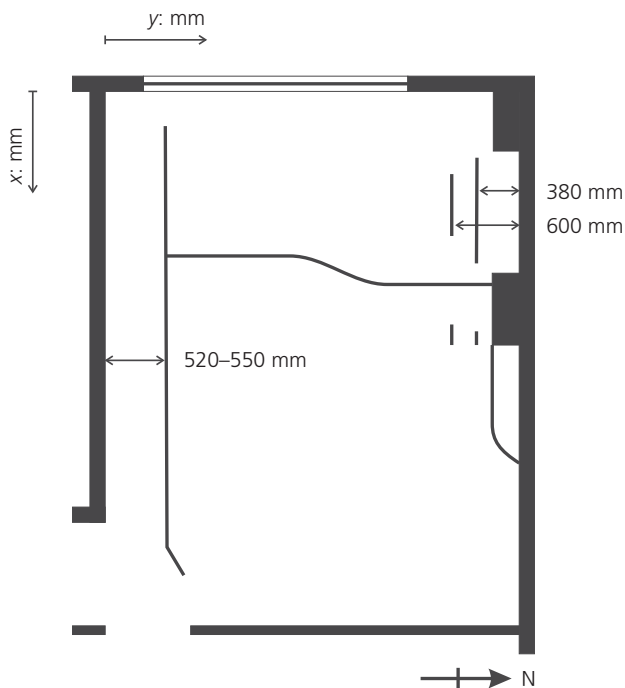
There was no evidence of any hot gases entering the room above the fire compartment. The upper surface of the slab contained visible cracks at the locations shown in Figure 9. These cracks generally coincided with the lines at which reinforcement in the upper part of the slab was curtailed (Figure 4). This is unsurprising, due to the step change in flexural capacity at these locations.

**Figure 9.** Crack pattern on the upper surface of the ceiling slab after the fire

Similar behaviour is seen along the east–west section (Figure 13), where a kink in the deflection profile around gauge B indicates the formation of another hogging crack (Figure 9). As previously noted, the eastern end ( $x = 4.6$  m) of the scaffold tube used to support these deflection gauges was not a fixed point on the slab and so may itself have deflected.

is believed to be due to the formation of the hogging cracks across line 2 shown in Figure 9, resulting in compression close to the walls as the underside of the slab was cooled. The timing corresponds to the deflection profiles in Figure 12.

The cracks that appeared on the cool surface of the heated slab suggest that detailing of reinforcement may have implications for the behaviour of concrete structures in fire. These cracks and the resulting deflected profiles would not be predicted by current design methods. Although no compartmentation failure occurred as a result of cracking in the test considered here, the chances of such a failure would be greater with the longer spans and thinner slabs that are present in many modern buildings. Since the cracks appeared at locations where the flexural stiffness of the slab changed abruptly due to reinforcement curtailment, it would appear that specifying graduated reinforcement curtailment could reduce the chances of cracks forming during a fire.

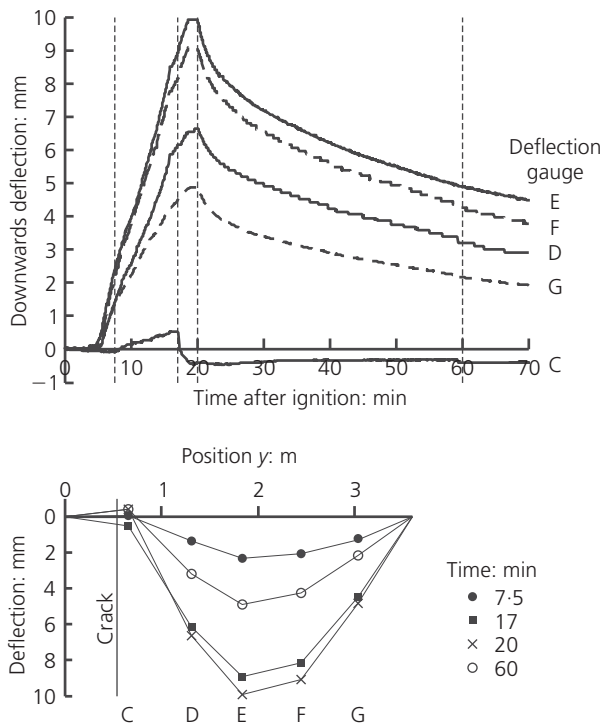
The peak deflection at the centre of the slab was around 10 mm, with 4 mm of this deflection recovered on cooling. Since the fire duration was short and high temperatures only penetrated a short distance into the concrete slab, the majority of the deflections recorded will have resulted from thermal curvature rather than from loss of material stiffness or strength. Across the north–south section (Figure 12), the deflections reduce towards the edges of the slab, as expected. It is notable that gauge C recorded negative (upward) deflections from around 18 min. This corresponds to the formation of a hogging crack in the slab that effectively moved the support from the wall to slightly inside the fire compartment. The crack formed slightly to the south of gauge C (Figure 9). As the fire cooled (Figure 8) but the upper layers of the slab continued to heat up (Figure 11), the deflection of the slab reduced but the hogging crack opened, as shown by the deflection profile at 60 min (Figure 12).

Figure 12. Vertical deflections along a north-south strip of the heated ceiling slab

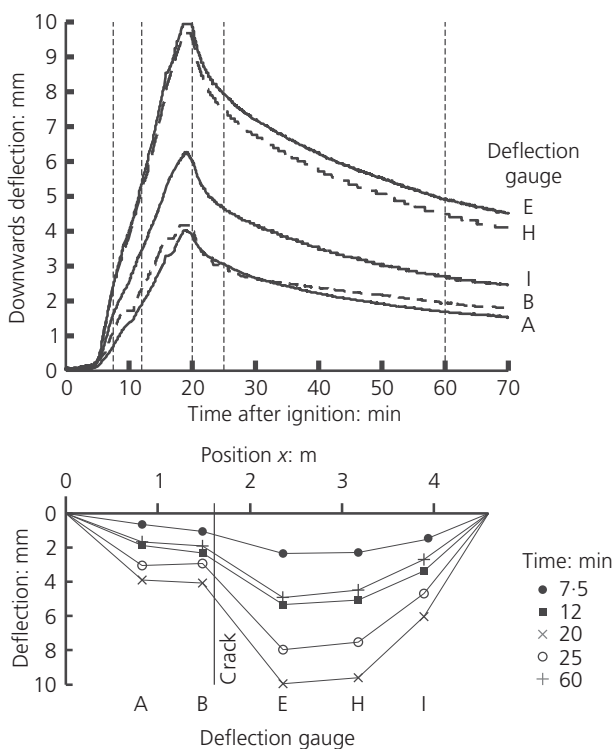
Figure 13. Vertical deflections along an east-west strip of the heated ceiling slab

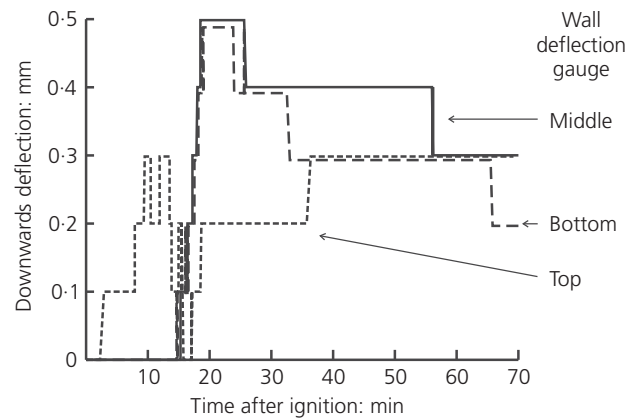
The very small horizontal deflections recorded for the internal wall of the compartment (Figure 14) show that the heating of this wall was small in comparison with that of the compartment ceiling.

Figure 14. Horizontal deflections of the internal structural wall of the fire compartment

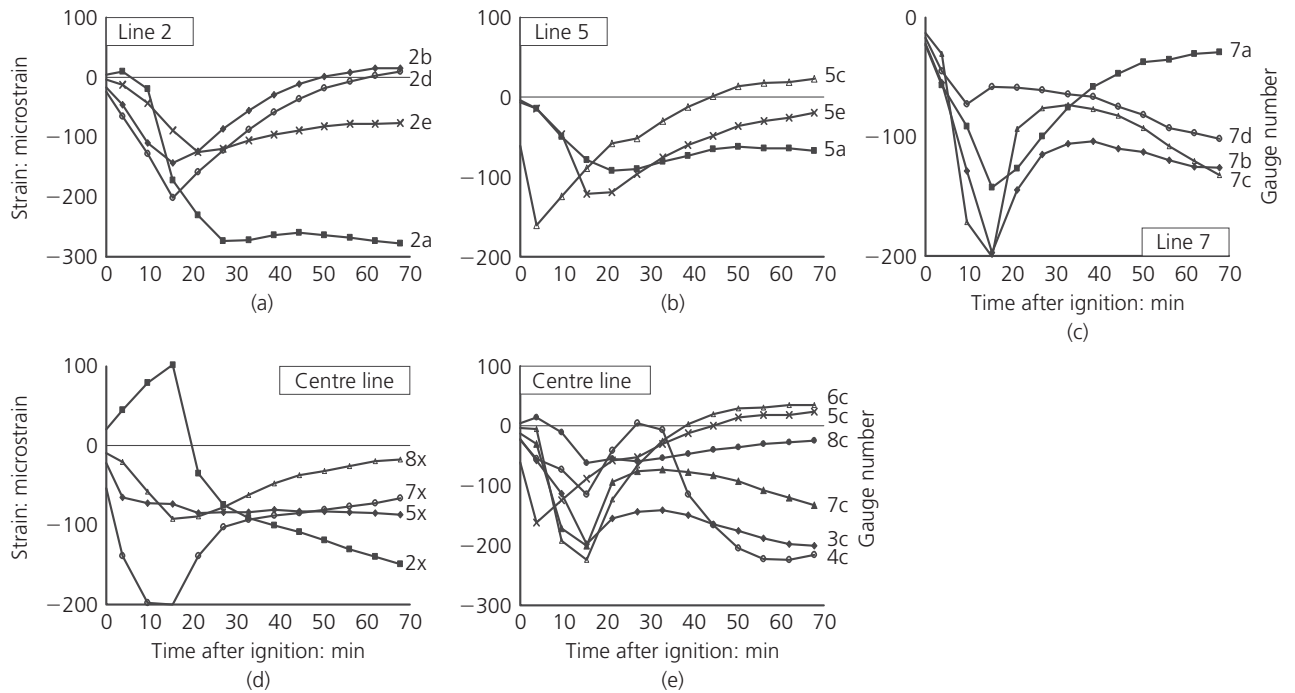
During the heating phase of the fire, the strains measured on the top of the slab increased rapidly. Heat from the fire caused the slab to expand, but it was the concrete in the lower parts of the slab that expanded, not the relatively cool upper surface where the strain gauges were located. The large compressive strains recorded on the top of the slab were dominated by geometrical compatibility with the surrounding structure and due to the internal self-equilibrating stresses created due to the thermal profile through the depth of the slab (Figure 11).

After the fire was extinguished at 19 min, the strains decayed rapidly as the bottom surface of the slab was cooled by water applied by the firefighters. However, the temperature in the upper parts of the slab continued to increase as residual heat conducted upwards (Figure 11). As a consequence, the compressive strains in gauges such as 3c and 7c (see Figure 7) again increased after around 30 min, due to the restrained thermal expansion of the top of the slab.

Figure 15. Strain gauge readings from the upper surface of heated slab at the locations indicated in Figure 7

structure during a realistic fire. In future tests it is recommended that higher resolution strain measurements are made in both time and space so that a full picture is possible of how strain develops within the slab.

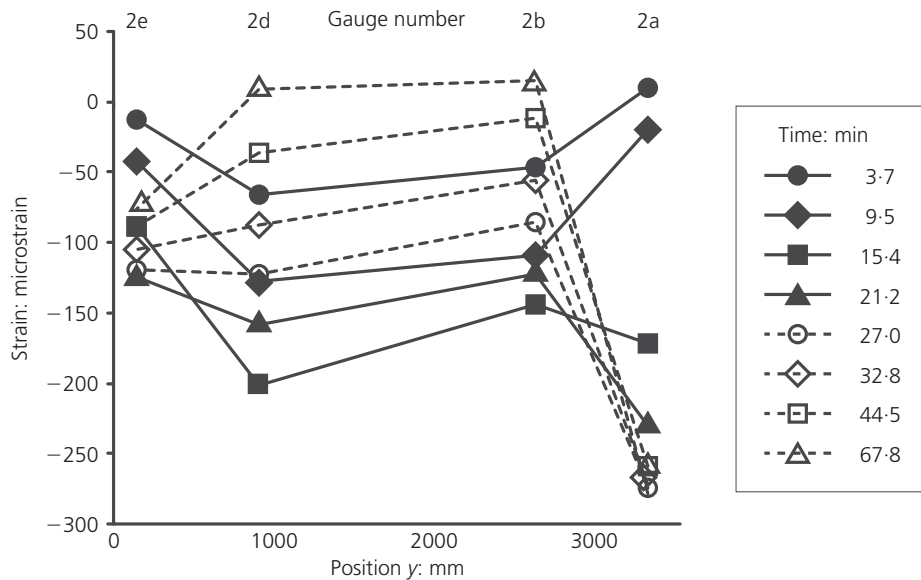
Figure 16 plots the strain profile with position along line 2 at selected time steps. During the heating phase (<19 min), the compressive strains are greater in the centre of the slab, as would be expected in a beam that is heated from underneath and is restrained against rotation and lateral expansion at either end. At 21.2 min (just after the fire was extinguished), there was a sudden jump in strain at gauge 2a and (to a lesser extent) gauge 2e. This

Figure 16. Strain profile with position along line 2 at selected time steps
