Internal characterization of embankment dams using ground penetrating radar (GPR) and thermographic analysis: A case study of the Medau Zirimilis Dam (Sardinia, Italy)

To appear in: *Engineering Geology*

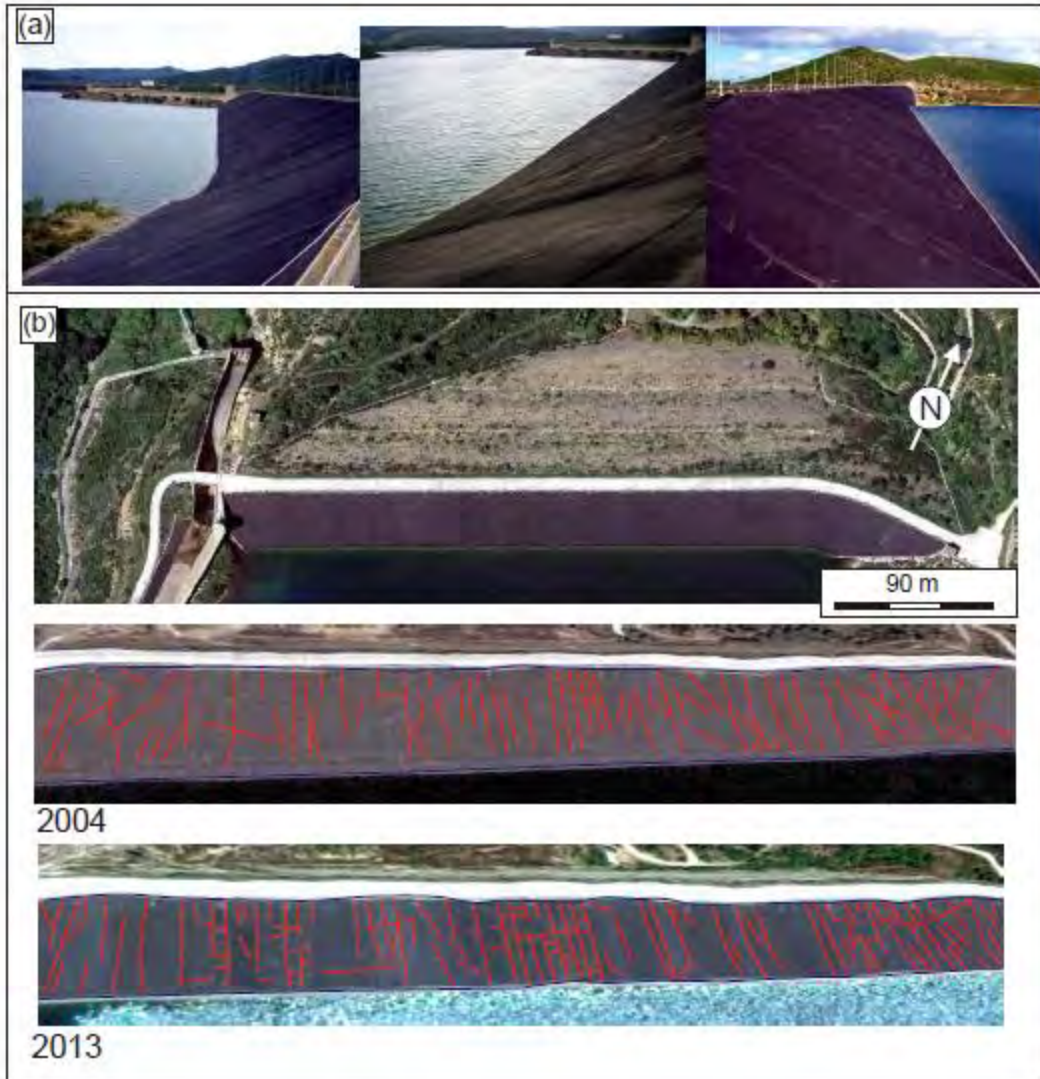
Figure 2

A surficial analysis of the upstream slope shows cracks that can be ascribed to three main groups (Fig. 2a): i) subvertical cracks perpendicular to the upstream slope (normal cracks) related to the limits between asphalt tiles; in general, these have linear traces, or eventually irregular trends between shingles, with differential relative movement (shear cracks: Fig. 2a), ii) subhorizontal cracks, having interruptions or small steps at the intersection between shingles, and defining small bulges or depressions; and iii) transverse cracks, showing a vertical component, that are less representative, usually affecting the asphalt layers and their limits. Deformation of the slab surface can also be expressed without rupture, by means of slope changes along the surface, topographical internal depressions between transverse and irregular cracks, and non-linear trends between different asphalt laminae. Crack distribution highlights the construction limits and indicates apparent differential movement between panels, as shown by shear and transverse cracks pre- and post-dating the reparation of the upstream dam face (see Fig. 2b for a comparative analysis between 2004 and 2013).

Figure 2. a) Photographs from the studied zone showing deformation and cracks along the dam slope. b) Photographs from 2004 and 2013, taken before and after the last reparation, are included where cracks can be identified.

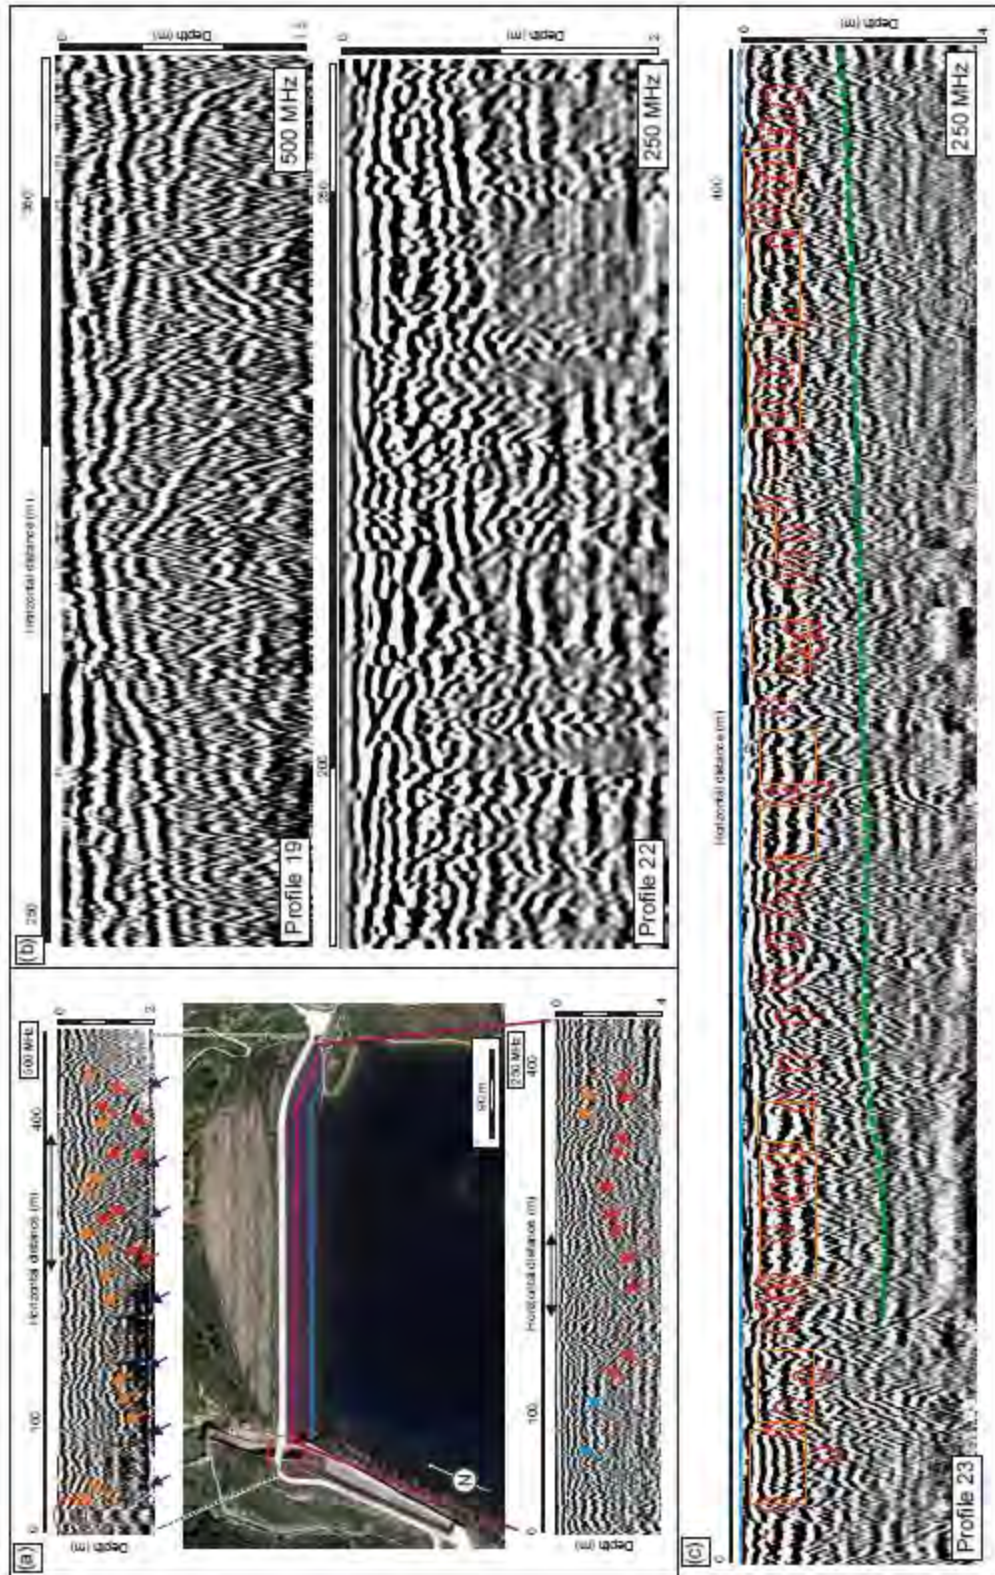
Figure 5

Data obtained in zone 1 (the upper part of Fig. 5a and b: 500 MHz), over the crest of the dam, show irregular reflector trends, with depth variations, tilting and changes in the thickness of the uppermost, more reflective unit. This result differs from the expected structure having homogeneous layers. In some cases, changes in the thickness of the upper units exceeded 1 m (Fig. 5a and b), or tilted reflectors or non-horizontal geometries were identified below this depth. The general trends of these changes along the crest are (i) a progressive increase in thickness of the upper unit in the western abutment (Fig. 5a), showing irregularities at approximately 2 m depth, (ii) a sudden decrease in thickness of the shallowest unit at 275 m (Fig. 5b: 250 MHz), defining a relative high, and again a concave-upwards geometry between this position and 450 m. At approximately 2 m in depth, a subhorizontal reflector, parallel to the surface, was found, indicating that the described structural changes only affect the upper part of the structure. This supports the identification of surficial structural changes that do not respond to propagation from deeper levels of the dam.

Along the upstream slope (zone 2; lower part of Fig. 5, a, b and Fig. 5 c: 250 MHz) different profiles over the asphalt shingles were conducted to identify its structure and the

Figure 5. a) GPR profiles over the crest and upstream zones (see photograph for location). In the profiles, reference to the structural changes, interruption of the expected horizontal distribution and net interruptions are marked by arrows. Coincident profiles for 250 and 500 MHz are shown. b) Detailed view of profiles included in (a) and made with 250- and 500-MHz antennas are shown. Net changes, structural variations, and thickness changes of most surficial units can be identified. Meters reference from (b) is the same as that in (a) where the profile location is marked by an arrow. c) Complete profile along the lower part of the dam where net interruptions related to the construction characteristics and changes of structure, thickness and dip of reflectors can be identified along the 250-MHz profile. The profile location is marked in (a). Note that changes are in many cases limited by net hyperbolic anomalies that present a correlation between profiles and are interpreted in terms of limits between asphalt layers.

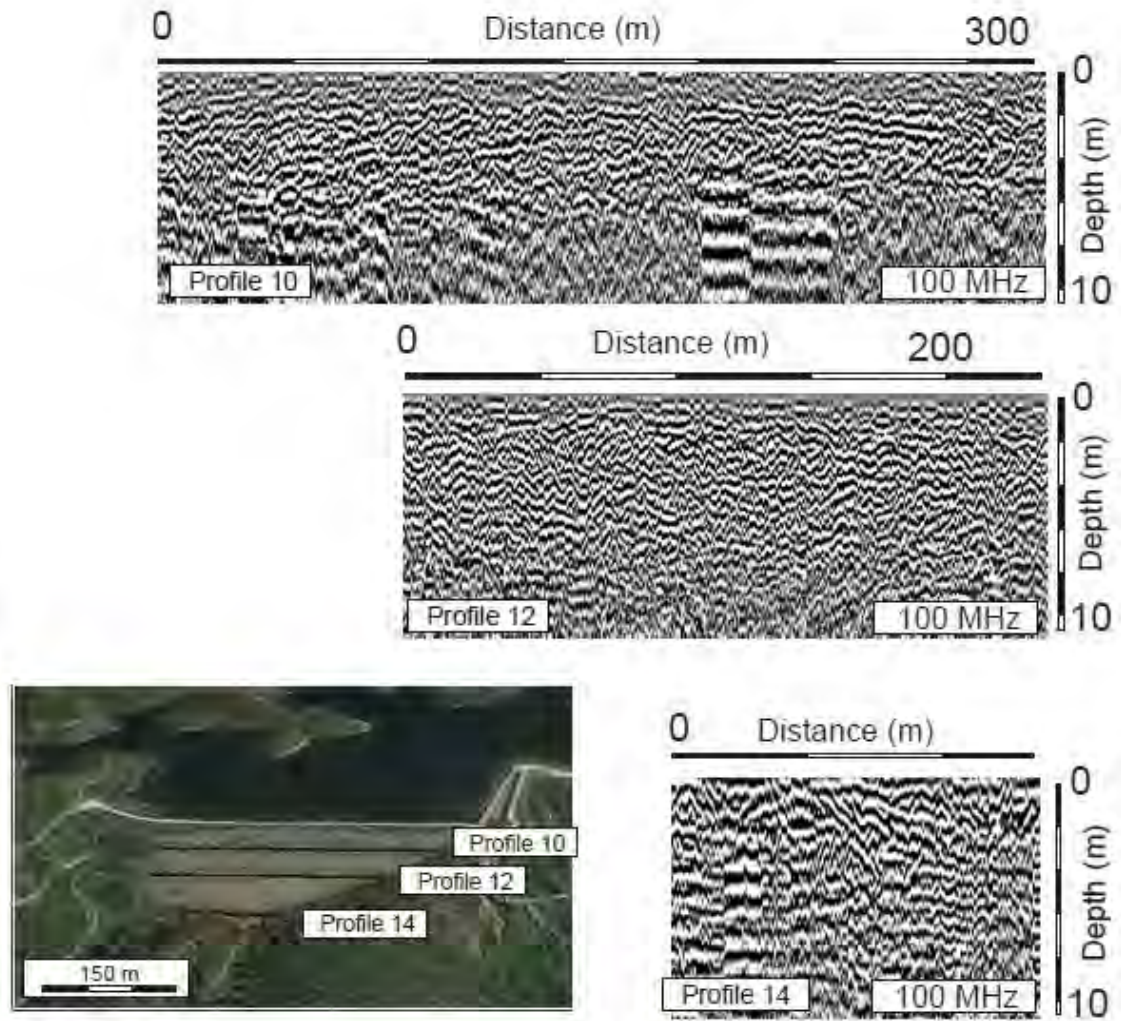
Figure 6

The survey along the downstream face did not show significant changes (Fig. 6; 100 MHz). In general, homogeneous or progressive thickness changes in the reflective upper unit or horizontal and progressive tilted reflectors were identified. A similar thickness, ranging from 6 to 9 m, was interpreted along the upper and intermediate profiles, with a lower penetration occurring when approaching the natural materials below the dam. At the abutments, the upper constructive levels show a more homogeneous pattern and do not define geometries liable to be interpreted in terms of sudden changes in thickness or tilted reflectors.

Figure 6. GPR profiles conducted along the downstream slope at different heights along the construction berms. A photograph with the location of the profiles is also included. All the profiles were conducted using 100-MHz antennas.

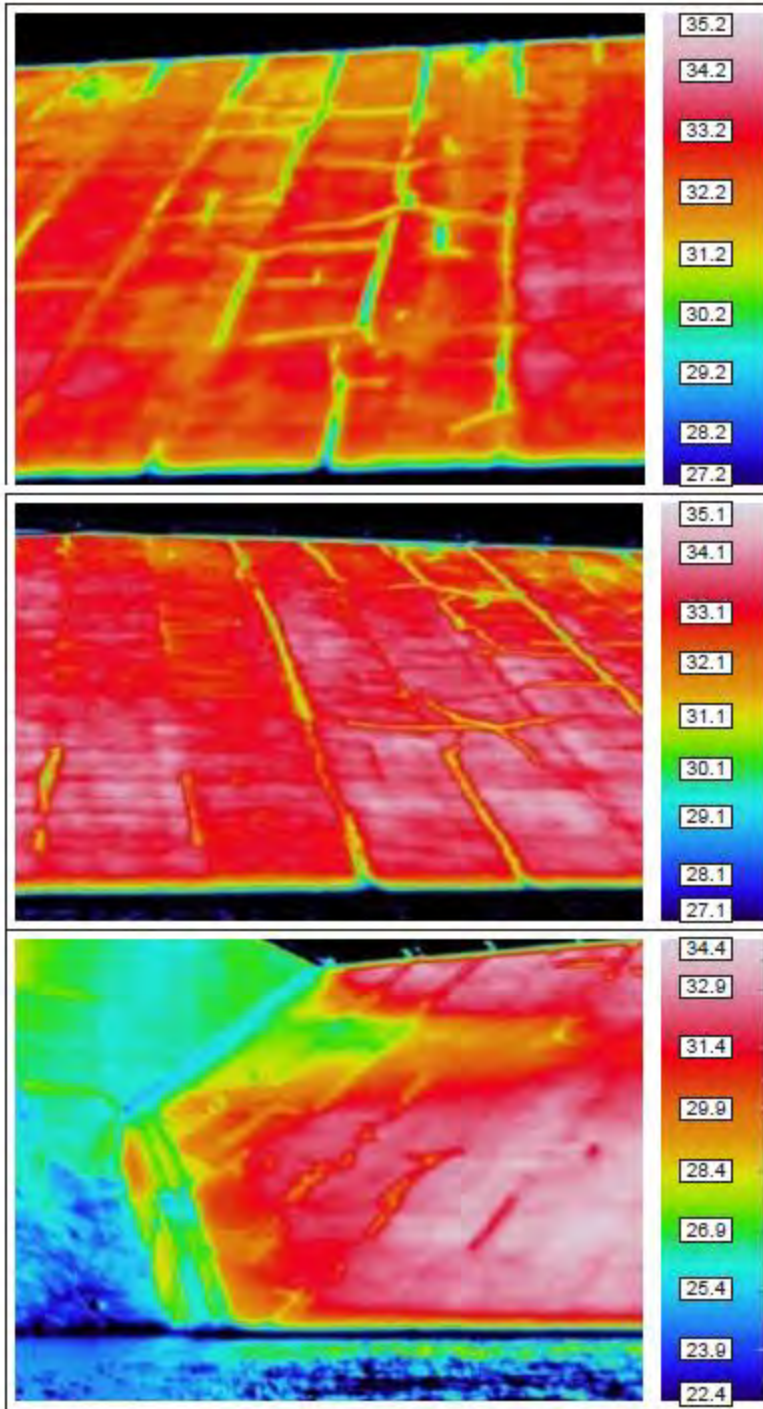
Figure 7

the upstream side of the dam (Fig. 7) to identify thermal changes in the asphalt layers or underlying units. Obtained results permitted us to identify two groups of linear thermal anomalies, one parallel to the main slope of the dam surface and a second that is perpendicular (horizontal). This distribution is interrupted at certain sectors where the parallelism disappears and irregular trends can be identified. These trends correlate in general with the surficial limits identified during the inspection and with the hyperbolic anomalies with a direct correlation between profiles identified using the GPR.

Figure 7. - Thermographic photographs from different sectors of the dam.

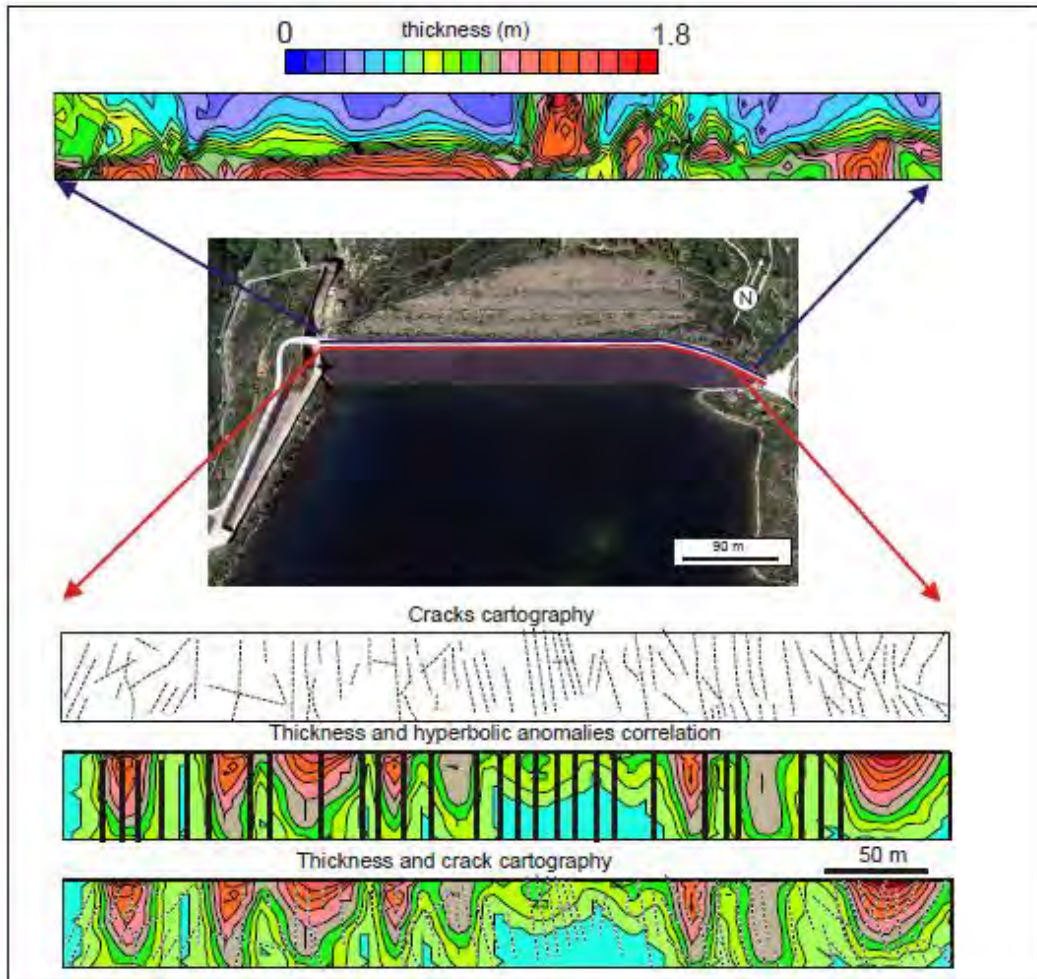
Figure 8

To evaluate the correlation among the identified changes, anomalies and their distribution, an integrated analysis of the different obtained profiles was conducted. The objective of this analysis was to evaluate the position of the lower limit for irregular trends, tilted reflectors or interruption of layers. The analysis was performed by picking up the position of the lower limit of the non-horizontal areas from the different profiles, especially the 250-MHz profiles, that were the most systematically performed. A model of the correlation of the identified limits along the different profiles from survey zones 1 and 3 was completed to evaluate the degree of correlation between the profiles and their potential correlation with the identified cracks and problems affecting the asphalt layers. On the one hand, it seems that the systematic group of the hyperbolic anomalies identified in the radargrams with a direct correlation between profiles can be ascribed to the construction limits of the impervious slabs (Fig. 8) that were also identified during the thermographic analysis (Fig. 7). The comparison between the surficial movements and cracks to the underground structure shows that the sectors showing the strongest structural changes in the GPR profiles (Fig. 9) correlate with the sectors where higher

Figure 8. Model of involved thickness of deformed units along the crest and upstream slope of the dam obtained from the integration of the different profiles (a photograph with the location of the studied sectors is also included). In the model developed over the asphalt slab, hyperbolic anomalies with a direct correlation between profiles and the surficial identified cracks are shown.

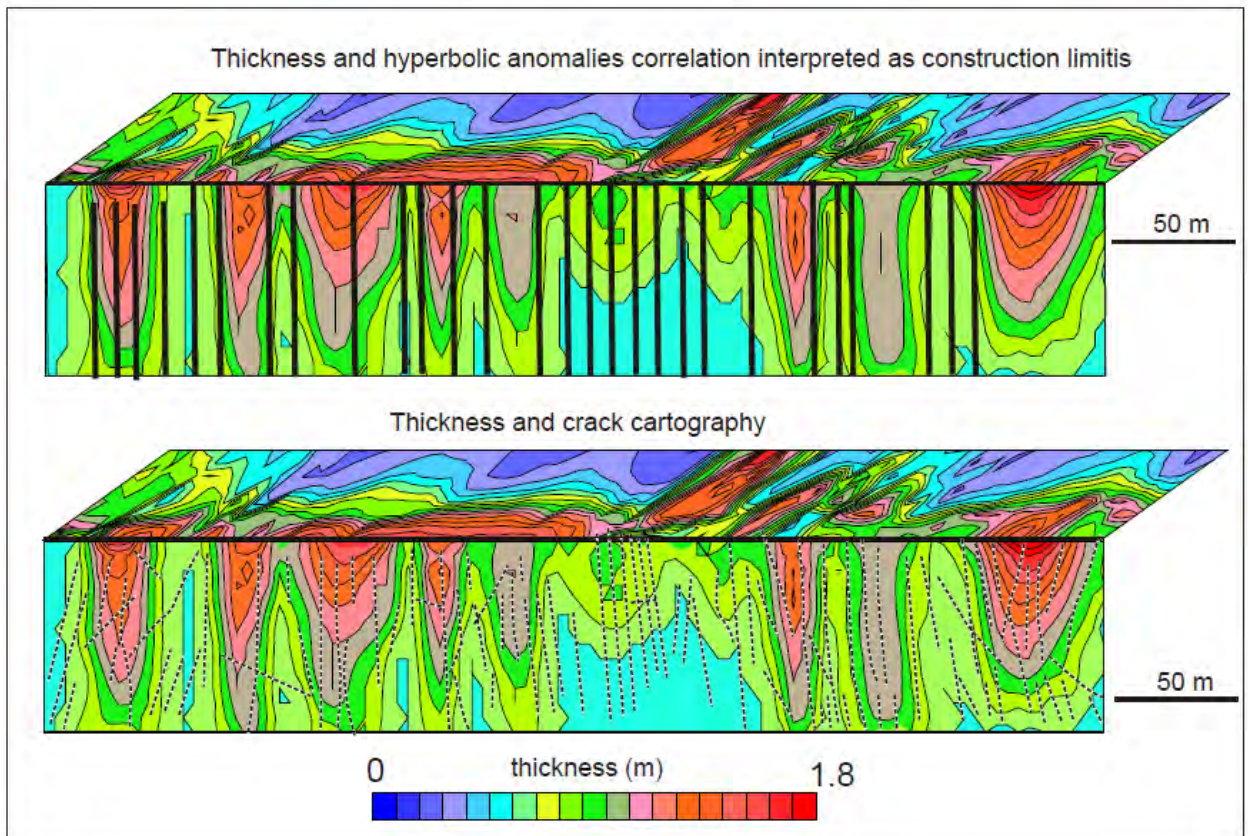
Figure 9

surficial movements were detected. The thickness distribution of the involved materials and non-horizontal reflectors coincide with a stronger deformation of asphalt laminae. This correlation substantiates that the surficial movements involve a greater thickness than the asphalt layers and include materials of the dam structure itself. The same methodology of correlation between profiles was also applied for the upper part of the dam (crest), although in this sector, there is no evidence of cracks affecting the survey zone. However, this analysis can permit the direct comparison of the underground structure along the crest and the upstream face (Fig. 9).

Figure 9. Oblique models showing a correlation of deformed sectors identified in the GPR profiles at the crest and upstream slope. Isolated anomalies with lateral correlation and cracks identified in the asphalt are also included. Note that the cracks are drawn using the most recent aerial photograph in the area (2013) after repairing and reconstruction.
