Condensation Risk – Impact of Improvements to Part L and Robust Details on Part C

Project Reference Number: CI 71/6/1 BD2414

Interim report number 7: Final report on project fieldwork

Malcolm Bell, Melanie Smith & Dominic Miles-Shenton
Buildings and Sustainability Research Group
Leeds Metropolitan University

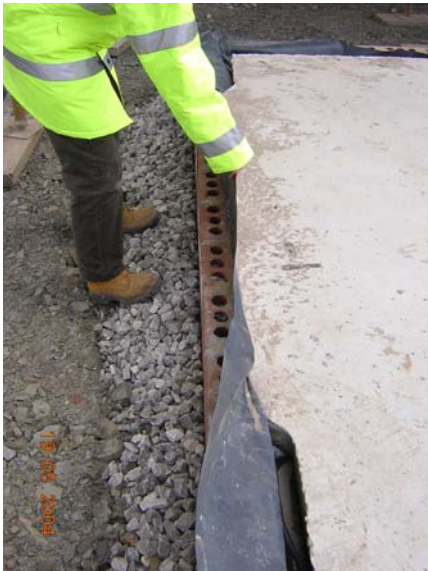
Figure 3.12 Omission of edge insulation at patio door reveal – and RD 8.06.

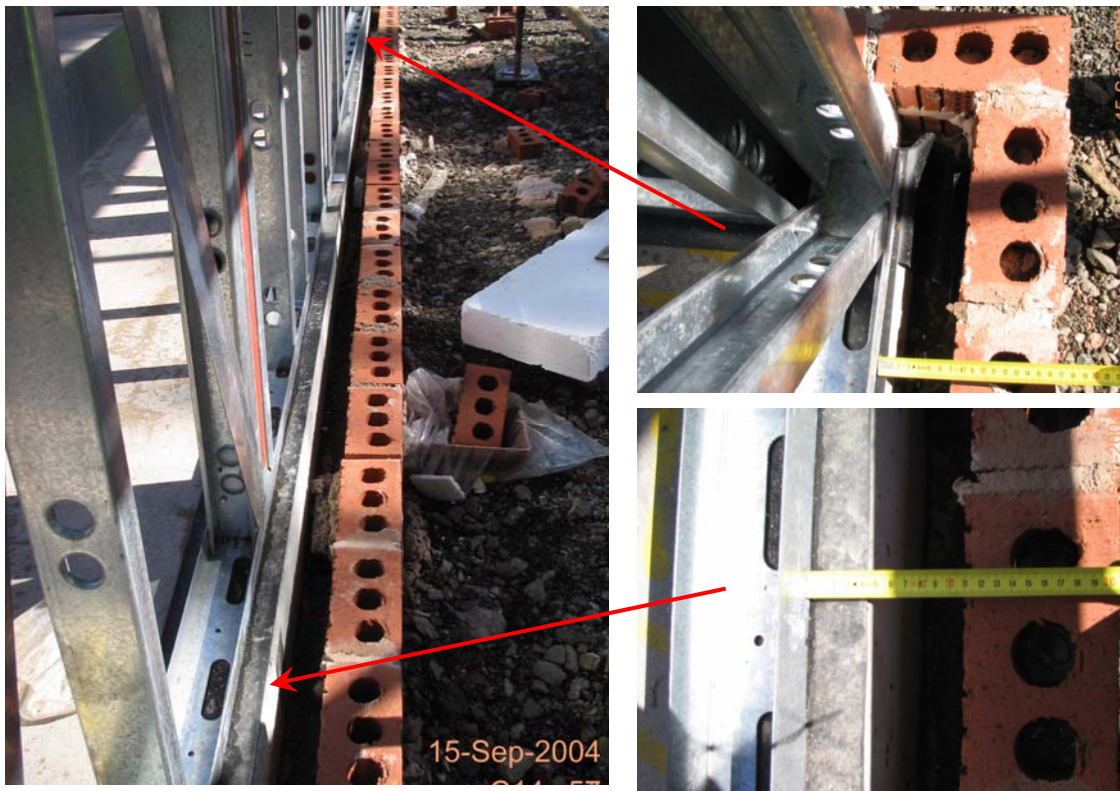
Figure 3.18 Slab not square in steel frame construction.

51. Whatever the cause of the misalignment (setting out of the base or manufacturing errors in the steel frame) its effect was to make it very difficult to maintain continuity in the external insulation. The practical response to this problem was two-fold; either the wall insulation was stopped at dpc level and a separate piece of insulation placed in the

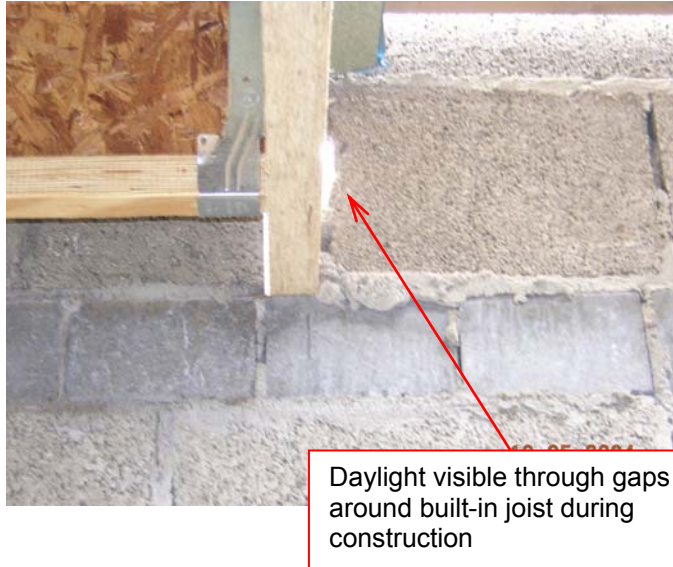
an illustration of the difficulties of insulating across the joist ends. In figure 3.31 the joist ends protrude into the partially filled cavity but instead of trimming the joists to a tight fit the insulation has been cut back, not only reducing the insulation thickness but also leaving room for air flow which bypasses the insulation. This is, perhaps, something of a curio in this project and the problem is not particularly severe but it is conceivable that in extreme cases, even greater thicknesses of insulation could be removed.

Figure 3.30 Built-in joists in masonry external walls¹.

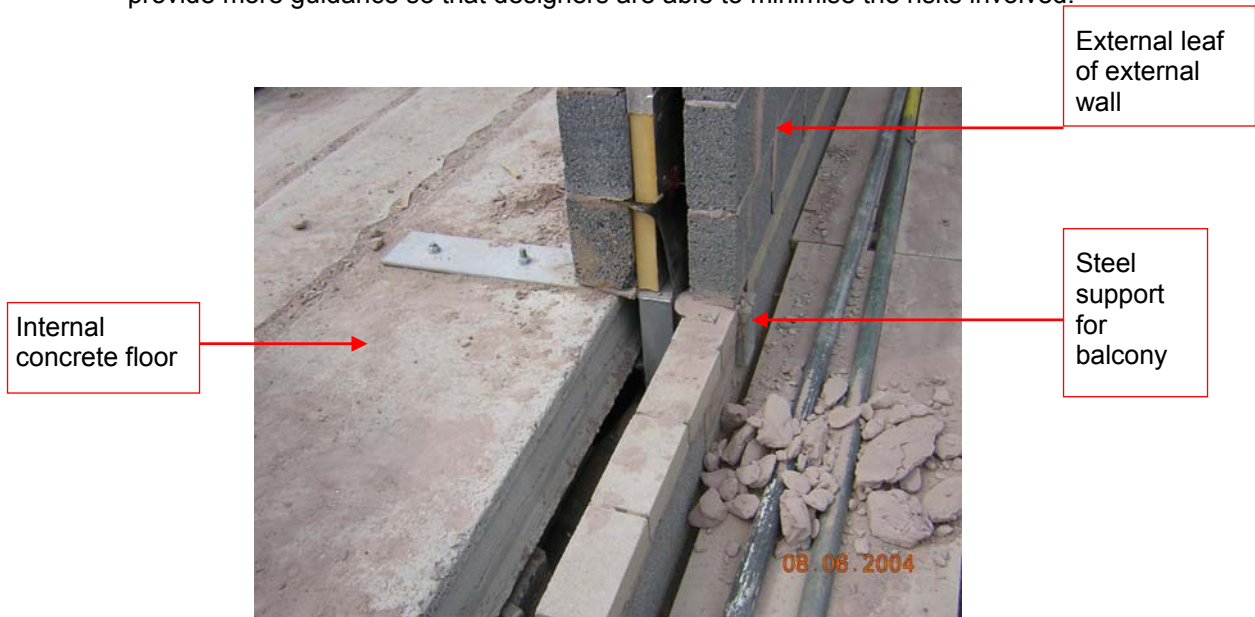
61. In general site observations indicated that a reasonable level of care had been taken to minimise the bridging problems created by through fixings. However for structural reasons fixings for two types of balcony consisted of substantial steel sections that penetrate the insulation layer. Figures 3.33 and 3.34 show some of the fixings used on a partial-fill masonry site and a timber frame site respectively. Although it is not within the remit of this project to carry out the detailed three dimensional analysis that would be required to understand the impact of such fixings, revisions to Robust Details should provide more guidance so that designers are able to minimise the risks involved.

Figure 3.33 Balcony support through partial-fill masonry construction.

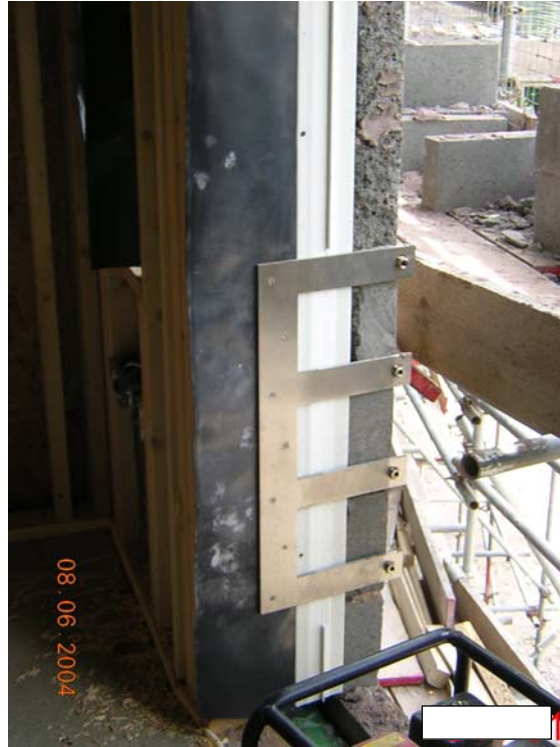
Figure 3.34 Balcony support through timber-frame construction.

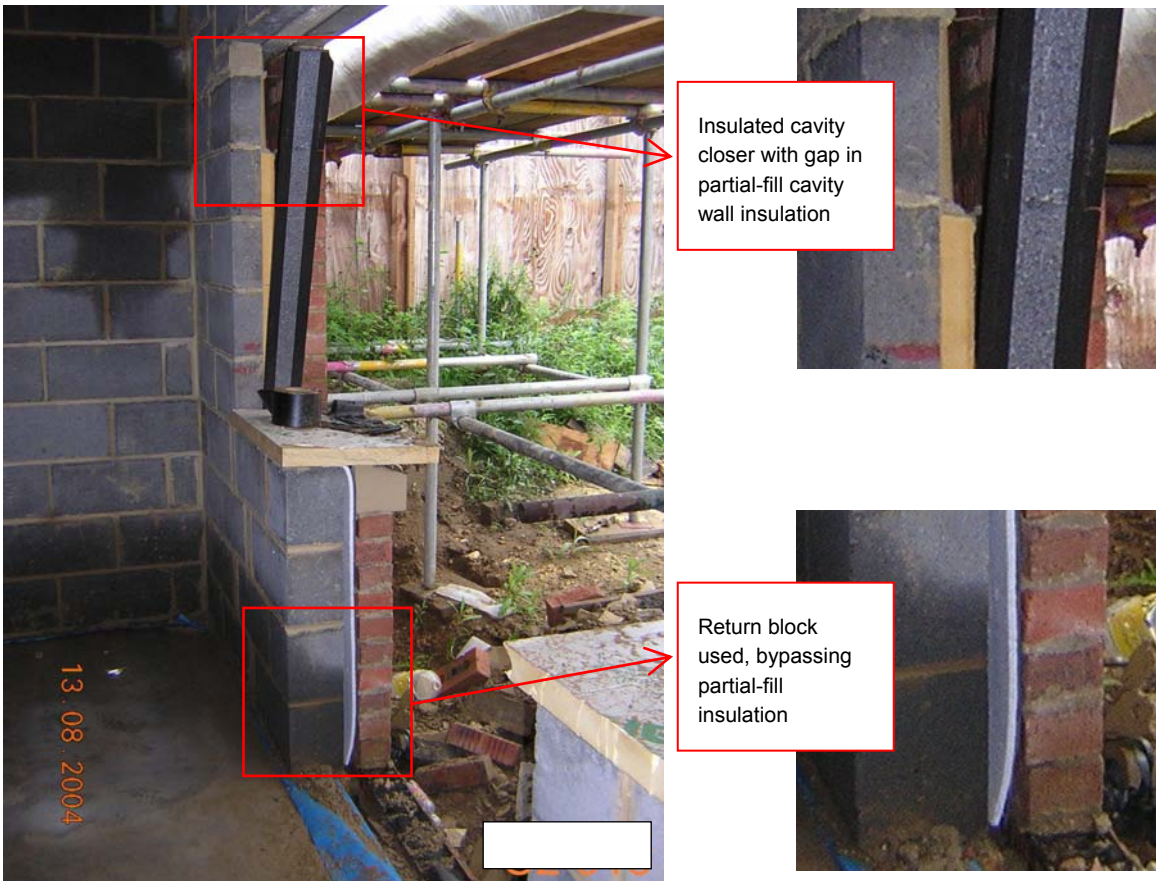
Figure 3.39 Inconsistencies in cavity closure detailing.

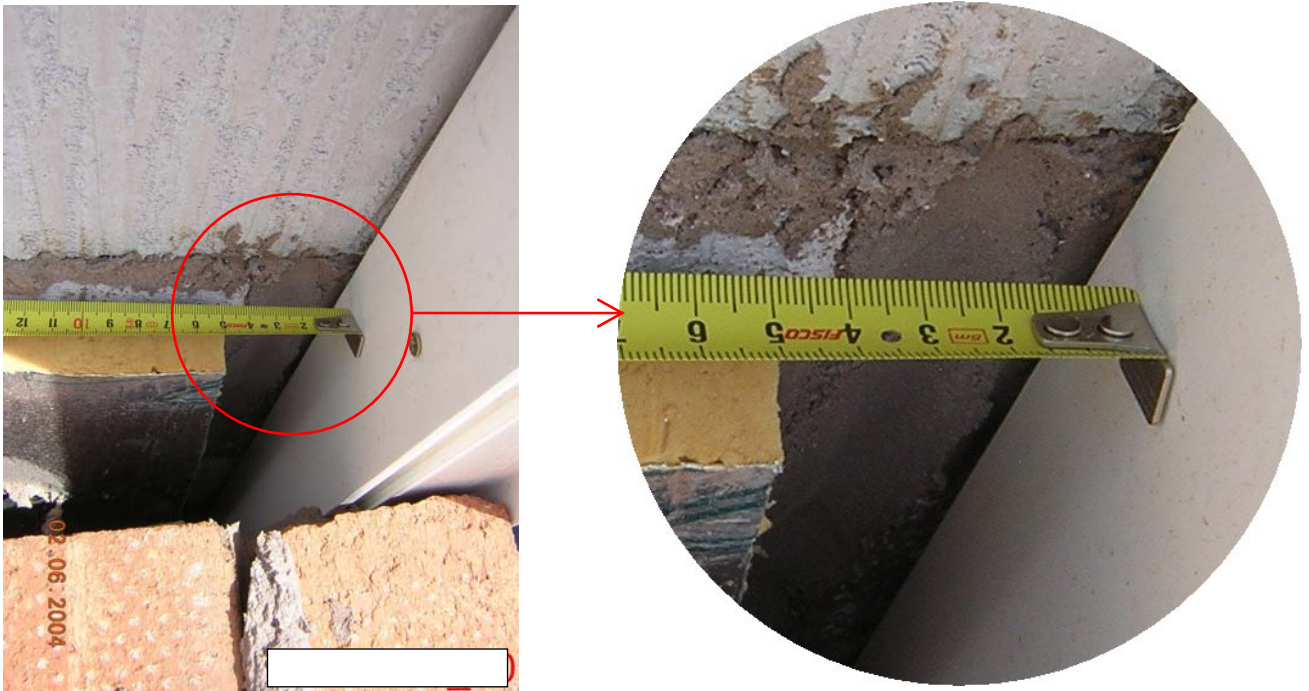
Figure 3.43 Up to 50mm of uninsulated area around jambs and reveals, causing potential thermal bridging problems.

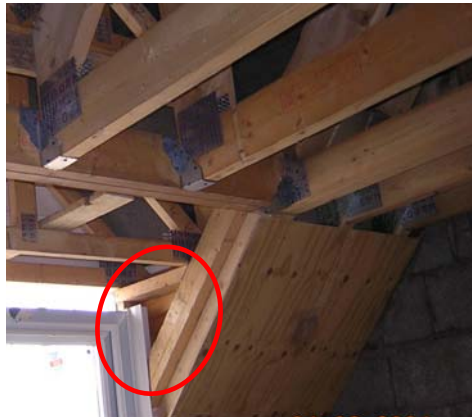
Figure 3.64 Small triangle of external wall difficult to fill with insulation.

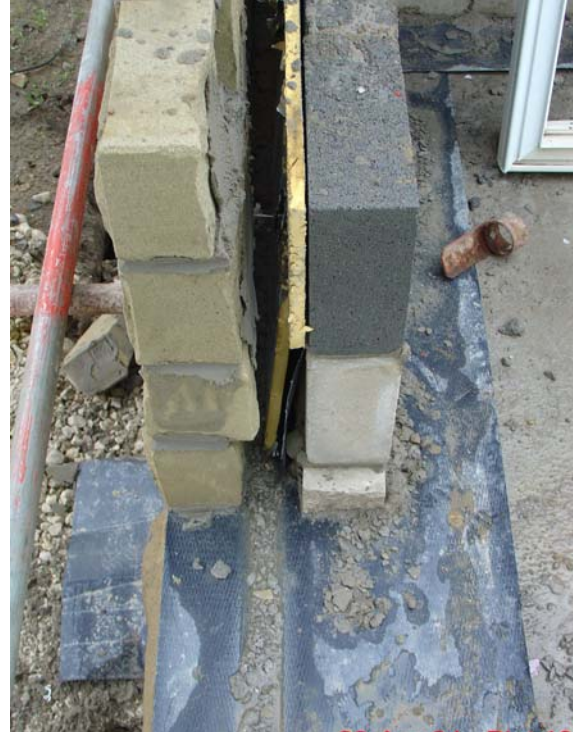
Figure 3.69 Partial fill insulation displaced by cavity tray resulting in gaps around insulation.

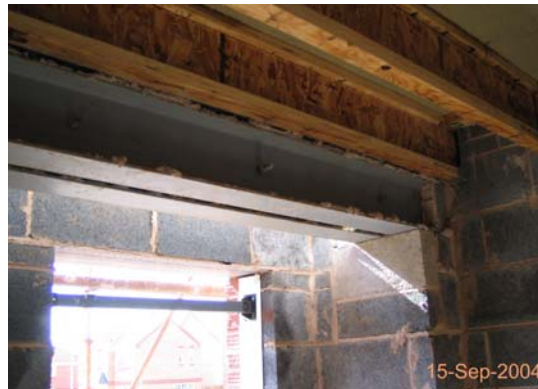
Figure 3.71 Steel work at large openings.

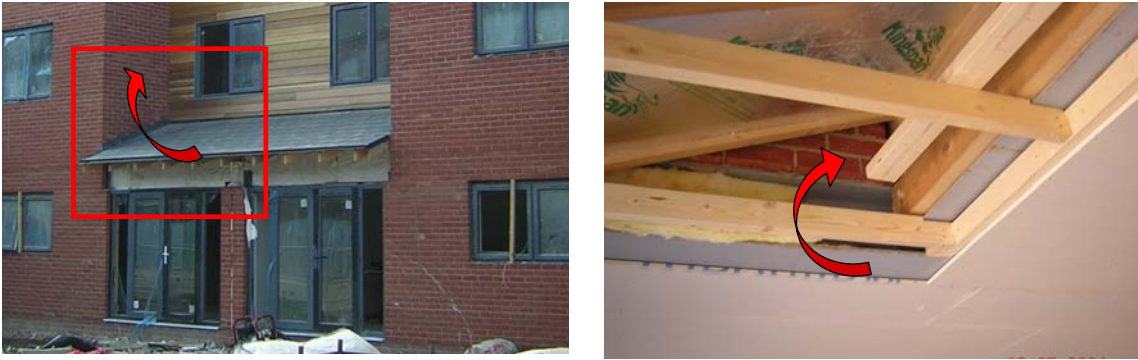
90. Figure 3.72 shows a different arrangement where the thermal bridge is, perhaps less obvious. In this case the ground floor “projection” fits between two flanking walls. However the flanking walls do not extend to the foundations but, in order to create a large unobstructed space below, they are supported by steel sections within the first floor void. The internal view of the construction in figure 3.73 shows the steel beam with some insulation between the flanges and the sloping roof with insulation at rafter level. Although this may seem like a reasonable detail, due to the fact that there is no insulation below and around the steel (as opposed to between the flanges) considerable heat loss would be expected into the brickwork above resulting in a relatively low surface temperature of the flange and increased condensation risk. Since steel has a very low thermal resistance the insulation between the flanges has almost no effect on heat flow or the surface temperature of the lower flange.

Figures 3.72 and 3.73 Thermal bridging through structural steel in first floor space.

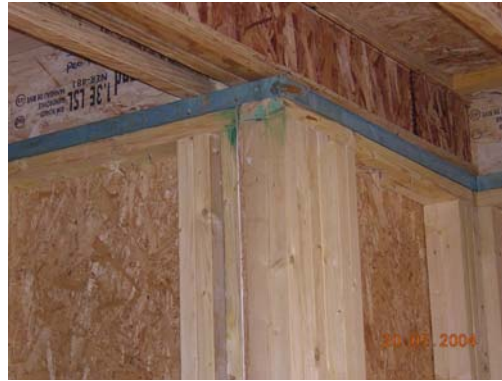
Figure 3.76 High timber concentration at corner post.

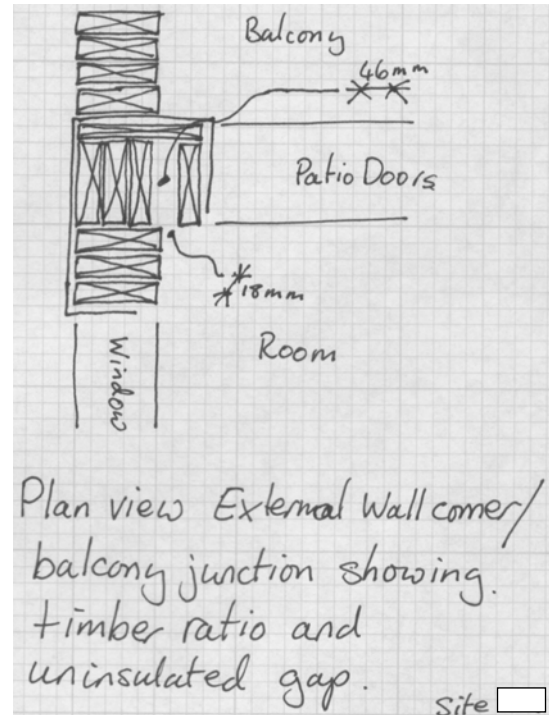
Figure 3.78 High timber concentration at opening to balcony.

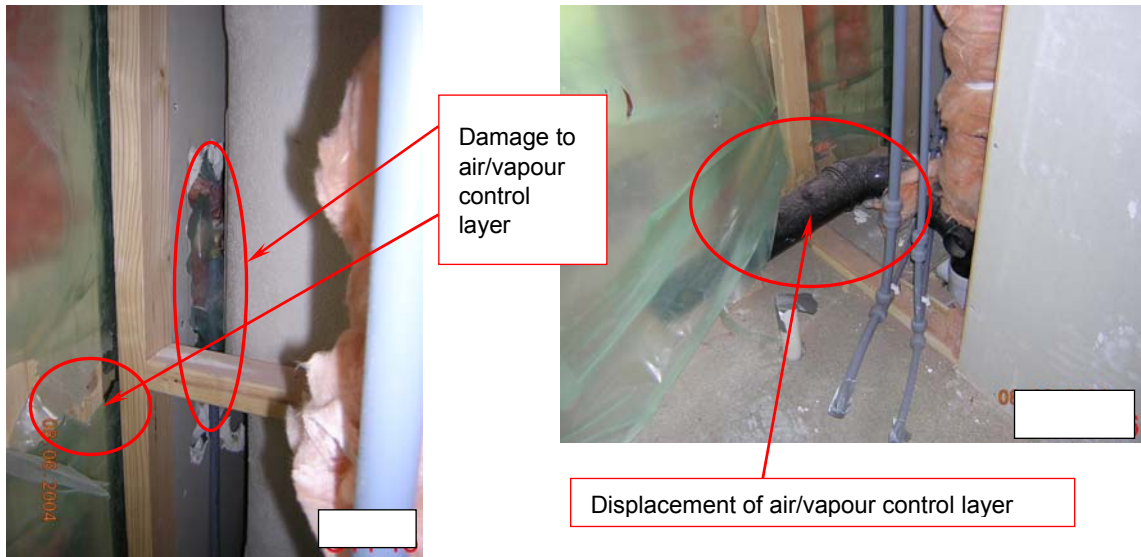
96. Areas where continuity of the air/vapour control layer is particularly vulnerable are behind baths, shower trays and kitchen units and in services voids. Figure 3.81 illustrates the construction of a services duct in a bathroom (timber frame dwelling) showing damage to the air/vapour control layer and internal lining to the services duct.

Figure 3.81 Damage to and displacement of the air/vapour control layer.

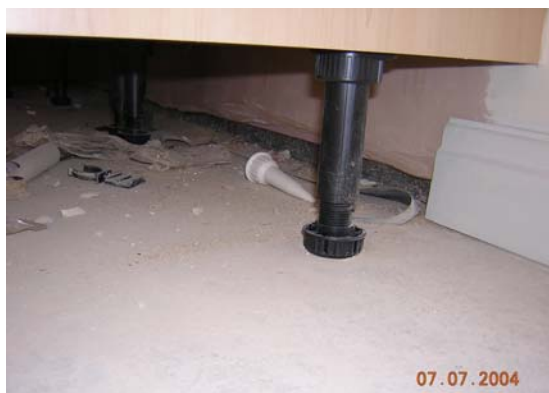
Figure 3.82 Plasterboard finish stopped short of the floor under kitchen fittings.

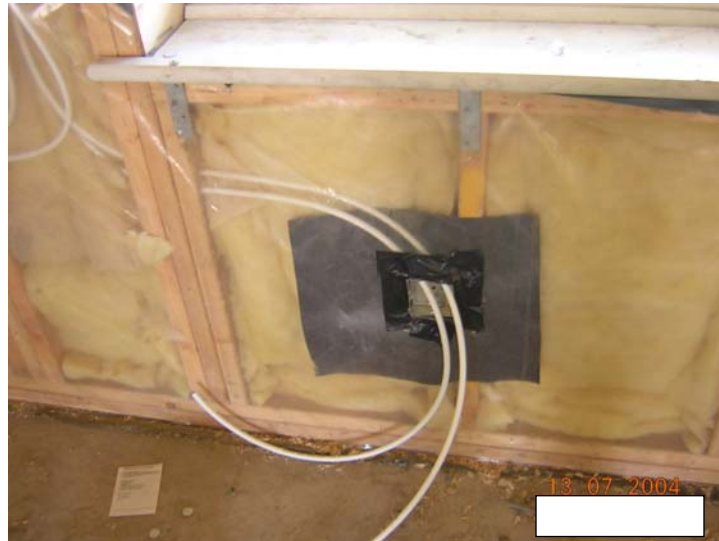
Figure 3.87 Air/vapour control layers not lapped to DPC¹.

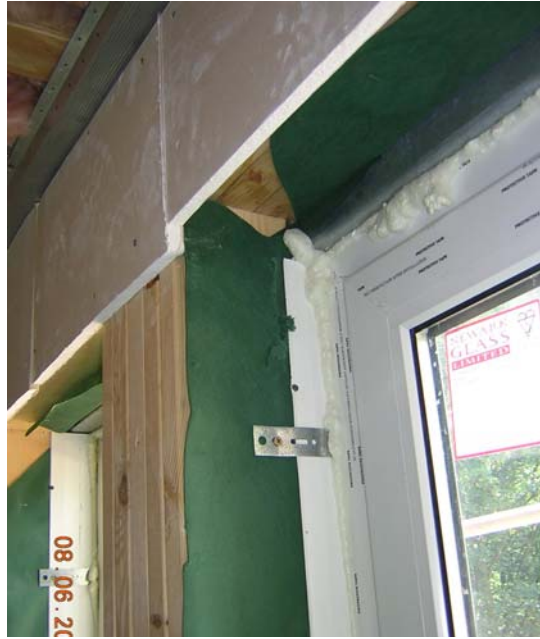
Figure 3.89 Air/vapour control layer not applied to studs – no evidence of layer across lintels and wrapping into head of opening.

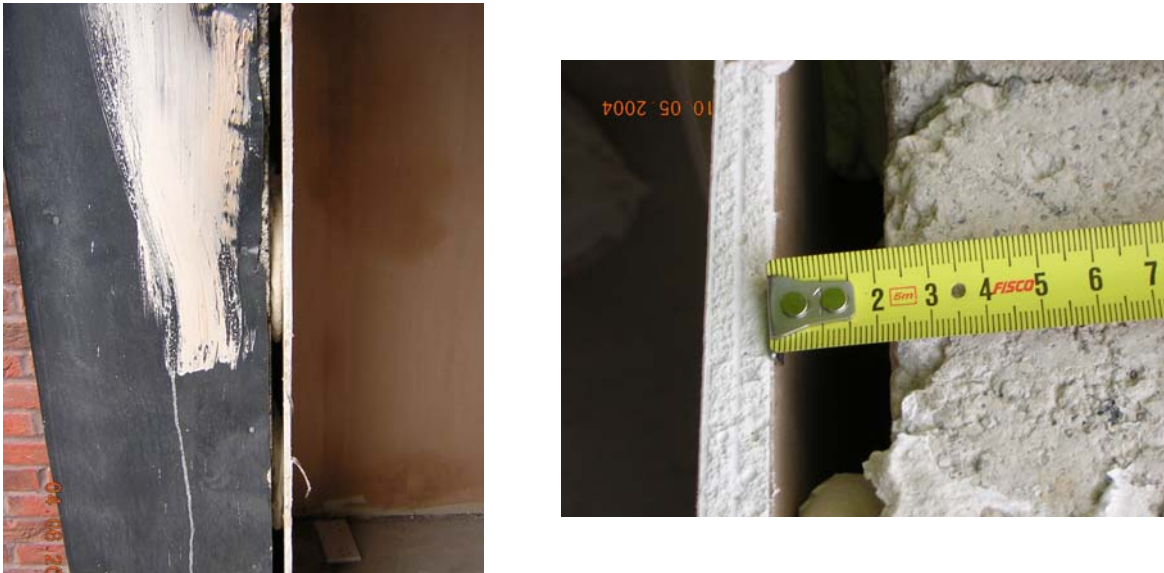
Figure 3.91 Lack of continuity of plaster adhesive to plasterboard lining.

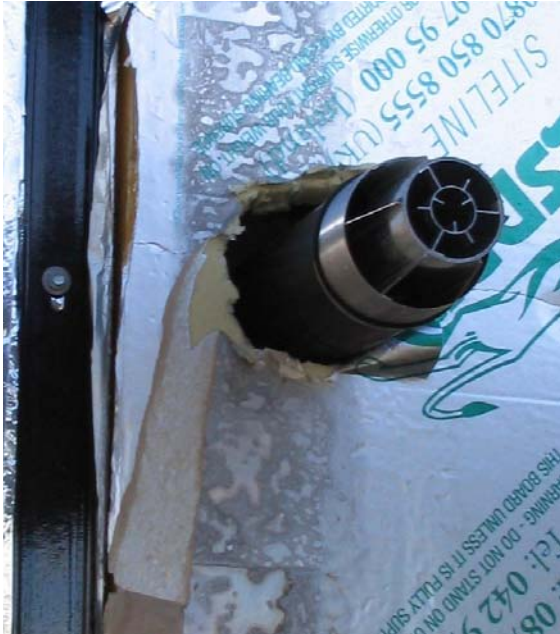
Figure 3.94 Penetration through the insulation/vapour layers in light steel frame construction.
