A Study of
Spliced Wooden Tie-Beams

JOHN C. GUSTAFSON

Thesis for the Degree of
Architectural Engineer

PRESENTED, JUNE, 1906

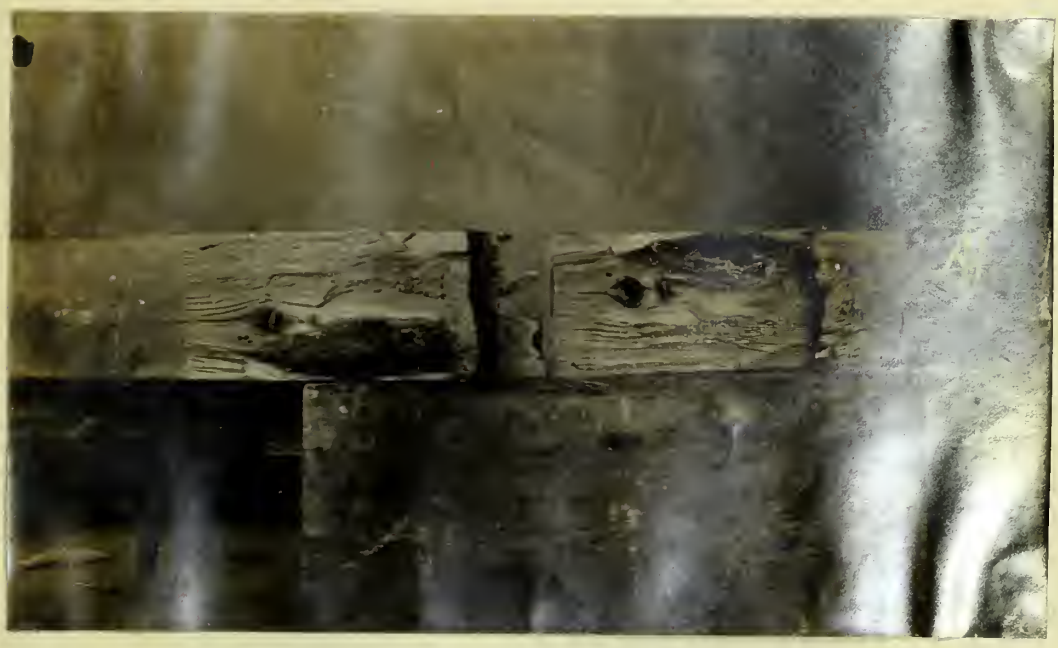
This piece was a good stick of timber with but few knots, these all at one end, as clearly shown in the picture.

The failure was due to longitudinal shear, on one side only. It started at the shoulder and extended toward the connection until stopped by a knot, where it broke across in tension. The sheared surface shows that there was a defect in the interior of the wood, namely a place about ten inches long containing dry resin, which separated the wood fibers, and thus greatly aided the piece to shear at this point.

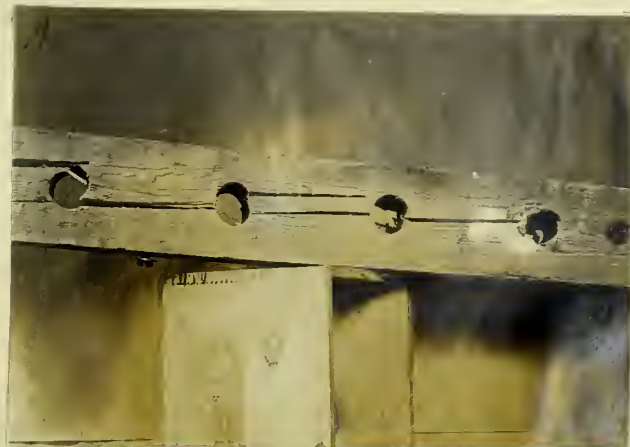
Joint A 2.

This is the same as joint A 1, namely a solid tension piece without splice, reduced in section to 5-5/8" x 3-5/8", with a net area of 20.4 sq.in. Season checks extended the full length of the piece on the 3-5/8" face; these season checks were not large ones, nevertheless, in order to reduce the tendency to shear along the line of pins, three half-inch bolts were inserted, one between the last two 2" pins, one between the third and fourth 2" pins, and one between the first two 1-1/2" pins. There were no knots of such size or character as to be harmful. Dry rot existed in the lower half of the timber, and well up into the reduced section. It may be noted that the carpenter, in looking over the lumber before making the test pieces, considered this stick the best in the entire pile; there was no indication of defect on the outside, and it was only when the piece had been cut into that dry rot was revealed.

Failure took place in the lower connection, it shearing out along the line of pins, and extending to the shoulder of the reduced section. The shear, within the connection, followed the season checks. There is no doubt that the piece would have stood the test considerably better had there been no dry rot.

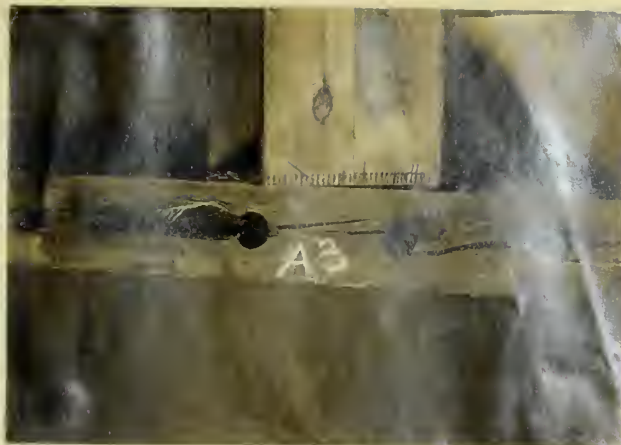
Joint A 3.

Similar in design to the two preceding. There were two knots in the reduced section, one at each end, about five inches from the shoulder. In the lower connection there was a large knot at the third large pin and also a smaller one at the second large pin. At these places there was some cross grain. Season checks extended the full length of the piece on the 5-5/8" face.

Failure took place in the lower connection, because of shear along the line of pins. The manner of failure was peculiar. The piece sheared off between the last two inch pin, and the end; this failure was followed by a loud report, and immediately the wood sheared along the line of the remaining pins. As in the previous case 1/2" bolts were inserted in the connections.

An examination of the ruptured end, revealed dry rot in the interior of the piece along the neutral axis. Between the first and second 2" pins the wood was so badly rotted as to leave a cavity fully 2" in diameter. The dry rot extended well down in to the 1-1/2 inch hole and up toward the next 2" hole. It was evidently caused by a small hole in the knot at this place. A similar, although not so serious a defect, was found in the other end of the timber also caused by the presence of a small hollow knot. The holes in these knots were very small, and were discovered only after careful examination.

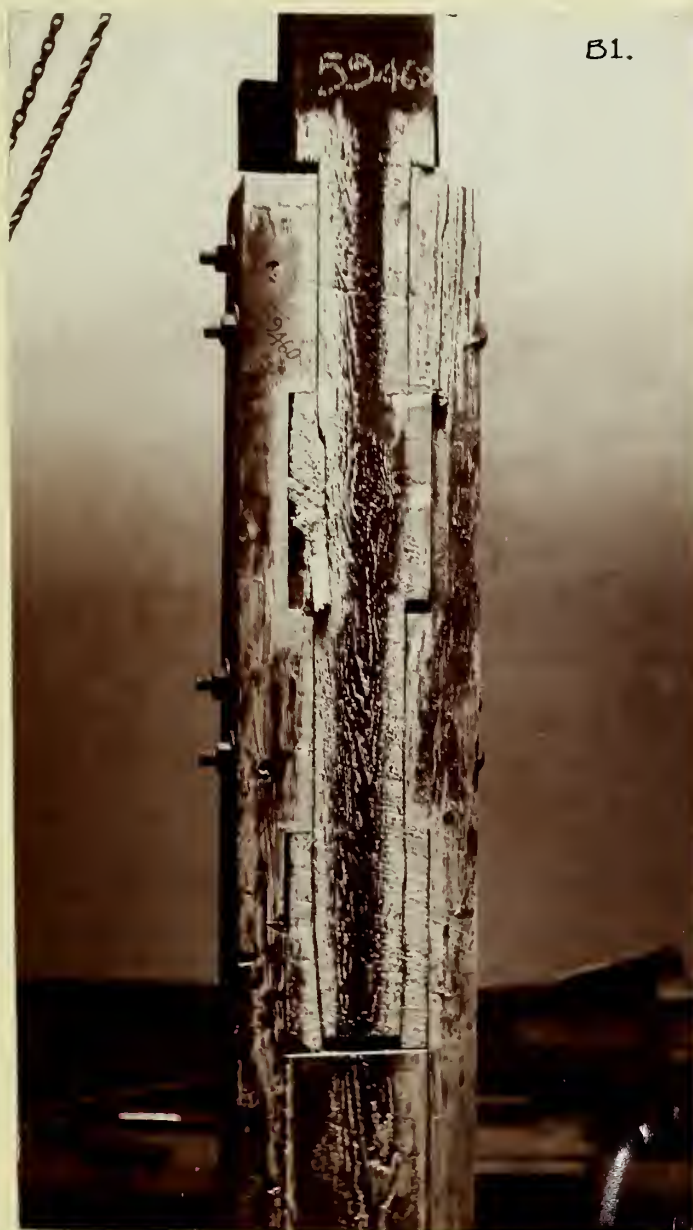
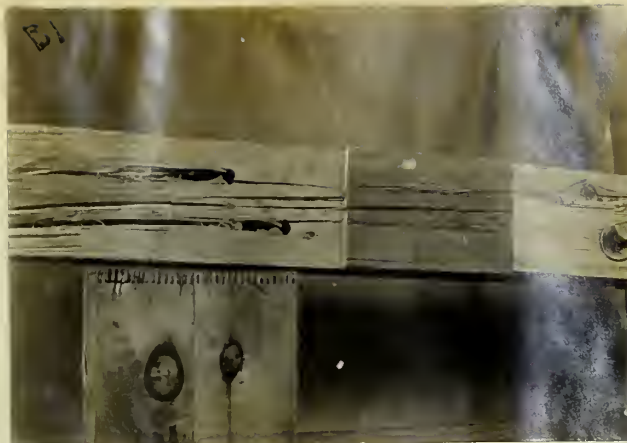
Joint B 1.

This piece was of good sound material, having a few slight season checks, but not of such a character as seriously to lessen the strength of the stick. There were no knots in the lower half; there was a bad one in the upper half about twenty inches above the joint. The splice pieces were in excellent condition.

The lower half of the splice shows very little effect of the stress to which it was subjected, other than a few cracks at the shoulders, showing that there was a tendency to shear along the plane from shoulder to shoulder.

Failure took place in the upper half of the splice, due to shear of the shoulders on the north splice piece and the timber. These having sheared the shoulder of the stick, directly opposite sheared also. There was a great amount of bearing against the shoulders.

The bolts in the splice were badly bent, showing that, although not calculated to carry any of the stress, they were subject to considerable of it. It is most likely that the greater part of this bending was caused after failure due to shear had

begun. So badly were these bolts bent that the cut washers were pulled into the wood, crushing and splitting the ends of the splice-plates. The shear followed the grain of the wood, and presents a clean even cut.

The fibers in front of the bolts were badly injured, and presented a wedge like appearance. This wedge action of the fibers is greatly marked and undoubtedly accounts for the condition of the splice, the fibers of which were twisted, torn and, as may be seen in the cut, curled back upon each other.

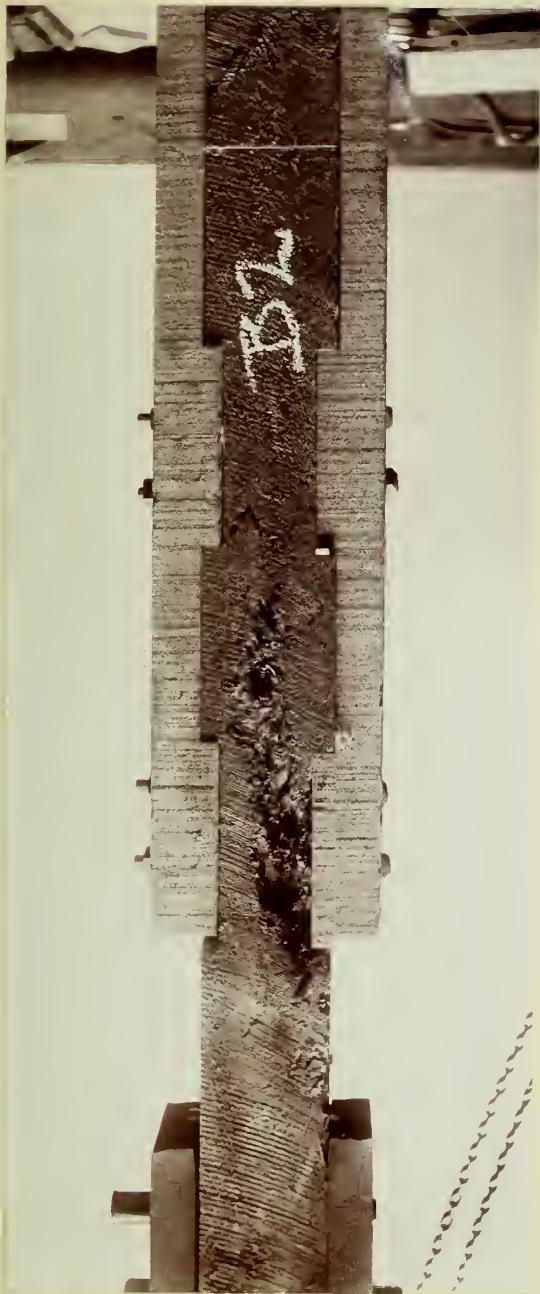
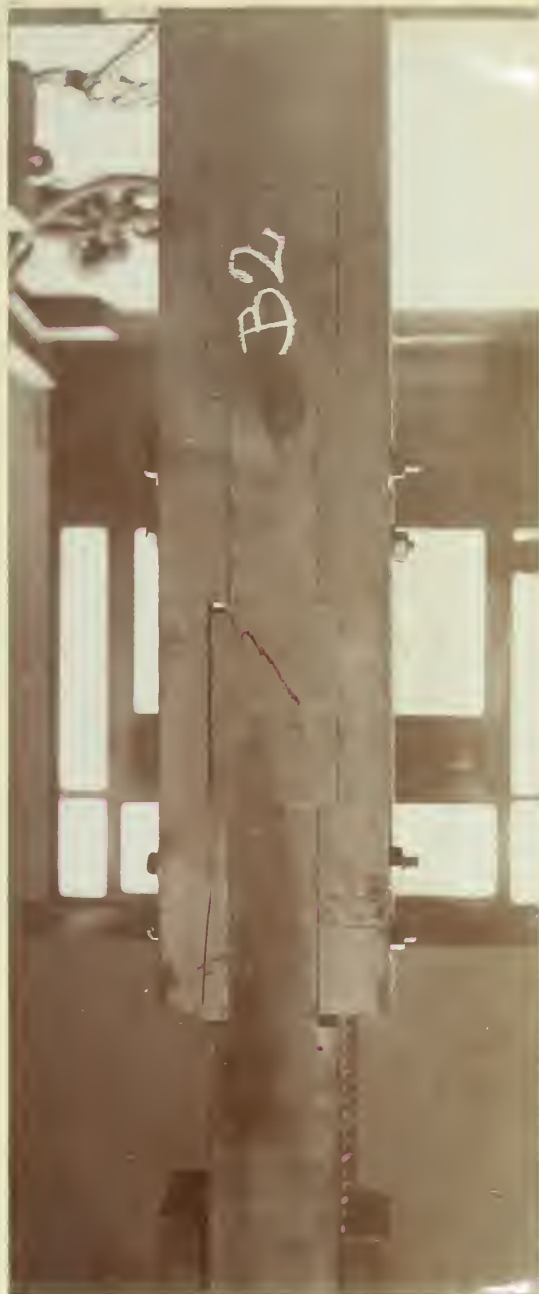
Joint B 2.

The condition of this piece maybe best understood by a glance at the picture, which shows a bad defect in the upper half, varying in depth from $1/4$ to $3/4$ of an inch, 3" wide, about 12" long, and filled with dry resin. In addition to this defect there is a long oval knot about $2-1/2$ x $1-1/2$ inches diameter, $8-1/2$ " above the joint, but extending partially through the stick. The splice pieces are of good clear material, of straight grain, and with but a few small knots.

Failure took place in the upper half of the splice due to shear and tension. The first failure took place in the upper shoulder of the south splice piece, this shearing off completely; then shear began at the lower end of the top shoulder of the stick itself, extended for a few inches, then broke across in tension on a 45 degree line, and finally sheared off on the upper end of the opposite shoulder. The appearance of the fracture is rough and jogged. See picture.

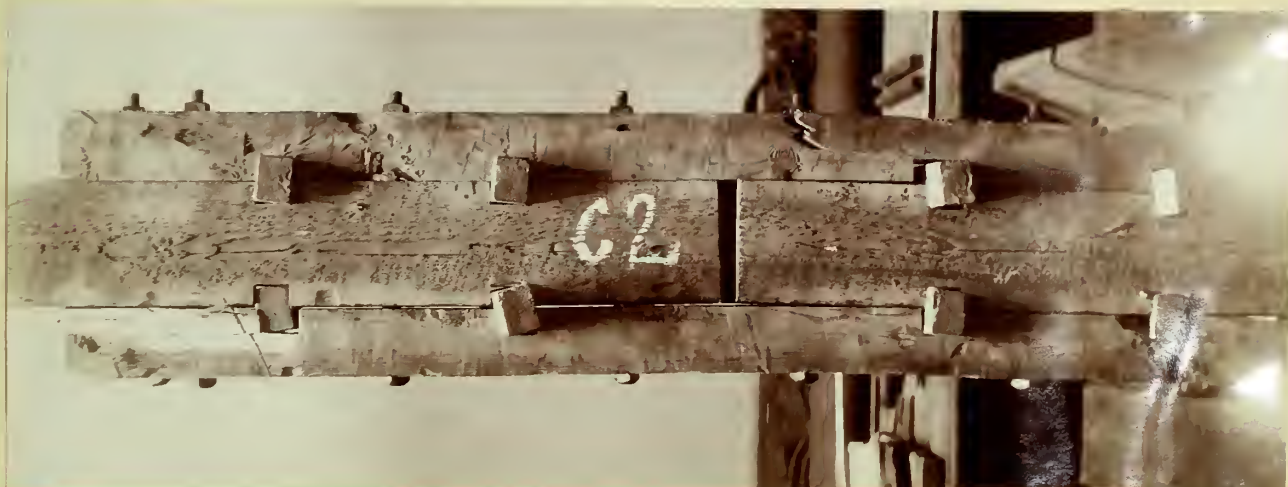
Joint C 2.

In this the stick itself was in good condition, having but a few season checks, and only one small knot in the lower

half of the splice, just below the lowest key on the south side. The splice pieces were not of proper material; a glance at the picture will show the defects.

Failure in this case was due to shearing of the shoulders on the splice plate. The first failure took place by the shearing off of the top shoulder on the south plate. This plate showed signs of weakness under a load of 10000lbs. when it was noticed that a crack started at the key directly below the joint. It was not until under a load of 49000 lbs. that failure of the north splice plate was noticed, when it sheared at the key below the joint, then broke in tension at the first bolt below the joint. At 35000 lbs. there were continued cracking sounds, and bending of the test piece toward the north; the splice plates also drew away from the timber at both ends. The keys began to rotate as early as 10000lbs., which rotating in this case was exceedingly great, consequently there was considerable crushing of the fibers at the sides and edges of the holes. It may be noted that the two upper keys on the south side, and the two lower keys on the north side rotated the most, the rotation of both pairs being about equal; comparatively little rotation took place on the other two sets of keys.

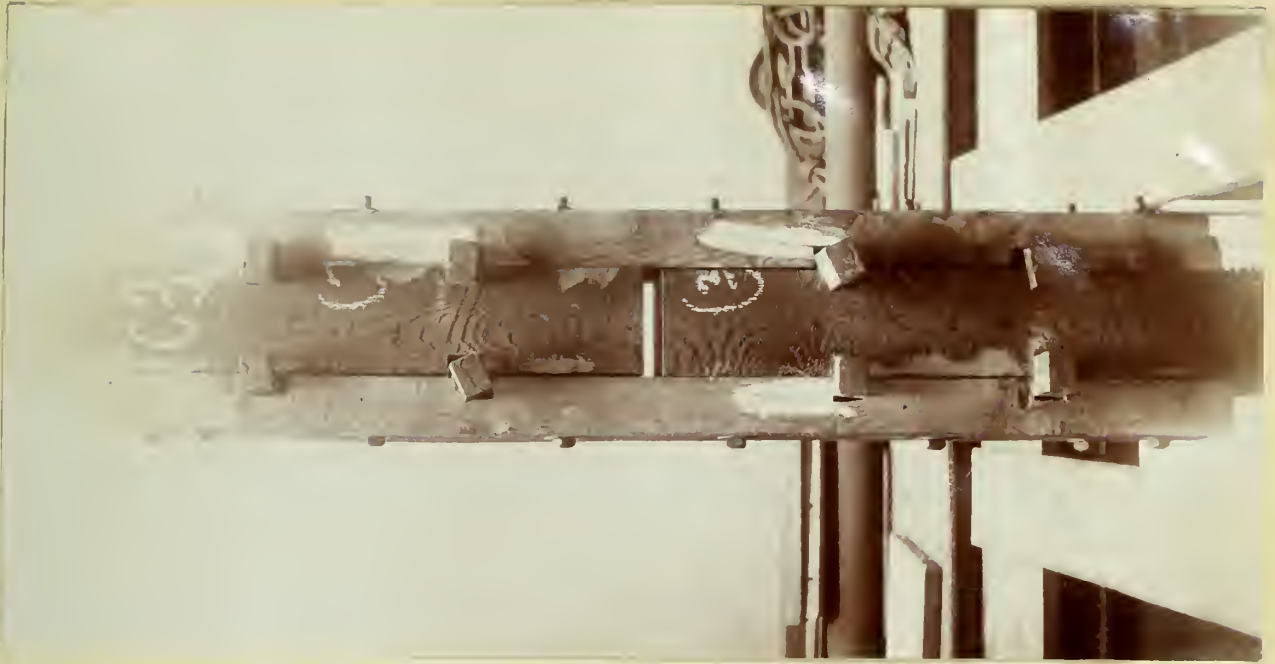
Contained some slight season checks in the lower half, and a small knot at the lower key. The upper half of the stick was in fair condition, there being only a few small, sound knots.

The failure was due to shear and to rotating of the keys. Shear took place at the lower shoulder of the north, and also at the upper shoulder of the south splice plate. At the other shoulder cracks appeared. The shear planes, instead of being clear and clean cut as in the previous cases, were rough and uneven, due probably to the presence of the bolts. The end bolts were bent considerably; the washers were crushed into the splice plates so badly as to split them to the end. The keys rotated badly; and again those keys in the lower north, and the upper south sides show the worse condition; the holes were badly distorted and out of line, while the remaining four were in fair condition.

This piece also bent; but toward the south instead of the north, as in Joint C2; this bending was noted at about 50000lbs. The rotating of the keys was first noted at 10000lbs. Because of this rotating of the keys the splice plates were pushed away from the main member fully $1/8$ of an inch. The joint was opened to $15/16$ of an inch, and so remained.

Showing condition of keys at end of test.

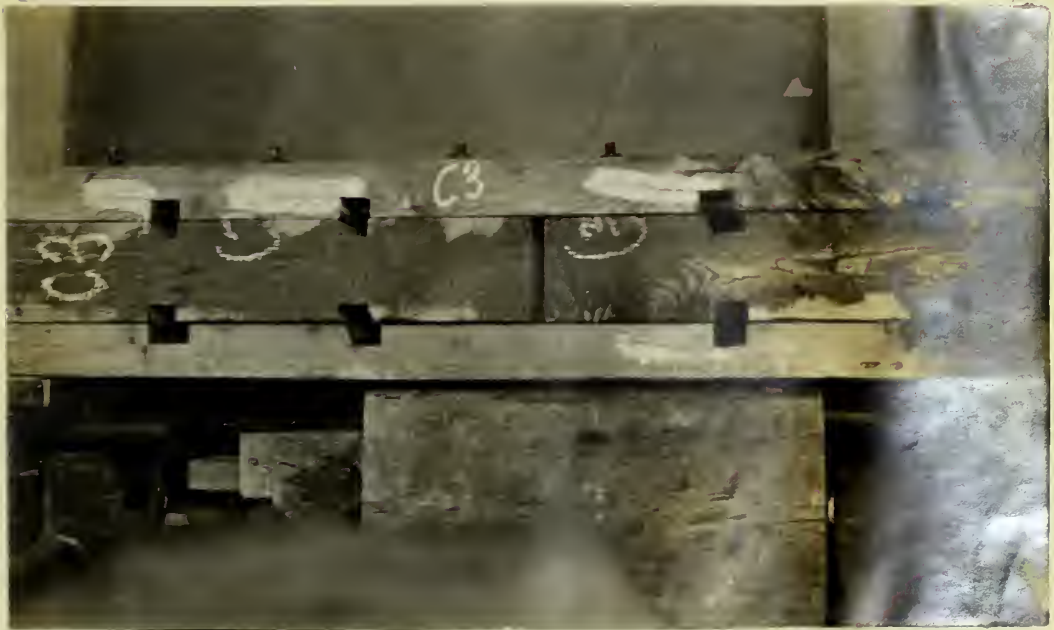
Showing condition of holes. Keys removed.

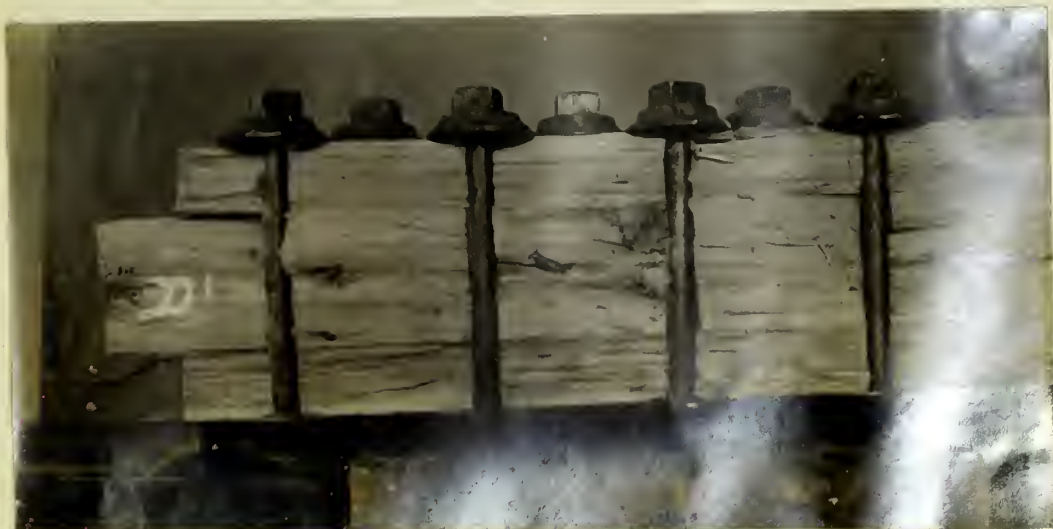
The piece failed in tension at the first bolt from the end of the splice piece, the failure occurring in the 6x6. The fracture revealed dry rot in the main member, which rot existed at the point of fracture and for some six or eight inches up into the timber.

The motion of the extensometer was, for the most part, unsteady, at first moving slowly and evenly, then increasing in motion uneven and irregular. The bolts showed signs of bending at 40000lbs., as evidenced by the appearance of the bolt heads against the washers. An examination of the bolts after the test, showed them to be but slightly bent; it also showed that the greatest bending occurred at the bolt nearest the end of the splice, the bending decreasing toward the joint.

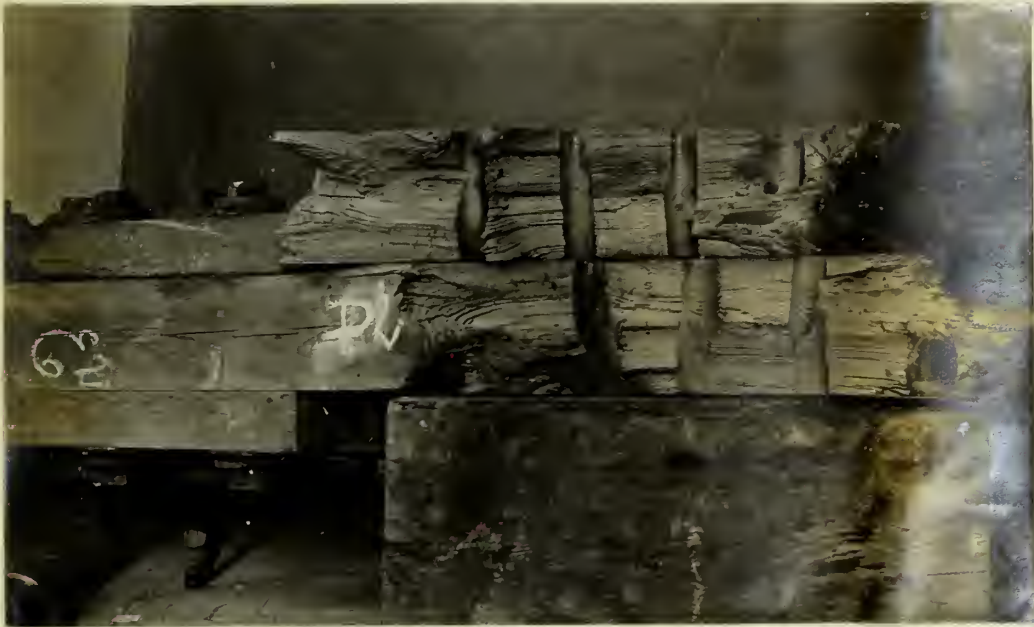
Joint D 2.

This piece, in the lower half, was a fairly good stick; in the upper half, there was a large knot a few inches below the first small pin, and also another large had knot above the first 2" pin. At these knots there was considerable cross-grain. The piece was also badly season checked, as were also the splice plates.

The failure occurred at the knot near the first pin in the top connection, breaking there, and then shearing along the line of pins to the knot at the first 2" pin, where it broke in tension. The piece further failed by shear along the pins in the lower connection.

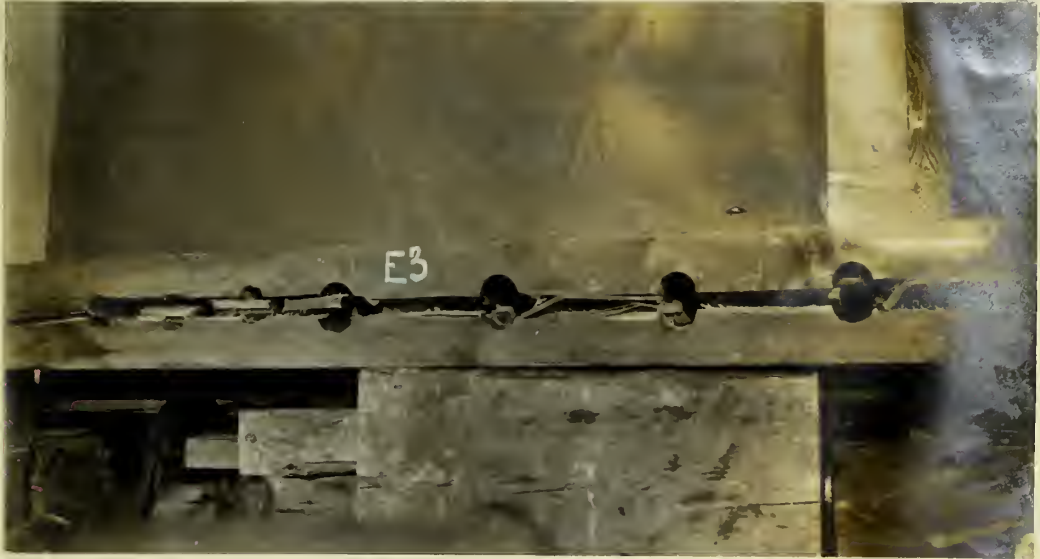
This stick was of good material, but slightly season checked, and with but few small sound knots. It failed in the lower connection, due to shear and bearing, and the pins pulling out through the timber. The fractured end shows uneven bearing of

the pins against the wood, one side of the holes being badly crushed, the other showing only small signs of crushing. The wedge like action spoken of above, is very marked; the fibers are twisted, torn, and curled back one upon another. The three half-inch bolts, put in the connection to strengthen it against shear, were badly bent; the washers were pulled into the sides of the piece causing cracks to open at those places.

D 3, incorrectly marked E 3, showing condition of failure.

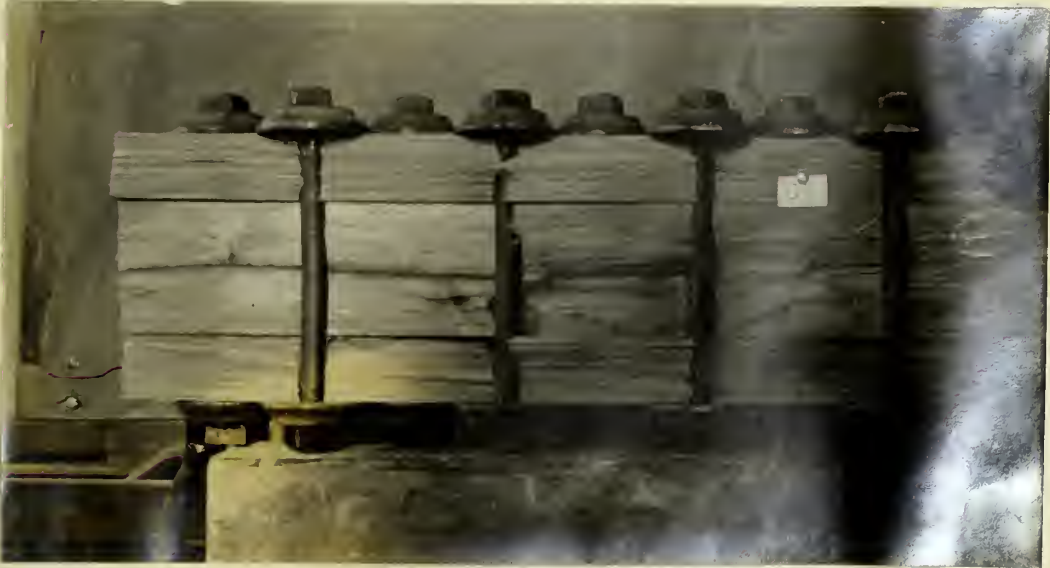
The above picture shows the condition of the bolts after the test.

As seen the bolts are slightly bent, even more than in the preceding tests; it also shows, that the greatest bending was at the bolt nearest the joint; and that maximum bending occurred in the center of the 6x6.

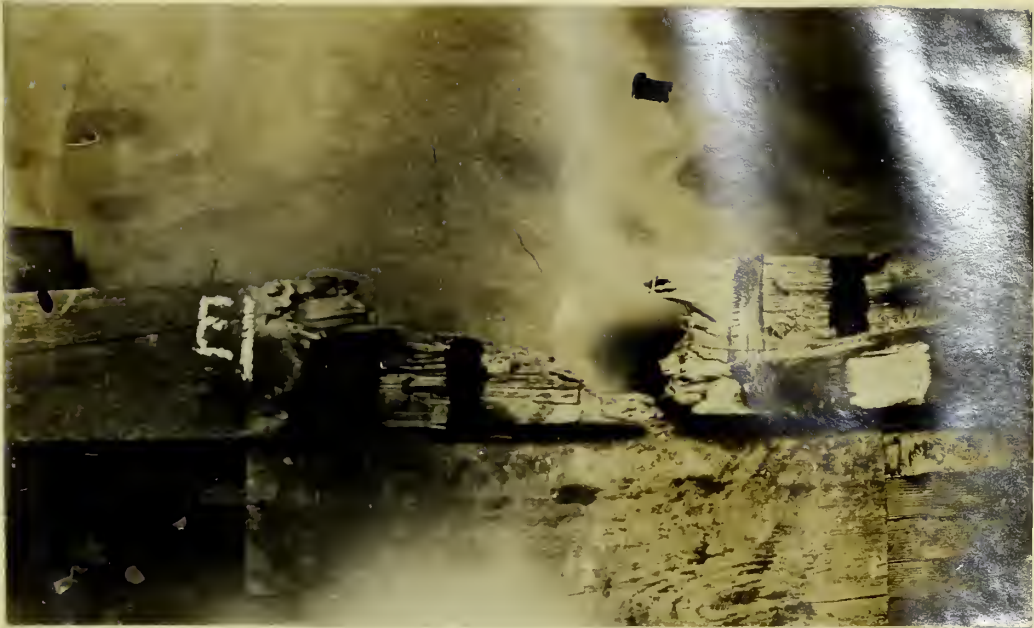
Failure was caused by the piece breaking at the two large knots below the splice plates; and then shearing along the line of pins to the knot in the connection, and breaking off completely at this point.

The indicator moved very slowly and steadily at first readings, but soon began to move more rapidly, with sudden jumps and jerks. The sounds were peculiar, and were as if the threads on the lagscrew tended to pull out of their places and take a new hold on the wood. The lagscrews are bent but little, such bending taking place at about the neutral axis of the piece. They appear to have tilted slightly away from the joint.

E 1 Showing condition of failure.

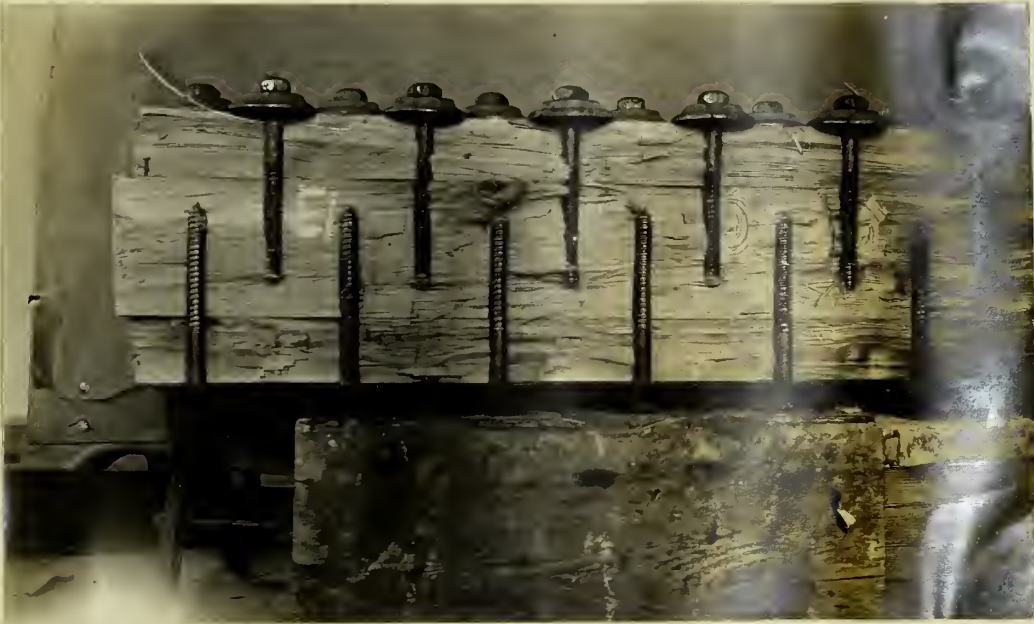
E 1 Showing condition of lagscrews after failure.

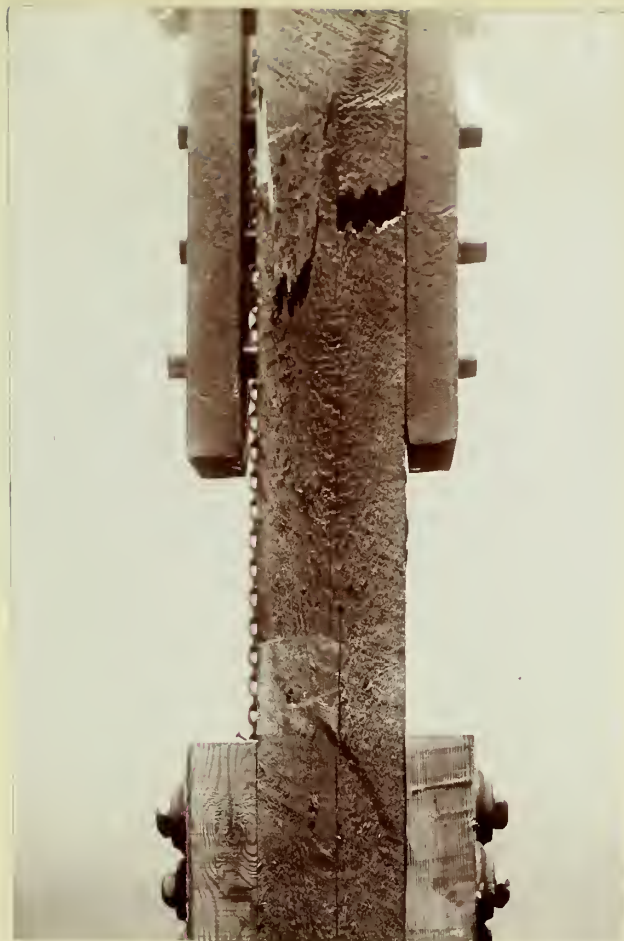
This was a fairly good piece of wood, containing only a few knots, as shown in the cut. The piece failed in the upper connection at the first small pin, then shearing between the first and second small pins, broke at the second, and finally sheared along the annular rings to the joint. The failure is best seen by the examination of the cuts.

E 3. Showing failure of test piece.

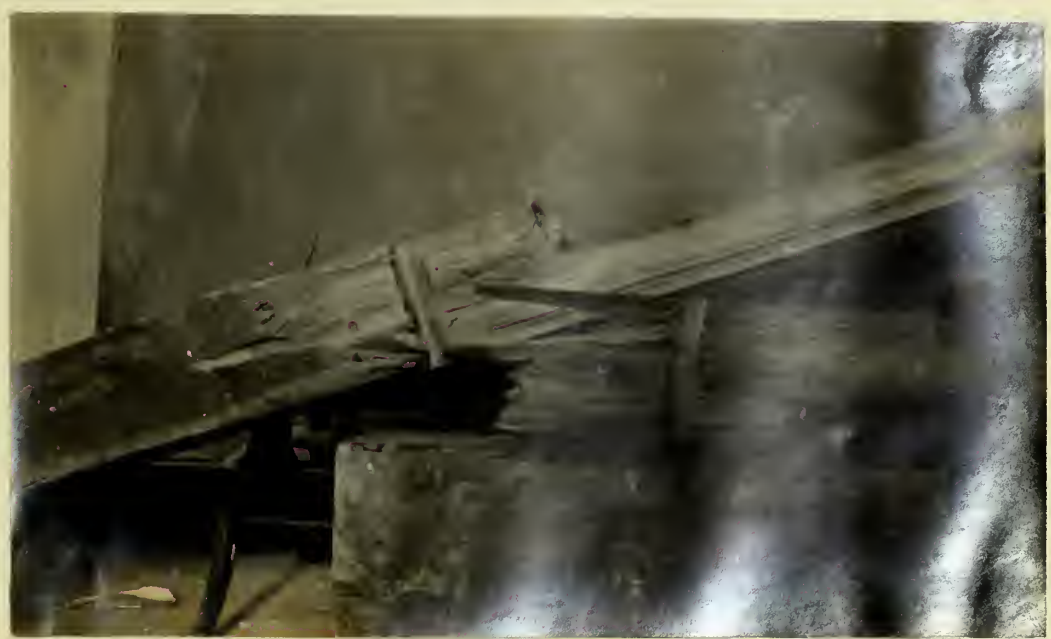
E 3. Showing character of failure.

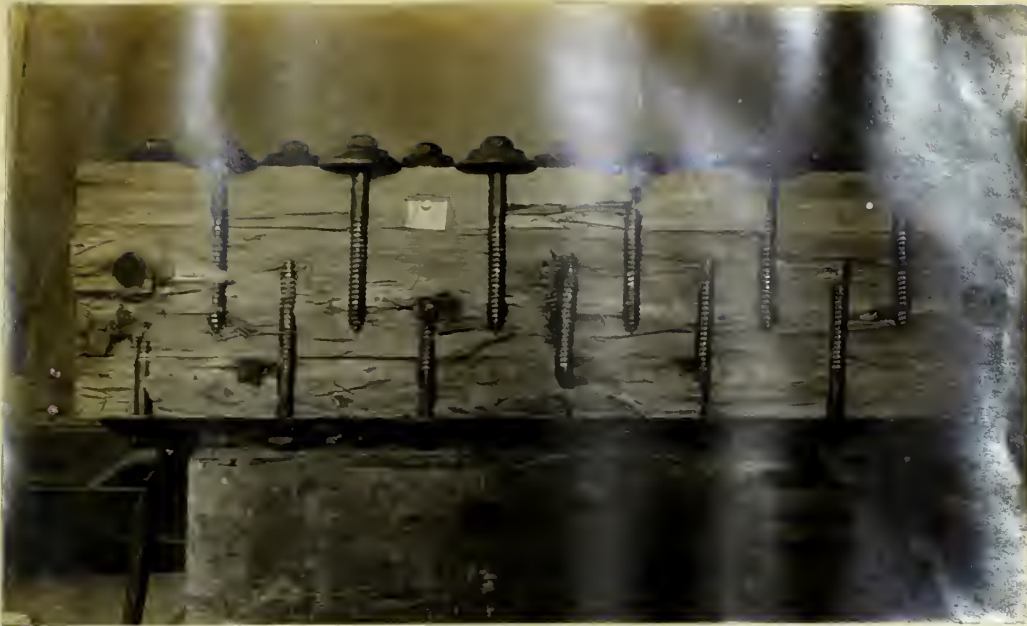
The appearance of the lagscrews after failure is the same as in the two preceding tests.

E 3. Showing condition of lagscrews after failure.

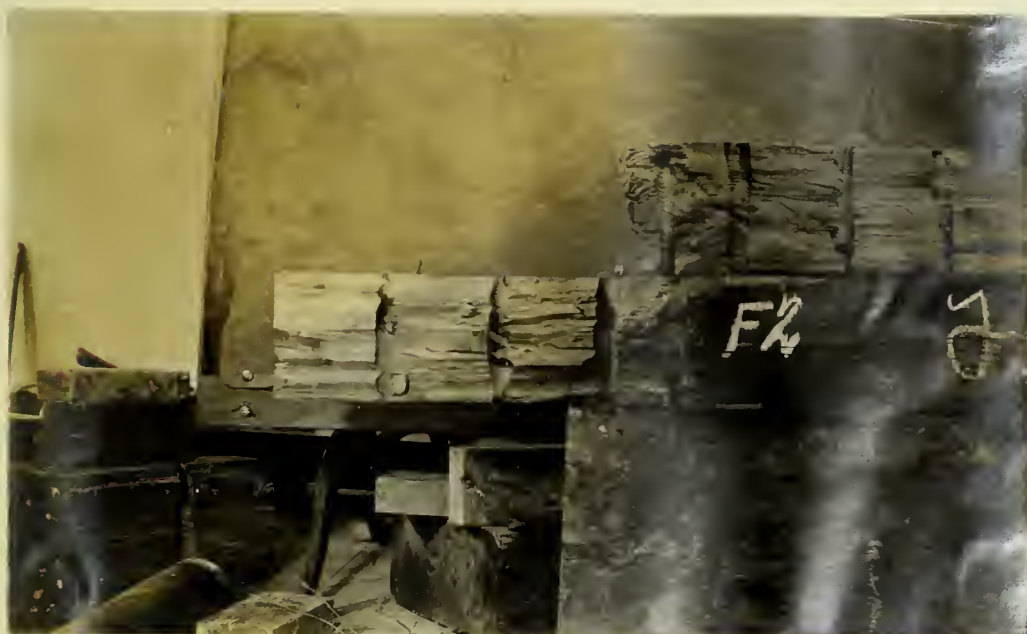
The upper half of piece contained a large oval knot 3 x 1-1/2 inches in diameter, just above the last bolt in the splice, which knot diminished on the opposite side to 1/2 inch in diameter. In other respects the stick was a good one.

It failed in tension at this last bolt, and then sheared along the bolts to the joint. The sheared surface is not clean and smooth, but rough and uneven, as if both shear and tension were acting at the same time. There was considerable bearing of the bolts against the wood, as evidenced by the distorted appearance of the holes, in both the fractured section and in the lower half of the splice.

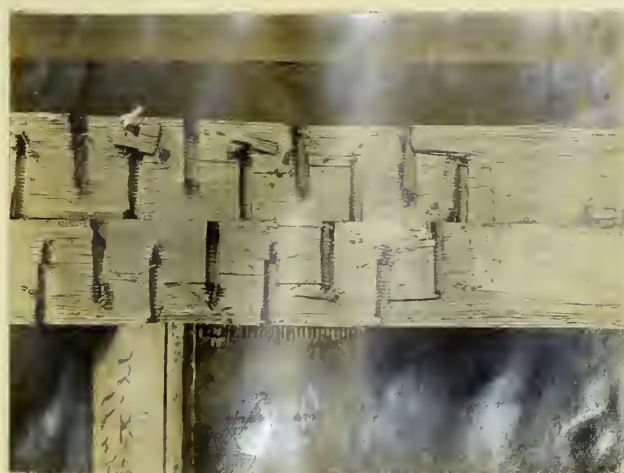
Joint G 1.

This was a good clean stick, with few defects, namely a small knot 10 inches below the first pin in the upper connection. It contained some slight season checks and cross-grain.

It failed by shear along the line of lagscrews to a knot where it broke in tension on the opposite side. The shear surface was quite fibrous, and showed the wedging of the fibers when any obstacle, such as a bolt or lagscrew, interferes with the shearing.

The cut shows the condition of the fracture.

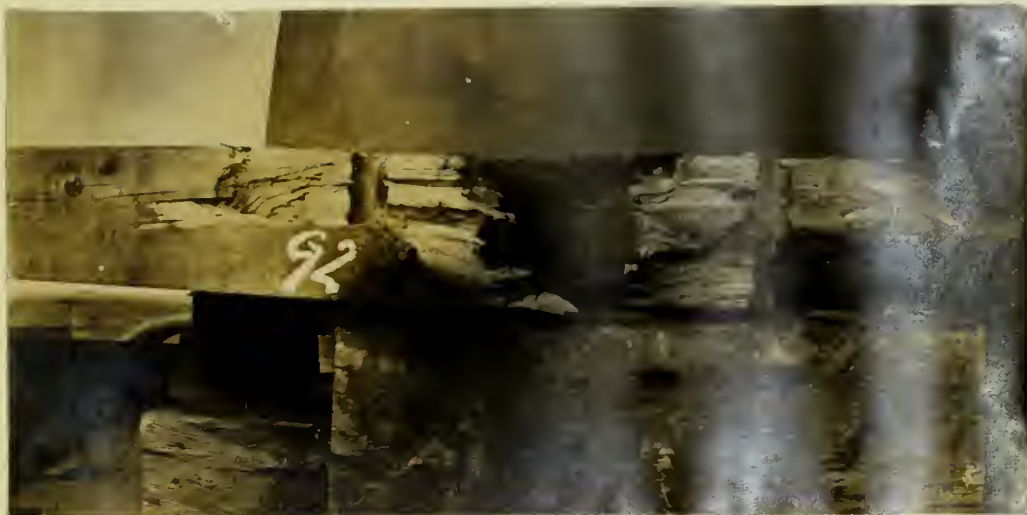
Joint G 2.

This piece broke in the connection, breaking in tension between the first and second small pins. There were two knots above the pin at which the failure first began.

There was evidently considerable crushing of the screws against the wood, the holes being distorted into a slight oval, the long diameter being $\frac{3}{32}$ to $\frac{1}{8}$ of an inch longer than originally. Slight cracks also appeared along the line of lagscrews.

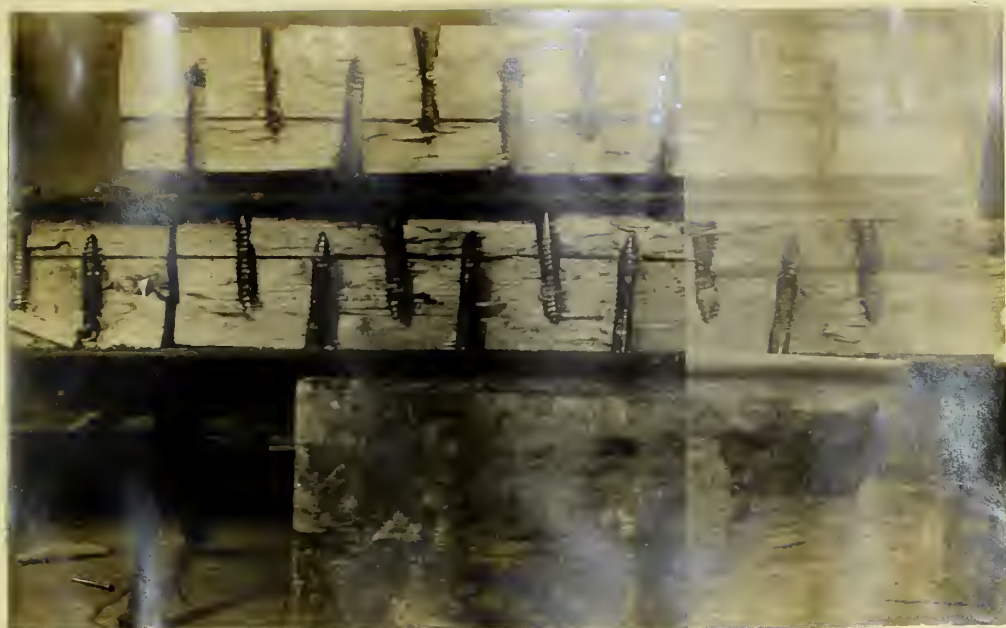
Joint G 3.

Was a good clear stick, with few knots and little cross grain. It failed in the splice due to the shearing out of the wood in front of the lagscrews in the lower half. The lagscrews bent considerably at the plate, but within the wood were straight and pulled over diagonally. They crushed considerably against the wood as may be seen by the cut.
