TABLE
BAD RIVER TRIP REPORT
Assessment of Mold and Moisture Conditions

Date:
December 31, 2002

Prepared for:
U.S. Department of Housing & Urban Development
Office of Native American Programs

EXAMINING MOLD AND MOISTURE CONDITIONS OF HOMES ON THE BAD RIVER RESERVATION

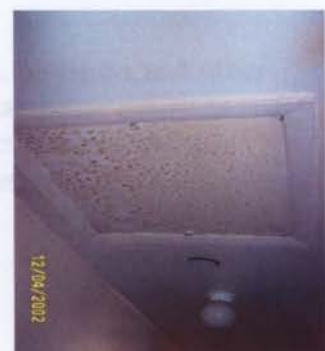
Another concern is that the perimeter of most hatches is not airtight when closed. Warm moist air can move up into the attic around the perimeter of the hatch. Although not present, the potential for water condensing on cool surfaces above the hatch could provide moisture for mold growth.

Figure 1 - Stained Attic Access Hatch

The hatches should be air sealed as shown in Figure 8. Latches should be installed to lock the hatches in place and provide positive closure.

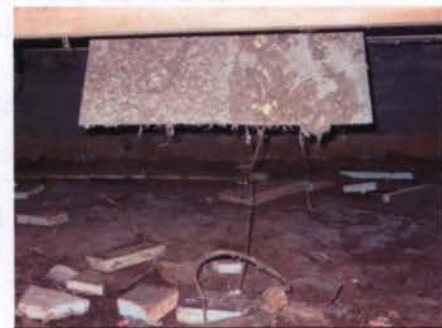
Return air ducts were found in the basements and crawl spaces. Leaky return ductwork can lead to mold and other IAQ issues in the home by drawing in pollutants found in these spaces and distributing it throughout the house. A disconnected return air plenum was found at 73245 West Denomie (Figure 2). Conditioned interior air was being deposited directly into the crawl space and crawl space air was being drawn into the return air plenum.

Figure 2 – Return Air Open to Crawl Space

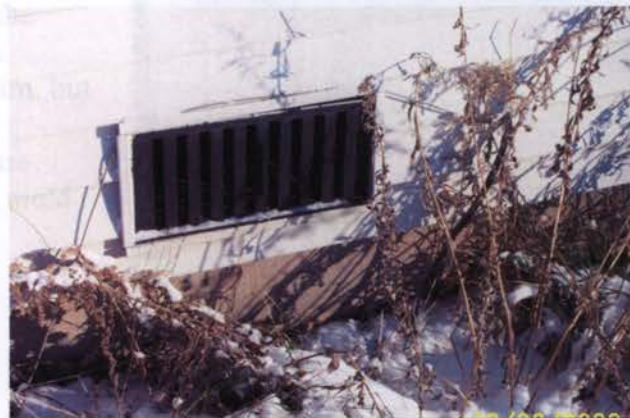
**Figure 2:** Crawl space vent

1. The crawl space should be accessed to determine the contribution of moisture from the foundation to the house. Exterior drainage, gutters, etc. should be considered to address foundation moisture. See Section 4.2.
2. Windows details, allowing for trimming the windows with more maintainable wood trim rather than drywall, should be installed on trouble windows.
3. Mold should be cleaned up according to New York City (NYC) and Environmental Protection Association (EPA) guidelines. See Section 6.
4. The attic hatch should be cleaned and insulated to prevent localized condensation and mold contamination.
5. Increase the surface temperature at the wall/ceiling juncture, thus preventing cold spots for condensation and mold contamination, should be followed. See Section 4.3.

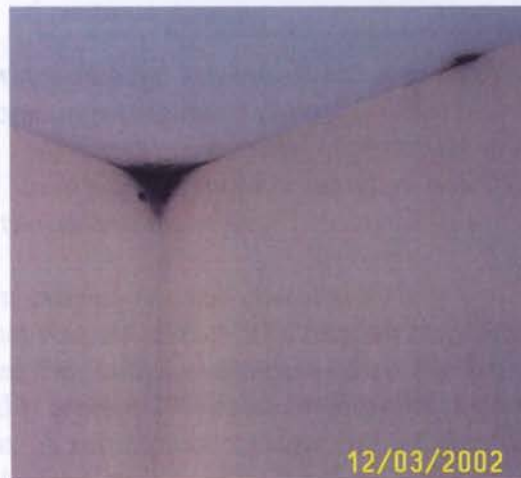
**Figure 3:** Mold growth at exterior wall/ceiling juncture

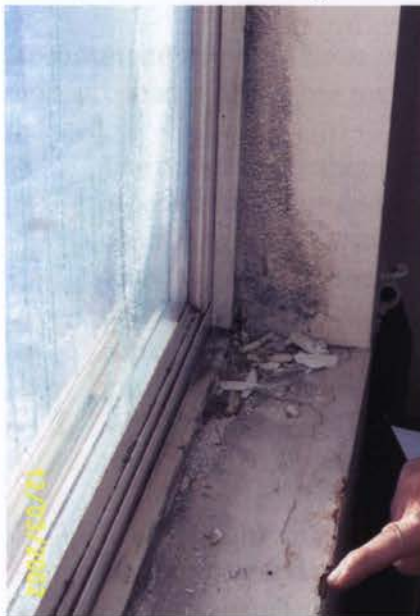
Extensive condensation occurred on all the windows throughout the apartment. The windows were not detailed with wood trim, but rather with drywall returns. Drywall is notoriously intolerant of elevated moisture conditions. Due to heavy condensation, mold

Figure 6: Window condensation, mold, and moisture damage

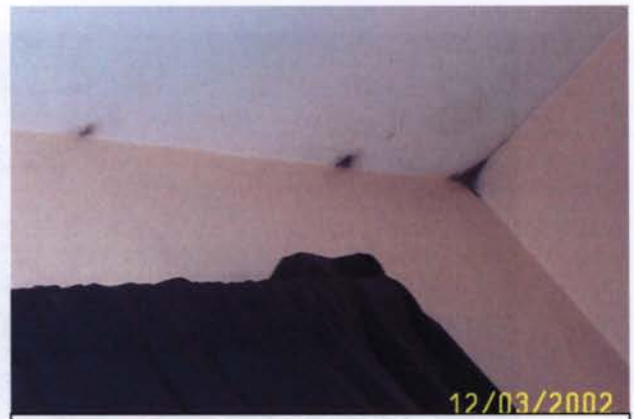
Figure 4: Mold growth at exterior wall/ceiling juncture

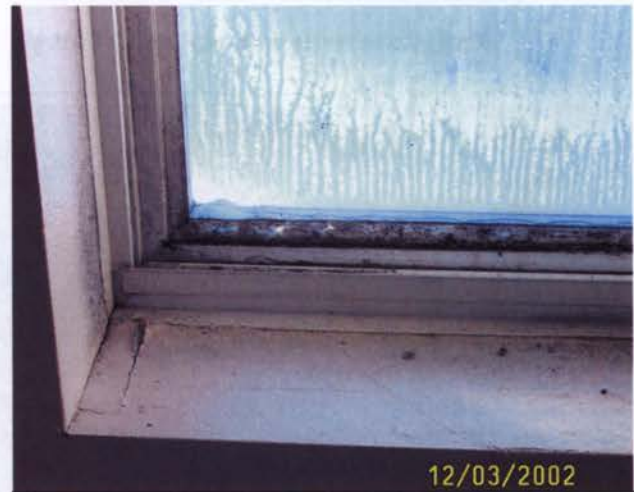
Figure 5: Window condensation, mold, and moisture damage

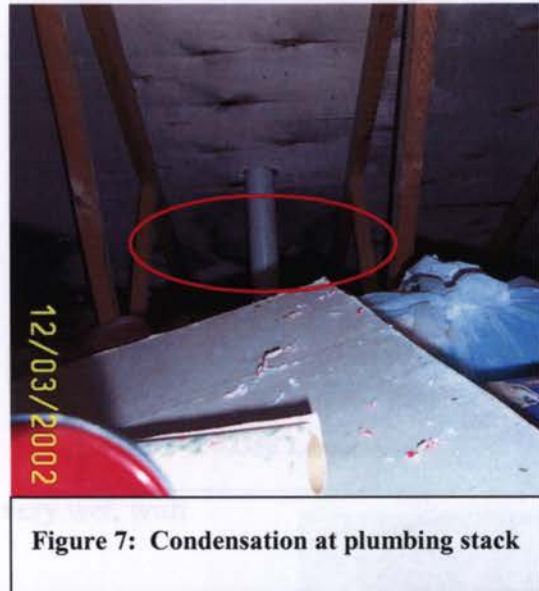
Figure 7: Condensation at plumbing stack

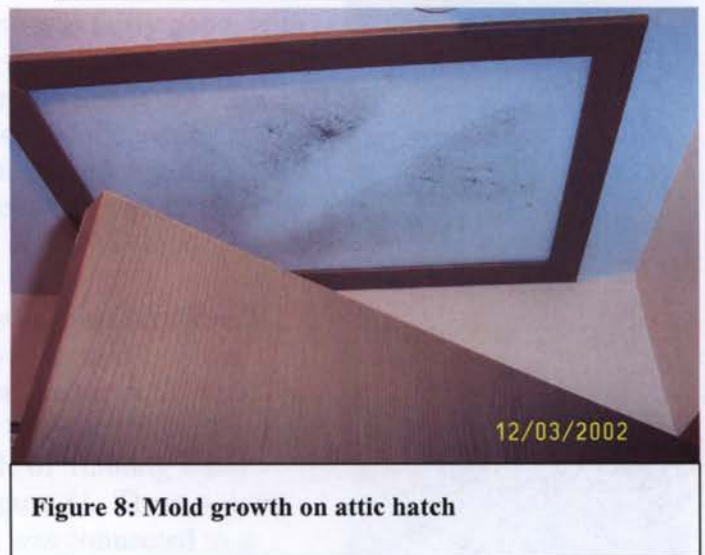
Figure 8: Mold growth on attic hatch

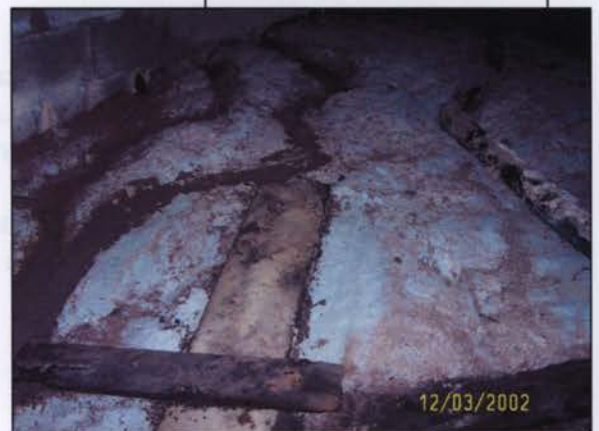
**Figure 3:** Crawl space. Note wood debris and signs of running water.

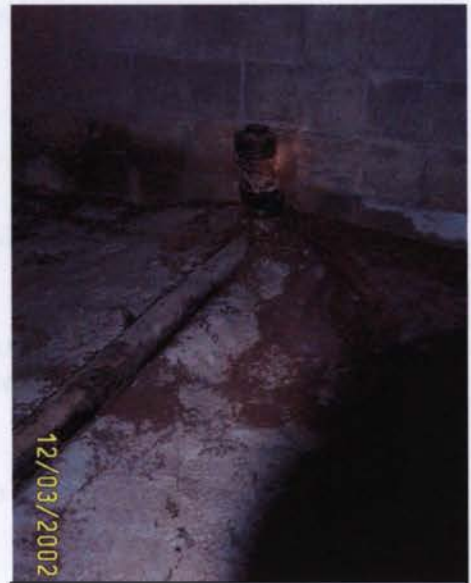
Figure 4: Sewer pipe in crawl space, possible leak.

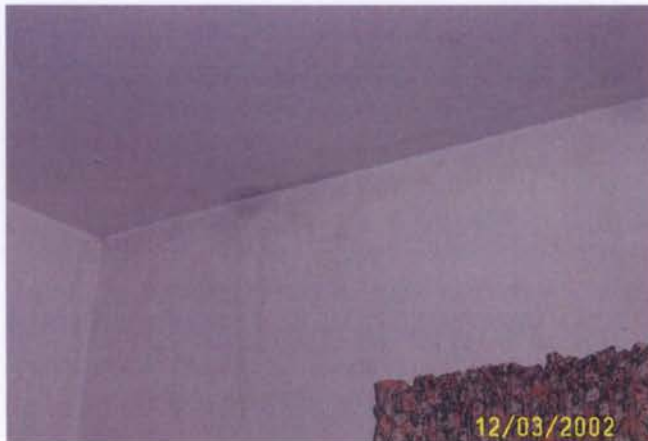
Figure 5: Water staining at wall/ceiling junction.

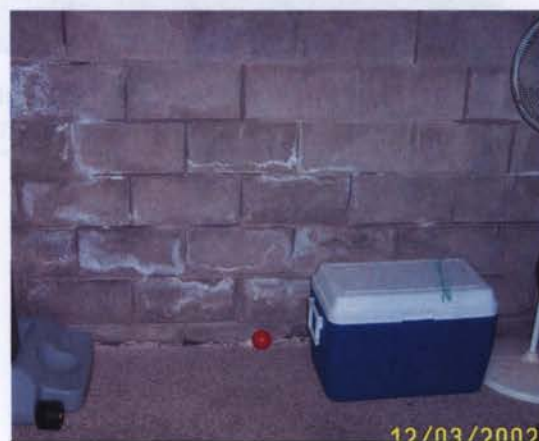
Figure 3: Staining from basement water entry.

1. Install gutters and downspouts. Ideally, downspouts can be placed on the elevation closest to the existing swale and can be discharged into the drain tile that is run to daylight at the swale. Whenever there is an existing grade to move water to daylight away from the foundation, the elimination of leaders at the base of the downspouts removes one of the chronic maintenance problems of roof drainage systems.
2. Ensure that the footing drains are clear and providing the optimum pressure relief from hydraulic pressure at the foundation.
3. Seal cracks between basement slab and concrete block walls.

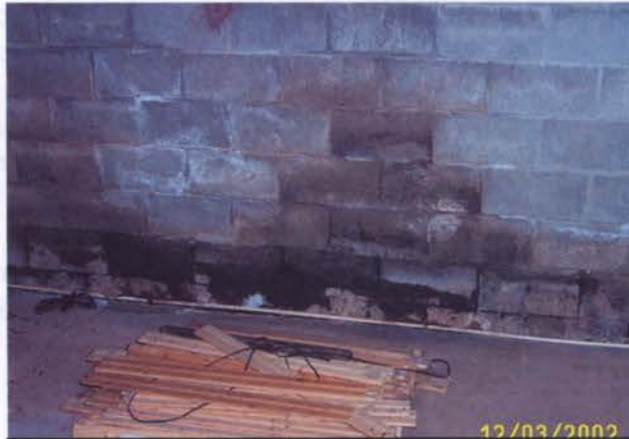
Figure 2: Wet foundation on the west foundation wall.

Basement Conditions: Staining and efflorescence provided clear signs of water entry into the basement. The west wall was wet at the time of inspection (Figure 2). There was a slight moldy smell in the basement. The basement was cluttered with the stored personal items and furniture. In a basement with moisture problems, excessive clutter, particularly of fabrics and paper, make an ideal location for mold contamination (Figure 3). An operating sump pump was connected to exterior footing drains. The sump pump was actively operating, discharging water through a long extension pipe about 20 feet behind the house. The fact that the sump pump was operating in the winter indicated a high water table. Cracks

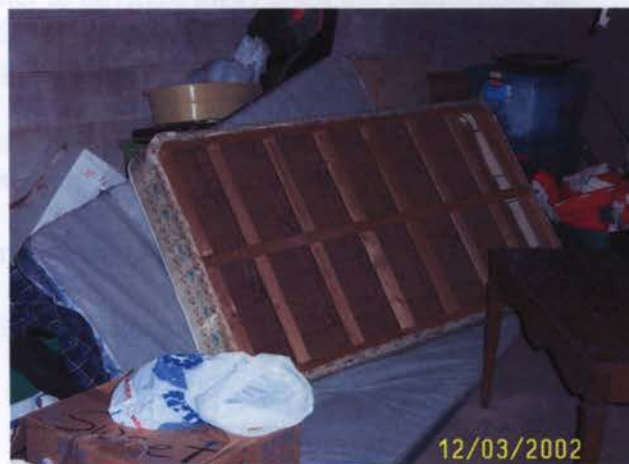
Figure 3: Basement clutter provides prime mold contamination sites.

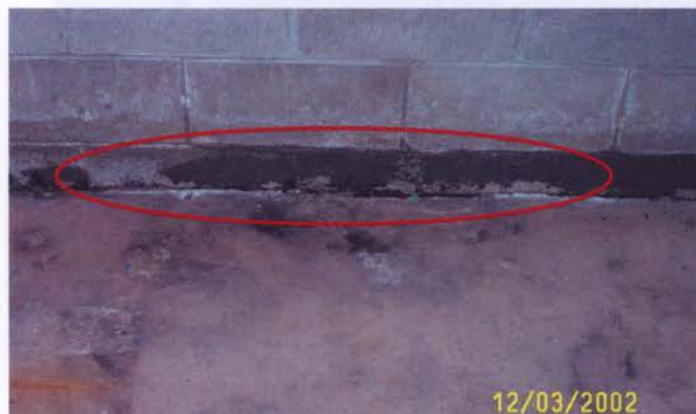
between the basement slab and block wall allowed for water entry at the base of the exterior walls (Figure 4). It should be verified that the footing drains were clear and provided the optimum pressure relief from hydraulic pressure at the foundation. This, along with improvements to the rainwater management system, could help relieve water entry at the foundation. A dehumidifier was operating in the basement. It was reported that the dehumidifier was fairly effective at reducing the moisture in the basement.

Figure 4: Crack between basement slab and foundation wall.

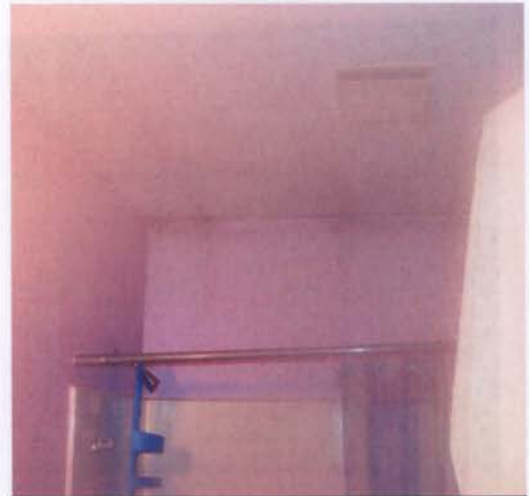
Figure 1 - Area above Bathtub

1. Abandon the bath soffit vent and install a new roof vent to exhaust the bath fan.
2. Close and seal crawl space vents to the exterior for the winter months. Currently these vents allow very cold air into the crawl space causing cold spots in the floor above and unnecessary heating costs to residents.
3. Fix the return air plenum in the crawl space.

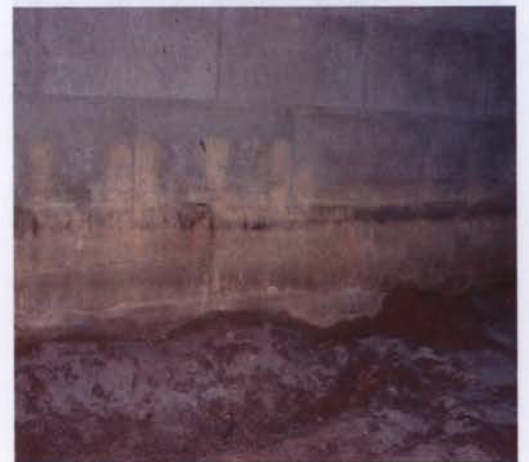
Figure 2 - Water Line on Block Walls

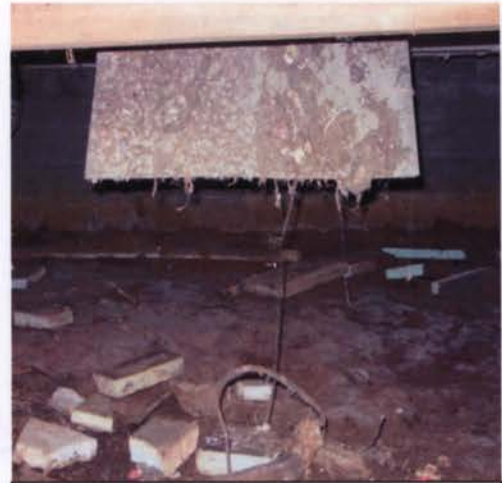
The return air register was centrally located in a hallway drawing air into a plenum between two joist spaces. However, sheet metal separating the return air plenum from the crawl space had come loose from the joists (Figure 4) so that return air was dumping directly into the crawl space. The crawl space also had a working sump pump.

Figure 4 - Open Return Air Plenum

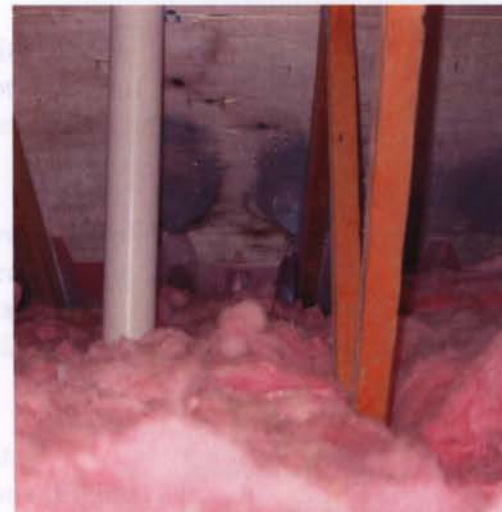
Figure 5 - Frost on Roof Sheathing

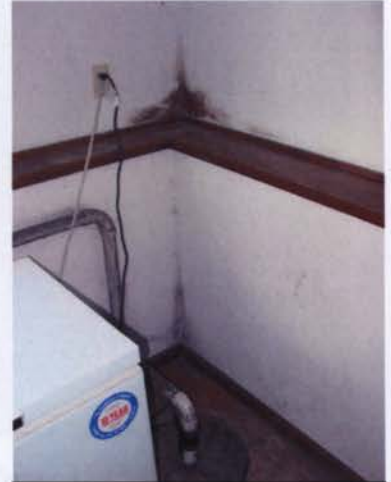
Figure 1 - Lower level, exterior corner @ sump

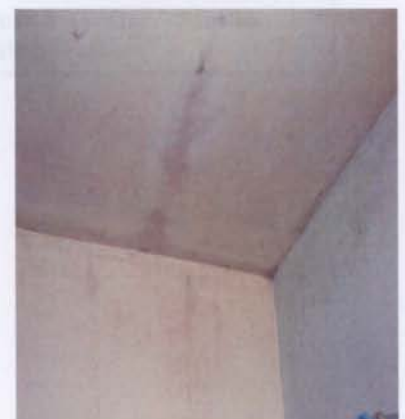
Figure 3 - Area above upstairs bathtub

1. Fix downspouts and conduct water away from house.
2. Fix grading around perimeter of house to shed water away from house.
3. Fix upper level toilet seal.
4. Make sure corrugated ventilation baffles are installed between all trusses and increase the insulation along the perimeter.

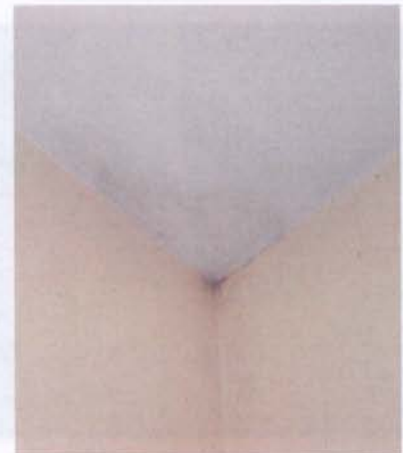
Figure 4 - Upper level wall/ceiling junction

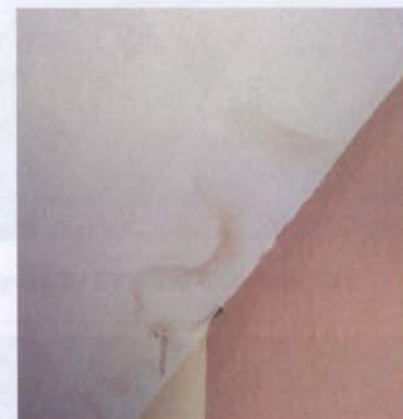
Figure 5 - Water Stains on Ceiling/Wall

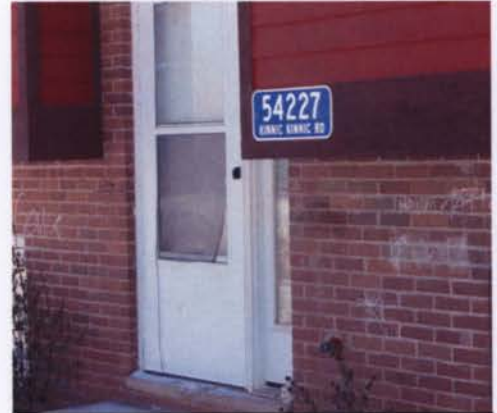
Figure 1 – Mold Stronghold

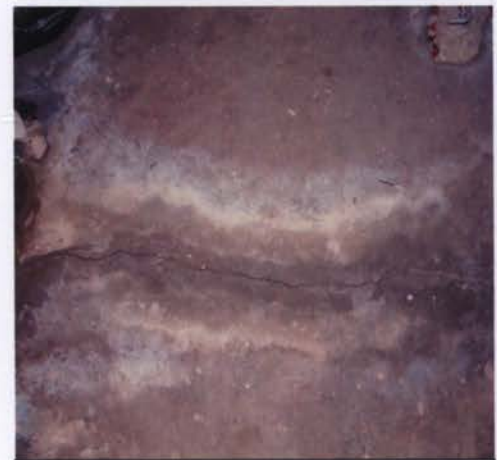
Figure 2 - Cracked Concrete Slab

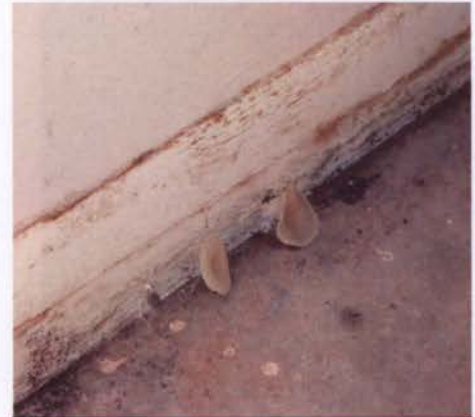
Figure 4 - Mushrooms at Baseboard

1. Fix downspouts and conduct water away from house.
2. Fix grading around perimeter of house to shed water away from house.
3. Remove drywall and anything else that was contaminated with mold in the lower level. Clean all remaining surfaces, and allow everything to dry before reattaching new finish surfaces.
4. Wipe down all vinyl windows, frames and glass with soap and water.

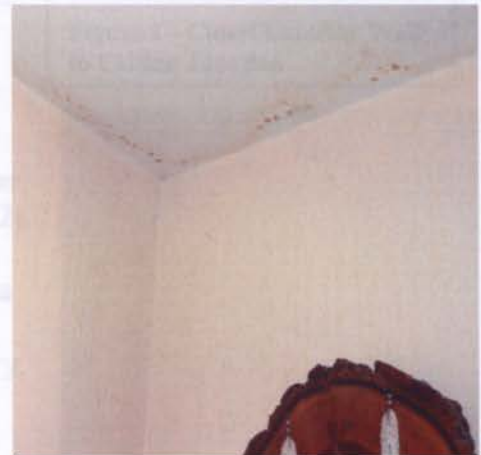
Figure 5 - Water Stains

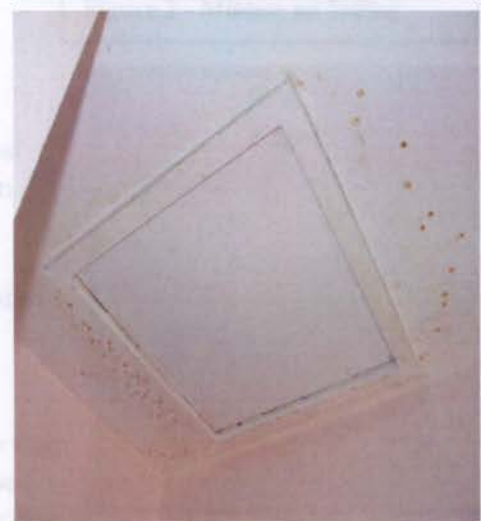
Figure 6 - Stains at Attic Access Hatch

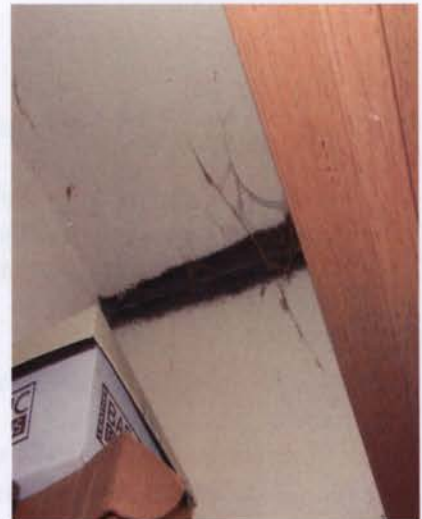
Attic: The attic was not inspected, but based on the mold problems at the exterior wall to ceiling junction; it was likely that there was insufficient insulation along the perimeter of the roof structure. This allowed the wall to ceiling corner to be below the interior dew point and thus water condensed at this location. Conditions conducive to mold growth were thus achieved.

Figure 1 - Closet Exterior Wall to Ceiling Junction

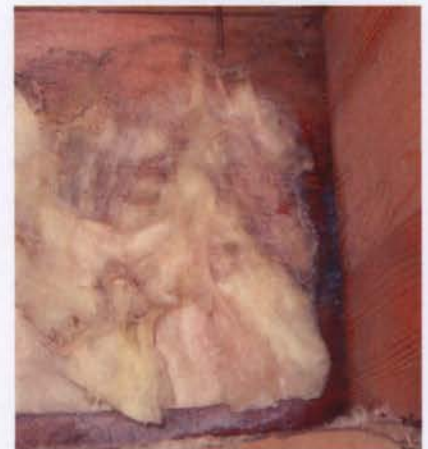
Figure 3 - Frost on Band Joist

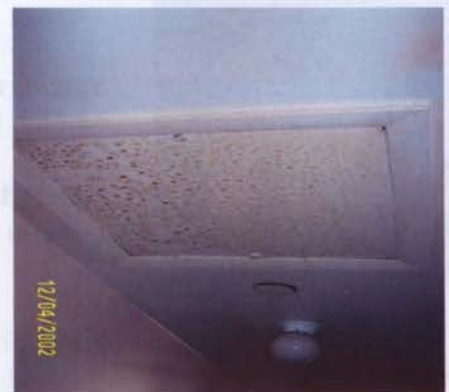
Figure 2 - Staining on Attic Access

1. Reconnect the bath fan exhaust hose to the roof jack.
2. Insulate the top of the attic access hatch.

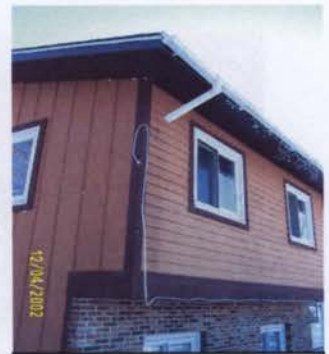
Figure 1 - Broken Downspout

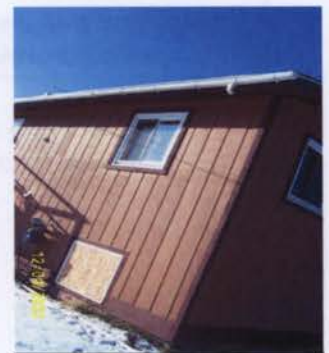
Figure 2 - Broken Downspout

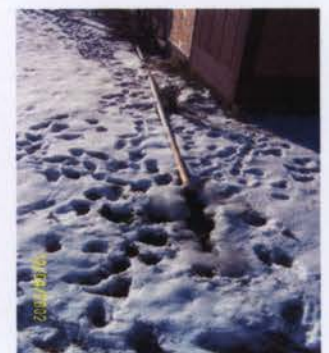
Figure 3 - Sump Pump Discharge

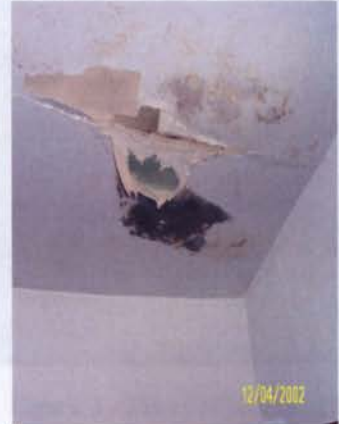
Figure 4 - Lower Level Bathroom Ceiling

1. Fix the plumbing leak in the upper level bathroom and then remove and repair damaged drywall in the lower level bathroom ceiling.
2. Repair downspouts and direct water away from the building.
3. Perform minor regrading around the perimeter of the building so that water sheds away from the structure.
4. Rework sump drainage. The existing ice buildup could continue to the point that the end of the pipe would become blocked and then the water would back-up in the discharge pipe.
5. Change Propervent insulation baffles to thinner units and pack more insulation along perimeter of roof trusses.

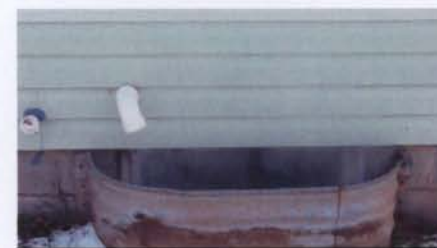
Figure 4 - Furnace Exhaust into Window Well

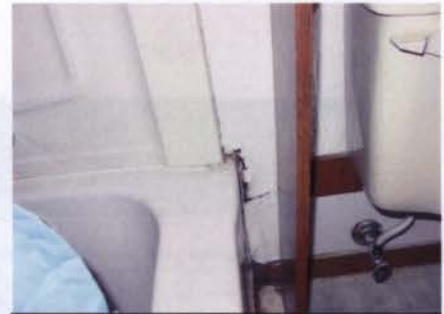
Bathroom: There was mold growing at the junction between the tub and the drywall (Figure 5). This appeared to be from water splashing out of the tub, saturating the wallboard, and then growing mold.

Figure 5 - Mold at Edge of Bathtub

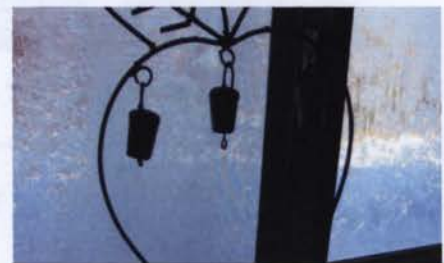
Figure 6 - Moisture on Plastic Window Covering

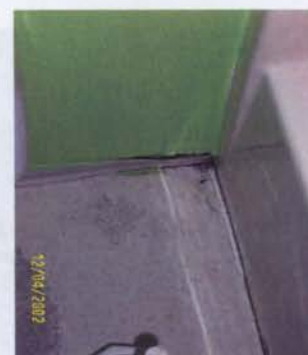
Figure 2 - Mold at Bathtub

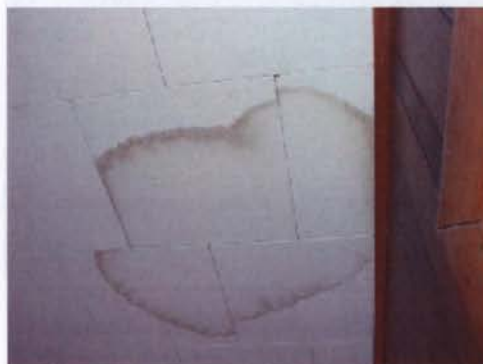
Figure 4 – Ceiling water spotting, a consequence of attic condensation.

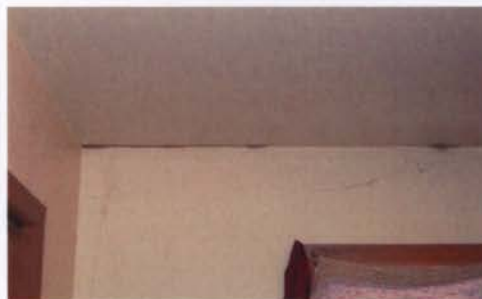
Figure 1 – Ceiling-wall joint showing darkening at truss locations.

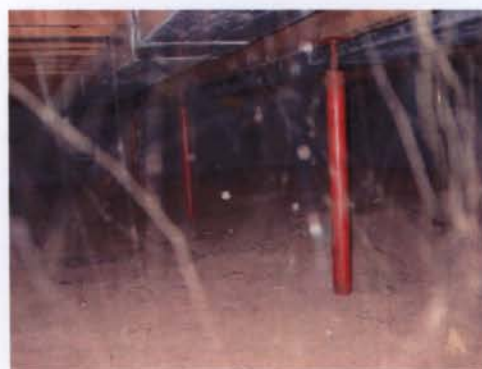
Figure 2 – Dry tall crawl space. However, cobwebs make the crawl space unpleasant to visit for maintenance and repair.
