NATIVE VILLAGE OF KWINHAGAK

TRIP REPORT

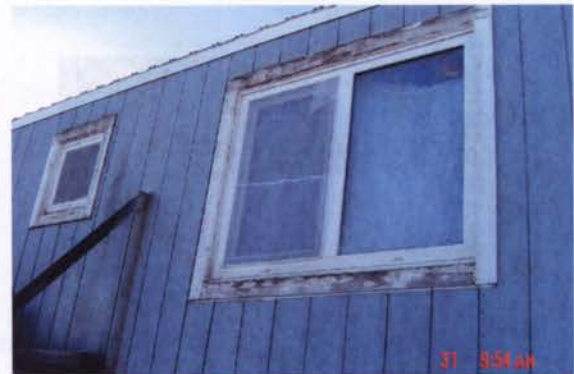
Figure 1: No roof overhang, and poorly sealed and flashed windows, has led to water intrusion.

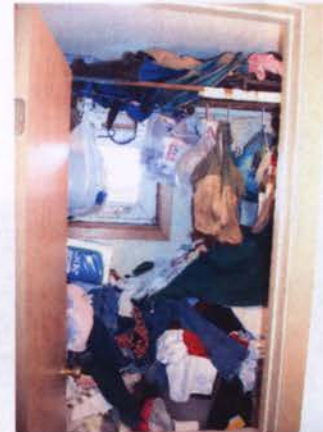
Figure 2: Clutter causes condensation problems on exterior walls.

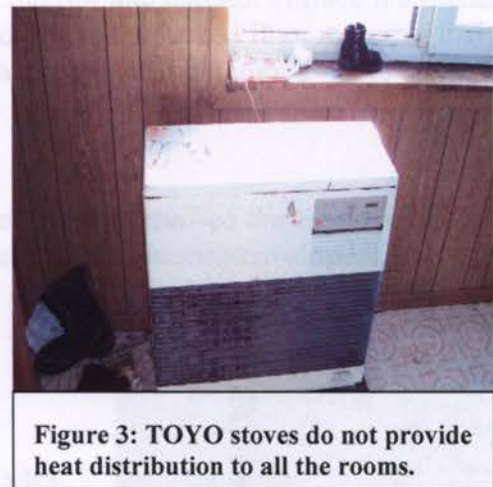
Figure 3: TOYO stoves do not provide heat distribution to all the rooms.

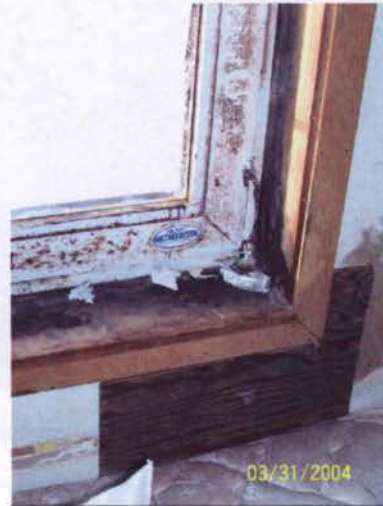
Figure 4: Condensation and mold on window frames

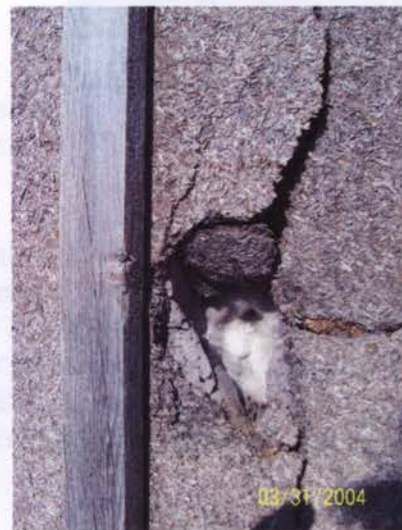
Figure 5: Hole in exterior cladding.

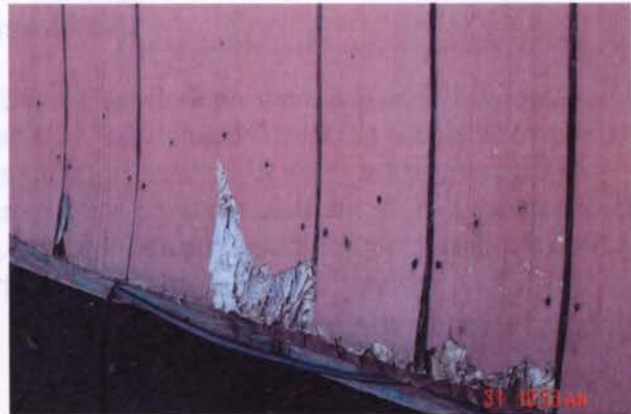
Figure 6: Deteriorated siding at the base of exterior wall.

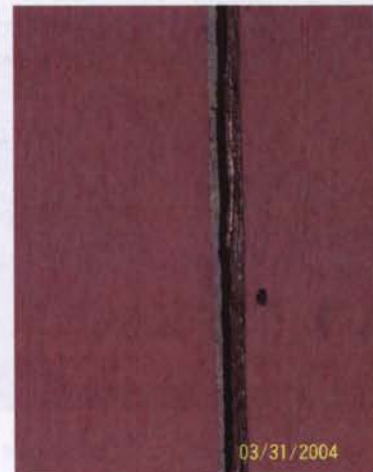
Figure 7: Gaps in siding,

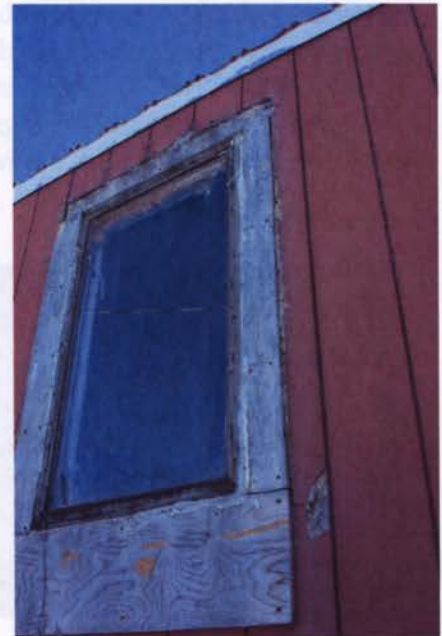
Figure 8: No overhang and poor window flashing caused water damage around several windows.

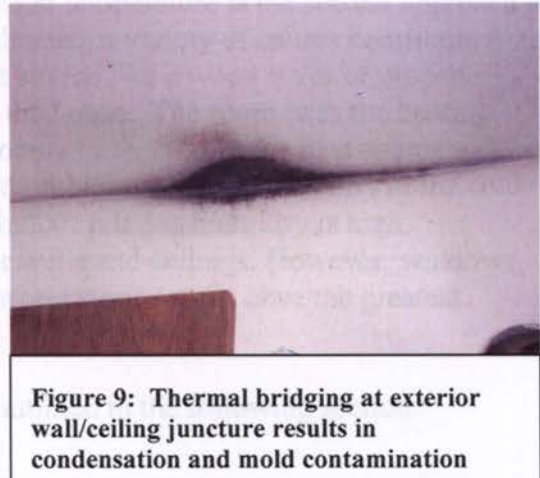
Figure 9: Thermal bridging at exterior wall/ceiling juncture results in condensation and mold contamination

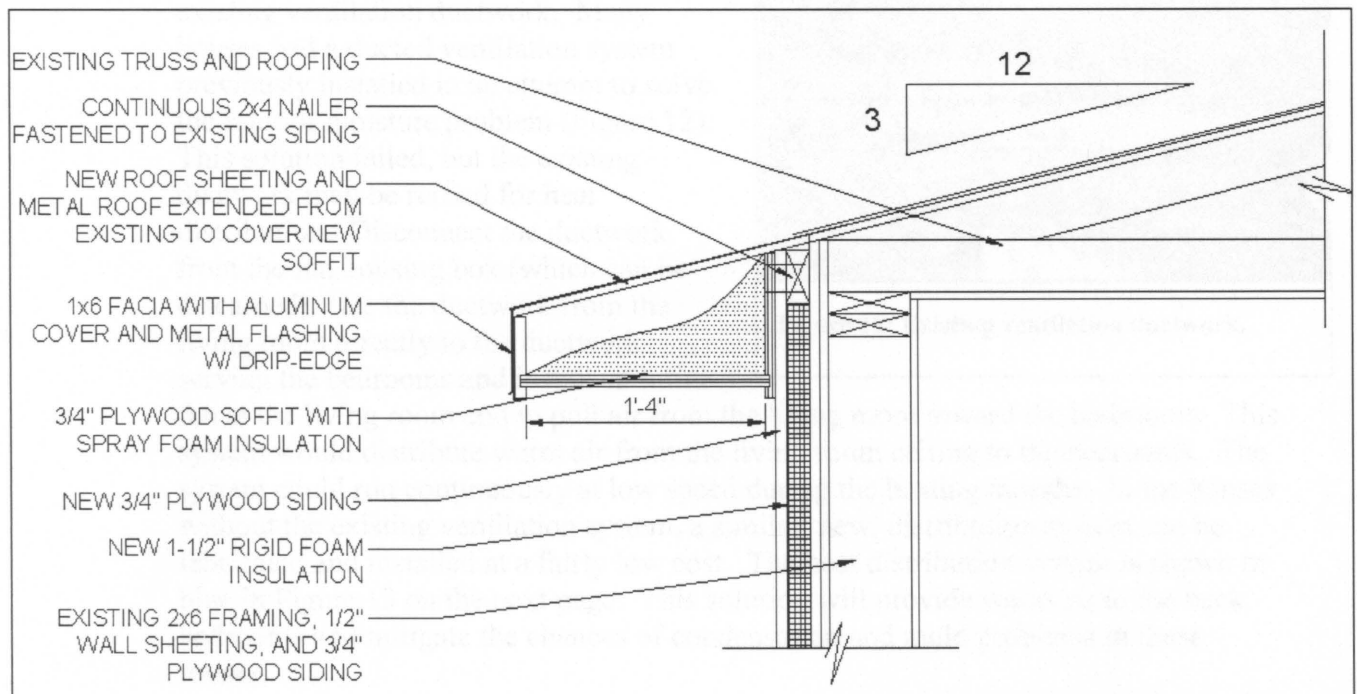
Figure 10: Retrofit roof overhang and exterior renovation

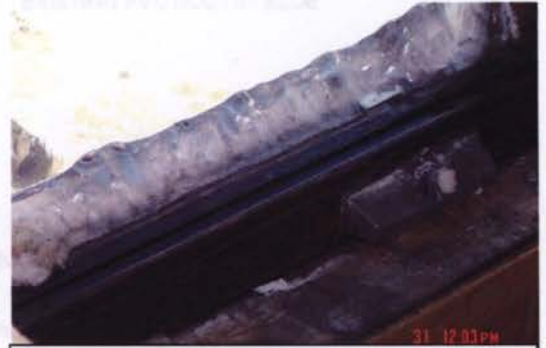
Figure 11: Ice on interior window indicate thermal bridging at the frames.

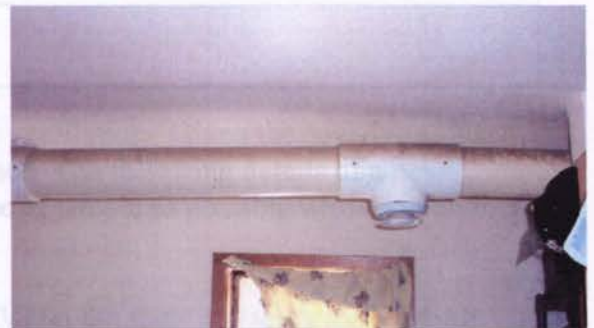
Figure 12: Existing ventilation ductwork.

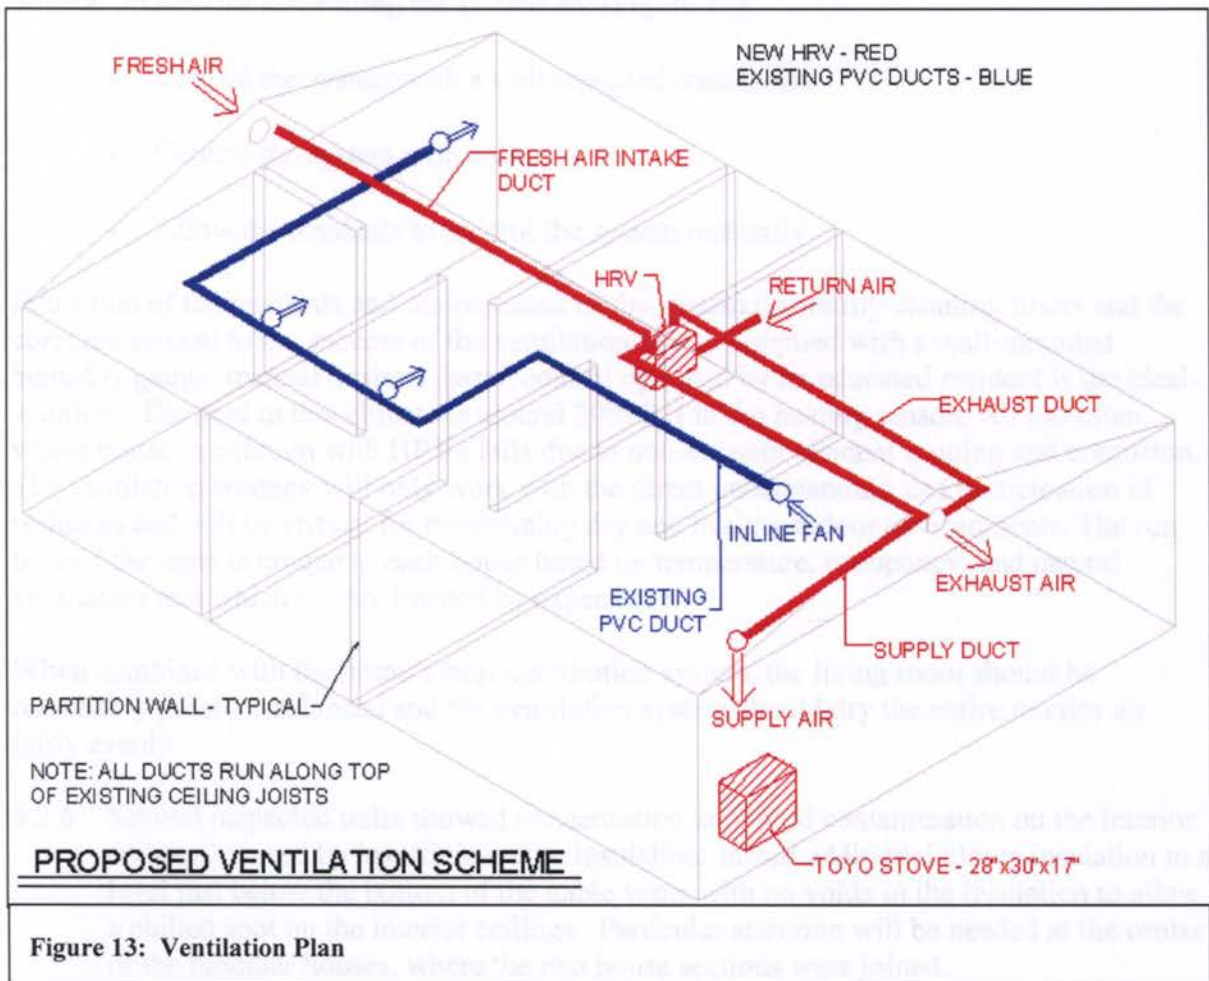
- 5.2.2 Install a new system to provide whole house ventilation. Given the severity of the climate, a system with heat recovery is advised. The following details of a new ventilation system have been developed to be as simple as possible while responding to the realities of the climate.

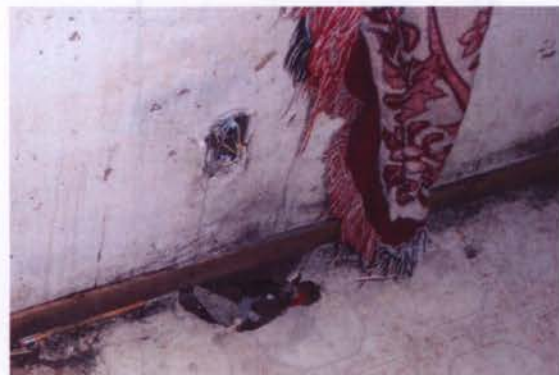
Figure 14: Water damage at base of exterior wall and the electrical outlet.

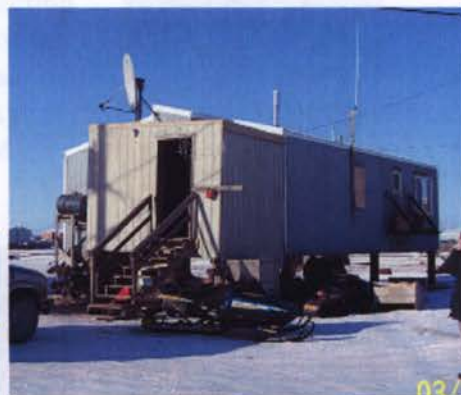
The lack of overhangs allowed water to drain off the roof directly down the face of walls. This necessitated a water-tight seal between the roof and wall interface. Based on observation, this seal was probably not watertight and water entered walls at this junction. All the windows were missing flashing at the head of the window allowing water infiltration into walls. Heavy condensation and water leakage from the exterior caused the deterioration of interior walls and jambs around windows.

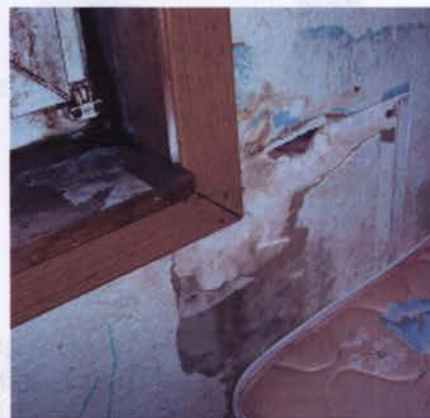
Figure 5: Window sill mold and wall deterioration

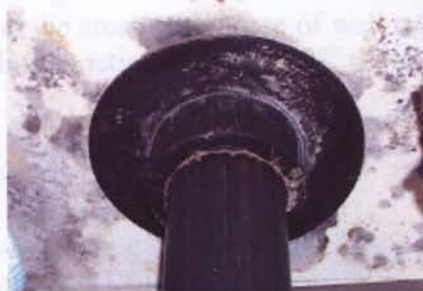
Figure 6: Stove pipe at ceiling

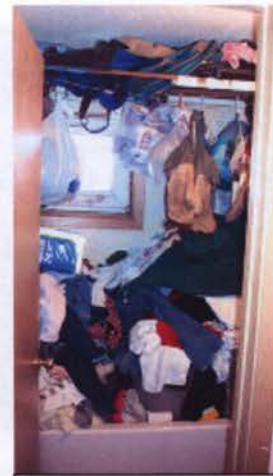
Figure 7: Bathtub storage

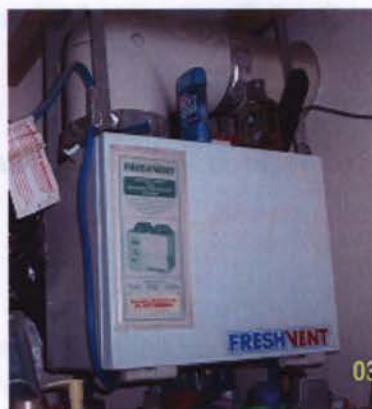
Figure 11: Fresh air system

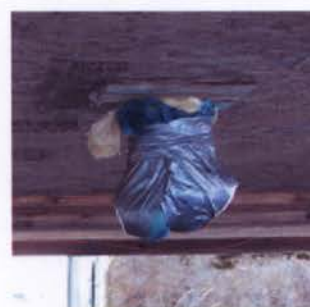
Figure 13: Covered fresh air supply

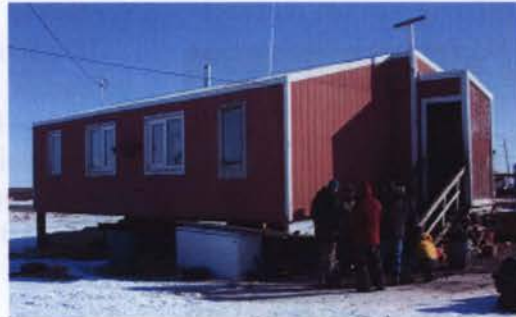
Figure 1: Exterior On the Tundra

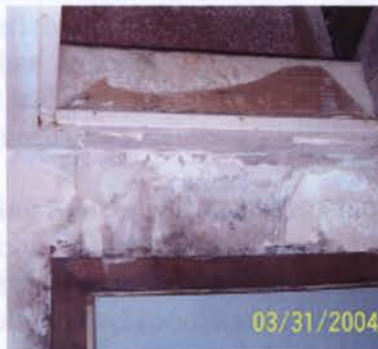
Figure 2: Mold at the front entry door

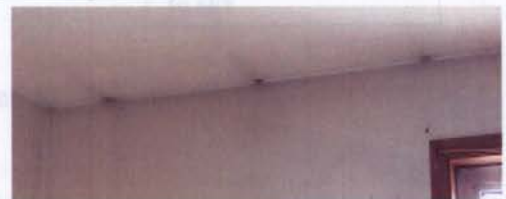
Figure 5: Mold at wall to ceiling juncture at truss bearing locations

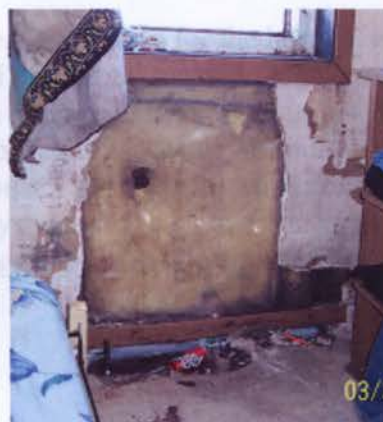
Figure 7: Missing drywall & hole in floor next to wall

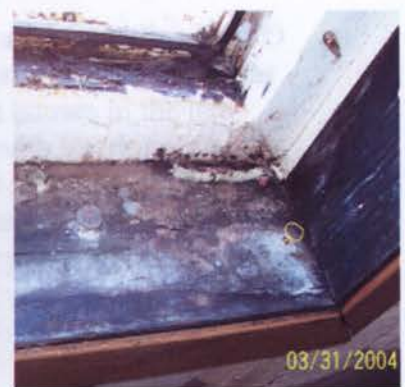
Figure 8: Moldy window sill

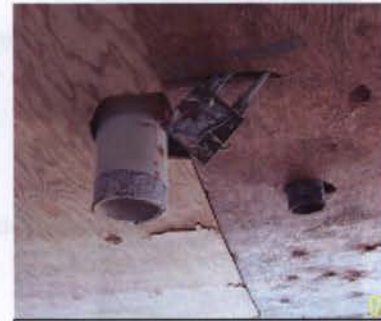
Figure 9: Penetrations through platform

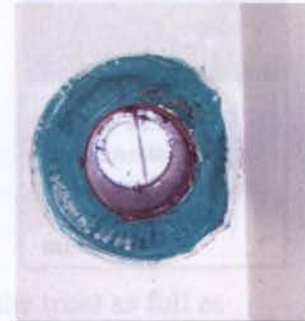
Figure 10: Vent open to sky

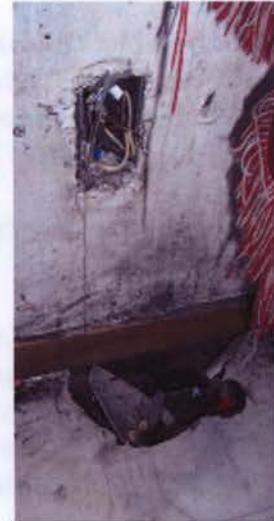
Figure 12:
Nonfunctioning
outlet and a hole in
the floor due to
moisture

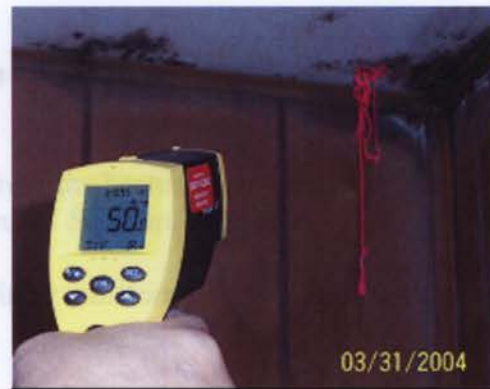
Figure 6: Cold exterior corner

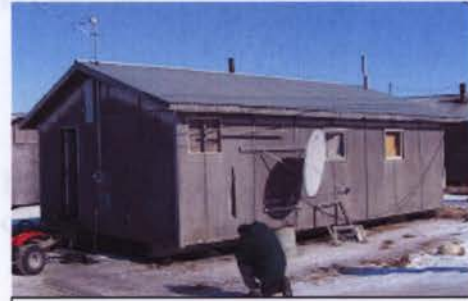
Figure 1: Exterior On the Tundra

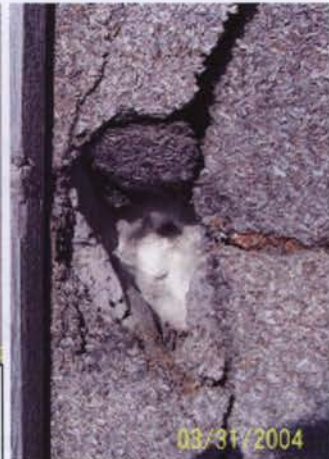
Figure 5: Hole through siding

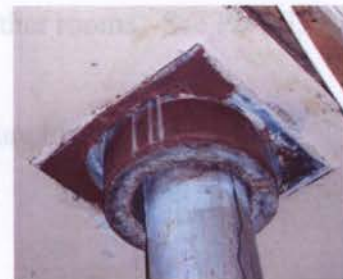
Figure 6: Stove pipe

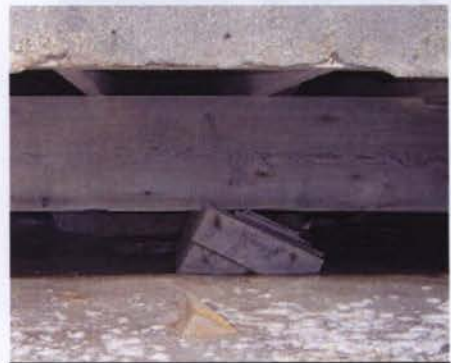
Figure 7: Pier, support beam and floor joists

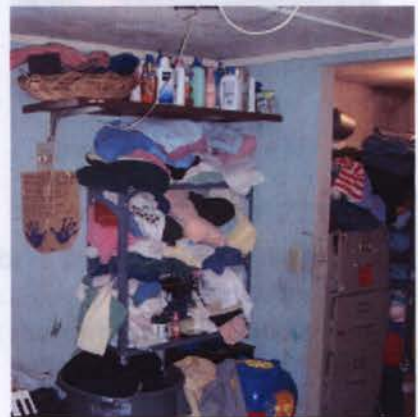
Figure 8: Clothes against exterior walls

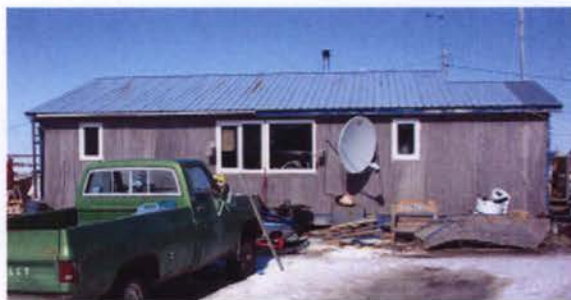
Inspection Number: 1-5**Address:** On the Tundra**Type:** Frame one-story**Foundation:** Piers**Heat Type:** TOYO Stove**Bedrooms:** Three**Occupancy:** 6 winter occupants,
15 summer occupants**Age:** Approximately 30 years**Attic:** Not accessible

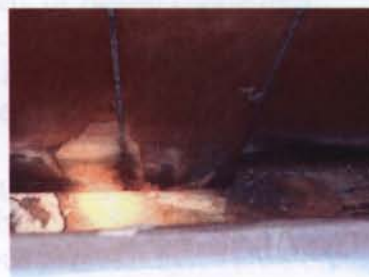
**Figure 2: Moldy base of paneling behind a bed**
