# UPPER SIOUX INDIAN COMMUNITY

## TRIP REPORT

### Assessment of Mold and Moisture Conditions

Final Report

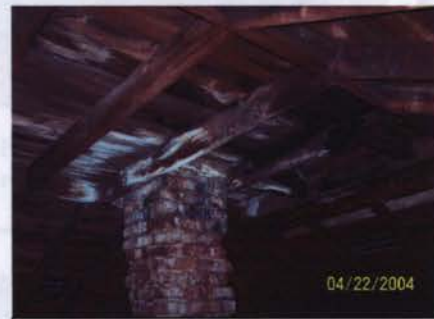
Only one attic had leakage problems around the chimney where it went through the roof (Figure 1), which, in turn, caused significant damage to the walls through which the chimney stack was located (Figure 2).

Figure 1 - Water damage under roof and on chimney due to roof

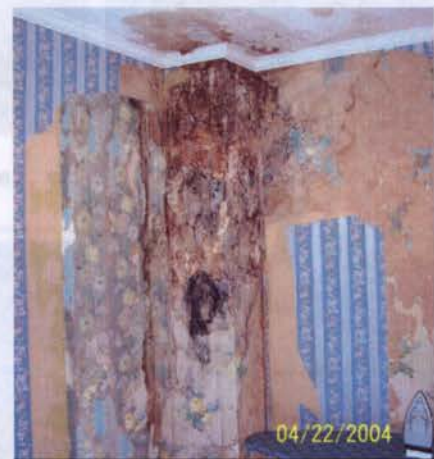
Figure 2 - Water damage from leaky roof around chimney

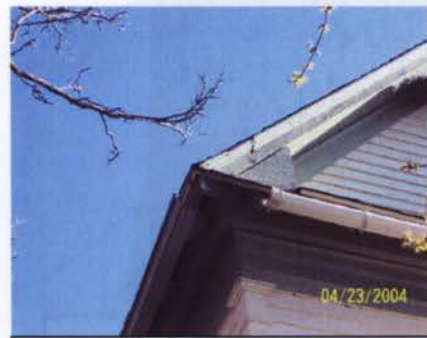
Nearly all homes had missing or incomplete gutter systems, though some homes did have gutters to keep visitors from getting wet while waiting at the door (Figures 3 & 4). Gutters are important tools for moving water away from the house and need to be fully installed.

Figure 3 - Home with incomplete gutter system

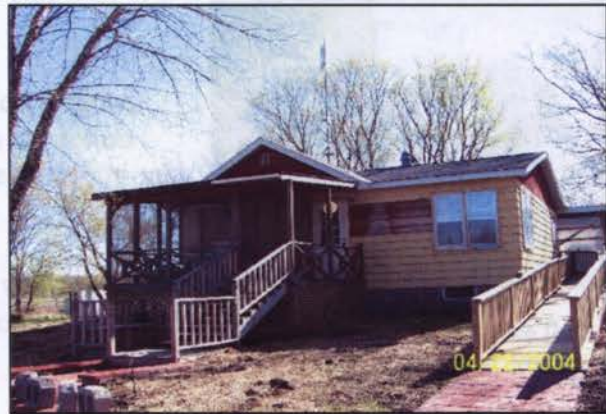
Figure 4 - Home with gutter over doorway; home was raised to improve the site drainage.

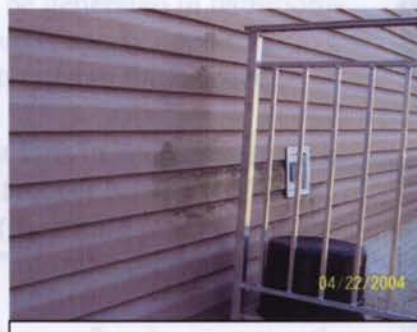
A few homes had problems on the exterior of the buildings. One building had algae growth on the north face siding (Figure 6). Another house was missing trim around

Figure 6 - Algae growing on north face

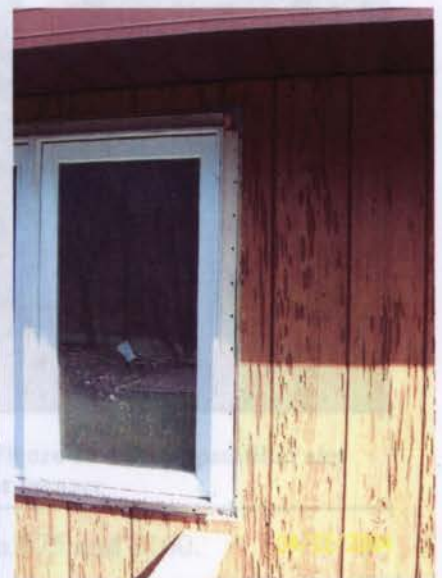
Figure 7 - Missing trim around windows

several of the windows in the rear of the home (Figure 7), was missing flashing at the deck, and was missing fascia on the gable end (Figure 8). One home had flashing at the front porch that collected

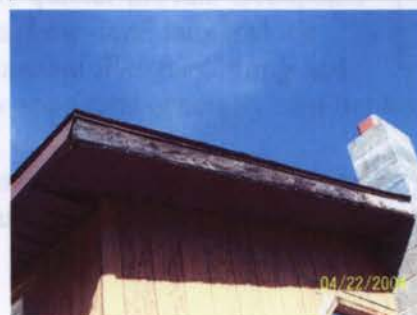
Figure 8 - Missing fascia at gable end

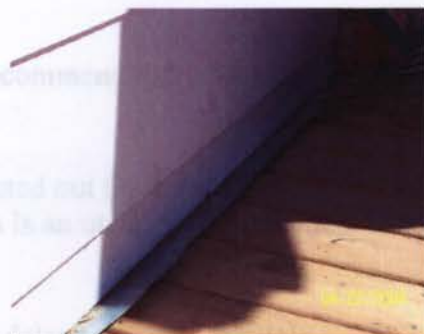
water at the house instead of shedding it away (Figure 9).

Figure 9 - Poorly installed flashing collects water.

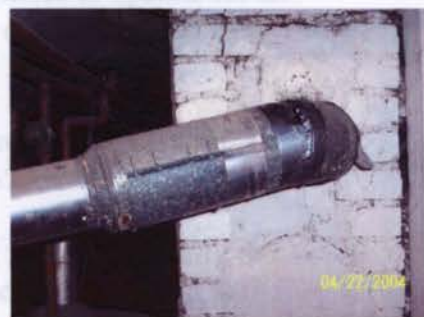
Figure 10 - Gap in furnace flue

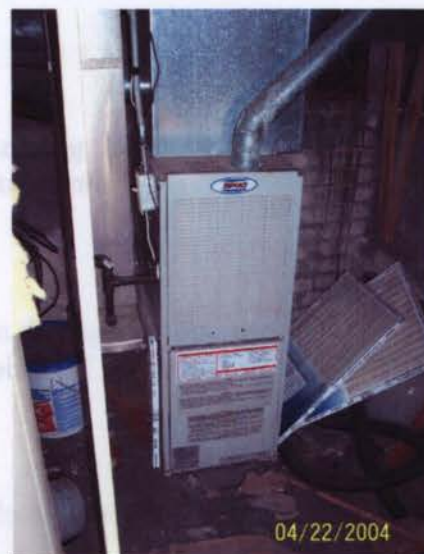
Figure 11 - Uncapped filter slot at furnace

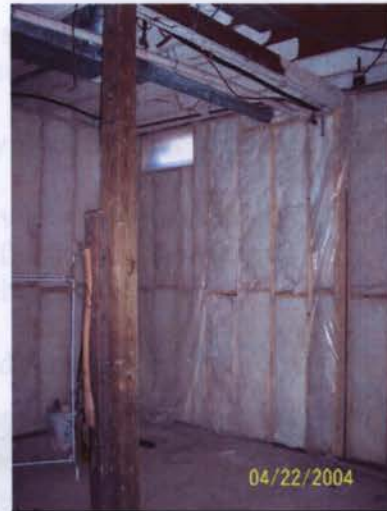
Figure 2 - Vapor barriers on the basement studs

- Install a low-sone bathroom exhaust fan in the bathroom with a fan delay timer and a range hood in the kitchen that is vented to outside.
- Install a gutter system with leaders at the base of the downspouts.
- Remove the inner vapor barrier from the basement walls before installation of the drywall.
- Place new beams and supports below the sagging floor joists.
- Get the water problem checked and determine how best to solve the problem.

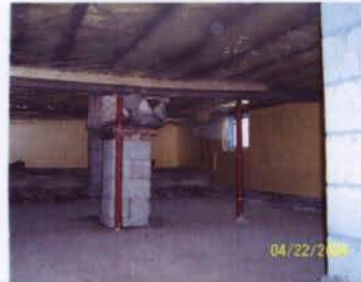
Figure 2 - Sagging beam in crawl space.

- Install a low-voltage bathroom exhaust fan in the bathroom with a fan delay timer and a range hood in the kitchen that is vented to outside.
- Install a gutter system with leaders at the base of all downspouts.
- Repair or replace the dryer vent termination.
- Place new beams and supports below the sagging floor joists.
- Get the water problem checked and determine how best to solve the problem.

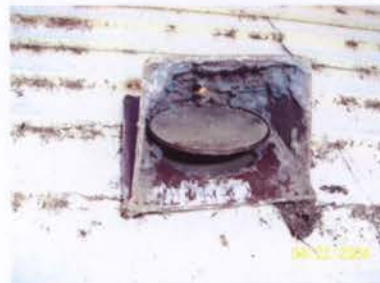
Figure 3 - Dryer vent port in open position.

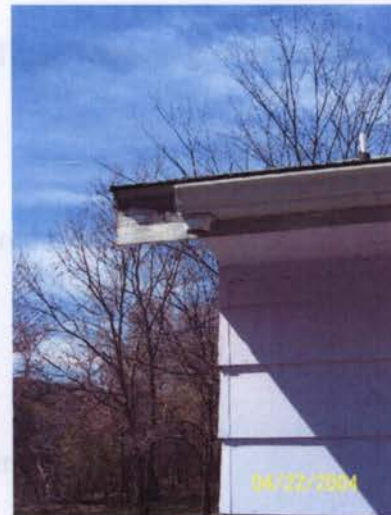
Figure 2 - Missing downspout.

- Replace the recirculating kitchen range hood with one that exhausts to the outside.
- Install downspouts with leaders.
- Fix the problems with the flashing.
- Put the vapor barrier back over all of the soil and seal it to the perimeter of the crawl space.

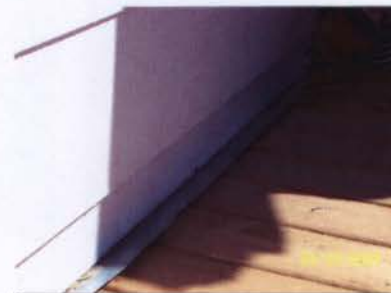
Figure 3 - Poorly installed flashing.

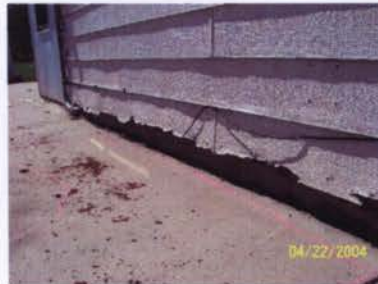
Figure 3 - Damaged siding.

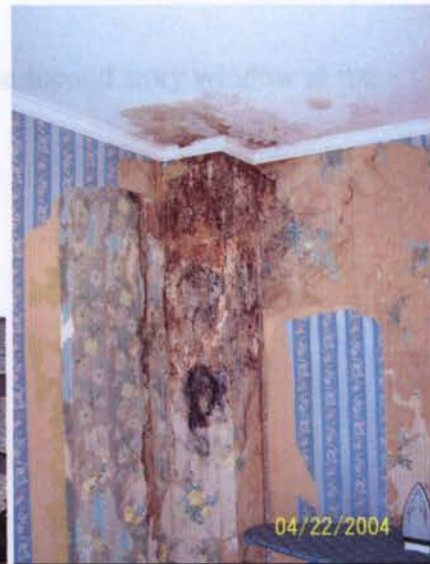
**Mold and Moisture Conditions:** Mold was not found in the home, but significant moisture damage was on the walls on the second floor through which the chimney ran (Figure 2).

Figure 2 - Moisture damage on walls due to roof leak.

- Repair the roof, walls, and chimney as needed.
- Repair furnace flue with B-vent duct.
- Install a kitchen exhaust fan that vents to the outside.
- Replace bath fan exhaust duct with insulated duct.
- Replace siding at the base of the house and under the second story window at the front of the house.

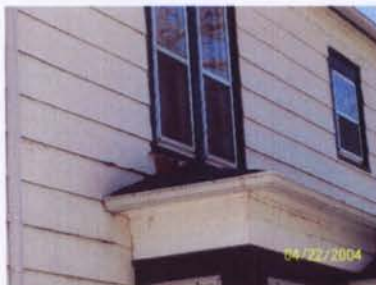
Figure 4 - Water damage below 2nd story windows.

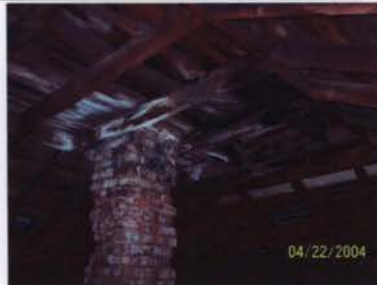
Figure 5 - Water damage under roof.

**Attic:** The attic had moisture damage under the roof where the chimney went through the roof (Figure 5).

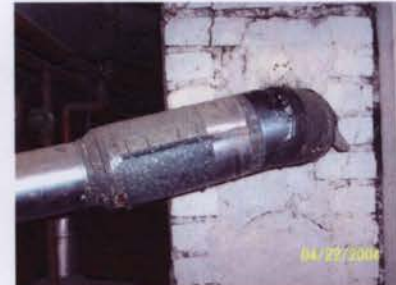
Figure 6 - Gap in furnace flue in basement.

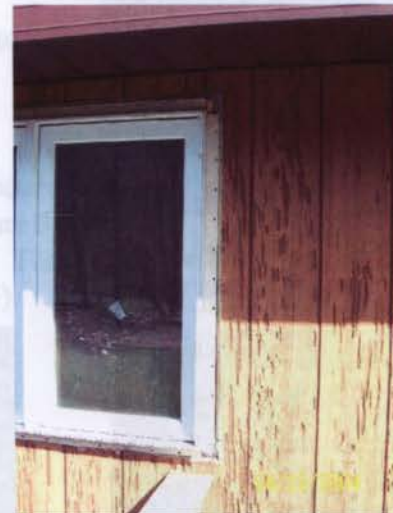
Figure 2 - Missing trim around windows.

- Install flashing above window beneath the deck on the rear of house.
- Install a gutter system with downspouts and leaders.
- Finish installing the trim around the windows and the sliding glass door.
- Repair the fascia on the gable end.

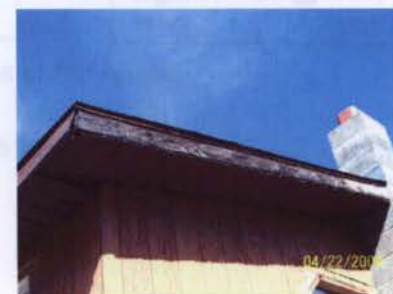
Figure 3 - Missing fascia on gable end.

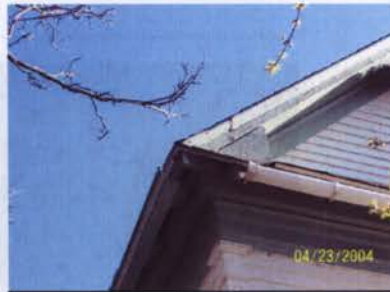
**Rainwater Management:** The site drainage was adequate. The gutter system was incomplete (Figure 2) and had no downspouts.

Figure 2 - Missing section of gutter and downspout.

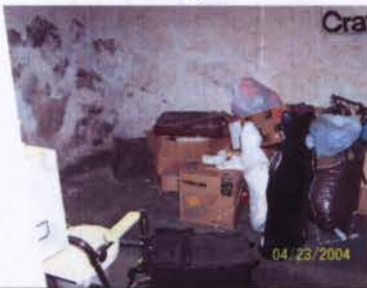
**Basement:** The basement was dry with carpets and cardboard boxes on the floor increasing the potential for mold (Figure 3). There was also a crack in the foundation wall (Figure 4). The termination port for the dryer vent was clogged (Figure 5).

Figure 3 - Clutter and cardboard boxes in

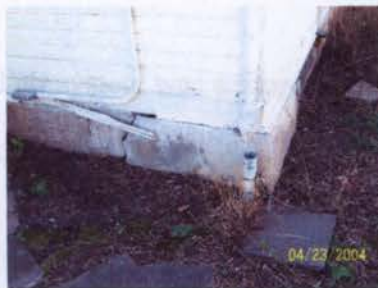
Figure 4 - Cracked foundation

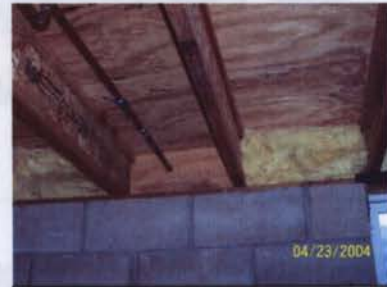
Figure 2 - Uninsulated band joist

**Basement:** The basement was dry. There were locations in the basement where the band joist was uninsulated (Figure 2).

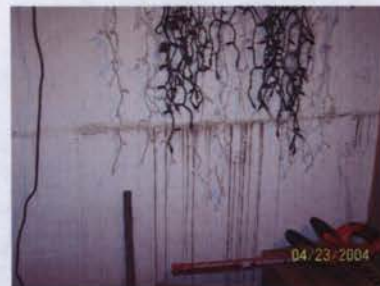
Figure 2 - Leaky cold joint in basement wall.

- Install gutter system, including downspouts and leaders.
- Grind out a 3/8" "V" at the cold joint and seal with a high quality concrete sealant.
- Check the furnace specifications to determine whether the Schedule 40 PVC piping is permissible.
