# 1           **Structural integrity monitoring of onshore wind turbine concrete foundations**

2           Magnus Currie<sup>1\*</sup>, Mohamed Saafi<sup>2\*</sup>, Christos Tachtatzis<sup>3</sup> and Francis Quail<sup>4</sup>

8           Signs of damage around the bottom flange of the embedded ring were identified in a large  
9           number of existing onshore concrete foundations. As a result, the embedded ring experienced  
10          excessive vertical displacement. A wireless structural integrity monitoring (SIM) technique was  
11          developed and installed in the field to monitor the stability of these turbines by measuring the  
12          displacement patterns and subsequently alerting any significant movements of the embedded  
13          ring. This was achieved by using wireless displacement sensors located in the bottom of the  
14          turbine. A wind turbine was used as a test bed to evaluate the performance of the SIM system  
15          under field operating conditions. The results obtained from the sensors and supervisory control  
16          and data acquisition (SCADA) showed that the embedded ring exhibited significant vertical

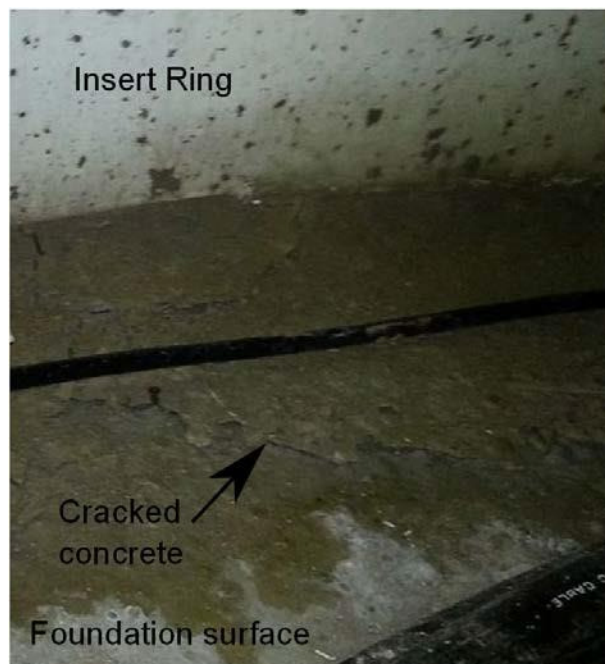
76 The onshore wind turbine concrete foundations with embedded ring shown in Fig. 1 are widely  
77 used around the world. These types of foundations are the subject of this study with respect to  
78 vertical movement. Several wind farms were visited to identify the main cause of this vertical  
79 movement using Endoscopic filming through boreholes created in the foundations. The  
80 Endoscopic filming showed significant voids filled with water under the flange of the embedded  
81 ring. Significant erosion was also observed on the upper side of bottom flange due to the uplift  
82 forces placed on the foundation by the rotor. These voids have caused excessive vertical  
83 movement of the ring, leading to concrete cracking (Fig. 2) and failure of the water proofing  
84 system.

314 Fig. 2 Cracked concrete foundation as a result of excessive displacement of the embedded ring.

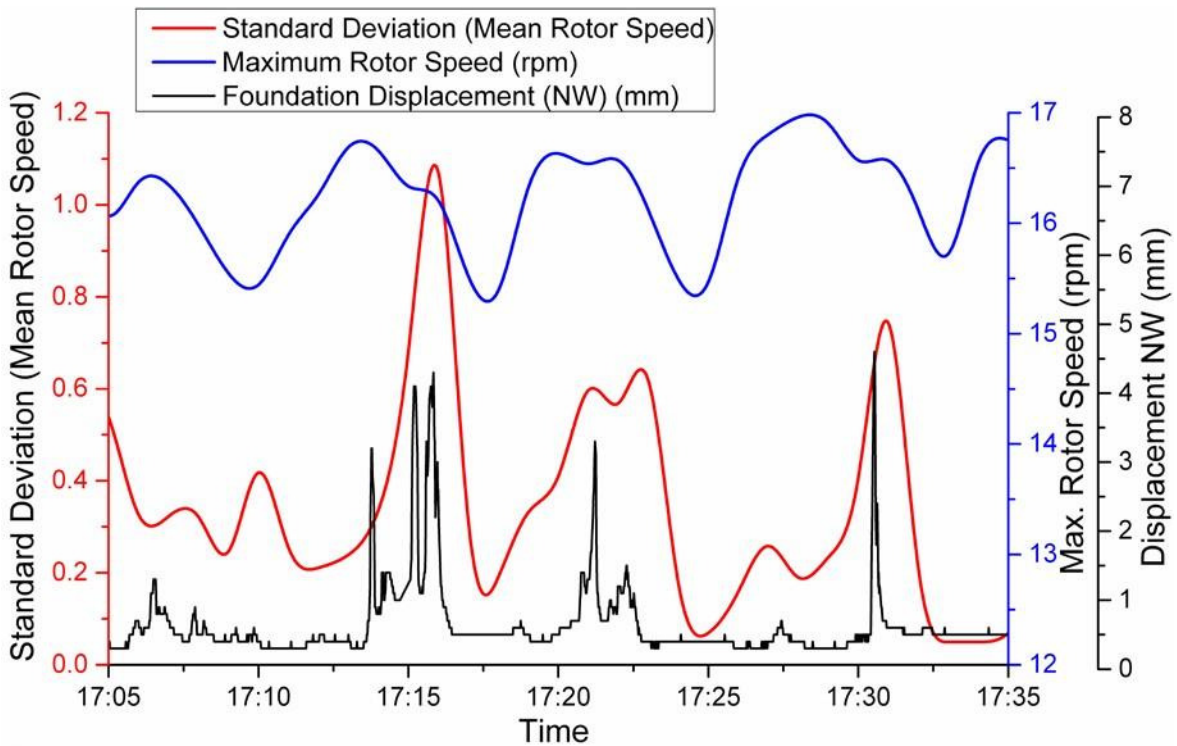
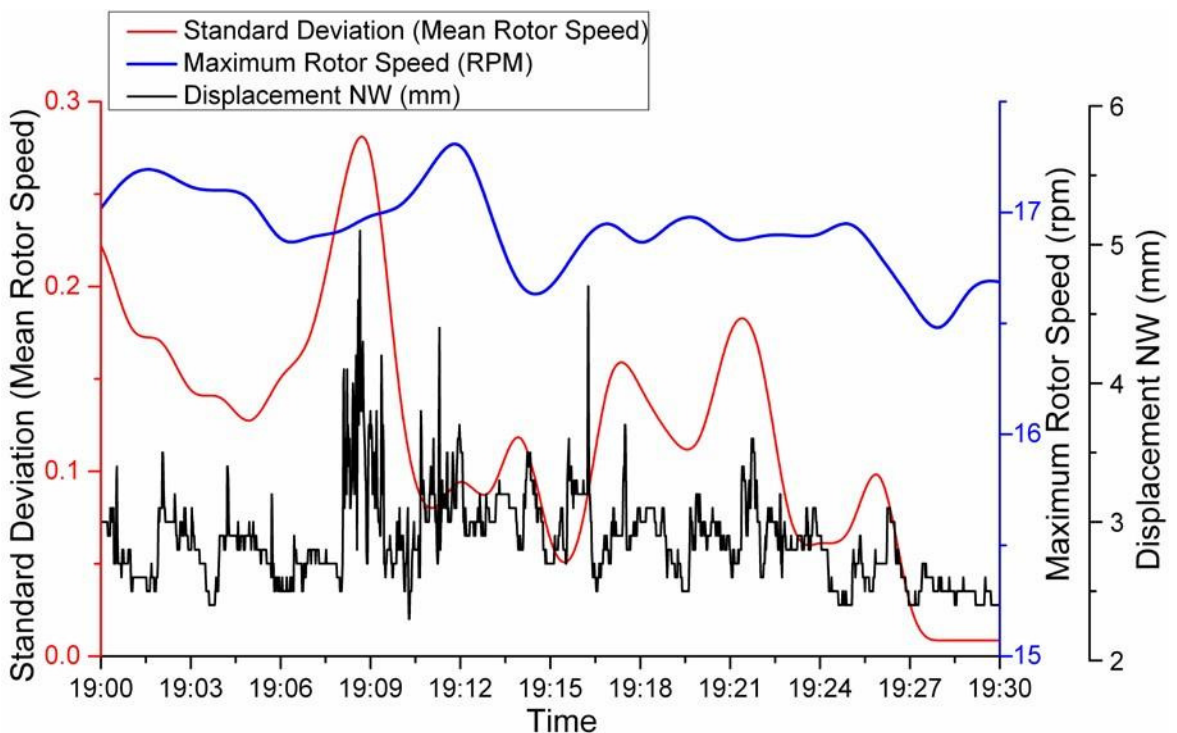
413 Fig. 5. Effect of rotor speed on the vertical displacement of the embedded ring.

144 Fig. 5a depicts the structural response of the embedded ring subjected to dynamic loading during  
145 the turbine operating conditions over a period of 30 min. As can be seen, large drop offs in the  
146 maximum rotor speed were observed. This was due to the drop in the wind speed. The standard  
147 deviation of mean rotor speed exhibited peaks higher than 0.6, suggesting a period of turbulence.  
148 The spikes in the ring displacement occurred in line with the standard deviation peak. This  
149 means that during periods of turbulent wind, the rotor is subjected to sudden acceleration and  
150 deceleration. This sudden change in the momentum resulted in the ring lifting and falling of the  
151 embedded ring. This suggests that the embedded ring experiences vertical displacement during  
152 sudden acceleration and deceleration of the rotor resulting from the change in the wind speed and

153 direction. Vertical displacement could also occur during shut down and start up events as this  
154 produces sudden acceleration and deceleration of the rotor. Figure 5b shows a number of peak  
155 displacements up to 5 mm. In this case, some of the peaks appeared to be related to the rotor  
156 speed standard deviation e.g. turbulence, whilst others, such as at 19:12, appeared to be related to  
157 the maximum rotor speed peaks.

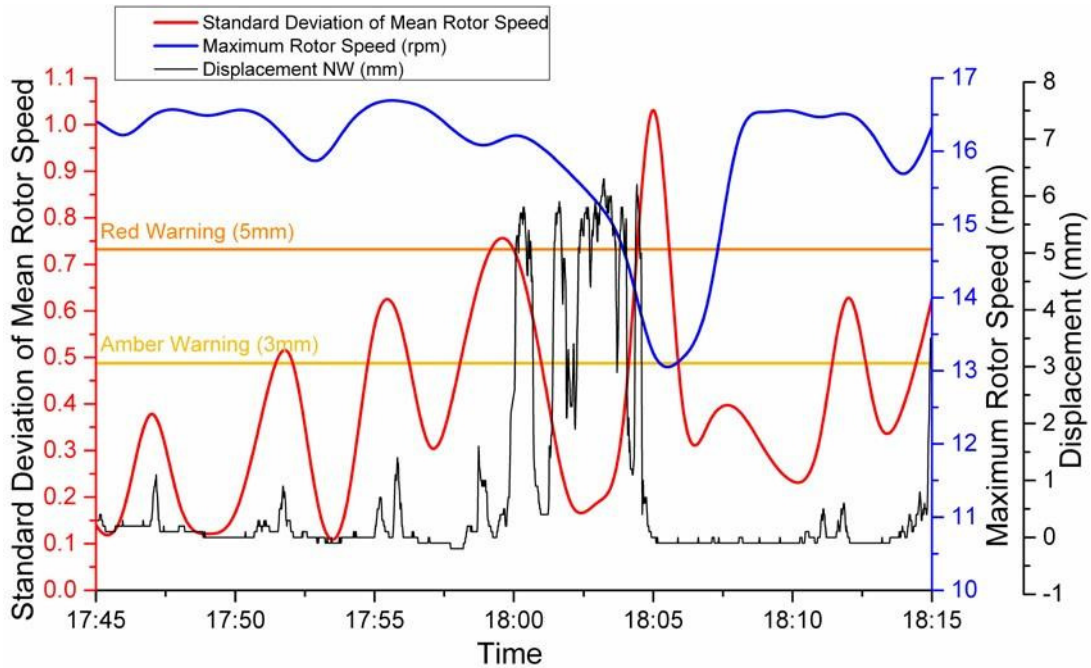
158 As shown in Fig. 6, the embedded ring experienced significant vertical displacement at  
159 high wind speeds. Serious displacement was deemed by the operator to be any movement over 5  
160 mm in magnitude. Most of the vertical displacement was witnessed in the rising direction with  
161 the tower settling back downwards after rotor speeds stabilised. A significant period of  
162 displacement over approximately 5 min was observed between 18:00 and 18:05. The amber and  
163 red warning lines at 3 mm and 5 mm respectively indicate the warning bands required by the  
164 operator for analysis. At 18:01 there was a large drop off in the rotor speed, which triggered  
165 large upward then large downward displacements of over 5 mm, breaching the red warning line.  
166 Five small displacement peaks between 0.5 mm and 1.5 mm were also observed. Each of these  
167 peaks correlated with the rotor speed standard deviation peaks as shown in Fig. 6.

428 Fig. 6. Effect of high wind speed on the vertical displacement of the embedded ring.

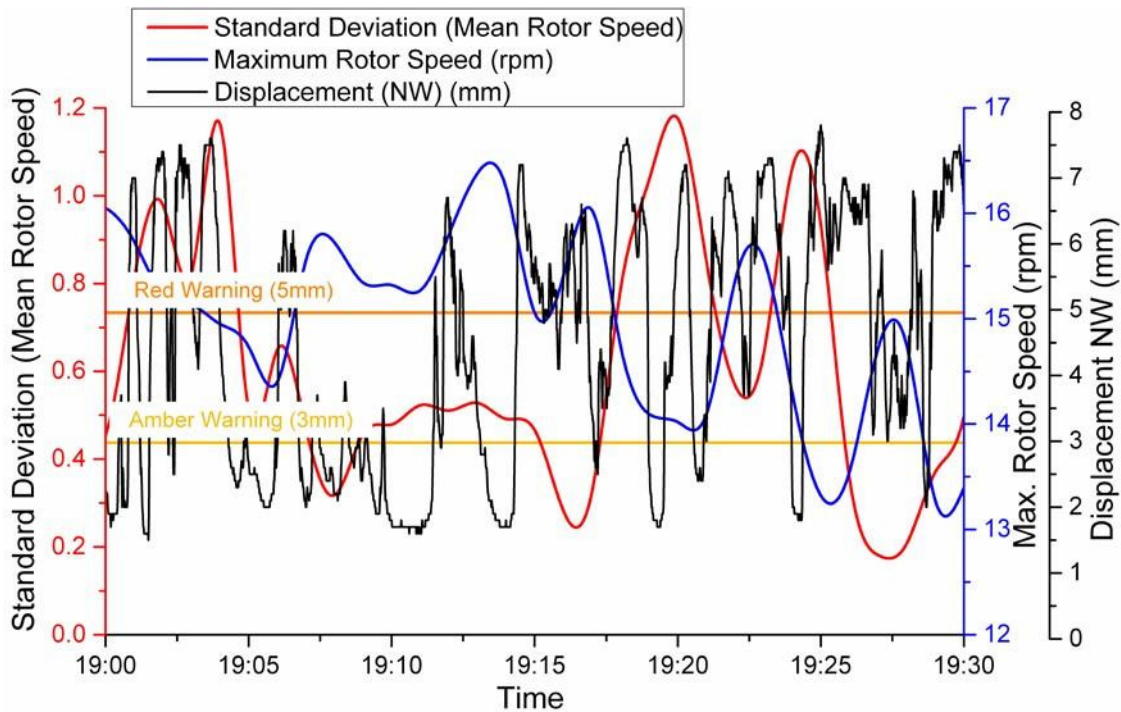
168 High wind speeds also resulted in significant vertical displacement of the ring as indicated in  
169 Fig. 7. This illustrates one of the many variable periods of displacement observed during the  
170 monitoring period. As can be seen, rising and falling of the ring around 7 mm through 6  
171 prescribed cycles were observed over a period of 15 min. The overall displacement pattern  
172 correlated roughly with the maximum rotor speed peaks and troughs as well as with the mean  
173 rotor speed standard deviation peaks. It is clear that there was a significant ring movement  
174 tracking the significant fluctuation in the rotor speed, particularly between 19:18 and 19:25, with  
175 a full cycle occurred approximately every minute. This cyclic (rise and fall) movement would be  
176 evident to an observer on site. The displacement during this period travelled through all three  
177 warning bands, resulting in red warning alerts, which would result in a warning alarm.

444 Fig. 7. Cyclic vertical displacement of the embedded ring as a result of high wind speed.

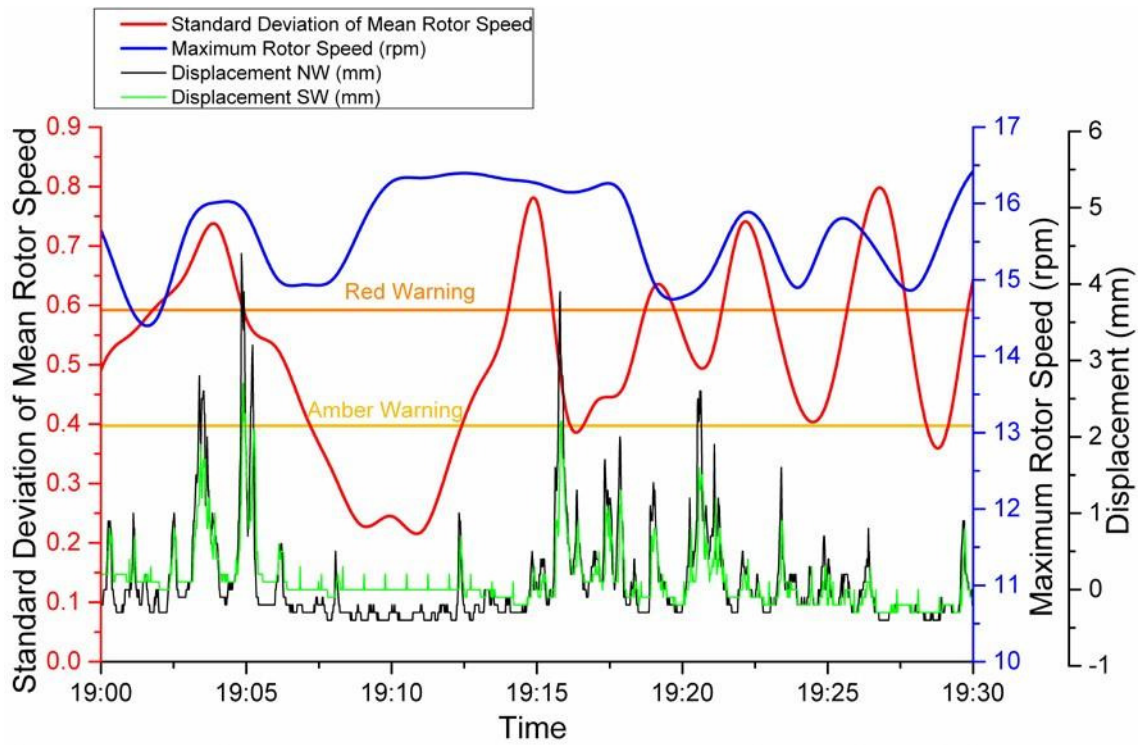
448 a)

179 Figure 8a shows the effect of the wind direction on the vertical displacement of the embedded  
180 ring. As shown, the southwesterly wind was turbulent causing rotor speed changes between 14.5

181 rpm and 16.5 rpm. As previously discussed, the displacement peaks correlated approximately  
182 with periods of the high mean rotor speed standard deviation. The NW and SW sensors picked  
183 up exactly the same movements. However, the sensor NW, orthogonal to the wind direction,  
184 recorded larger displacements at every peak. This was the result of the wind direction and  
185 ultimately the position of the rotor. It is likely that the side where the wind hit will be pushed up  
186 a little but the greatest vertical movement was observed in the side where the rotor is rotating  
187 upwards as a result of the uplift force experienced on the NW side of the foundation.

475 Fig. 8: Effect of wind direction on the vertical displacement of the embedded ring a) comparison  
476 between NW and SW sensors, b) comparison between NW, SW and SE sensors during a major  
477 change in the rotor speed.

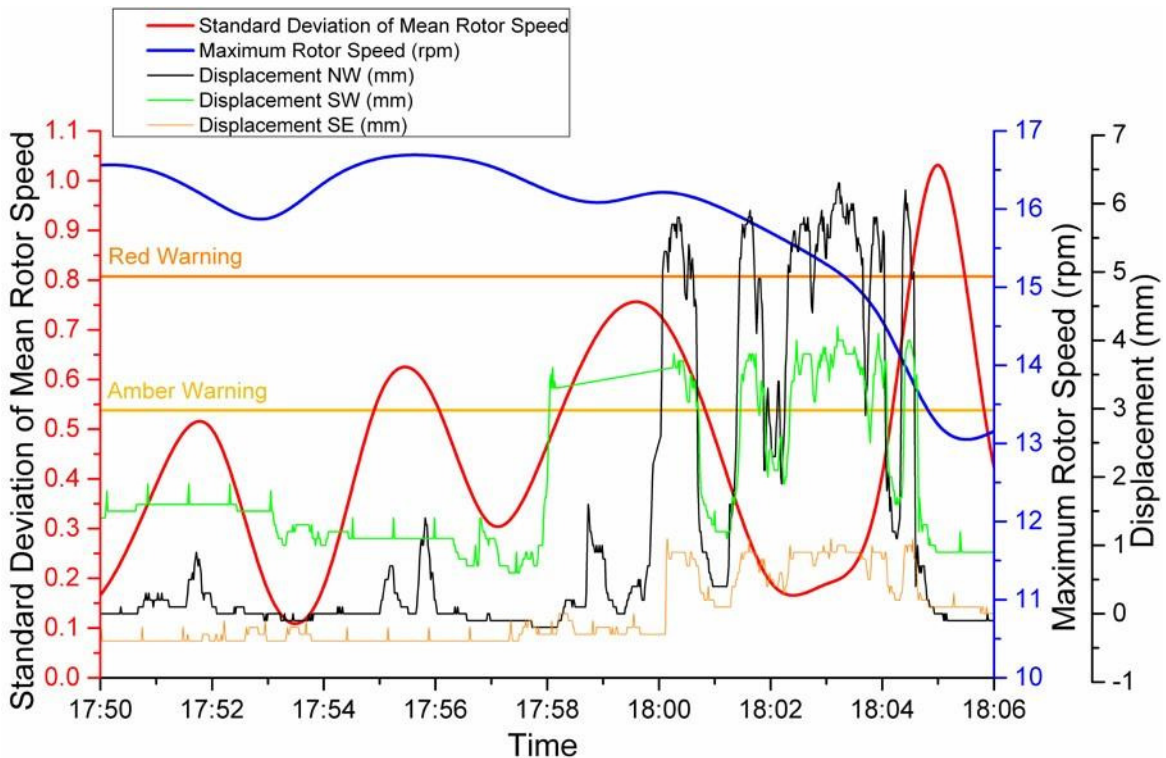
463 b)

188 Figure 8b shows the displacement recorded by the NW, SW and SE sensors during a major  
189 dip in the rotor speed. The NE sensor provided a corrupted signal. It appeared that the  
190 displacement was variable around the circumference of the ring as a result of the wind direction  
191 and the rotor uplift forces. The NW side of the ring exhibited higher displacement as compared  
192 to SW and SE sides. The response of the sensor in the SE corner was slightly below zero much  
193 of the time suggesting that the foundation has eroded allowing a negative displacement below the  
194 level the sensors were set at.
