Factors affecting the efficiency of repair to propped and unpropped bridge beams

P. S. Mangat* and F. J. O'Flaherty*

Sheffield Hallam University

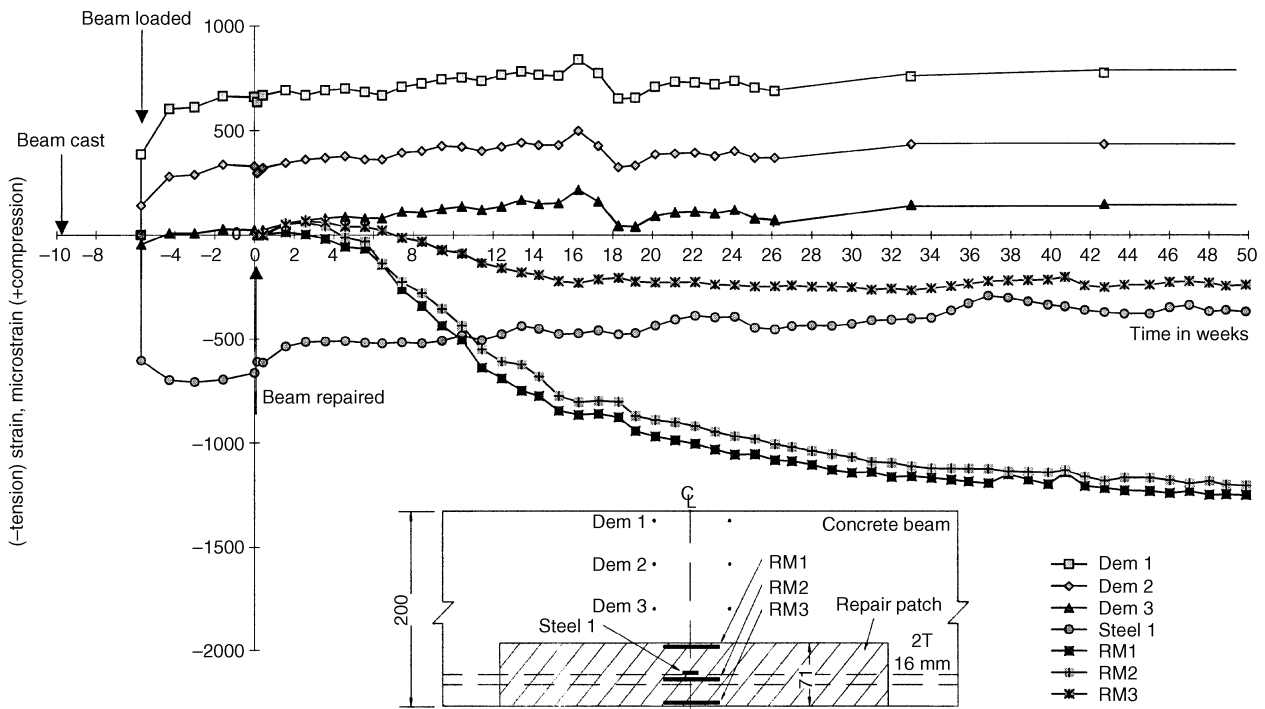
In Figs 9 and 10, the repair material shows slight contraction (positive strain) in the early stages from week 0 to week 5 (see gauges RM1, RM2 and RM3). The contraction is least in gauge RM1 compared with RM2 and RM3. This reflects maximum restraint to the free shrinkage of the repair patch at the substrate interface (location of gauge RM1). The substrate restraint decreases with increasing distance from the interface (locations RM2 and RM3) thereby permitting greater free shrinkage and, therefore, higher compressive strain. From week 5 onwards, the tensile strains in the repair material gradually increase (gauges RM1, RM2 and RM3 in Figs 9 and 10).

Figs 9 and 10). For example, in Fig. 9, the steel strain of 666 microstrain decreases to 369 microstrain at week 50. The steel reinforcement is clearly shedding tensile load to the repair material. The tensile strains monitored by gauges RM1 and RM2 in Fig. 9 approach 1300 microstrain towards the end of the monitoring period. No visual cracking was apparent in the repair patch. Cracking would have been prevented by a number of factors

- (a) E_{rm} being greater than E_{sub} (Table 2) enables shrinkage transfer of the repair material to the substrate at the interface¹²
- (b) repair material G4 having low drying shrinkage and the highest modulus of rupture (Table 2) and
- (c) a moderate degree of creep (Table 2) which results

Fig. 9. Strain profiles in the beam repaired with material G4(L), $E_{rm} > E_{sub}$, unpropped repair

Figure 9 shows that the reduction in tensile strain in the steel reinforcement (gauge 'steel 1') in the repair patch of material G4(L) was 297 microstrain over the 50-week monitoring period (weeks 0–50). The reduction in steel tensile strain in the repair patch of material L3(L) was 138 microstrain (Fig. 10). This indicates a stress transfer of 62 and 29 N/mm² respectively from the steel reinforcement. The redistribution is more effective in material G4(L) due to the absence of cracking.

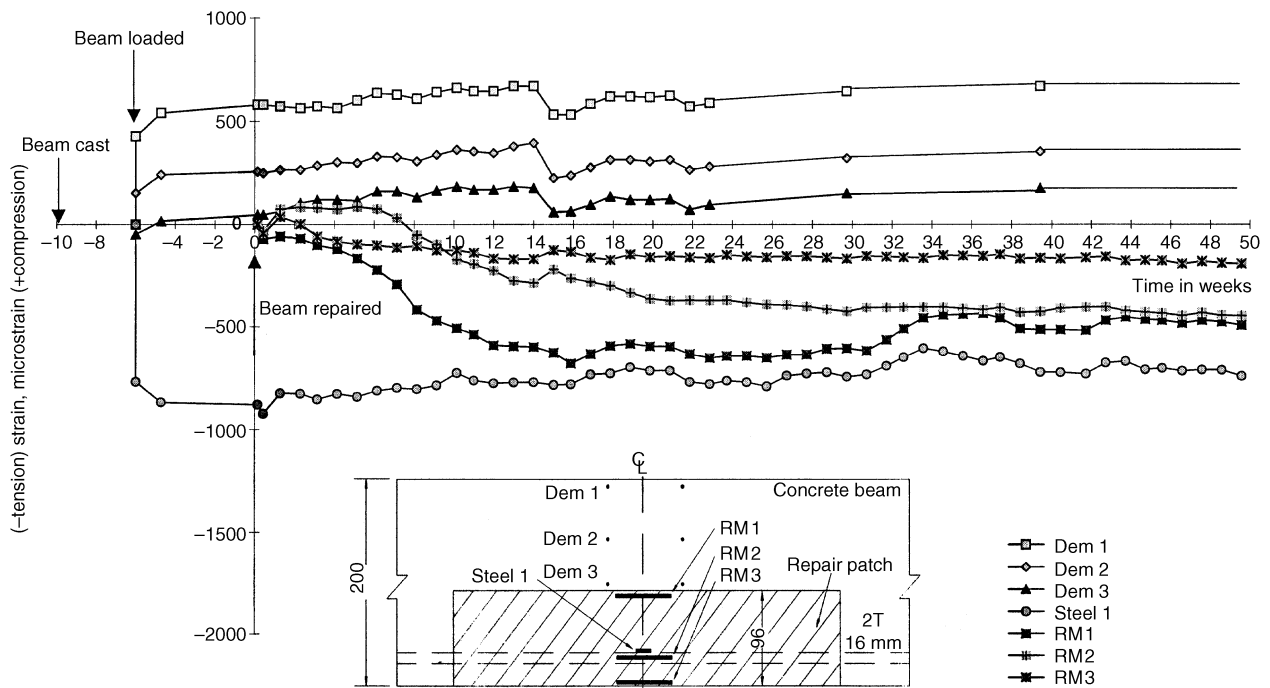
Fig. 10. Strain profiles in the beam repaired with material L3(L), $E_{rm} > E_{sub}$, unpropped repair

In the case of high stiffness ($E_{rm} > E_{sub}$) repair material L3(L) in Fig. 10, gauge RM1 at the repair/substrate interface goes into tension soon after the application of repair and develops a tensile strain of 680 microstrain after 16 weeks. The strain in gauges

RM2 and RM3 changes from compression to tension at week 8 and 2 respectively. Two tensile cracks of widths less than 0.1 mm occurred in the repair patch despite the material being of high stiffness ($E_{rm} > E_{sub}$) and, therefore, being capable of transferring shrinkage stress to the substrate and reducing restrained shrinkage tension.¹² This is due to the high shrinkage of material L3(L) (relative to material G4, Table 2) and its extre-

mely low modulus of rupture, while the creep of the two materials is similar.

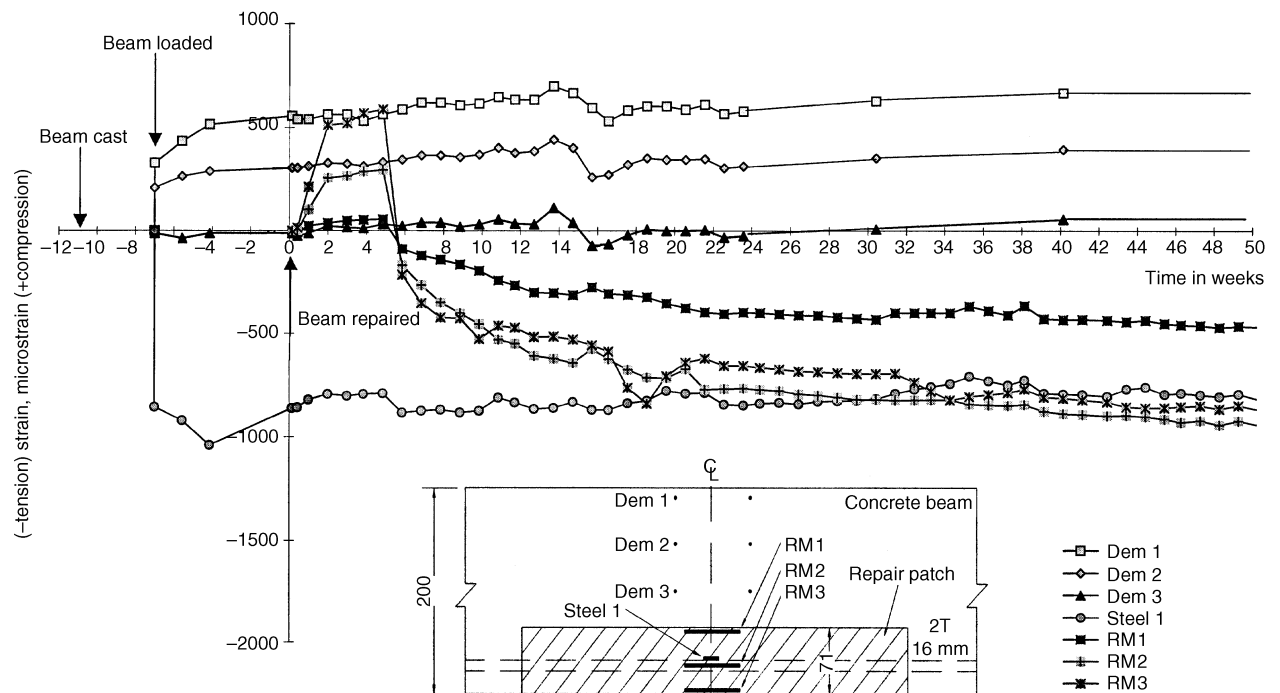
Laboratory tests, $E_{rm} < E_{sub}$. Material G6(L) has $E_{rm} = 0.56E_{sub}$ (Table 2). Strain profiles for the beam repaired with material G6(L) are plotted in Fig. 11. In the weeks immediately after the application of repair (weeks 0–5), gauges RM2 and RM3 show increasing compressive strains due to the high shrinkage of the repair material (Table 2). The compressive strain is negligible in gauge RM1 since it is attached to the repair material adjacent to the high stiffness substrate concrete ($E_{rm} \ll E_{sub}$), which restrains its

shrinkage effectively. The restraint to shrinkage decreases as the distance from the repair/substrate interface increases. Consequently, the shrinkage strains at gauge RM3 are much higher than gauge RM2 which in turn are much higher than gauge RM1. The compressive strains measured at gauges RM2 and RM3 in Fig. 11 (material G6(L)) are much higher than corresponding values recorded in Figs 9 and 10 for materials G4(L) and L3(L). This is due to the much higher free shrinkage of material G6(L) compared with the other two materials (Table 2). The virtual tensile strain in the repair material G6(L) at this stage (week 0–5) will be its free shrinkage (1100 microstrain) minus the strain reading in the gauge (RM1, RM2 or RM3). As material G6(L) has a relatively high creep (Table 2), significant relaxation would occur, thereby reducing the tensile stress in the repair patch (week 0–5). At week 5, the compressive strains abruptly change to tensile (see RM1, RM2 and RM3, Fig. 11). This is due to cracking occurring in the material, as the tensile strain due to shrinkage restraint exceeds the tensile strain capacity of the repair material. Three cracks of width less than 0.1 mm were observed in the repair patch due to a combination of low stiffness ($E_{rm} < E_{sub}$), and high shrinkage.

The strain in the steel reinforcement (gauge steel 1, Fig. 11) remains fairly constant from the time of repair, as the low stiffness ($E_{rm} < E_{sub}$) and cracked repair material is unable to attract stress from the steel reinforcement. The strains on the substrate concrete (Dem 1, Dem 2 and Dem 3) remain constant with time throughout. It can be concluded that a repair material with $E_{rm} < E_{sub}$ provides inefficient repair, since it is

Fig. 11. Strain profiles in the beam repaired with material G6(L), $E_{rm} \ll E_{sub}$, unproped repair

unable to attract load from the steel reinforcement and it cracks due to restraint provided by the stiffer substrate. Very high shrinkage aggravates cracking which results in even less stress redistribution from the steel reinforcement to the repair patch.

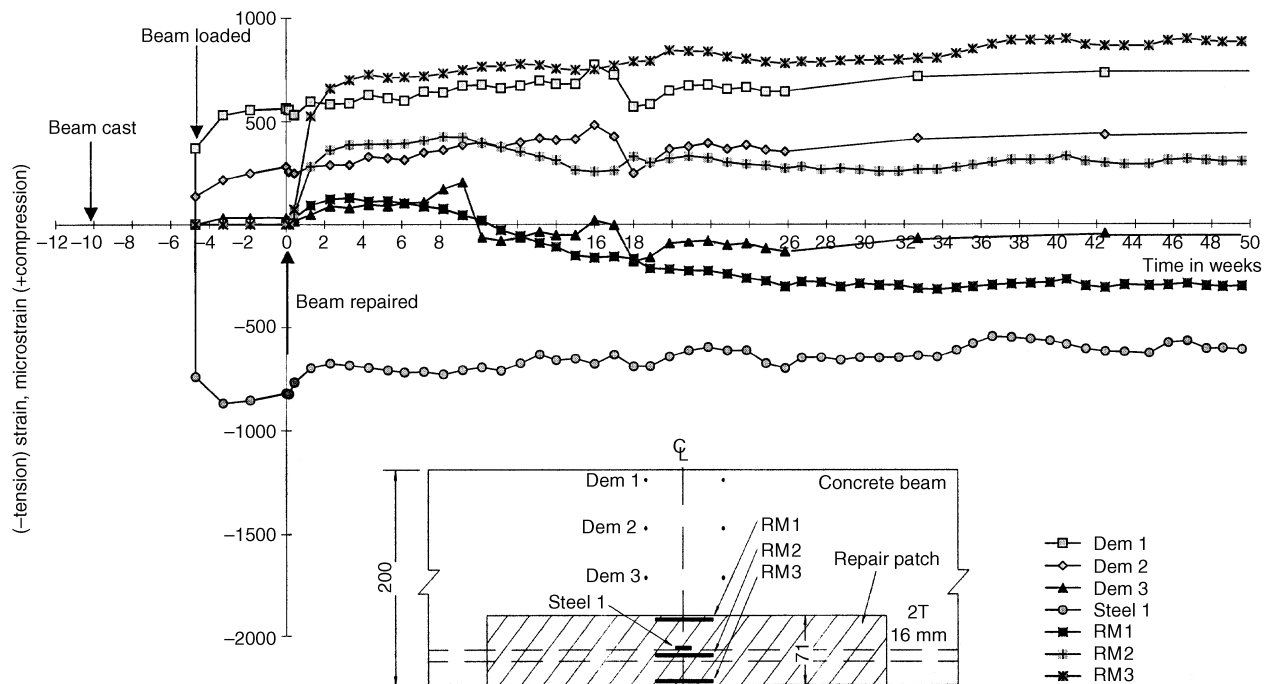
The strain profiles of the beam repaired with material G5(L), in the unpropped state, are plotted in Fig. 12; $E_{rm} = 0.96E_{sub}$ for material G5 (Table 2). The strain profiles from gauges Dem 1, Dem 2, Dem 3 and steel 1 are very similar in both Figs 11 and 12. Observations from gauge RM3 in Fig. 12 show a sudden increase in positive strain soon after repair. This is due to observed cracking out with the gauge length of RM3. The shrinkage of material G5(L) is very high (Table 2), which is responsible for cracking and, therefore, the high positive strains of gauge RM3.

The strains monitored at gauge RM2 are consistently lower than at RM3 due to partial shrinkage restraint provided by the steel reinforcement. The shrinkage restraint provided by the substrate concrete at the repair interface (gauge RM1) is not as high as in Fig. 11 (material G6). This is due to the higher elastic modulus of material G5 than material G6, which results in substrate restraint being greater for G6.

Fig. 12. Strain profiles in the beam repaired with material G5(L), $E_{rm} < E_{sub}$, unpropped repair

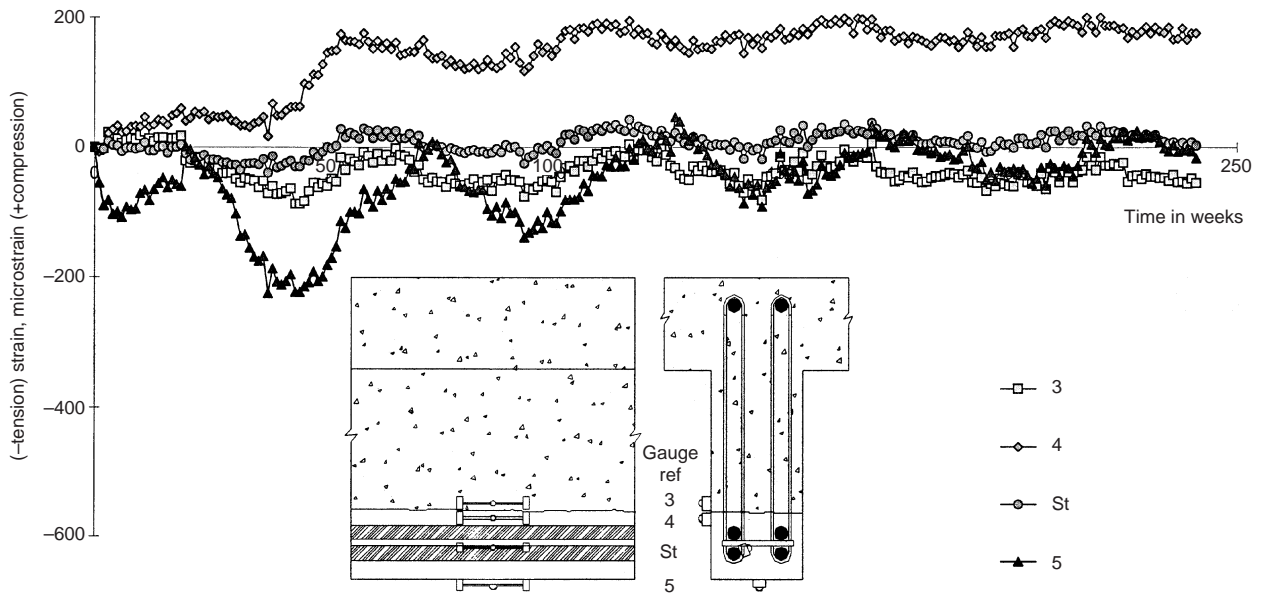
Fig. 13. Strain profiles in the lateral beam section repaired with material G4, Gunthorpe bridge, $E_{rm} < E_{sub}$, unpropped repair

The repair patch of material G4 in beam B8 (Fig. 13) shows fairly good strain compatibility between the substrate and repair material at the interface (gauges 3 and 4 respectively) over the first 20 weeks (approximately). The stiffness of the repair material is slightly less than that of the substrate ($E_{rm}/E_{sub} = 0.85$) and

the substrate is effective in restraining the shrinkage of the repair material. Over a period of time, however, the restraint to shrinkage becomes less and the strains monitored by gauges 3 and 4 drift apart. The repair material adjacent to the substrate (gauge 4) is able to attain shrinkage strains of around 200 microstrain which is about 50% of the free shrinkage of the repair material (Table 2). No tensile cracking due to restrained shrinkage was observed in the repair patch of beam B8 (Fig. 13). This was due to the relatively low free

shrinkage of material G4 and the fact that E_{rm} was only marginally less than E_{sub} , which resulted in less than absolute shrinkage restraint by the substrate.

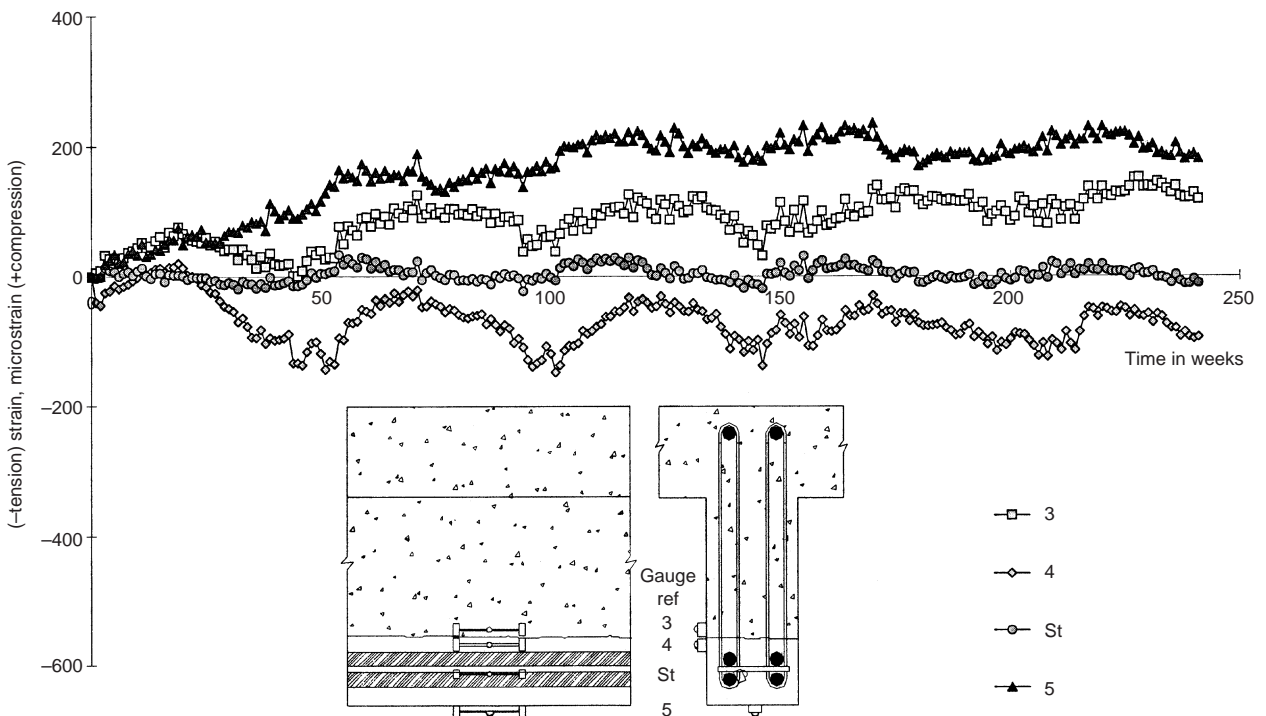
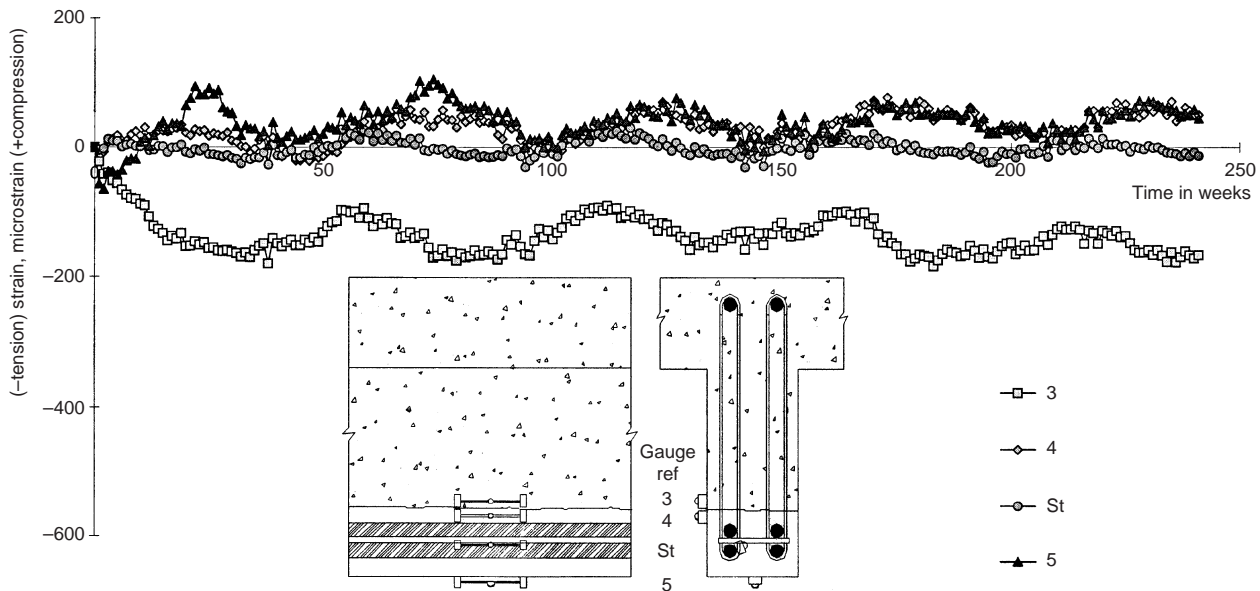
Fig. 14. Strain profiles in the lateral beam section repaired with material G5, Gunthorpe bridge, $E_{rm} \ll E_{sub}$, unpropped repair

Fig. 15. Strain profiles in the lateral beam section repaired with material G6, Gunthorpe bridge, $E_{rm} \ll E_{sub}$, unpropped repair

The stiffness of the repair materials G5 and G6 used to repair beams B6 and B7 (Figs 14 and 15) was much less than the substrate ($E_{rm}/E_{sub} = 0.70$ and 0.41 respectively). In addition, the free shrinkage of these repair materials was very high (Table 2). Soon after the application of repair, the substrate provided effective restraint at the interface and, therefore, caused typical restrained shrinkage cracking in the repair due to high tensile stresses. The corresponding high creep of materials G5 and G6 (Table 2) was unable to prevent cracking by relieving tensile stress. Cracking results in inconsistent strain differentials between gauges 3, 4 and 5 in Figs 14 and 15.

The strain–time profile of the steel reinforcement in Figs 13, 14 and 15 remains unaffected by the application of the repair patch. This indicates that repairs with $E_{rm} < E_{sub}$ are ineffective in causing long-term load redistribution from the reinforcement.

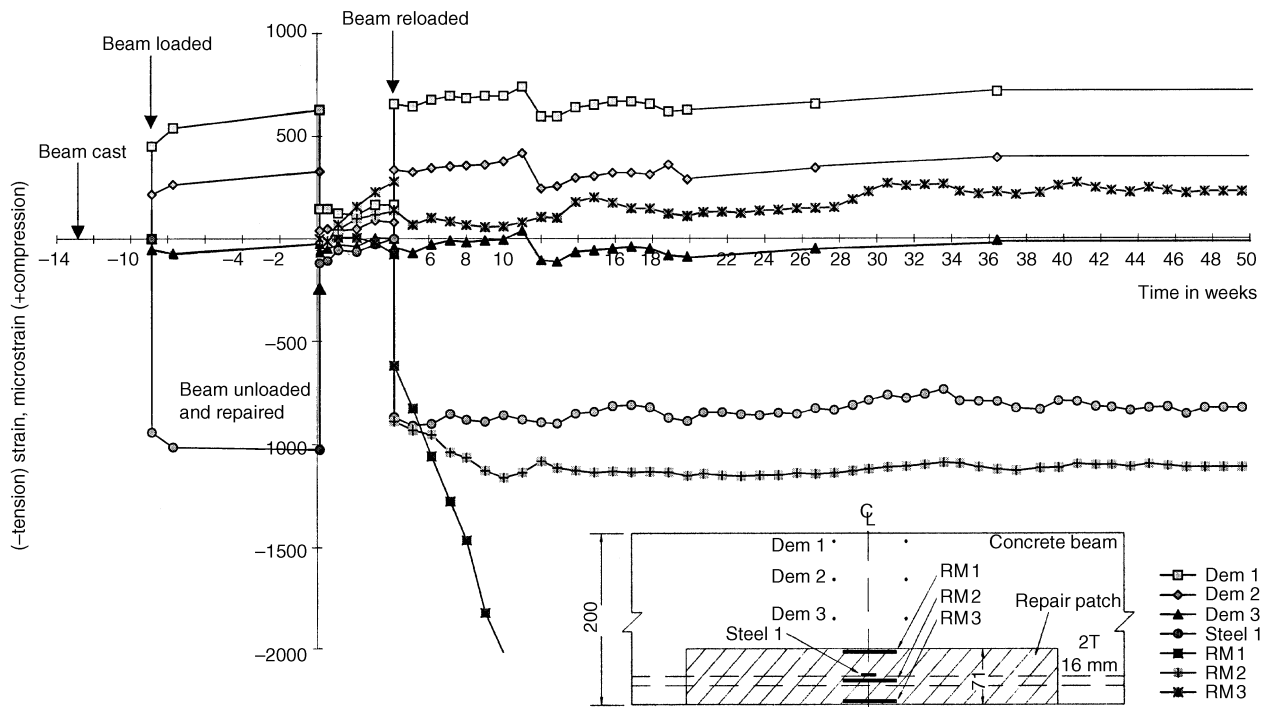
Laboratory tests ($E_{rm} > E_{sub}$). The strain–time graphs of the beam repaired with material L3(L) are plotted in Fig. 16. Datum readings were taken 24 h after the application of the repair patch (represented as week 0 in Fig. 16). Residual strains in the substrate concrete (gauges Dem 1, 2, 3) and steel reinforcement (gauge steel 1) were present at week 0, since the beam had been loaded at approximately week -9 to eliminate the effects of creep in the

substrate concrete, as described earlier. The beams were cured for four weeks prior to loading, shown as approximately weeks -9 to -13 in Fig. 16. Upon unloading the beam at week 0 (simulating propping), it is observed that some compressive strain remains in the substrate concrete (gauges Dem 1 and Dem 2, weeks 0–4) due to residual creep. A small tensile strain is also evident in the steel reinforcement at week 0, but this decreases towards zero at week 4 as the free shrinkage strain of the repair patch is transferred to the steel reinforcement while the beam remains in a propped state. During the propped repair period (week 0–4), gauges RM2 and RM3 record gradually increasing compressive strains due to the free shrinkage of the repair patch. The strains recorded by gauge RM1 at the interface are very small due to restraint provided by the substrate to the early age shrinkage of the repair material.

Upon reapplication of the load at week 4, gauges Dem 1 and Dem 2 attain high compressive strains which remain relatively constant for the remainder of the monitoring period. Tensile strain is induced in the steel reinforcement (gauge steel 1) which remains relatively constant throughout the monitoring period. Negligible redistribution of strain took place in this repair patch as indicated by the almost constant strains in the steel reinforcement (gauge steel 1) and repair material (gauges RM2 and RM3). The lack of redistribution was due to severe cracking which occurred in the repair material during the reloading operation at week 4 (indicated by the sudden large tensile strain in gauges RM1 and RM2, Fig. 16). Some of the crack widths were greater than 0.1 mm. Comparing the performance of this repair patch with a similar repair patch applied to an unpropped member (Fig. 10), it is clear that propping during the application of repair and subse-

Fig. 16. Strain profiles in the beam repaired with material L3(L), $E_{rm} > E_{sub}$, propped repair

quent reloading (depropping) greatly increases the tensile strains in the repair patch (compare gauges RM2 in Figs 10 and 16). The unpropped repair with material L3(L) (Fig. 10) developed insignificant cracking compared with cracking produced in the propped repair (Fig. 16). In the case of unpropped repairs, cracking in the repair patch is caused by restrained shrinkage effects which occur gradually over a period of time and are neutralized to some extent by creep¹³ and by the high stiffness ($E_{rm} > E_{sub}$) of a repair material.¹⁴ In propped repairs, cracking is caused by the sudden load sharing (composite action) induced by depropping,

which leads to typical flexural cracking in the repair patch.

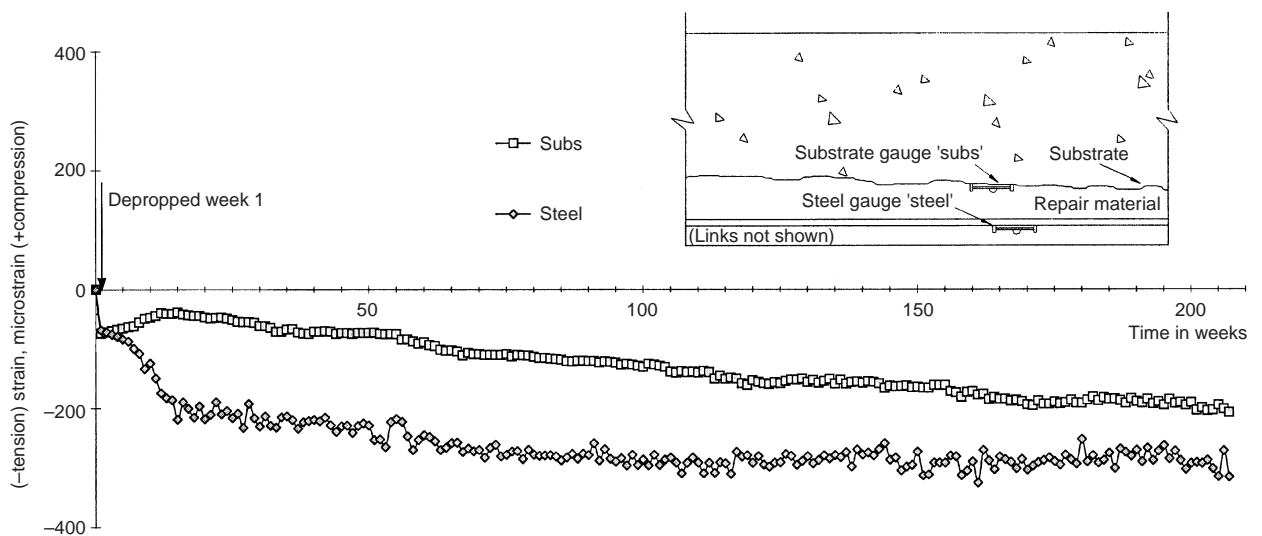
Field repairs, Sutherland Street bridge ($E_{rm} > E_{sub}$). The strain–time graphs for repair patches made with flowing materials S1 and S4 are presented in Figs 17 and 18 respectively. The location of the strain gauges in the repair material at the substrate interface ('subs') and on the steel reinforcement was outlined in the section entitled 'Strain monitoring'. Datum readings (at week 0 in the figures) were taken 24 h after the application of repair. The repair with material S1 (Fig. 17) was depropped at week 1. This

Fig. 17. Strain profiles in the portal frame beam repaired with flowing material S1, Sutherland Street bridge, propped repair, $E_{rm} > E_{sub}$

induced instantaneous tensile strains in the repair at the 'subs' gauge location and in the steel reinforcement (approximately 75 microstrain). The tensile strain in the reinforcement increased rapidly to approximately 220 microstrain at week 18. This was due to extensive cracking in the repair patch where closely spaced horizontal cracks across the width of soffit were observed. From week 18 onwards, the steel strain remained fairly constant until the end of the monitoring period. Material S1 has also been used to repair propped compression members,¹³ in which case no long-term cracking was observed in the repair patch.¹³ This indicates that cracking in the propped flexural repair is due to sudden load transfer upon depropping instead of long-term shrinkage effects.

The tensile strain recorded by the 'subs' gauge, upon depropping (Fig. 17), gradually decreases up to about 14 weeks. This is possibly due to the shrinkage transfer of the relatively stiffer repair material ($E_{rm} > E_{sub}$) to the substrate in a similar manner as was observed in bridge abutments repaired with sprayed materials.¹² In the long term, beyond 20 weeks, a gradual increase in tensile strain occurs in the repair material at the substrate interface ('subs' gauge), indicating load redistribution effects occurring in the repair patch.

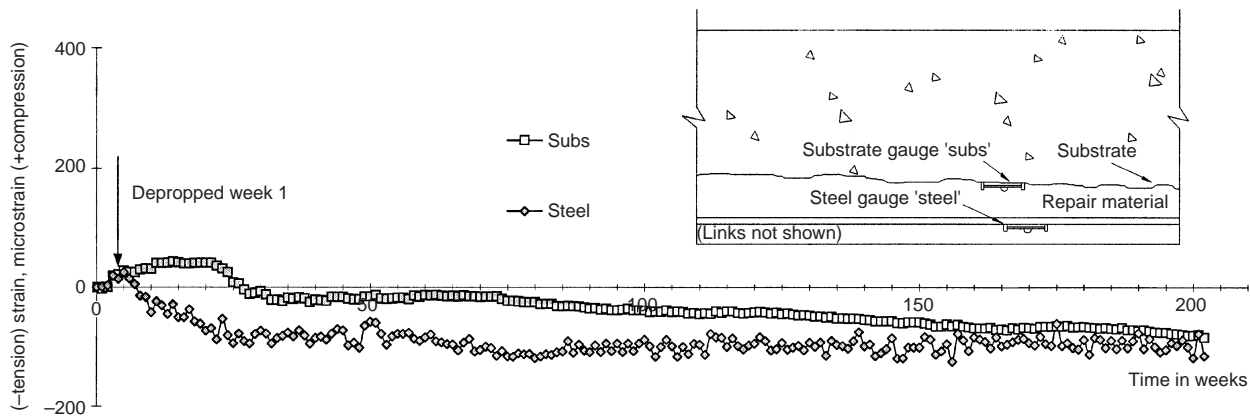
Fig. 18. Strain profiles in the portal frame beam repaired with flowing material S4, Sutherland Street bridge, propped repair, $E_{rm} > E_{sub}$

The repair with material S4, Fig. 18, was depropped at week 3. Between weeks 3 and 21, the tensile strain in the steel reinforcement increases gradually, without any sudden and rapid increase as shown in Fig. 17 for material S1. This is due to material S4 remaining uncracked throughout the monitoring period. The effects of depropping are far more inconsistent in field structures compared with laboratory repairs (see next subsection) due to the greater control of depropping in the laboratory. Repairs to propped compression members also showed inconsistent and erratic long-term strain distribution due to the non-uniform load transfer caused by the depropping process.¹³

The absence of cracking in the repair patch (Fig. 18) also allows some shrinkage transfer from the higher

stiffness repair material ($E_{rm} > E_{sub}$) to the substrate. In the long term the substrate develops tensile strain due to external load transfer; similar behaviour of load transfer has been observed in compression members.¹²

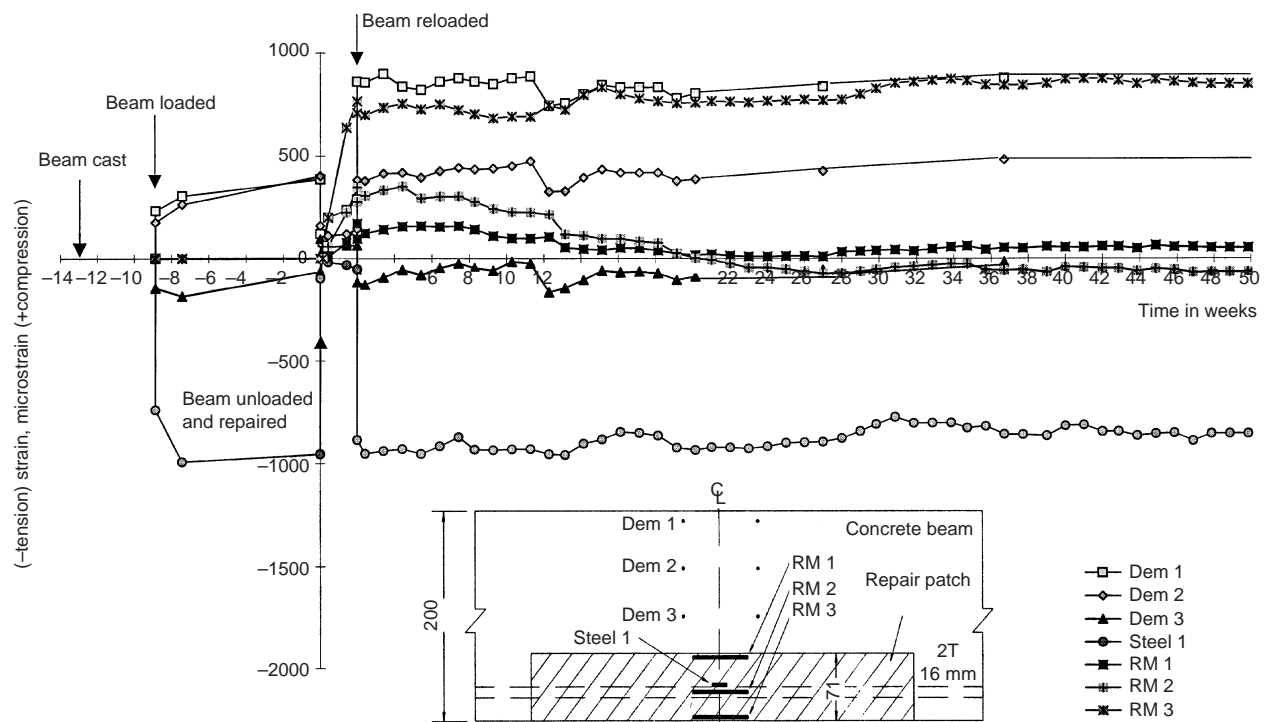
Laboratory tests, $E_{rm} < E_{sub}$. The strain profiles of the beam repaired with material G5 (Table 2), in the propped state, are presented in Fig. 19. The beam was cast in the laboratory at week -13, cured for 28 days to week -9 and loaded under service load for nine weeks (week -9 to 0). To simulate propped repair, the load was removed at week 0 and the repair patch applied. Upon hardening of the repair, at week +2, the load was reapplied (simulating depropping).

A comparison of Figs 12 and 19, representing unpropped and propped repairs, shows that the strain profiles in the substrate (compression zone) are similar in both cases (gauges Dem 1, Dem 2 and Dem 3). The strain profiles for the steel reinforcement appear similar in both cases but the magnitude of strain in the propped repair (Fig. 19) is clearly higher. This is due to the fact that upon application of load (depropping), the tensile zone (repair patch) cracked in the typical pattern of reinforced concrete beams. Such flexural cracking was not observed in the unpropped repair (Fig. 12) where effective structural interaction between the substrate and the repair patch occurred gradually with time. In the case of propped repairs, long-term interaction between the repair patch and substrate is ineffective both in beams and compression members.¹³

Fig. 19. Strain profiles in the beam repaired with material G5(L), $E_{rm} < E_{sub}$, propped repair
