Failure analysis of duplex 2205 gas separator welds

Nevasmaa, Pekka; Yli-Olli, Sanni

Published in:
BALTICA XI 2019

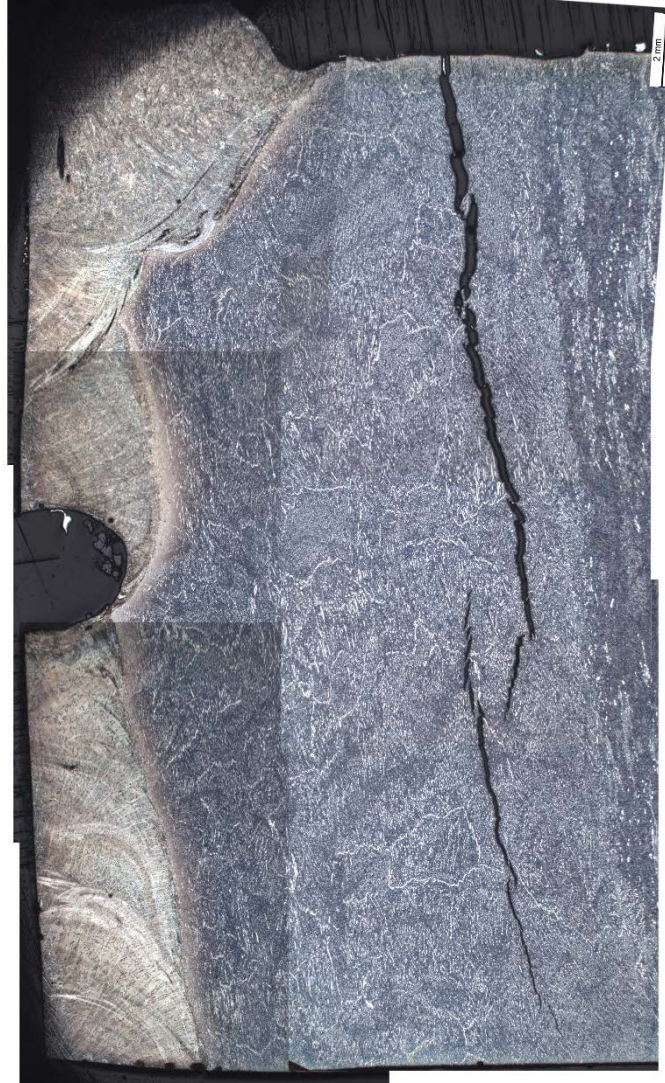
Figure 1. Cross section sample from a cracked detail: crack initiation at the plate surface close to the weld (left), crack propagation nearly through the entire section thickness, with occasional crack branching.

Additionally, the welded sides of samples cut along the weld centerline revealed internal volumetric imperfections and defects within the weld metal close to the weld centre region in the plate thickness direction (c.f. Figure 1). These imperfections imply that welding of the weld root region, in this respect, had technically failed, which, in turn, had prevented achieving a sound weld root and hence resulted in poor weld quality.

According to the LOM microscopy of the cross section samples, the main cracks appeared very deep; they had propagated nearly through the entire section thickness (Figure 1). Several individual microcracks, of which one has grown to a main crack, were discovered on the plate outer surface (Figure 7). Various secondary microcracks, as well as pronounced crack branching and crack bridging were also found along the crack propagation path.

copy revealed no evidence of the presence of any *brittle metallic phases*, such as sigma phase. The discovered internal volumetric *imperfections within the weld metal* close to the weld root region (c.f. Figure 1) imply that welding of the root had technically failed in this respect; however, the weld metal defects were not in direct connection to the observed failure and are hence of secondary importance in this sense.

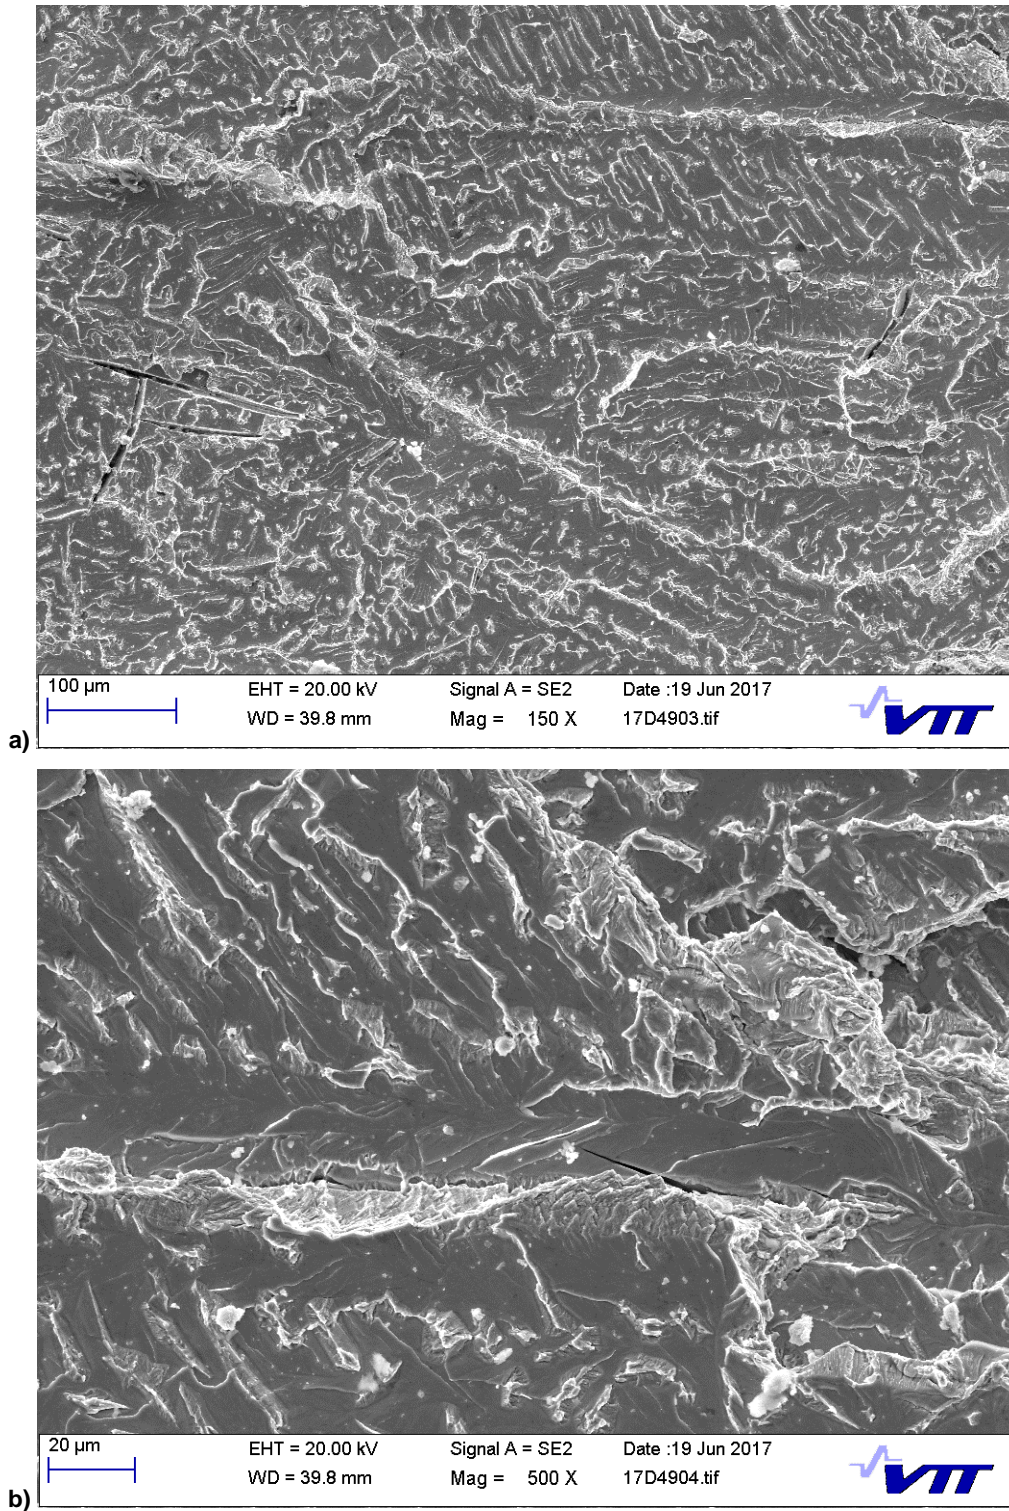
The results of the fractographic investigation using scanning electron microscopy (SEM) with energy dispersive X-ray spectroscopy analysis (EDS) are shown in Figures 2–5. The fracture surface had two different types of dominating areas. The first type was relatively flat showing several side cracks with random orientation, as well as ridges and very few striations and “feathery” like fracture propagation (Figures 2, 4 and 5). The second areas were smaller and revealed often relatively steep level changes between the flat areas, showing dimples and more ductile fracture propagation (Figure 3).

Figure 2. Fracture surface near the plate outer surface, showing “flat” fracture and side cracks. (a) Outer surface on top, fracture propagation from top to bottom; (b) detail of the fracture surface in (a).

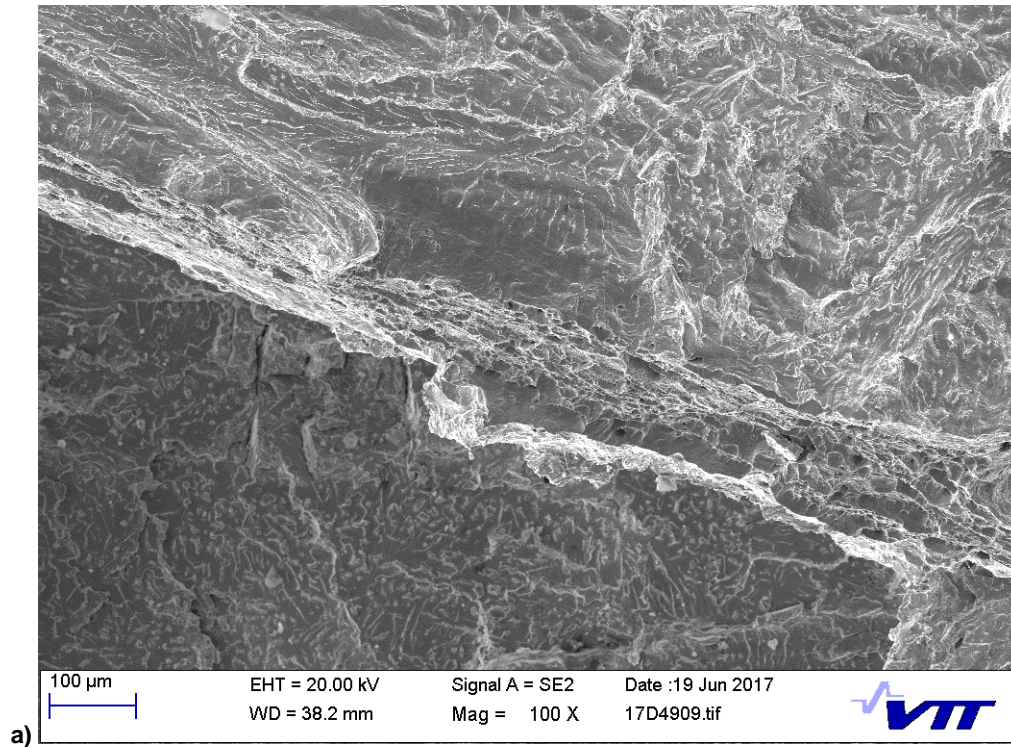
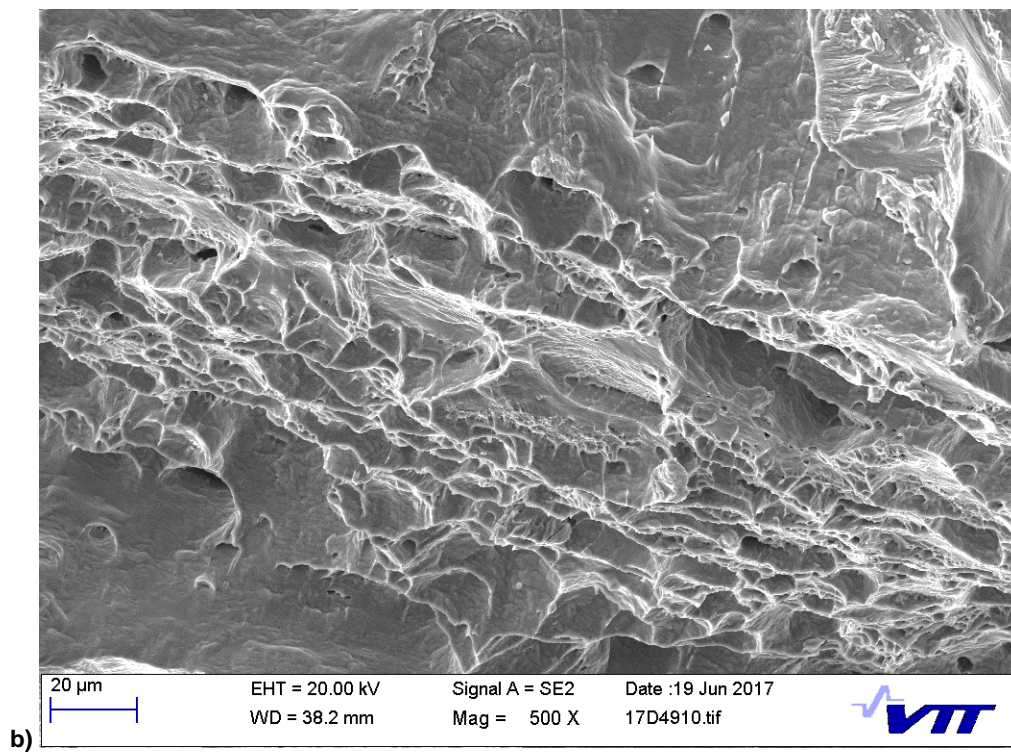
Figure 3. Fracture surface from the middle of the sample, showing level changes and dimples. (a) Outer surface on top, fracture propagation from top to bottom; (b) detail of the fracture surface in (a).

- (vi) The propagating cracks typically tend to circumvent the austenite phase, rather than grow within or across it (Figure 12)
- (vii) When cracks did propagate in the austenite, the associated fracture mode was ductile tearing, i.e. ductile overload (Figure 3).

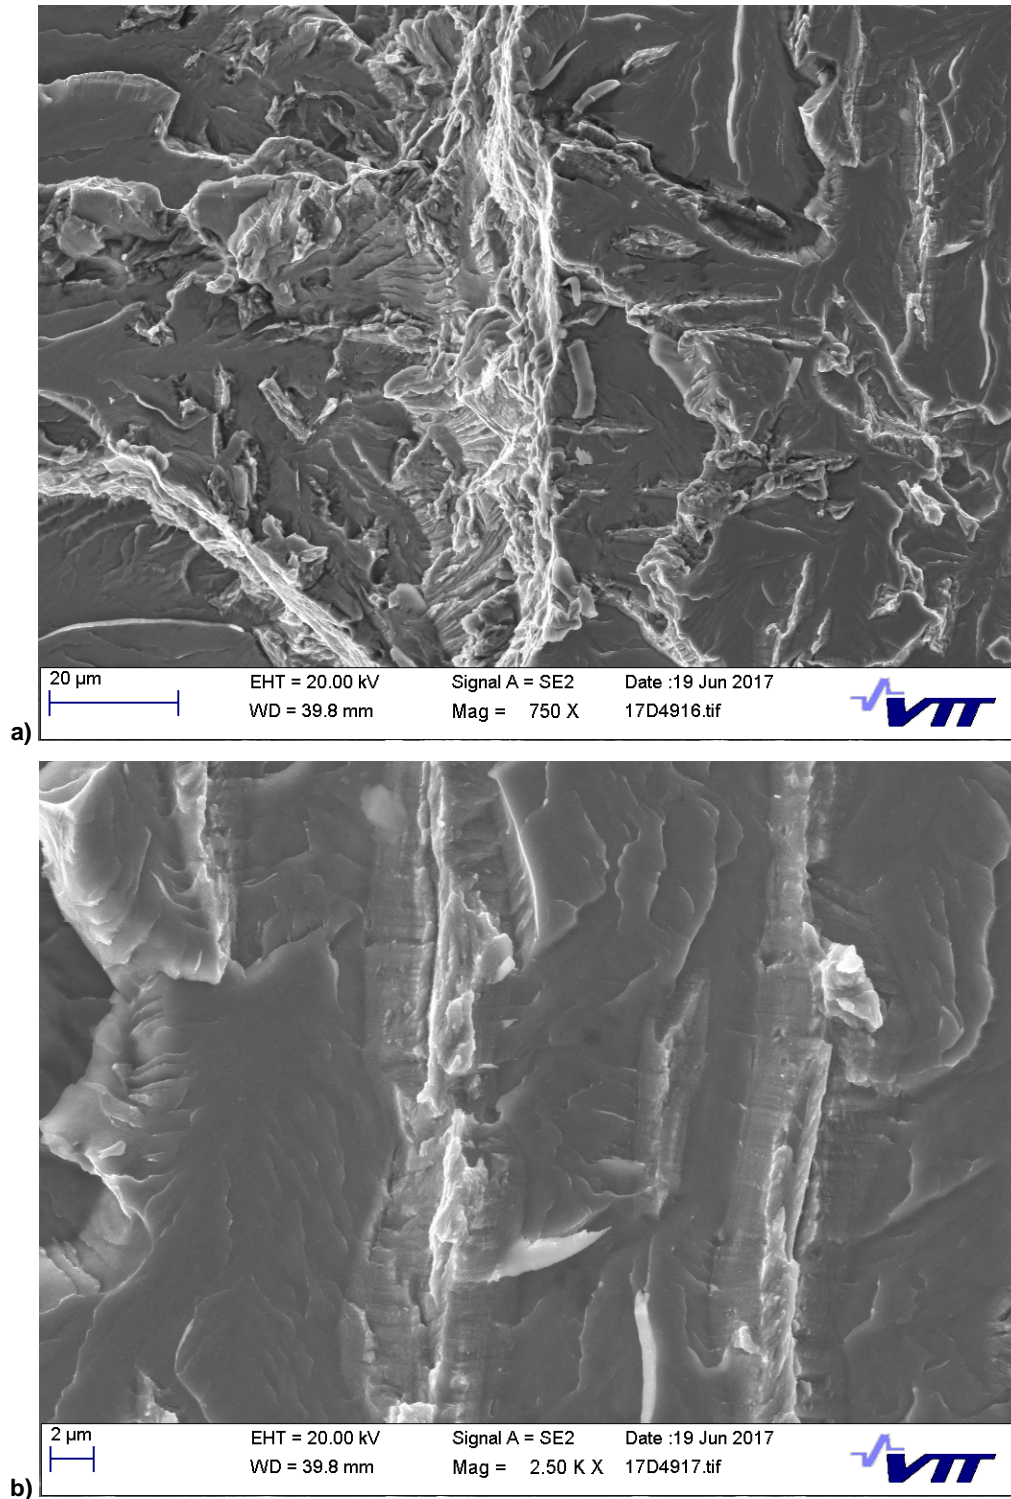
Figure 4. Fracture surface from the middle of the sample, showing (a) ridges; (b) striations. Outer surface on top, fracture propagation from top to bottom.

That the fractography revealed *local areas with striations* on the crack fracture surfaces, oriented perpendicular to the crack growth direction (Figure 4b), is considered somewhat unexpected. According to the customer, there should not have been such variable loads during the operational period of the present gas separator that are expected to cause any fatigue damage. The observed striations were therefore examined carefully, in order to rule out the possibility that they in fact could have been some kind of ridges caused by stepwise propagation of cracks provoked by the HISC mechanism. It is worth pointing out that a possibility of confusing between fatigue-associated striations and stepwise ridges caused by the HISC mechanism has been addressed in the literature. The authors opinion, however, is that the discovered features on the fracture surfaces in the present case are truly striations and, hence, an indisputable evidence of fatigue failure mechanism that has occurred at later stages of the crack propagation. Apart from striations, *ridges* were also discovered on the crack fracture surfaces (Figure 4a); however, the appearance of ridges clearly relates to a different scale of fractographic details; compare Figures 4a and 4b.

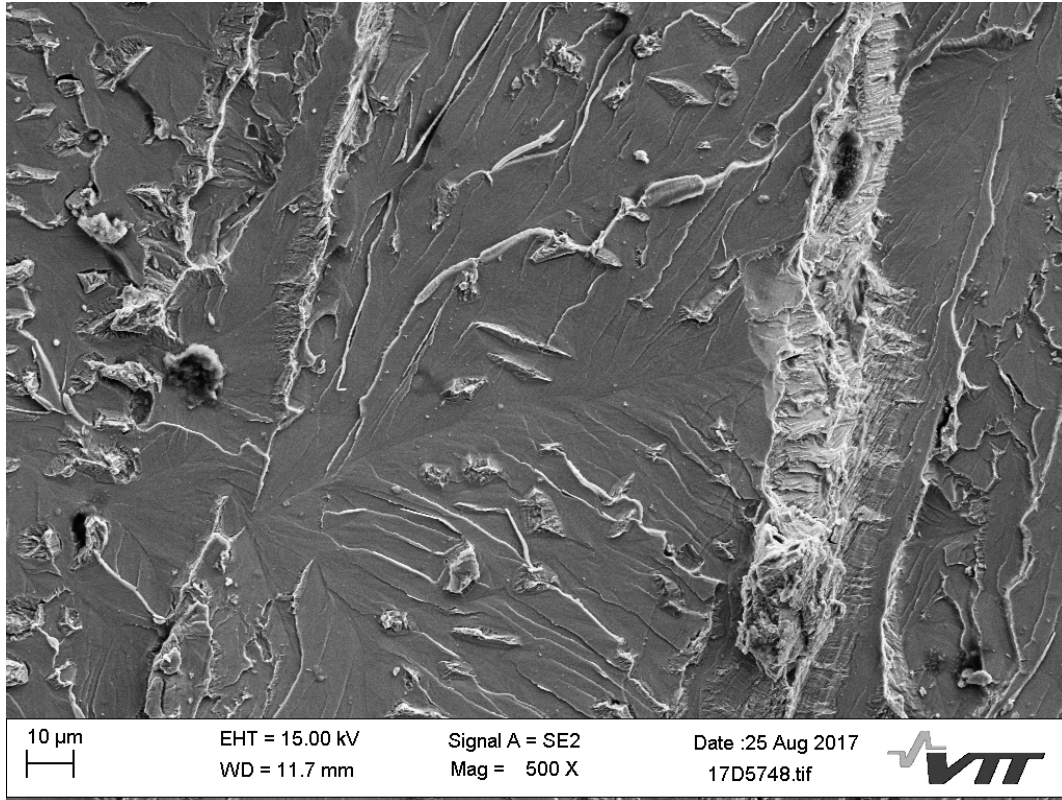
Figure 5. Fracture surface of the sample, showing features of “feathery” structure.

Literature on *hydrogen damage* reports that sc. “feathery” structure on the fracture surface accompanied by cleavage-like cracking macroscopically parallel to {100} crystallographic planes in <110> directions, with extensive slip on {111} planes intersecting transgranular cracks, has been attributed to sc. AIDE (Adsorption Induced Dislocation Emission) mechanism [5]. An example showing features of such “feathery” structure on the cleavage-like crack fracture surface in the present duplex material is given in Figure 5. The AIDE mechanism is one of the three postulated main micromechanisms associated with hydrogen-assisted cracking [5]. The features in Figure 5 can therefore be regarded as further evidence of the decisive role of hydrogen in inducing the crack initiation and assisting crack propagation in the present case. Since the examples given in the literature [5], however, were frequently associated with metallic materials other than duplex steel, the existence of the AIDE mechanism in the present case cannot be solely confirmed, nor excluded.

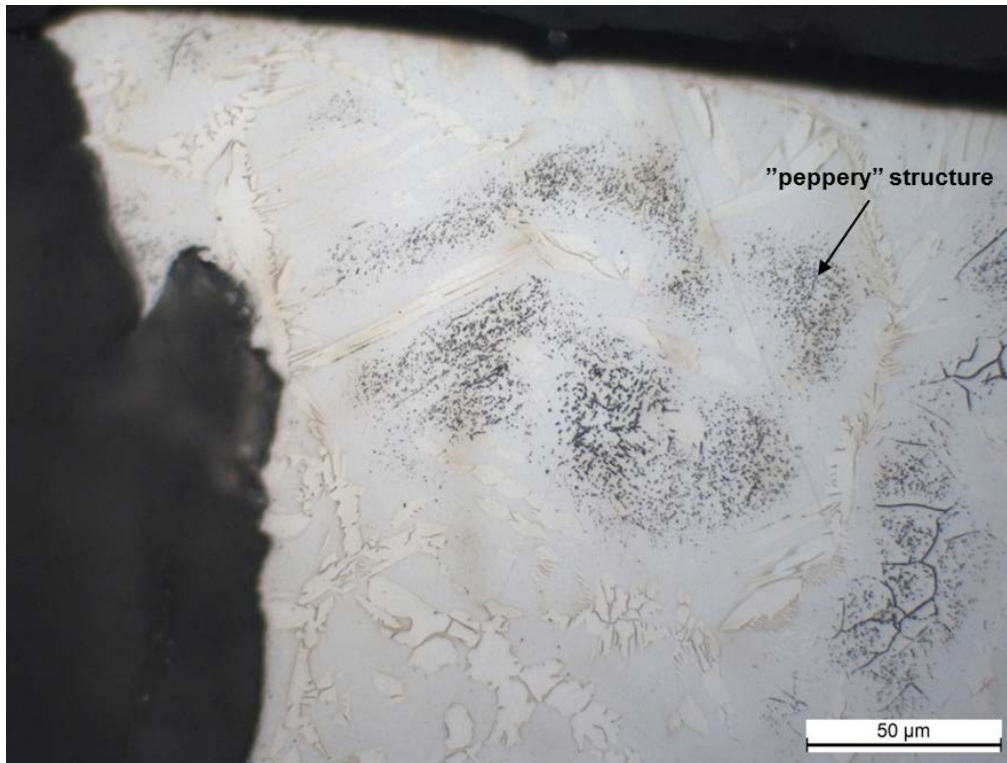
An abnormal “peppery” structure was observed as a thin layer immediately next to the plate surface and adjacent to the main crack. This anomalous structure presented coarse grain size composing of elongated side-plate/ lath-like austenite mainly in the ferrite grain boundaries and heavy intragranular precipitation within the ferrite phase (Figure 6). The depth of the anomalous structure varied from 80 to 200 μm, being ~90 μm at the crack initiation site (Figure 7).

Figure 6. A thin abnormal layer next to the plate surface, adjacent to the main crack ("peppery" structure).

- (ii) The presence of intragranular Cr₂N precipitates and a coarse-grained microstructure within a thin layer next to the plate surface, promoting crack initiation via HISC (Figures 6, 9 and 10).

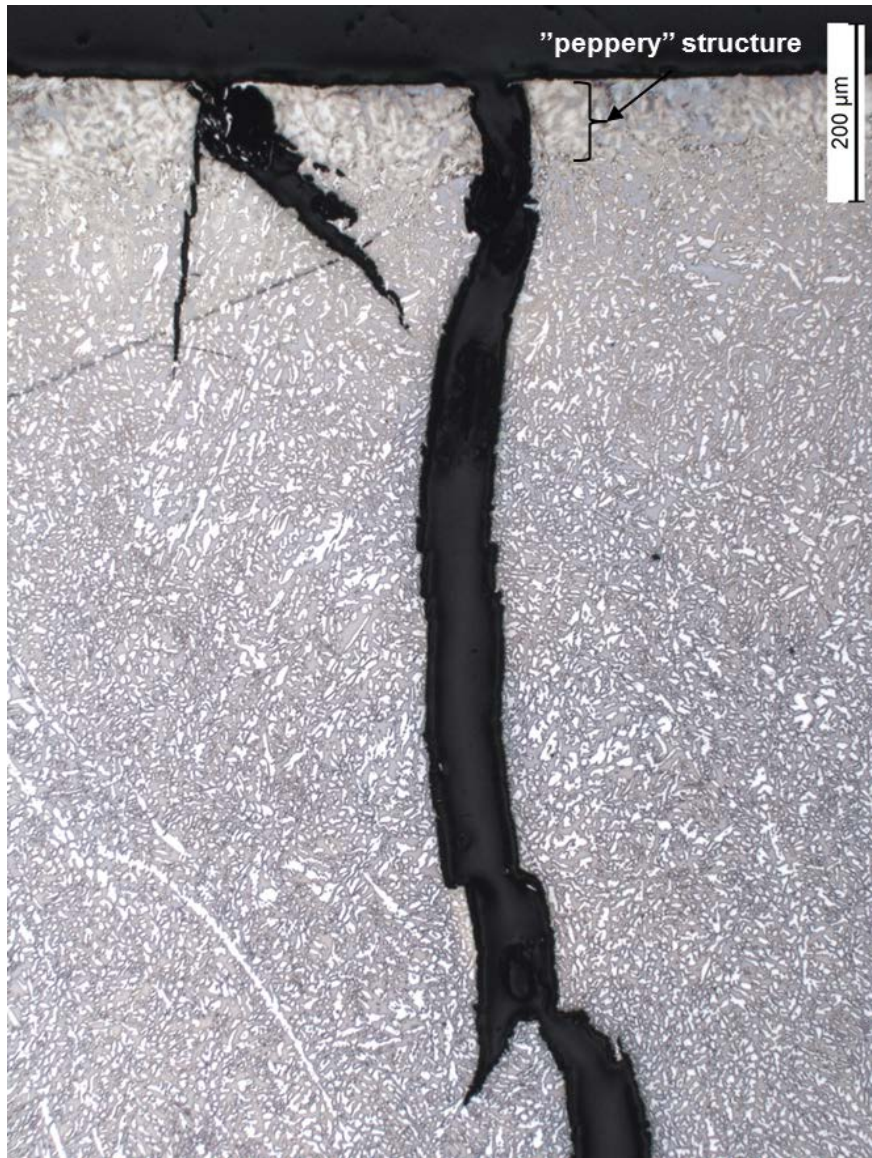
Figure 7. Crack initiation at the outer surface of the specimen close to the weldment, thin layer with “peppery” structure, several individual microcracks at the surface, crack branching along the propagation path.

- (i) The existence of multiple individual surface microcracks close to the plate outer surface, immediately adjacent to the primary crack, acting as initiation sites for HISC (Figure 7).

A crucially important factor promoting crack initiation in the examined samples is obviously the presence of *local anomalous microstructures* within a thin layer next to the plate surface and close to the individual surface cracks (Figures 6, 7, 9 and 10). It consists of a phase morphology rather resembling the HAZ than base material in the sense that the grain size is coarsened, and the austenite phase has elongated to resemble a side-plate/lath like structure decorating and delineating the primary-ferrite grain boundaries. The ferrite grain interiors show only small amount of austenite. Significant amounts of precipitates are recognised within the ferrite phase resembling classical intragranular “peppery” structure (Figure 10) typical of e.g. ferritic stainless steel HAZ [1] and consisting of chromium nitrides, Cr₂N, precipitated during fast cooling after prior heating stage. It is also noteworthy that this thin surface layer exhibited hardness clearly higher than that associated with either the ferrite or the austenite phase alone (Table 2). The presence of intragranular Cr₂N precipitates and coarse-grained microstructure have been attributed to an increased susceptibility to hydrogen embrittlement and a degradation of the HISC resistance of the duplex material [1]. There exists evidence that the Cr₂N precipitates induce a detrimental effect on the HISC resistance via their ability to lower the net section stress at failure, i.e., they impair the mechanical properties of the duplex microstructure under external loading conditions. This effect is further aggravated by the presence of hydrogen and subsequent transportation of diffusible hydrogen to areas with tri-axial stresses, such as weld toe.

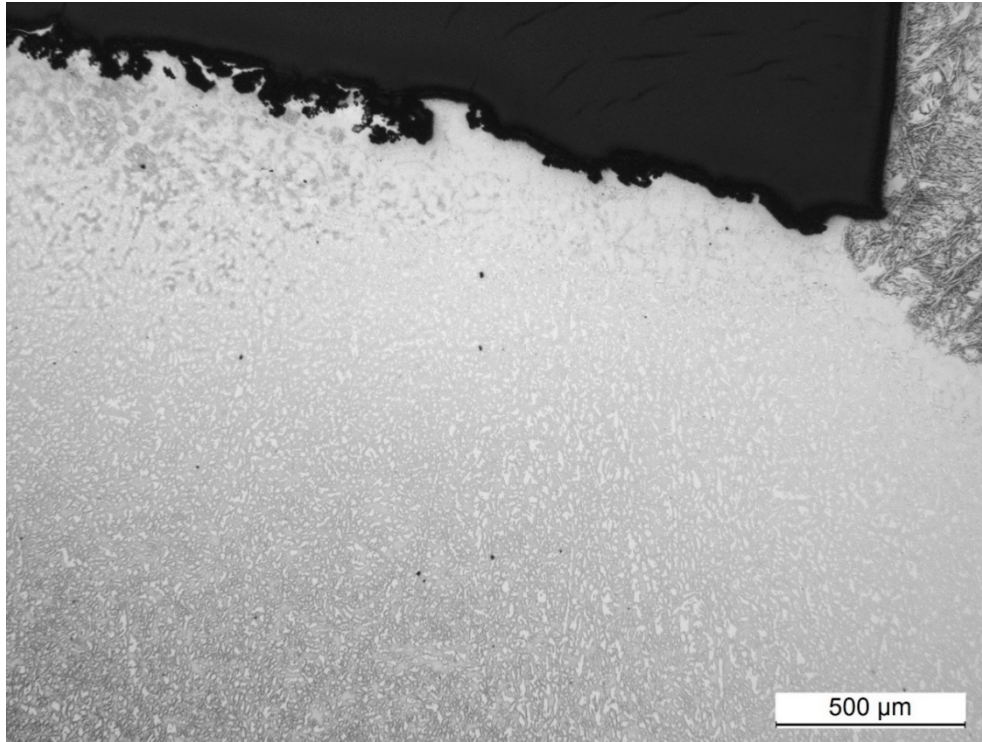
- (ii) A local anomalous 'rough' surface region adjacent to the circumferential butt-weld, which exhibited a coarse-grained region immediately beneath the plate surface, composing of elongated side-plate/lath-like austenite mainly in the grain boundaries of coarse ferrite grains that also revealed intragranular precipitation within the grain interiors (i.e. sc. "peppery" structure). This local microstructure resembled the HAZ rather than base material (Figures 8–10).

Figure 8. A local thin abnormal 'rough' surface layer (top, left) adjacent to the butt-weld (top, right).

- (ix) Continuous supply of large amounts of hydrogen from the flowing content of the gas separator and, possibly, local pitting corrosion reactions on the plate surface (Figure 8).

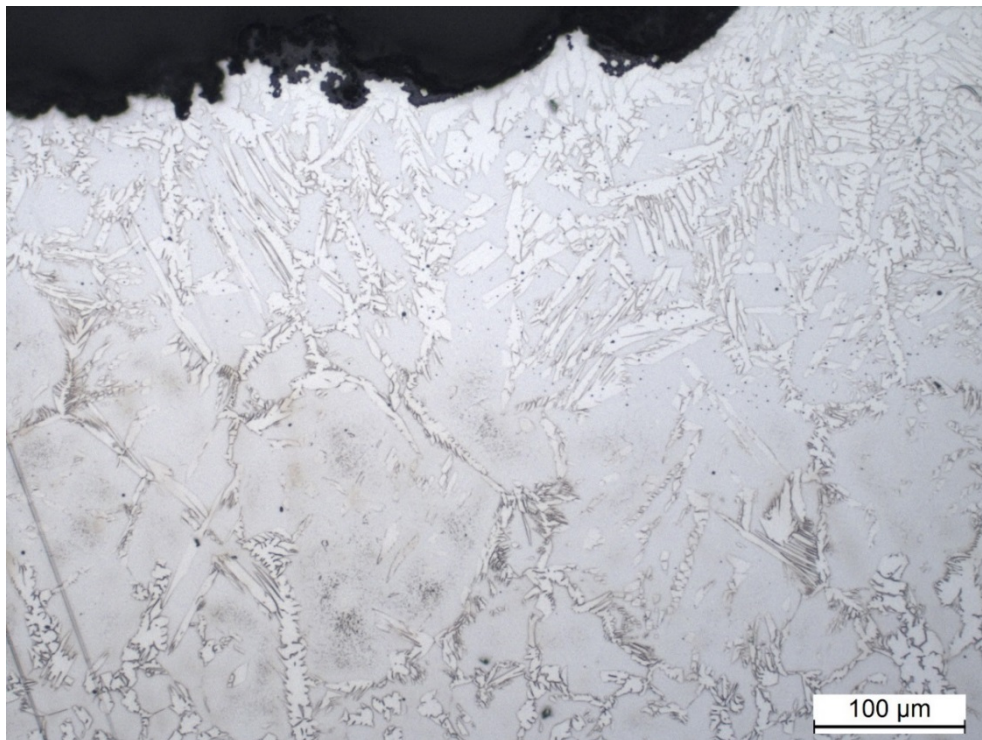
Figure 9. Detail from Figure 8. A local abnormal 'rough' surface layer adjacent to the circumferential butt-weld – grain-coarsened microstructure beneath the plate surface resembling the HAZ and composing of elongated side-plate/lath-like austenite mainly in the grain boundaries of coarse ferrite grains and traces of intragranular precipitation within the ferrite.

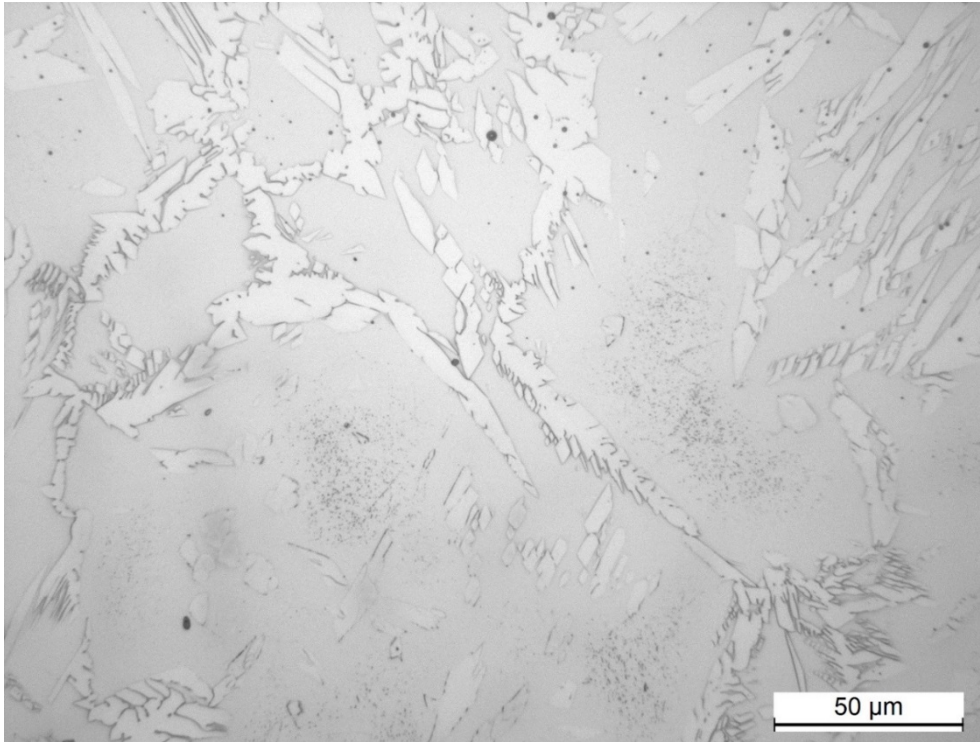
Figure 10. Detail from Figure 9. Coarse-grained microstructure beneath the abnormal 'rough' surface layer resembling the HAZ and revealing intragranular precipitation within the ferrite ("peppery" structure).

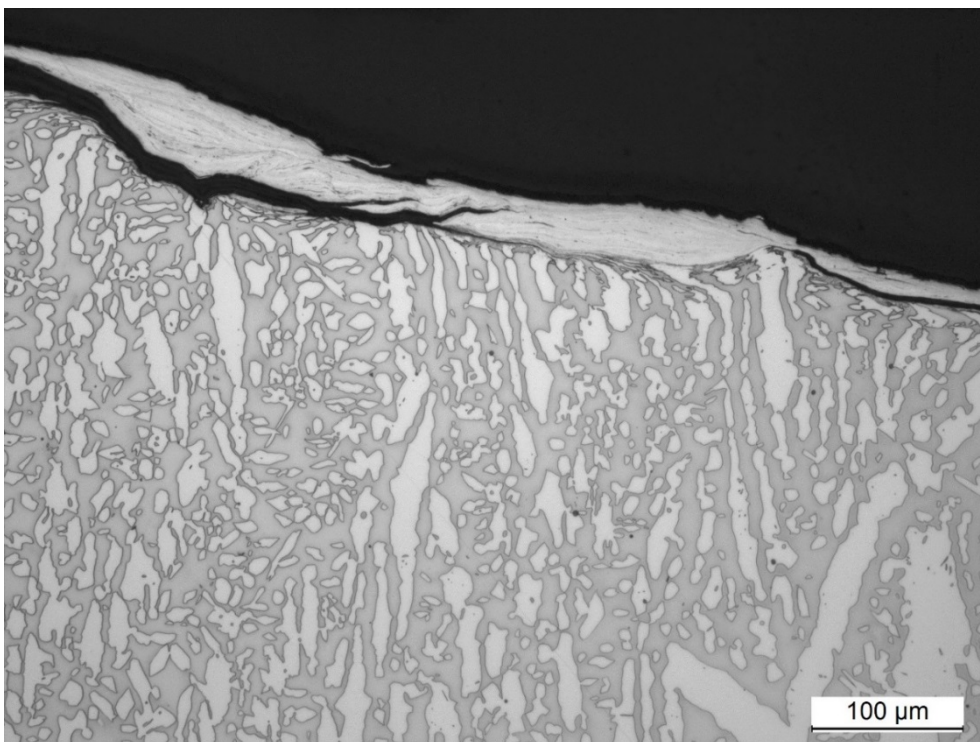
- (iii) A local thin, anomalously deformed and partially torn-off 'alien' surface layer at the plate surface immediately adjacent to the circumferential butt-weld, with a typical parent steel duplex microstructure beneath it (Figure 11).

Figure 11. A local thin anomalous, deformed and torn-off surface layer (white) on the plate surface adjacent to the circumferential butt-weld, typical parent steel duplex microstructure beneath the surface layer.

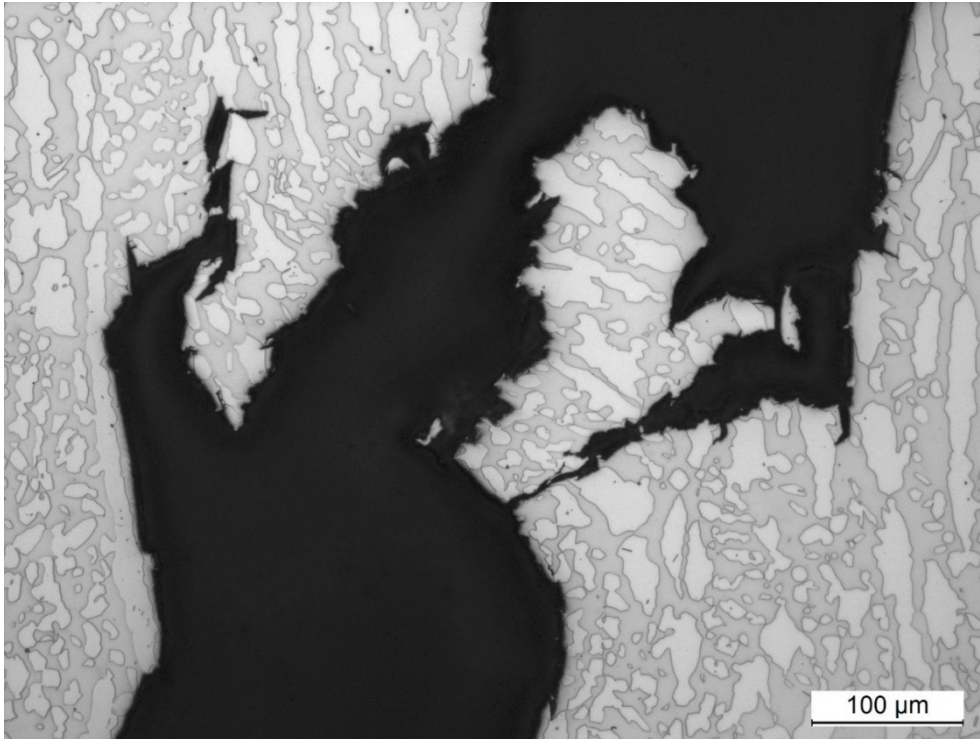
Figure 12. Crack propagation through the circumferentially welded gas separator specimen – propagation path mainly within the ferrite phase (grey) and circumventing the austenite phase (white).

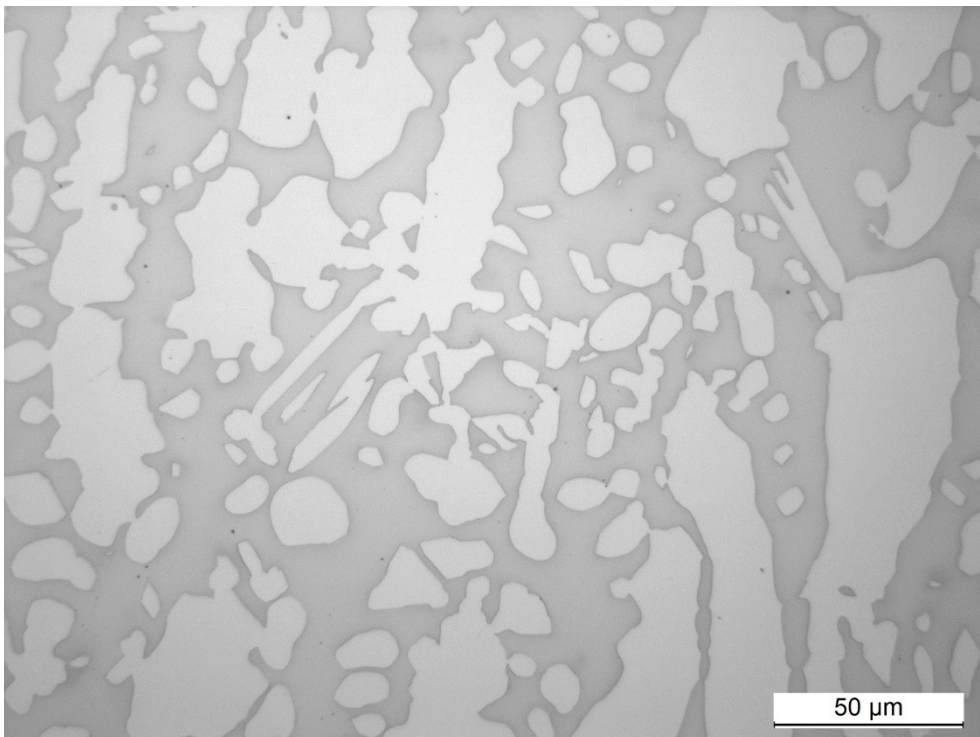
The microstructure of the base material and the weld metal consisted of a mixture of ferrite and austenite and was hence typical of duplex stainless steel. The microstructures also exhibited an appropriate balance between the ferrite and the austenite phases, approximately a ratio of 43/57 (Figure 13).

Figure 13. Microstructure of the base material; ferrite (grey), austenite (white).
