Boiler tube corrosion caused by urea injection of SNCR system

Katri Ekholm¹, Satu Tuurna², Sanni Yli-Olli²

¹Helen Ltd
Helsinki, Finland

²VTT Technical Research Centre of Finland
Espoo, Finland

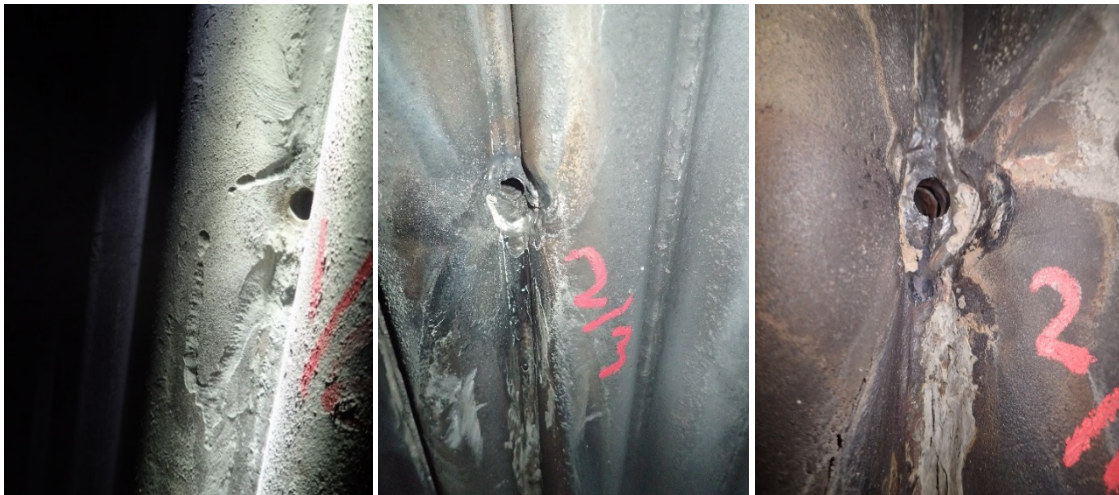
After entering the boiler, indications of corrosion were found near the holes for installing the urea injection nozzles.

Figure 4. Corroded holes for injection nozzles inside the boiler.

The construction of the self-made injection nozzle system enabled crevice corrosion. In the annual maintenance outage in summer 2016, the construction of the urea injection hole was changed and holes were coated with HVOF-coating, which have chromium carbides in nickel matrix. The urea injection was continued.

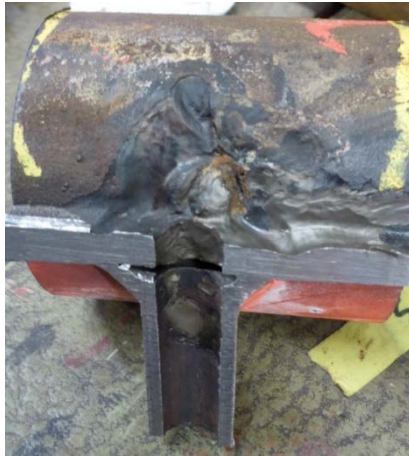
The visual and microscopic inspections indicated that the leakage was due to corrosion that started from a gap between the boiler tube and a small diameter tube installed for the urea injection nozzle. Boiler tube material is 15Mo3 steel.

Figure 5. A section of a failed boiler tube.

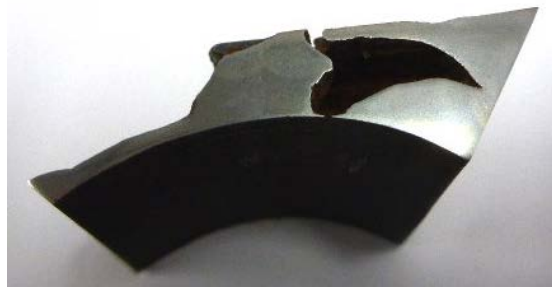
Sectioning of the corroded boiler tube showed corrosion on the fireside and at the connecting point of the boiler tube and the injection nozzle holder. After cutting down the part into smaller pieces severe corrosion was found also inside the crevice between boiler tube and injection nozzle holder. Leaking holes were found on the fireside of the tube and inside the crevice (varied in different tubes).

Figure 6. A corroded tube sectioned for microscopic examination; fireside on left, place for injection nozzle on top.

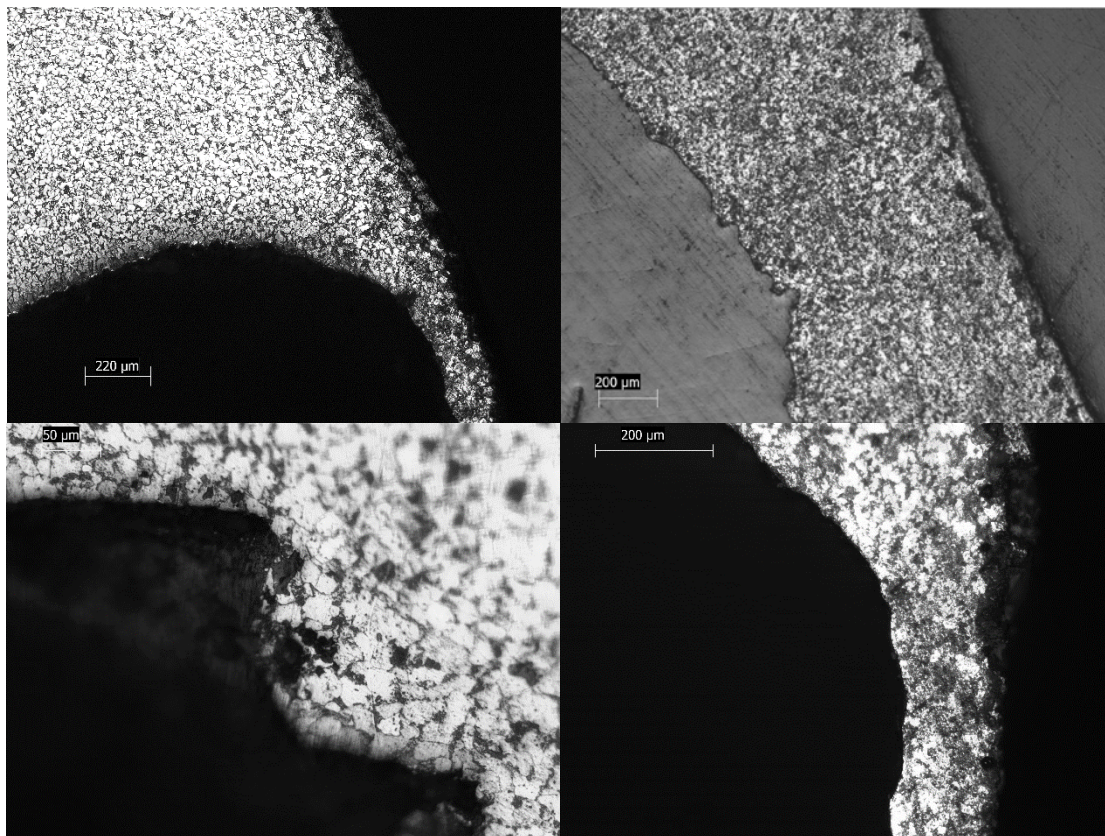
Figure 7. Fireside corrosion on the affected boiler tube.

Besides crevice corrosion, the corroded fireside area of the boiler tube showed pits and aggressive local corrosion.

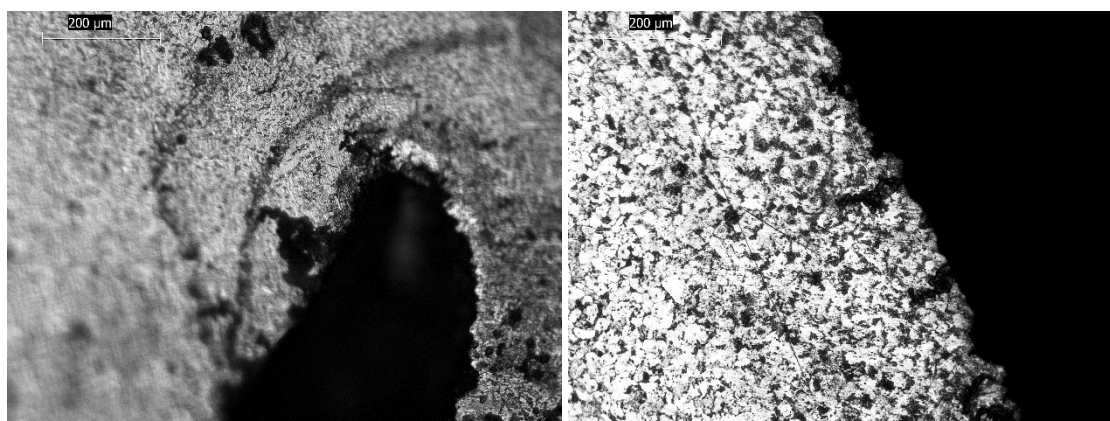
Figure 8. Corrosion in the crevice.

The microstructure of the base material was consistent with that expected of the steel grade 15Mo3. Microscopic examination showed transgranular corrosion, with corrosion pits in the crevice.

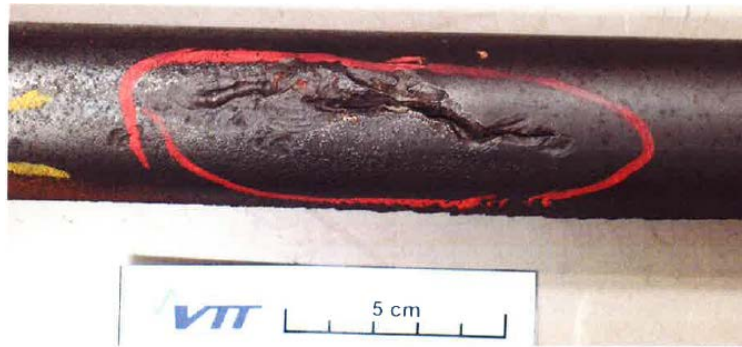
Macroscopic examination showed corrosion markings corresponding to the boiler (steam generator) tube leakage of the previous year. Figure 9 shows a failed superheater tube, assumed to indicate initial (primary) corrosion damage. Similar primary corrosion markings appeared in five failed superheater tubes, and the resulting steam flow had damaged four additional tubes, causing them to fail as well.

Figure 9. Failed superheater tube with indications of primary corrosion damage [11].

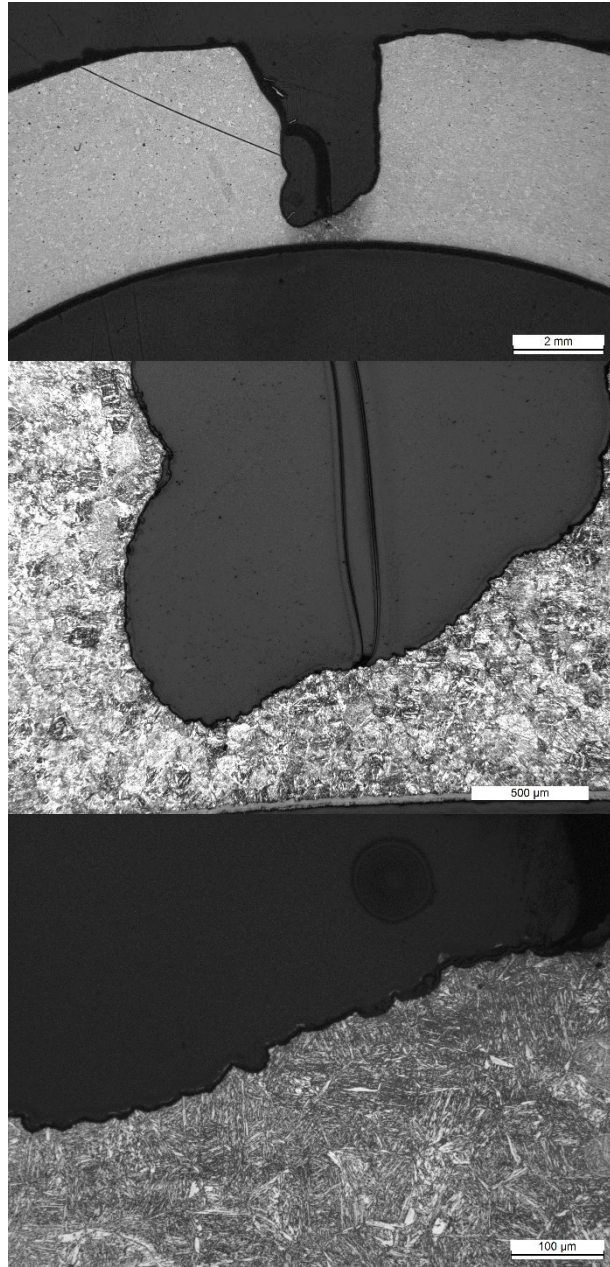
Figure 10. Cross-section of a failed superheater tube, indicating external corrosion [11].

The samples had a martensitic microstructure consistent with that expected of the steel grade X20CrMoV12-1. Microscopic analysis confirmed that the primary failure was due to aggressive external corrosion.

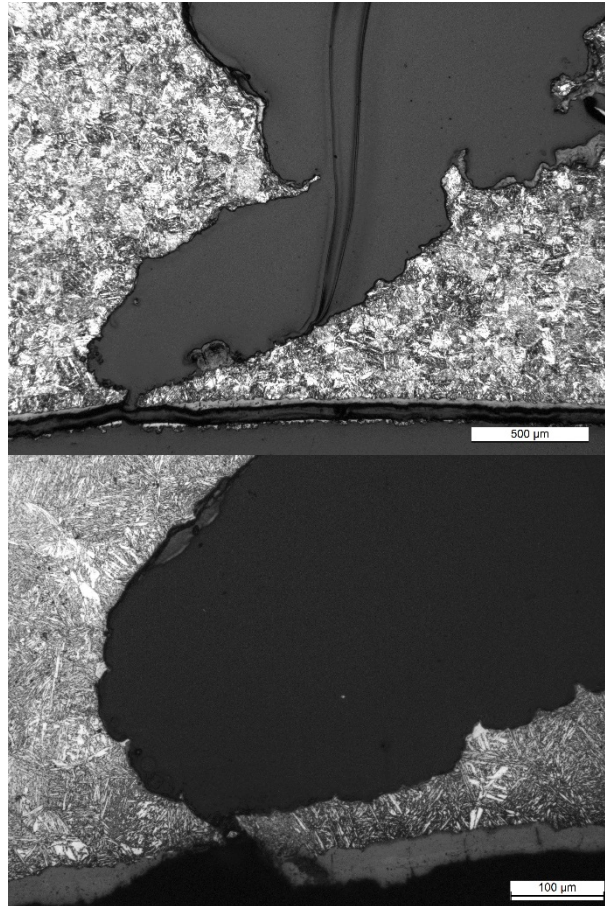
Figure 11. As in Fig. 10, adjacent cross-section [11].

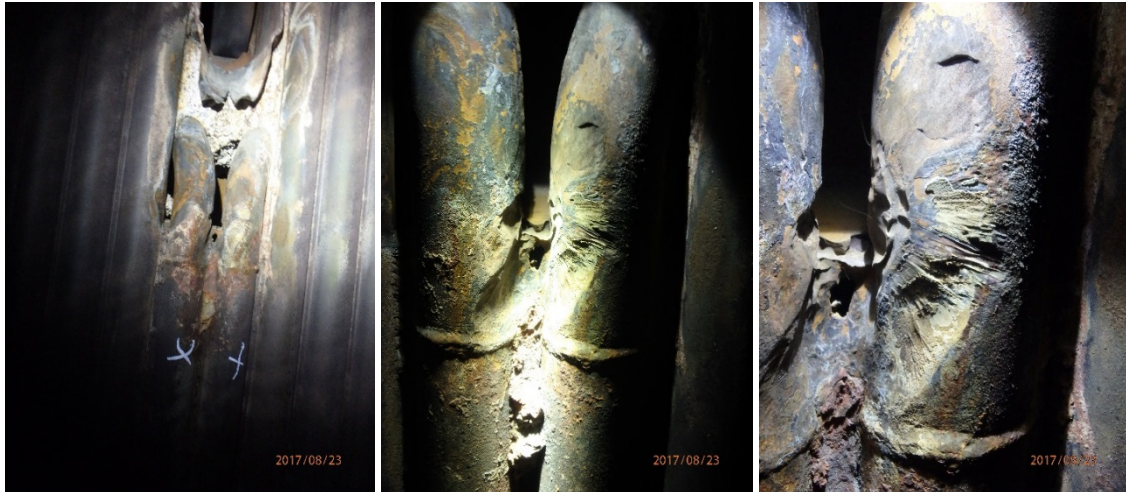
The other boiler in Hanasaari has commercial urea injection lances. In the annual maintenance in summer 2017, areas below the urea lances showed aggressive corrosion, Figure 12. Visual inspection indicated appearance that resembled the corrosion near the urea injection in the other boiler. No tube leakage was noticed before shutdown and entering the boiler. This case required no microscopic examination.

Figure 12. Corrosion below the urea injection lances.

Examination showed that some of commercial urea lances were not working properly and they were leaking large droplets.
