Boiler tube corrosion caused by urea injection of SNCR system

Katri Ekholm¹, Satu Tuurna², Sanni Yli-Olli²

¹Helen Ltd
Helsinki, Finland

²VTT Technical Research Centre of Finland
Espoo, Finland

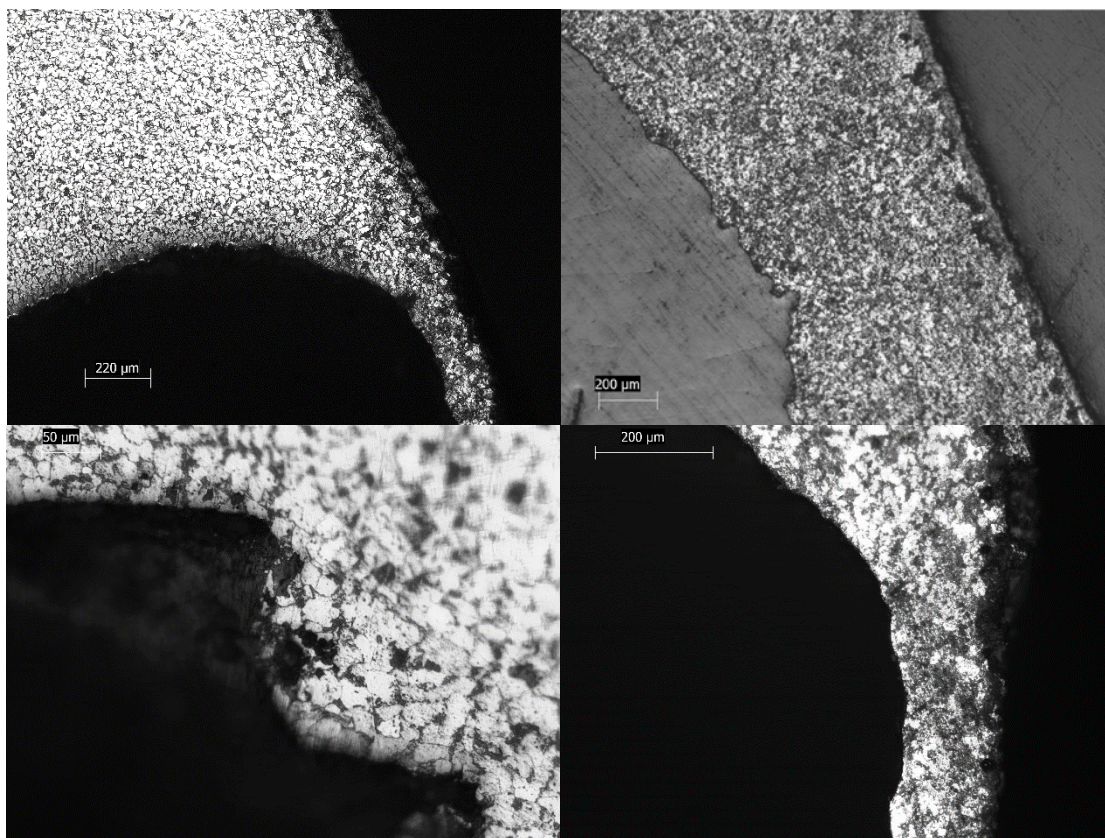
Figure 7. Fireside corrosion on the affected boiler tube.

Besides crevice corrosion, the corroded fireside area of the boiler tube showed pits and aggressive local corrosion.
