Failure mechanism of blast furnace tuyeres

Natasa Vuckovic-Spitzer, Institute of Metallurgy, Clausthal University of Technology, Germany

Tatjana Mirkovic, Salzgitter Flachstahl GmbH, Germany

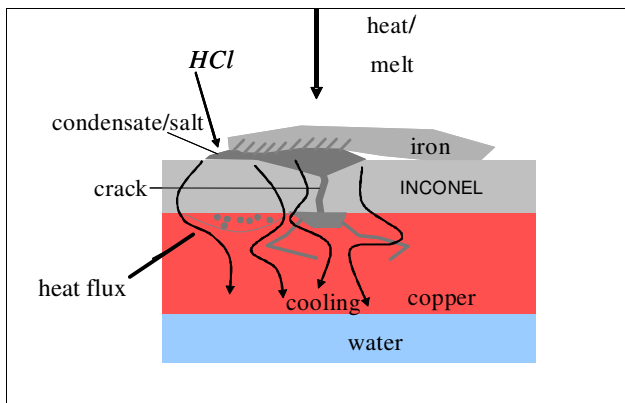
Figure 1: Schematic illustration of the tuyere failure mechanism

The tuyere failure begins with formation of a corrosive electrolyte (e.g., HCl dissolved in water condensate) in the gap between the tuyere surface and solidified iron droplet (Fig. 1). This acidic and corrosive solution attacks first the INCONEL 625® coating on the tuyere forming a channel which propagates to the copper. Cracks formed in the INCONEL 625® layer during the coating operation facilitate this process.

The corrosion process continues in the copper. The electrolyte reacts with impurities such as sulphides and oxides deposited at the grain boundaries forming the intergranular cracks. It is also possible that diffusion of the gases (e.g., hydrogen and/or chlorine) through the copper and their interaction with fine dispersed oxide and sulphide precipitates results in the formation of the micropores. The cracks and microporosity formed in the copper cause a significant decrease in copper thermal conductivity and deteriorate copper cooling within these regions. Due to continuous splashing of the hot iron and slag on the tuyere surface, the temperature of the copper rises, exceeds its melting point and local melting of the copper occurs. The liquid iron propagates through the tuyere wall reducing its thickness. Under certain thermal conditions a pocket of the steam can be formed on the inner tuyere wall. Simultaneously, the corrosion proceeds further through the solidified iron and copper.

The effects of permanent thermal load from above and reduced heat transfer due to steam beneath finally cause the rupture of the tuyere and the water flow into the furnace.

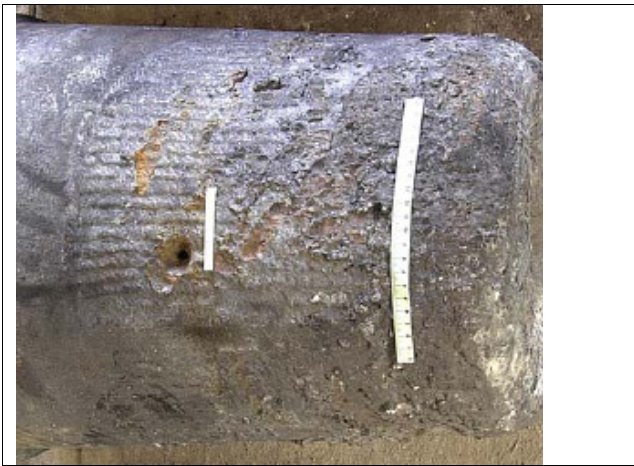
In order to get an overview of typical location of the failure sites and the failure extension, numerous destroyed tuyeres were visually examined. Observation of the destroyed blast furnace tuyeres showed that the failure areas are mostly located on the tip part of the tuyeres which is directly exposed to the furnace interior. In the majority of cases the defect areas are in the form of holes propagating through the tuyere wall and have a size of up to a few centimetres. (Fig. 2).

Figure 2: A tuyere showing defect in the form of small holes on its front part

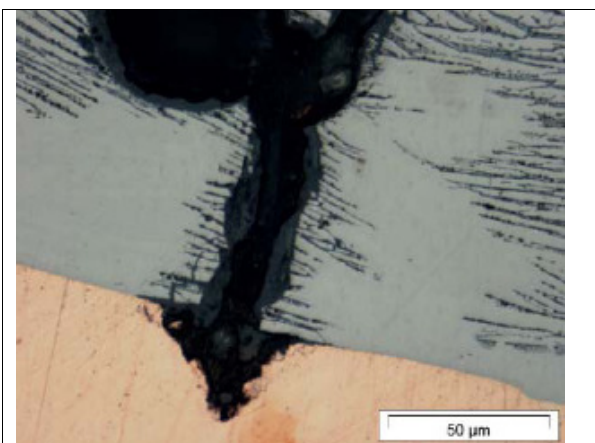
Figure 3: A channel extending through the iron layer to the copper

It seems that such cavities with rough walls are formed during a corrosion process in which the copper is dissolved and transported away with an electrolyte through the channel. As the corrosion process in the tuyere copper propagates, the cavities initiated at the copper/iron interface grow and may become as large as the one shown in Figure 4.

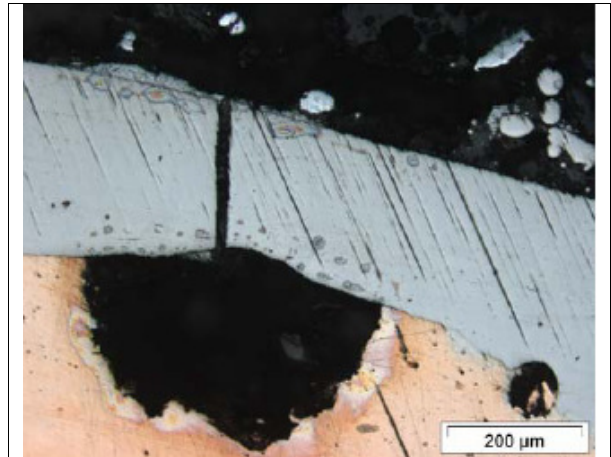
Figure 4: A large cavity in the tuyere copper

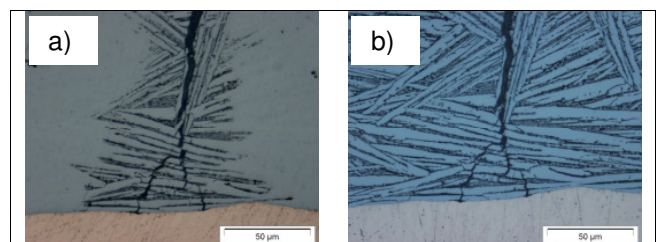
The needle-like structure of the iron visible in the surrounding of the channels is the result of an electrochemical reaction occurring between an electrolyte and the ferrite as less noble micro-constituent of iron [14]. The areas of corroded ferrite appear dark on the micrographs, while the more noble cementite appears as bright elongated grains (needles). This assumption was confirmed by metallographic observation of a tuyere sample exhibiting the needle-like structure in the surrounding of a channel in polished condition (Fig. 5a).

Figure 5: Iron microstructure in the surrounding of a channel: a) polished b) etched with 3% HNO_3

After etching with HNO_3 , the needle-like structure became visible over the whole iron surface due to the reaction between HNO_3 and ferrite (Fig. 5b). By subsequent polishing, the surface layer was removed and the needle-like structure of the iron was again visible only around the channel as shown in Figure 5a. This indicates that the iron revealing the needle-

like structure on the polished sample surface was already attacked with some electrolyte transported here through the channel (the crack in three-dimensions). The reaction between the electrolyte and ferrite in the iron occurred in the space surrounding the channel. The needle-like structure originated from this reaction can not be removed by polishing because it extends to some depth under the sample surface in the region adjacent to the crack. Another sign of corrosion in the samples of destroyed tuyeres are very small copper particles (from a few μm to tents of μm diameter) that have been discovered in the regions of dissolved ferrite in the iron layer. This copper could be brought there with some electrolyte in the form of copper ions and thereafter precipitated as metallic copper by cementation with ferrite.

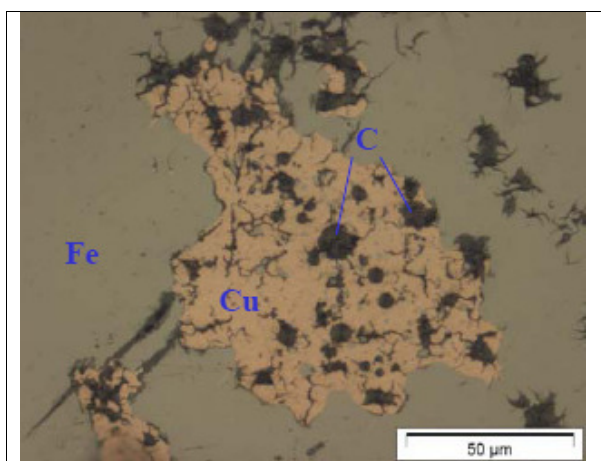
Also, relatively large copper particles (with diameter of several tents to several hundreds μm) interspersed with graphite (Fig. 6) were found in the iron layer adhering to the tuyere copper.

Figure 6: Copper inclusions containing graphite flakes found in the iron layer

Such type of copper inclusions is a consequence of the local tuyere melting by attack of molten iron, whereby an iron-copper-carbon melt is formed. According to Figure 6 one may get the impression that graphite was precipitated from copper. However that is not possible due to the negligible carbon solubility in copper [15]. As the Fe-Cu-C melt cools down, the precipitation of the carbon as graphite flakes from the melt takes place first. Then the copper-rich liquid phase precipitates on the graphite flakes. In the regions of the melt with larger amount of the copper-rich phase the adjacent droplets of the copper-rich liquid coalesce to form larger copper particles. The correctness of this explanation was proved by a laboratory experiment where liquid pig iron was poured on a non-cooled tuyere section. Metallographic examination of the samples cut from the attacked region of the copper revealed a very similar microstructure to that shown in Figure 6. This microstructural feature of the investigated tuyere

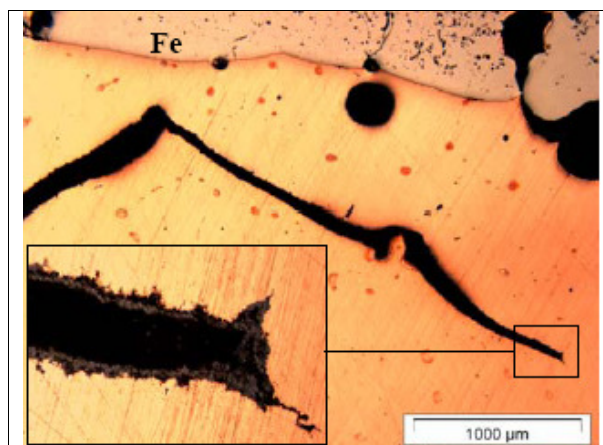
Figure 7 shows a polished tuyere sample containing cracks of several millimeters in length in the copper near the copper/iron interface. Observation of the etched sample revealed that the cracks propagation occurs along the grain boundaries due to intergranular corrosion. This defect can be caused by local attack of an electrolyte at the copper grain boundaries containing less noble precipitates such as oxides and sulphides. The crack tip at a high magnification is presented at the small picture in the lower left corner of Figure 7. It shows the path of the further development of the crack through the copper and gives clear evidence of corrosion process. The dark-grey phase visible on the crack walls is likely a mixture of dried electrolyte residues and corrosion products. Another explanation for the cracks is that hydrogen diffusing through the copper reacts with the oxides at the grain boundaries forming water under a high pressure.

Figure 7: Cracks propagation in tuyere copper

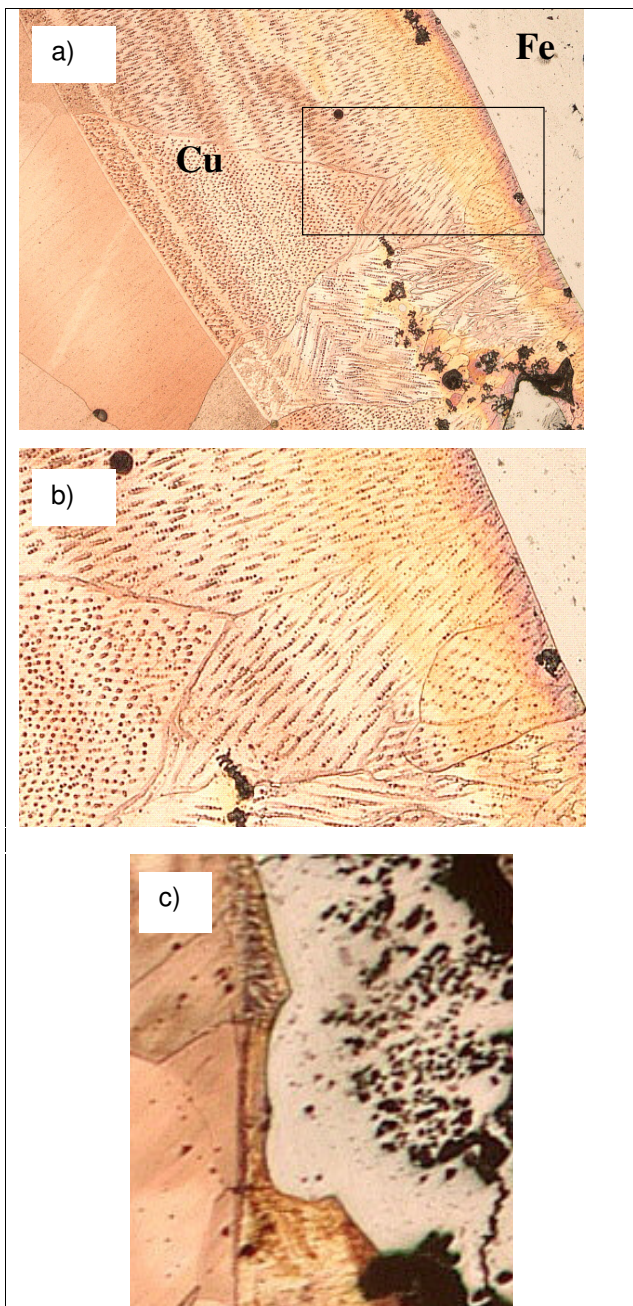
Optical photomicrograph presented in Figure 8a reveals copper microporosity in a zone extending parallel to the interface copper/iron. The area of porous copper marked by the rectangle in Figure 8a is shown enlarged in Figure 8b. As can be seen in Figure 8b, the copper porosity spreads across the entire copper grains and exhibits orientation depending on the crystal grain orientation. The porosity can be attributed to a chemical reaction, which occurred between diffusing species (e.g. hydrogen and/or chlorine) and small precipitates (e.g. oxides and sulphides) dispersed along dislocations lines in copper. Figure 8c shows progress of local melting into the zone of porous copper induced by molten iron. The dark areas visible in the iron layer indicate the occurrence of corrosion.

Figure 8: Microporosity in tuyere copper

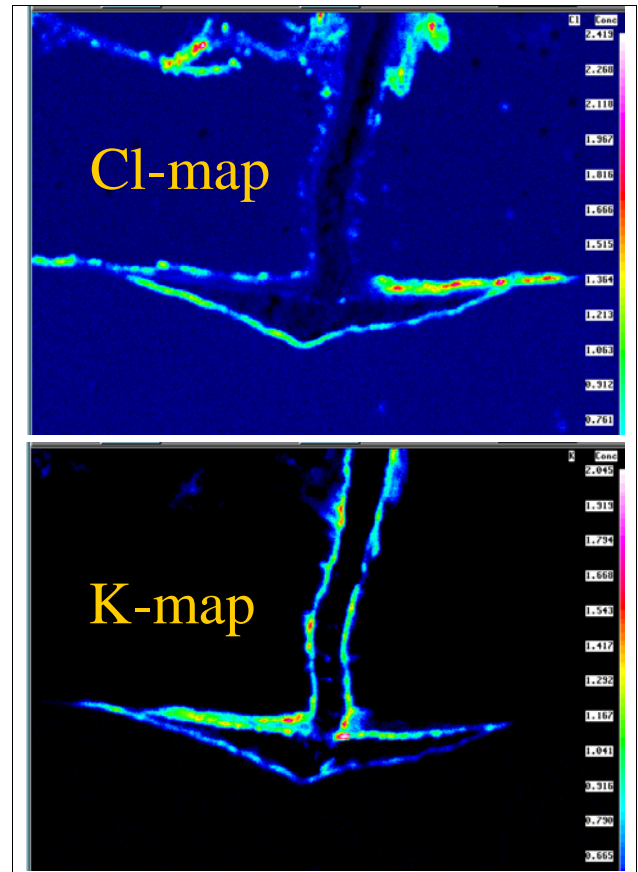
The important role of chlorine in the failure mechanism of tuyeres was confirmed by ESMA analysis of a sample of a destroyed tuyere. The mapping area was chosen to include a channel going through the iron layer and forming a cavity at the copper/iron interface. Mappings of the elemental distribution were done for Cu, Fe, Si, S, Cl, Zn, K and Na. Chlorine and alkalis showed similar distribution within the analyzed area. They are mostly present on the channel wall and at the edges of the cavity in the copper as show the elemental maps for chlorine and potassium (Fig. 9). The coincidence of the distributions of K, Na and Cl indicates the presence of KCl and NaCl. But there are some areas in the chlorine map (the upper left corner of the chlorine

map and the interface copper/iron) where a high observed chlorine concentration (1.8 – 2.3 wt. %) is not correlated with especially high concentrations of alkalis. It seems that chlorine has higher mobility than the alkali metals in the attacked regions of tuyeres, which can be explained by simultaneous chloride transport by both metal chlorides and HCl, whereby the latter one spreads more easily.

Figure 9: Elemental maps of Cl and K in a failure site

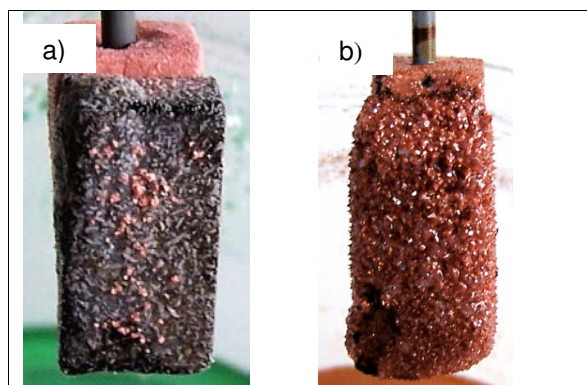
member of the galvanic couple, the Armco iron corrodes providing cathodic protection to the copper. The galvanic couple consisting of tuyere copper and rapidly solidified iron exhibited quite different dissolution behaviour in HCl solution. During the first 8 days of immersion, except for the initial dissolution of the surface oxide film, the copper piece did not show any observable changes in the appearance. Simultaneously an intensive formation of the hydrogen bubbles on the iron indicated the dissolution of its ferrite phase. However, after this period, a rapid dissolution of the copper began which was observed by the diminution of the copper piece size and subsequent copper deposition from the solution onto the surface of the iron piece in the form of fine particles (Fig. 10). After 15 days the experiment had to be stopped due to breakdown of the welded joint. At that moment the whole surface of the iron piece was covered with fine copper particles (Fig. 10b).

Figure 10: Deposition of copper from HCl solution on the cementite-rich iron: a) after 12 days and b) after 15 days of immersion

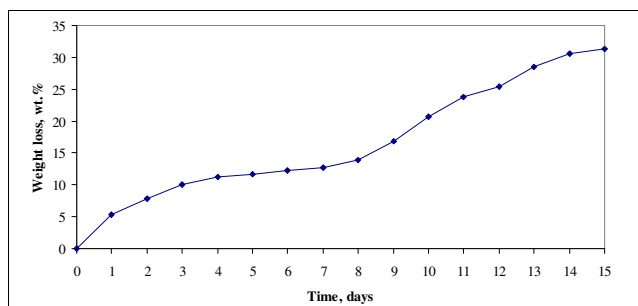
This visual observation of the tuyere copper-rapidly solidified pig iron couple is in accordance with its weight loss-time curve presented in Figure 11, where a significant increase in the weight loss after 8 days indicates the initiation of the copper dissolution. Thus, the dissolution curve can be divided into two stages. The first stage corresponds to the ferrite dissolution from the rapidly solidified iron. The second stage beginning around the eighth day of immersion involves an intensive copper dissolution, even though a considerable amount of copper precipitates again from the solution on the iron part of the sample.

Figure 11: Weight loss-time curve for the couple consisting of tuyere copper and rapidly solidified iron in 0.5M HCl
