EXPERIMENTAL AND NUMERICAL ANALYSIS OF A HELICAL SPRING FAILURE

Abstract. Results of experimental and numerical analysis of a broken motor vehicle helical spring are presented in this paper. Location of the fracture is on a first active coil of the spring. Experimental part of the research employed optical microscopy that revealed fractured surface microstructure and allowed for detection of inclusions. Corroded fracture surface limited scanning electron microscopy examination (SEM). Nevertheless, corrosion pits on the edge of the spring wire which served as crack initiation points could be detected by SEM along with radiating ridges left by the fracture front that propagated to the opposite edge of the wire. Optical emission spectrometer with glow discharge source sample stimulation was used to determine material chemical composition that is adequate to spring steel 61SiCr7. Additionally, hardness test was performed and obtained value was used to derive maximum tensile strength of the steel. Experimentally collected data served as input for numerical analysis of helical spring. Finite element analysis of a helical spring model was performed. Stress distribution was determined and

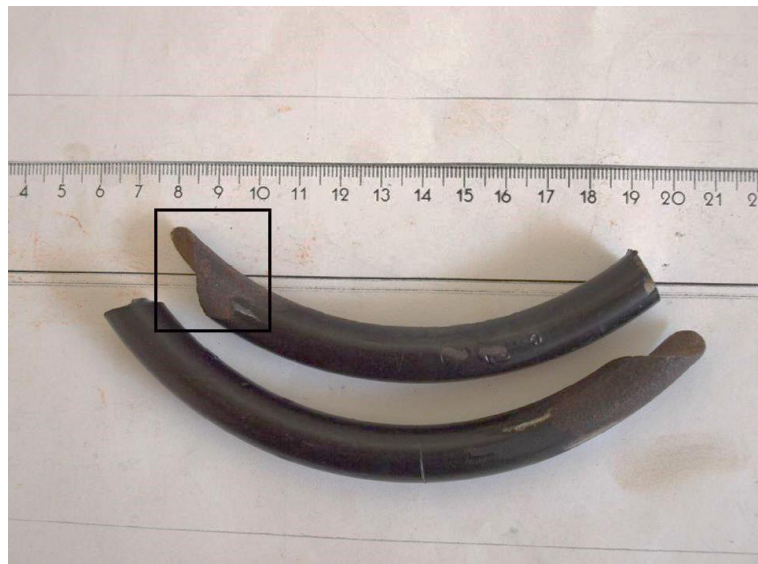
Figure 2: Specimens extracted from failed coil spring

In order to perform experimental analysis, specimens were cut from fractured helical spring, Fig. 2. Fracture surface is oriented at 45° to the wire centerline which is typical for torsional fatigue failure under cyclic loading. Protective layer of polymer-based paint is damaged around the fracture surface. Damage can be contributed to the contact of bearing and first active coil.

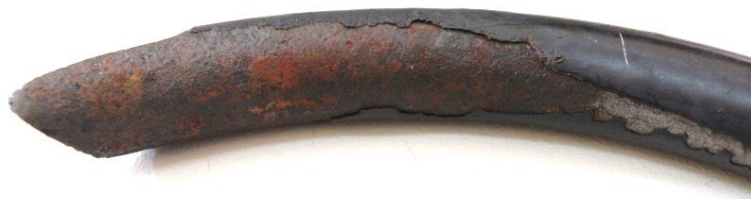
Figure 3: Heavily corroded wire surface

Heavily corroded outer surface of the wire is exposed in Fig. 3 and there is a layer of rust on the fracture surface, also, Fig 4. Thicker and darker semicircular part of the rust layer marks portion of the surface where crack formed gradually and was exposed to corrosive environment for a longer period of time before the final failure occurred. Rest of the fracture surface is covered in lighter layer of rust and marks a portion of surface where accelerated crack propagation happened.

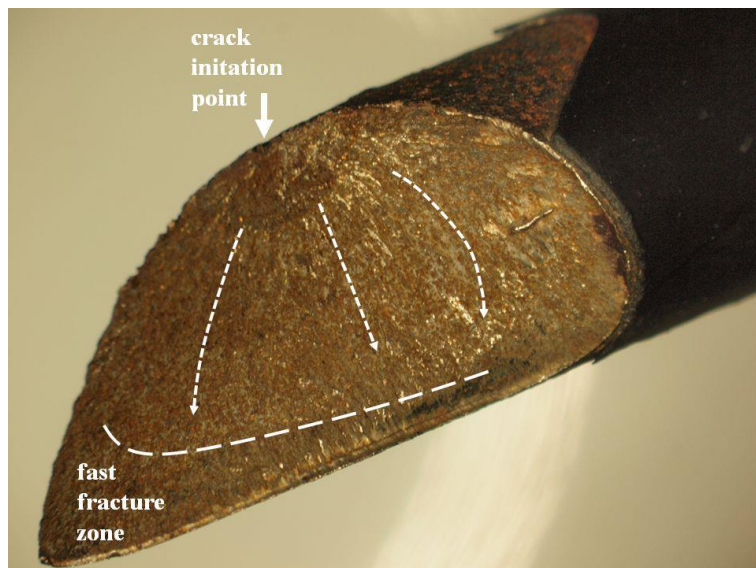
Figure 4: Fracture surface

Corrosion pits can be observed at the point where the protective layer of paint was damaged. Fracture originated from one of this pits and continued propagation towards opposite end

leaving radiating ridges behind and suggesting fatigue failure caused by cyclic loading from the vehicle. At the side opposite of the crack initiation point, fast fracture area can be observed corresponding to the final stage of failure.

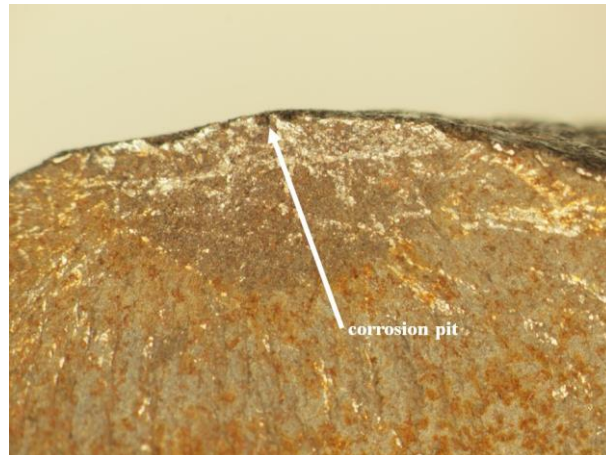
Figure 5: Corrosion pit serving as crack initiation point

Corrosion pits can be observed at the edge of the fracture surface where the protective paint layer is damaged. Main pit served as crack initiation point from which crack propagated towards opposite edge of the wire causing final failure.

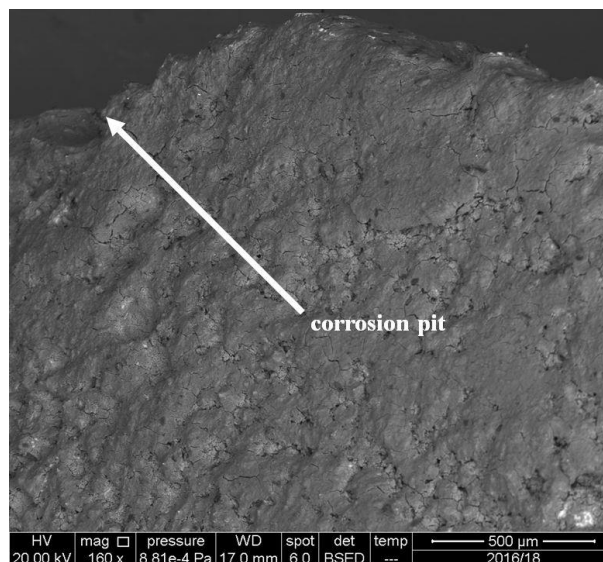
Figure 6: SEM magnification of crack initiation point at corrosion pit

SEM analysis was difficult to perform because the fracture surface was damaged by corrosion. Examination of the fracture surface at 80x magnification revealed a heavily oxidized and corroded surface which obscured fracture surface details. Although an attempt was made to remove the corrosion layer using aggressive cleaning agent, corrosion products could still be seen on SEM images.

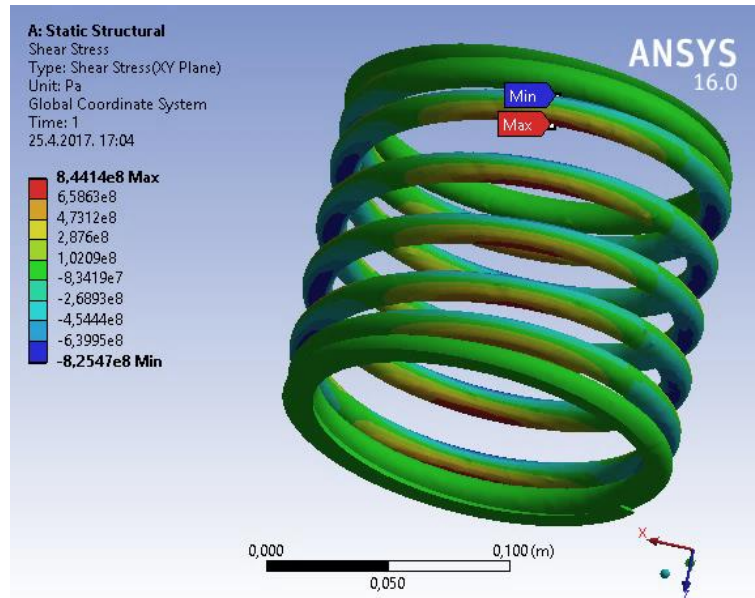
Figure 7: Shear stress distribution

It can be noted that the maximum value of stress is numerically predicted just at the point where actual fracture occurred. During service, dynamic loads and shocks resulted in contact between the bearing coil and the first active coil. As a result of repeated contact and impact between the coils, the contact surfaces were gradually worn out leading to crack occurrence and fracture. FE model was built to simulate frictionless contact behavior between the mentioned coils.

According to Eq. 2, maximum shear stress in considered helical spring is 827.4 MPa which can be correlated to 844.1 MPa obtained numerically.

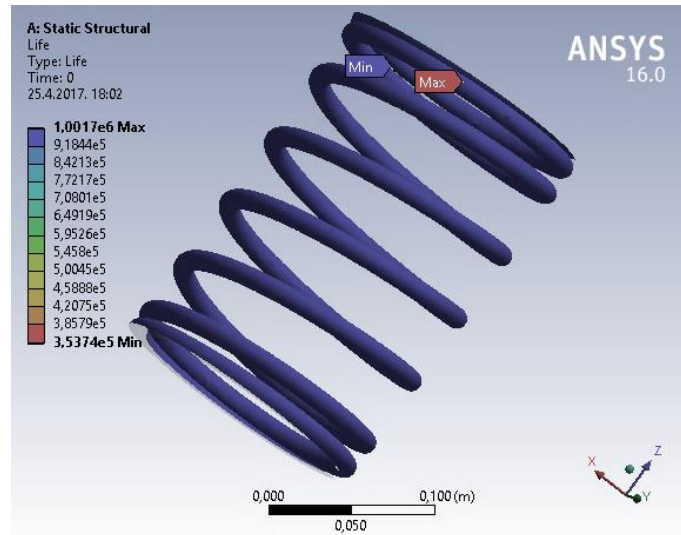
Figure 8: Fatigue life

Also, in order to numerically predict fatigue life of helical spring, fatigue analysis is performed and results are presented in Fig. 8.

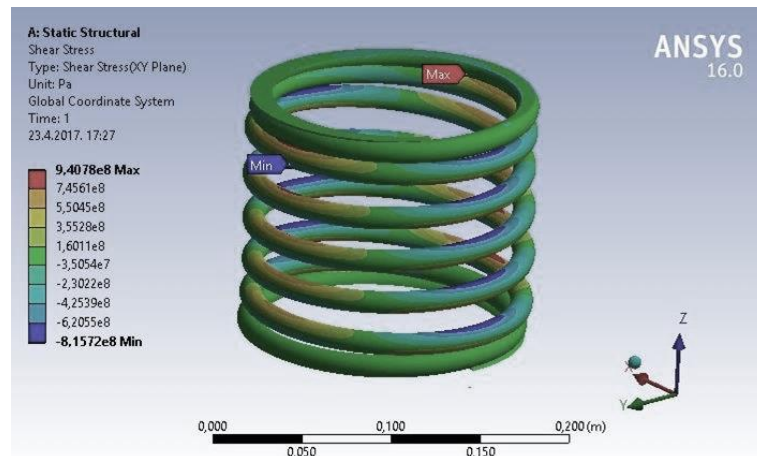
Figure 10: Shear stress distribution with road irregularities load accounted

Fig. 10 has shear stress distribution in the considered helical spring with load from road irregularities added and Fig. 11 predicted fatigue life.

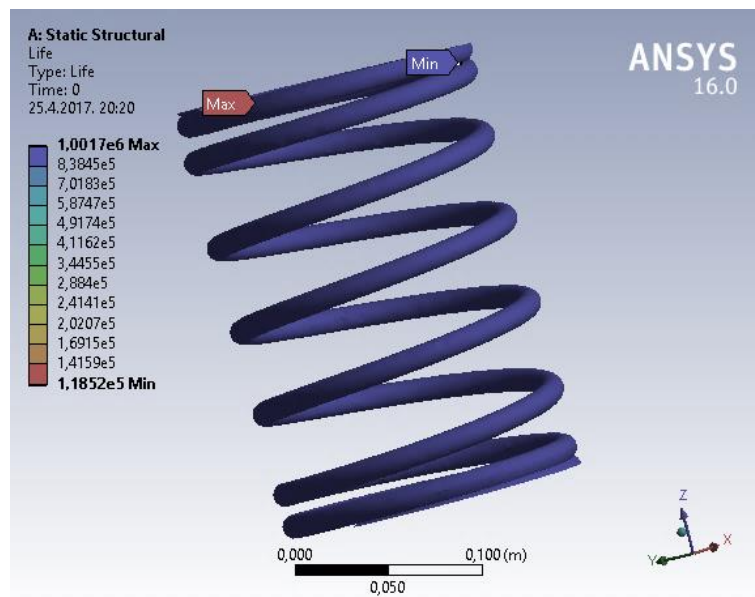
Figure 11: Fatigue life with road irregularities load accounted

Performed finite element analysis served to determine stress distribution along the spring, contact point between the coils and fatigue life of undamaged spring. Comparing results of numerically predicted and analytically calculated maximum stress level, it can be noted that FE model successfully represents real helical spring. In order to obtain accurate fatigue life, load on helical spring is modelled first just as a quarter of average vehicle weight, then additionally with load from road irregularities. Difference in fatigue is significant suggesting that load from road irregularities should also be included in vehicle helical spring calculation.
