Failure analysis of recurrent cases of fatigue fracture in flash butt welded rails

L.B. Godefroid*, G.L. Faria, L.C. Cândido, T.G. Viana

Universidade Federal de Ouro Preto, Ouro Preto, Minas Gerais, Brazil

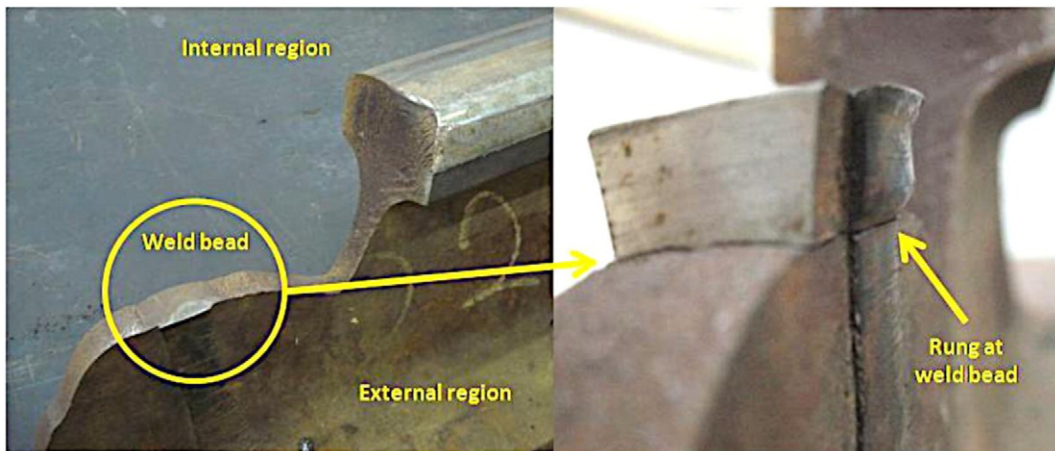
Fig. 1 presents the inferior part of the fracture surface of the rail, which was used in the macrofractographic analysis. It is possible to observe the fracture aspects at the head and at the web of rail. The rail web presents a region that reflects more intensely the light (flat and brightening). Fig. 1 also shows that this flat region is localized at the internal side of the railroad, where train wheels exert higher fatigue efforts over the structure. It is important to observe in this Figure the bad quality of the superficial

Fig. 1. Rail fracture surface, highlighting a rung at the welded bead.

finishing. The problem is not lack of atomic union between the pieces during the welding or a geometrical misalignment of the rails in the welded junction, but the lack of adequate finishing after welding.

be strongly moved while they are in high temperature; rails moving in high temperature may cause permanent strain at welded joint, promoting another structural discontinuity. The dimensional and finishing control of welding burr must be urgently modified; more rigorous criteria for burr removal and superficial finishing must be adopted aiming to diminish the presence of stress concentration points in the welded joint. Welding parameters may be analyzed, to guarantee a minimum microstructure modification at the weld region; a soft microstructure must be avoided, to improve the fatigue crack resistance of the welded joint. Finally, considering the relative small size of the fatigue crack that led to catastrophic failures, it is suggested the use of a steel with chemical composition and microstructure that have higher values of fatigue crack resistance and also greater fracture toughness.

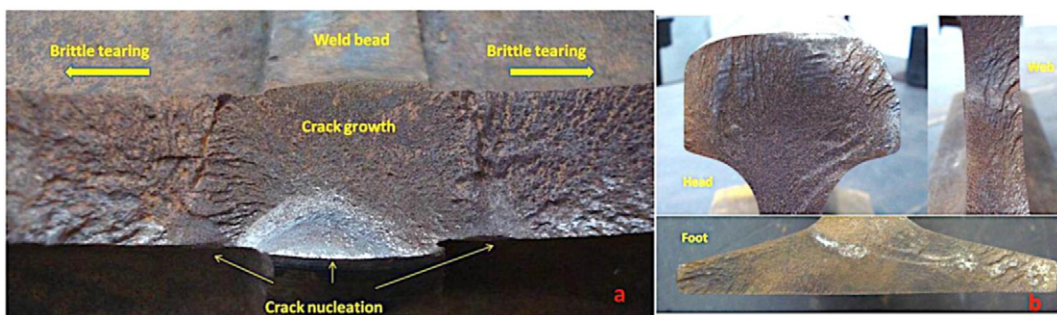
Fig. 2(a) presents a detail in the welded region. It is possible to observe three flat surfaces that reflect light more intensely. One of these flat surfaces, the biggest and central, highlights, because it has a curvature radius of almost one third of web rail thickness (6 mm). This area characterizes crack nucleation and stable crack growth. Chevron marks are observed at right and left side of the welded joint. This is an evidence of crack instable growth (brittle fracture, later confirmed in the microfractographic analysis) toward the head and the foot of the rail (residual stress regions), leading to the final collapse of the rail.

It is important to note that crack nucleation areas are localized at stress concentration regions: welded joint, sharp edges and grinding striations associated to the burr presences due to the welding procedure. These evidences, associated with a cyclic loading (below the material yield strength), which occurs in a normal operation routine of a railroad, lead to a final diagnosis of fatigue failure.

Fig. 2(b) presents details of unstable crack growth regions (head, web and foot). In these areas is possible to see chevron marks, indicating that these parts were fractured by a brittle mechanism. The brittle behavior was confirmed later in the microfractographic analysis. It is supposed that fatigue crack grew until get a specific curvature radius (one third of rail web), considered the critical size, and promoting a stress intensity factor correspondent to the material fracture toughness, causing a catastrophic failure at the welded joint.

Fig. 2. (a) Detail of crack nucleation and stable growth regions (intense light reflection – flat surface), Brittle tearing areas (chevron marks); (b) Head, web and foot presenting brittle fracture surfaces. The rail web thickness is 18 mm; fatigue crack depth is 6 mm; fatigue crack width is 16 mm.

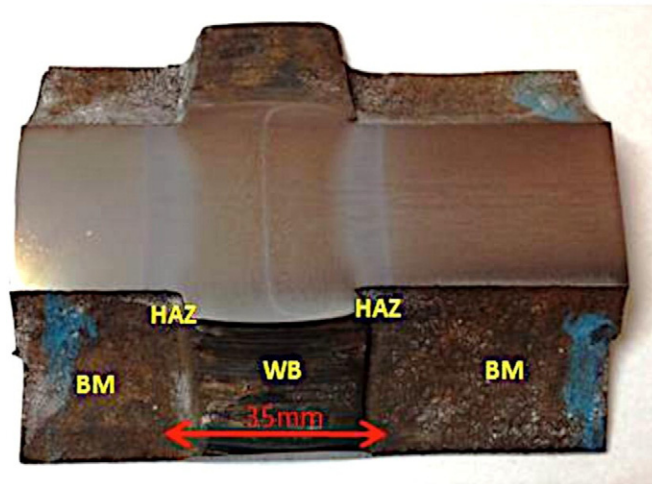
As the crack nucleation occurred at the web of the rail, a selected and prepared surface for metallographic analysis was sampled in this area. Fig. 3 presents the prepared and etched (Nital 2%) surface. It is possible to see the base metal (BM), the heat-affected zone (HAZ) and the weld bead (WB). A central line (CL), revealed by its white contrast is also observed, and characterizes the method of union of rails by flash butt welding. Using this etched sample, it was possible to measure the distance between the two HAZs (35 mm). Samples were observed in an optical microscope (OM).

Fig. 3. Welded joint prepared for metallographic procedures. BM = base metal; HAZ = heat-affected zone; WB = weld bead; CL = central line.

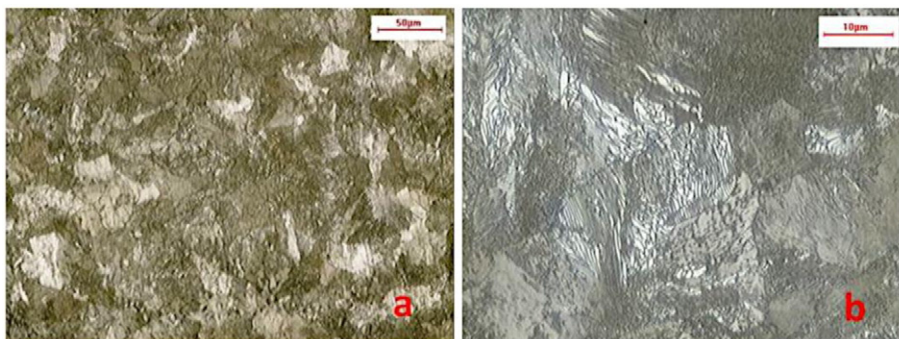
Fig. 4 presents micrographs of BM regions etched with Nital 2%. As expected, the steel structure is constituted of pearlite. Coarse pearlite reflects more the incident light and the constituent is revealed more brilliant. Fine pearlite (major fraction) has darker colors, because its colonies reflect less light.

Fig. 4. Micrographs of BM; Nital 2%, OM. (a) 400 \times ; (b) 2000 \times .

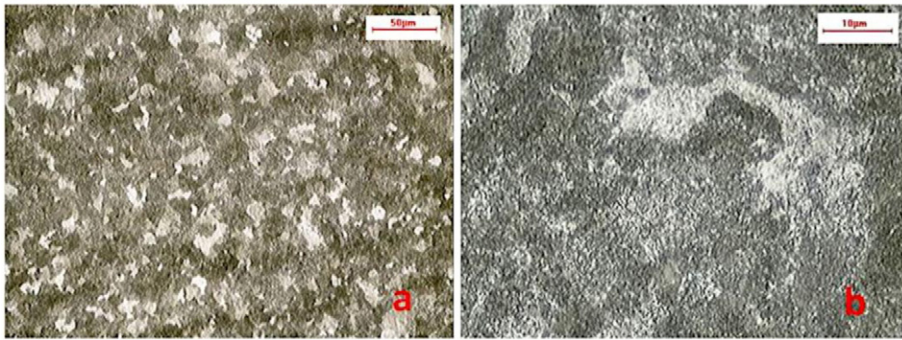
Fig. 5 presents micrographs of HAZ regions. These figures show the pearlite fragmentation (iron and carbon diffusion implied in the cementite lamellae partial disintegration) due to high heat input during welding process in this area.

Fig. 5. Micrographs of HAZ; Nital 2%, OM. (a) 400×; (b) 2000×.

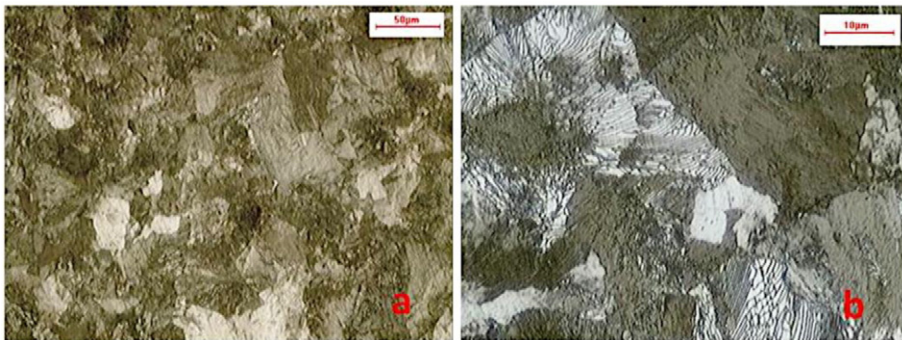
Fig. 6 shows micrographs of WB regions. In this area it was possible to observe that pearlite colonies have higher sizes, indicating higher preexisting austenite grain sizes. In Fig. 7 it is possible to see the central line. In this line, the microstructure is constituted of pearlite and pro-eutectoid ferrite. Ferrite grains are localized at pearlite colonies boundaries, indicating local decarburization.

Fig. 6. Micrographs of WB; Nital 2%, OM. (a) 400×; (b) 2000×.

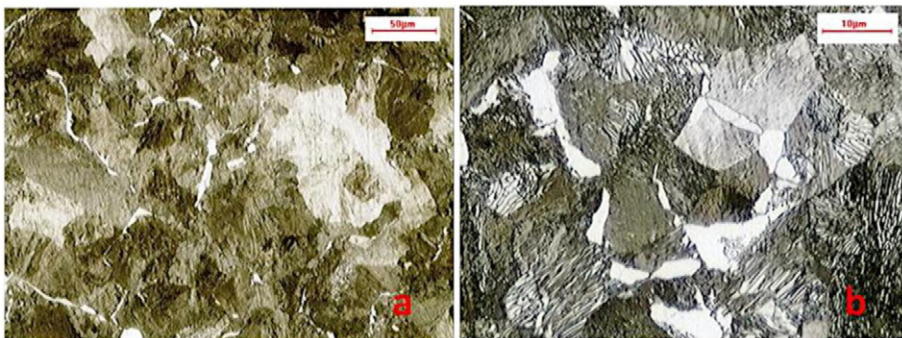
Fig. 7. Micrographs of CL; Nital 2%, OM. (a) 400×; (b) 2000×.

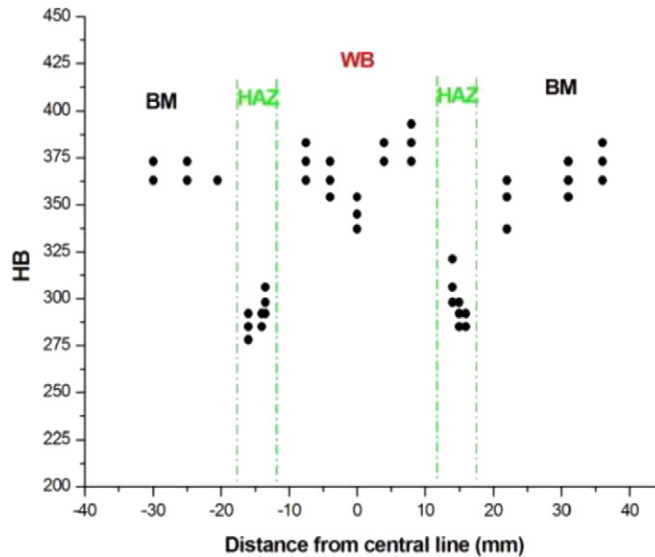
The used sample in the microstructural characterization was submitted to Brinell hardness tests (ASTM E10-08, force = 187.5 kgf, diameter = 2.5 mm). Measures were done in BM, HAZ, and WB regions and CL. Fig. 8 presents the Brinell hardness profile measured in the failed welded joint. As expected, obtained values in BM and WB were similar, because both structures

are pearlitic with small differences between colony sizes and interlamellar spacing. In CL, hardness values decrease slightly. This result may be explained due to pro-eutectoid ferrite presence in this area. In HAZ, hardness values presented a high decrease, justified by pearlite fragmentation verified in this region.

Fig. 8. Brinell hardness data. BM = base metal; HAZ = heat affected zone; WB = weld bead; central line (CL) at reference position 0.

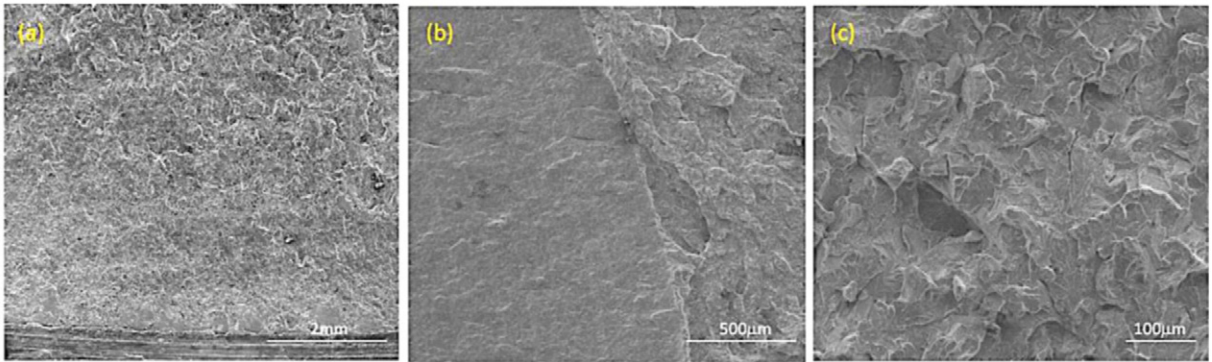
The microfractographic analysis was performed in a scanning electron microscope (SEM). **Fig. 9** was obtained using the same region as shown in **Fig. 2(a)**. In **Fig. 9(a)** it is possible to confirm the phenomenon of fatigue as the main cause of crack nucleation and stable growth. This figure shows a flat fracture surface without plastic deformation and with beach marks, all typical of fatigue. **Fig. 9(b)** presents the transition area of stable to instable crack growth. In the part corresponding to the fatigue process it is still possible to see some beach marks. Finally, **Fig. 9(c)** reveals cleavage facets and river marks, indicating a final brittle fracture caused by a rapid tearing.

According to the obtained results, it is possible to affirm that the studied failure was caused by two mechanisms. First, a fatigue crack nucleated and then grew steadily in the welded bead, specifically in internal parts of the rail web, where severe stress concentrators were observed (coarse burrs, grinding striations, sharp edges). Second, the fatigue crack grew, initially stably, until a

Fig. 9. (a) Start of fatigue crack nucleation and growth; (b) transition area; (c) brittle fracture area. SEM.

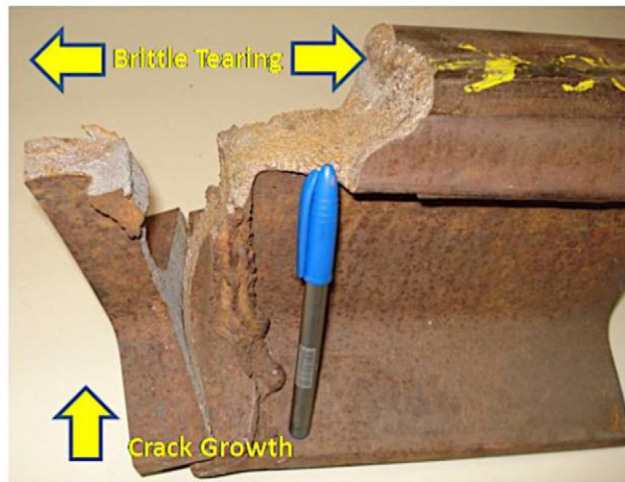
Fig. 10 presents the start of fatigue cracking from the rail foot, a vertical crack growth through its web and the final fracture in its head. All these steps of fatigue cracking occurred in the welded region.

Fig. 10. Crack nucleation and growth from the foot of the rail, resulting in a brittle fracture of the welded bead at web and head areas.

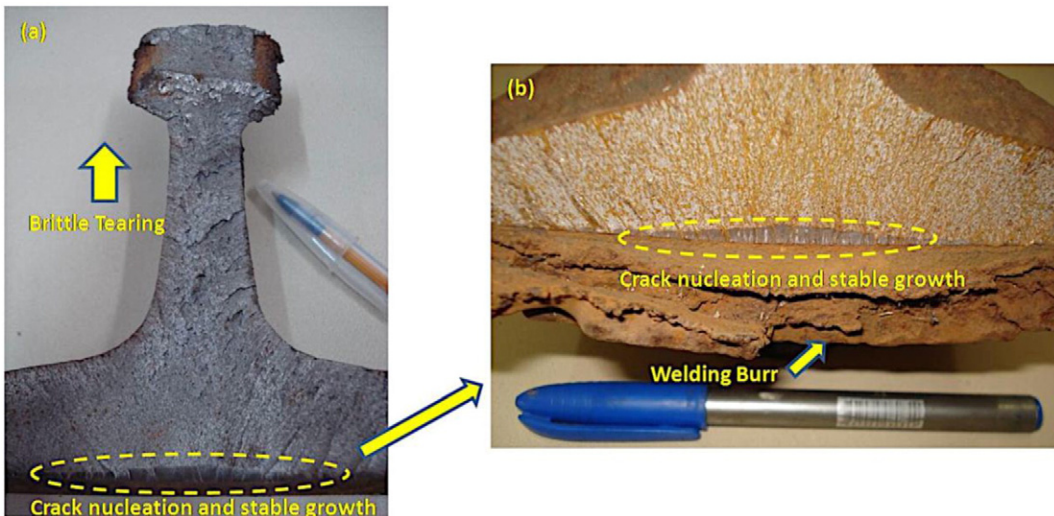
Fig. 11(a) shows a general view of the fractured surface. It is possible to see two distinct areas: at the rail foot there is a semi-circular, dark and flat area (typical of fatigue crack nucleation and stable growth), different from the head and web areas that present chevron marks with high intensity of reflected light (fractured by brittle mechanism).

Fig. 11(b) highlights the foot area, where is possible to observe that the semicircular area has typical characteristics of a nucleation and stable crack growth under fatigue conditions. This area is situated exactly at the weld bead where a coarse burr is

present (stress concentration). It is supposed that fatigue crack grew until get a specific radius (around 3 mm) at the foot of the rail promoting a stress intensity factor correspondent to the material fracture toughness, causing a catastrophic failure at the welded joint.

Fig. 11. Fractured surface of the rail in the weld region. (a) General view. (b) Highlighting the foot area where exists a coarse burr.

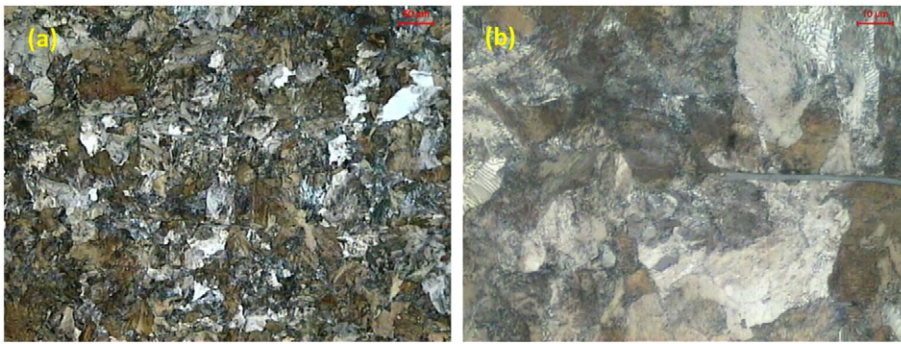
Base metal (BM), heat-affected zone (HAZ) and weld bead (WB) samples were metallographically prepared, etched with Nital 2% and microstructurally analyzed in an optical microscope (OM). Fig. 12 presents the BM microstructure. It is possible to observe pearlite as the main constituent with a small amount of ferrite. It is noticeable the presence of manganese sulfide inclusions along of all base metal. These inclusions have an elongated morphology aligned with the rail rolling direction.

Fig. 12. Micrograph of BM; Nital 2%, OM. (a) 200×; (b) 1000×.

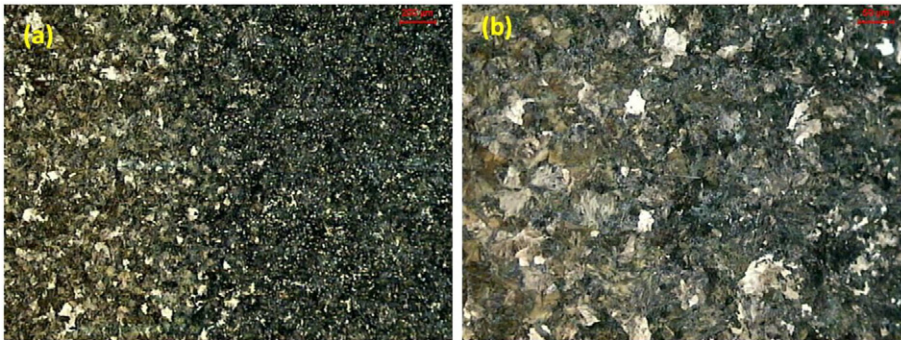
Fig. 13 presents micrographs of the transition region between the base metal (left) and the HAZ (right). It is observed that this is a region of microstructural discontinuity, where in the base metal there is a structure formed by colonies of well-defined and coarser pearlite, while the HAZ shows a granular aspect, giving evidence of pearlite crumbling (cementite spheroidization), probably due to the high heat input in this area during the welding procedure. These characteristics may be better observed in Fig. 14, which presents micrographs of the HAZ region.

Fig. 13. Micrograph of transition area between BM and HAZ; Nital 2%, OM. (a) 200×; (b) 1000×.

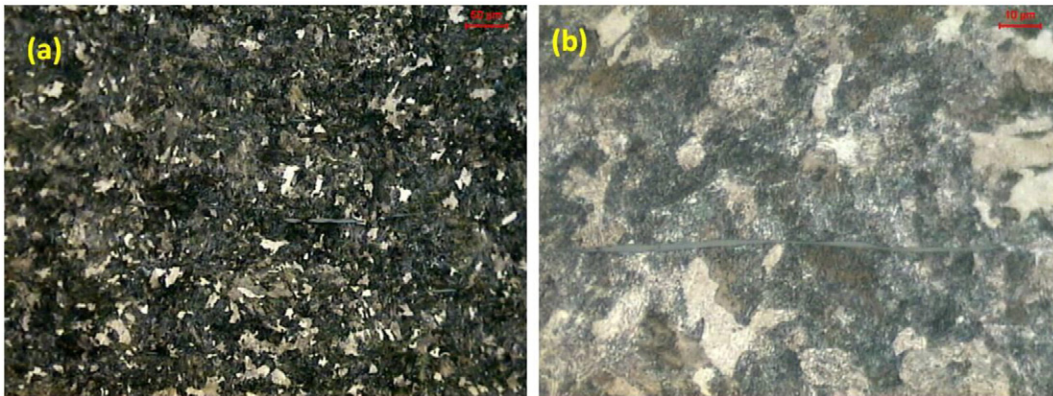
Fig. 14. Micrograph of HAZ; Nital 2%, OM. (a) 200×; (b) 1000×.

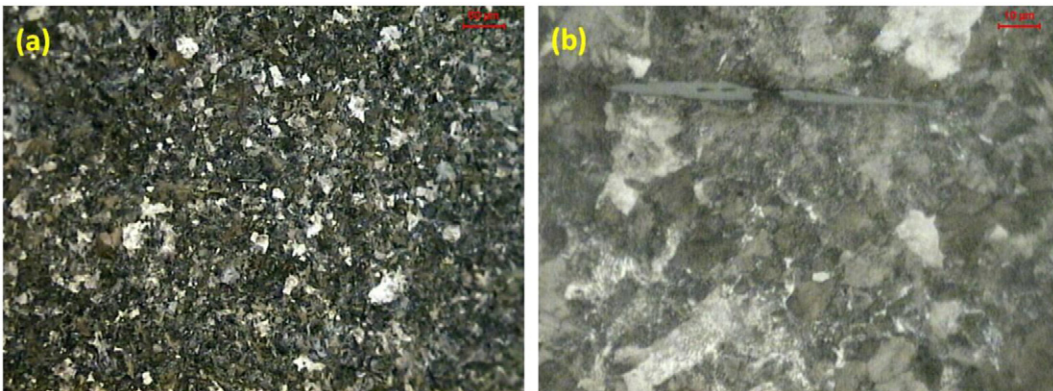
Fig. 15 shows the micrographs of the WB area. It is possible to ensure that pearlite is also the main constituent, however the average size of their colonies is significantly lower, compared to the BM microstructure. Manganese sulfides are also present in WB region with elongated morphology in the rail rolling direction.

Fig. 15. Micrograph of WB; Nital 2%, OM. (a) 200×; (b) 1000×.

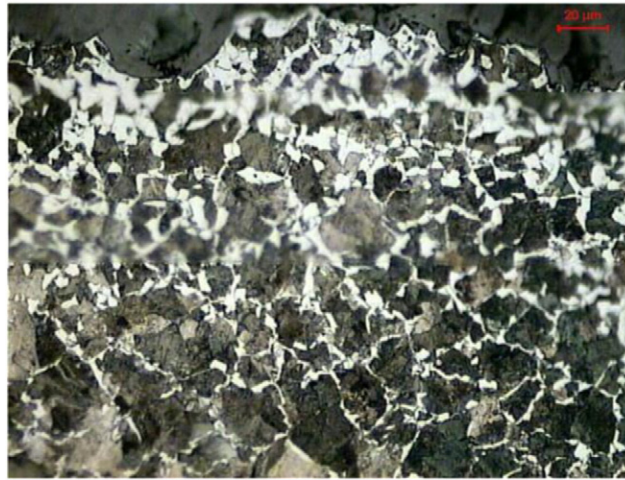
A sample from the region where the crack had nucleated under fatigue loading, at the rail foot, was prepared, etched with Nital 2% and analyzed. Fig. 16 presents the obtained result, where is possible to verify a big amount of pro-eutectoid ferrite between pearlite colonies. This characteristic may be an evidence of local decarburization during welding.

Fig. 16. Micrograph of the crack nucleation area (rail foot); Nital 2%, OM.

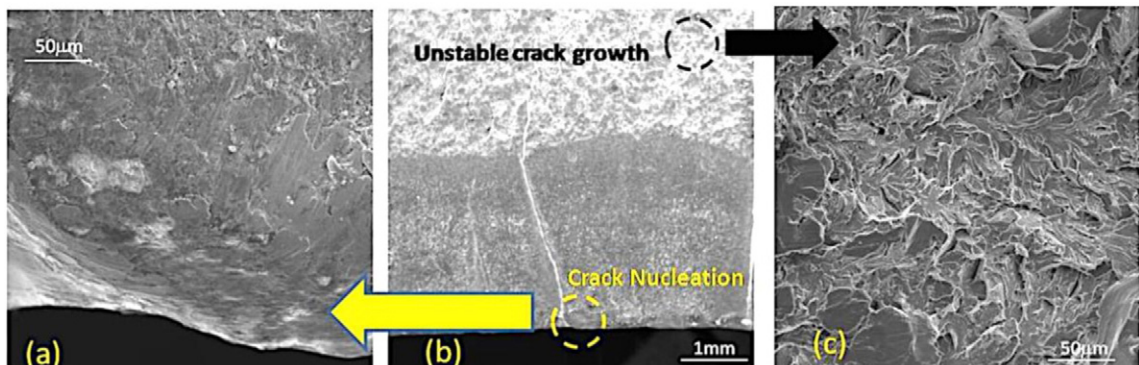
A sample from the rail foot, collected next to the crack nucleation area, was analyzed in a scanning electron microscope (SEM). Fig. 17 presents the microfractographs of two different areas: the fatigue cracks nucleation and crack stable growth regions, as

well the unstable tearing area. At the crack stable growth, it is possible to observe a flat surface without plastic deformation, typical of a fatigue crack growth. At the crack unstable growth area there are cleavage facets that are typical characteristics of a brittle fracture.

Fig. 17. (a) Start of fatigue crack nucleation and growth; (b) fatigue crack nucleation and growth regions; (c) brittle fracture area.
