GEOLOGICAL CHARACTERISATION OF THE LAI PING ROAD LANDSLIDE

GEO REPORT No. 166

N.P. Koor & S.D.G. Campbell

**GEOTECHNICAL ENGINEERING OFFICE
CIVIL ENGINEERING AND DEVELOPMENT DEPARTMENT
THE GOVERNMENT OF THE HONG KONG
SPECIAL ADMINISTRATIVE REGION**

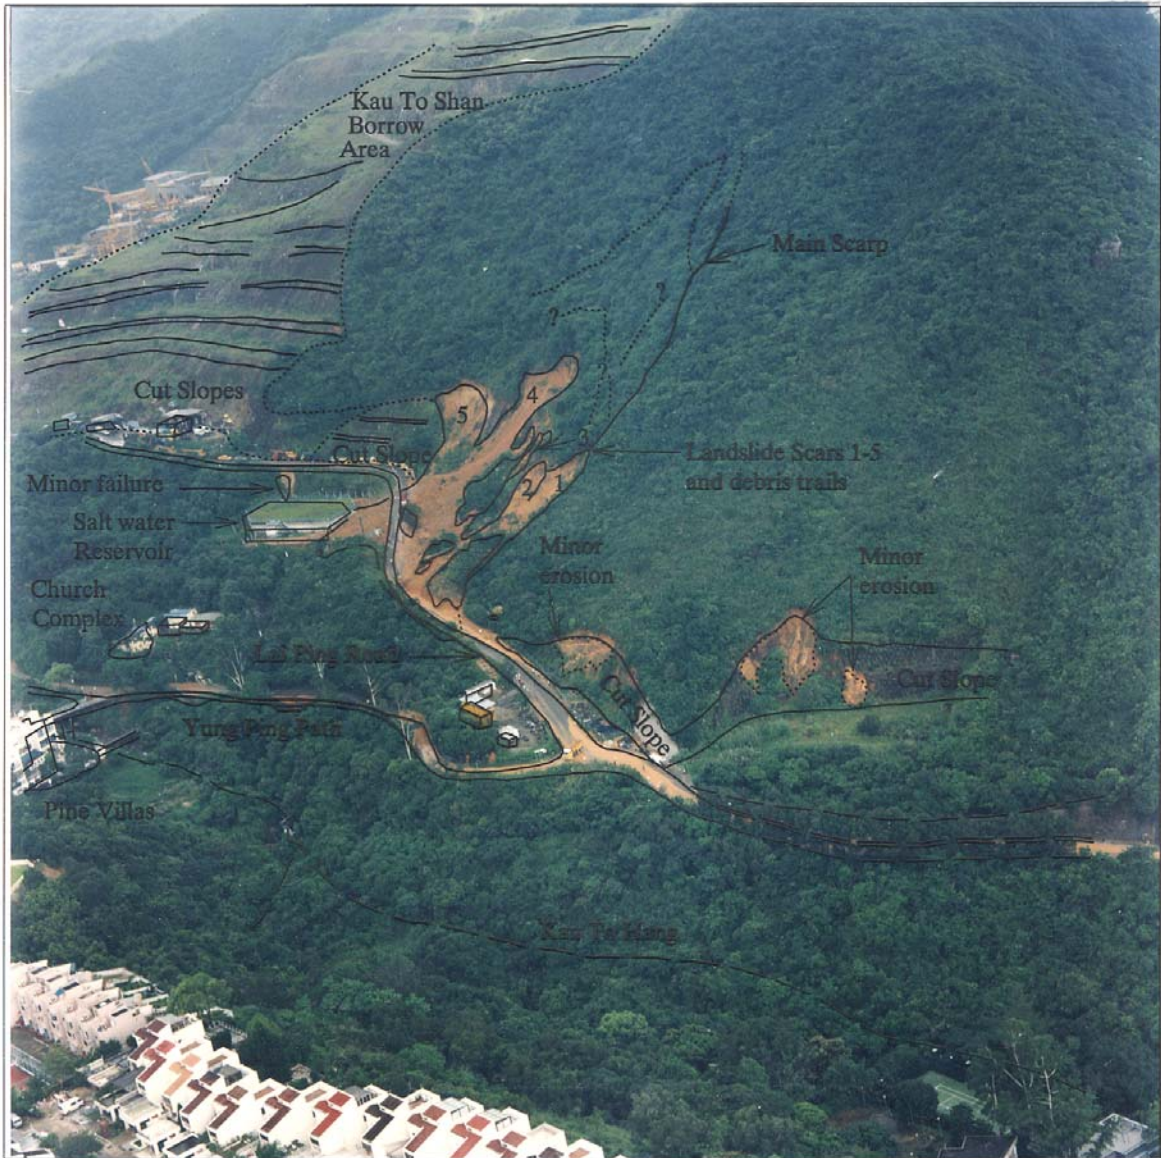
Plate 1 - Oblique Aerial View of Lai Ping Road Landslide Site from the South, Annotated to Show Landslide Scars 1-5, the Approximate Location of the Main Scarp, the Extent of the Debris, Locations of other Minor Failures, the Kau To Shan Borrow Area, the Church Complex and Other Structures (Taken on 4/7/97)

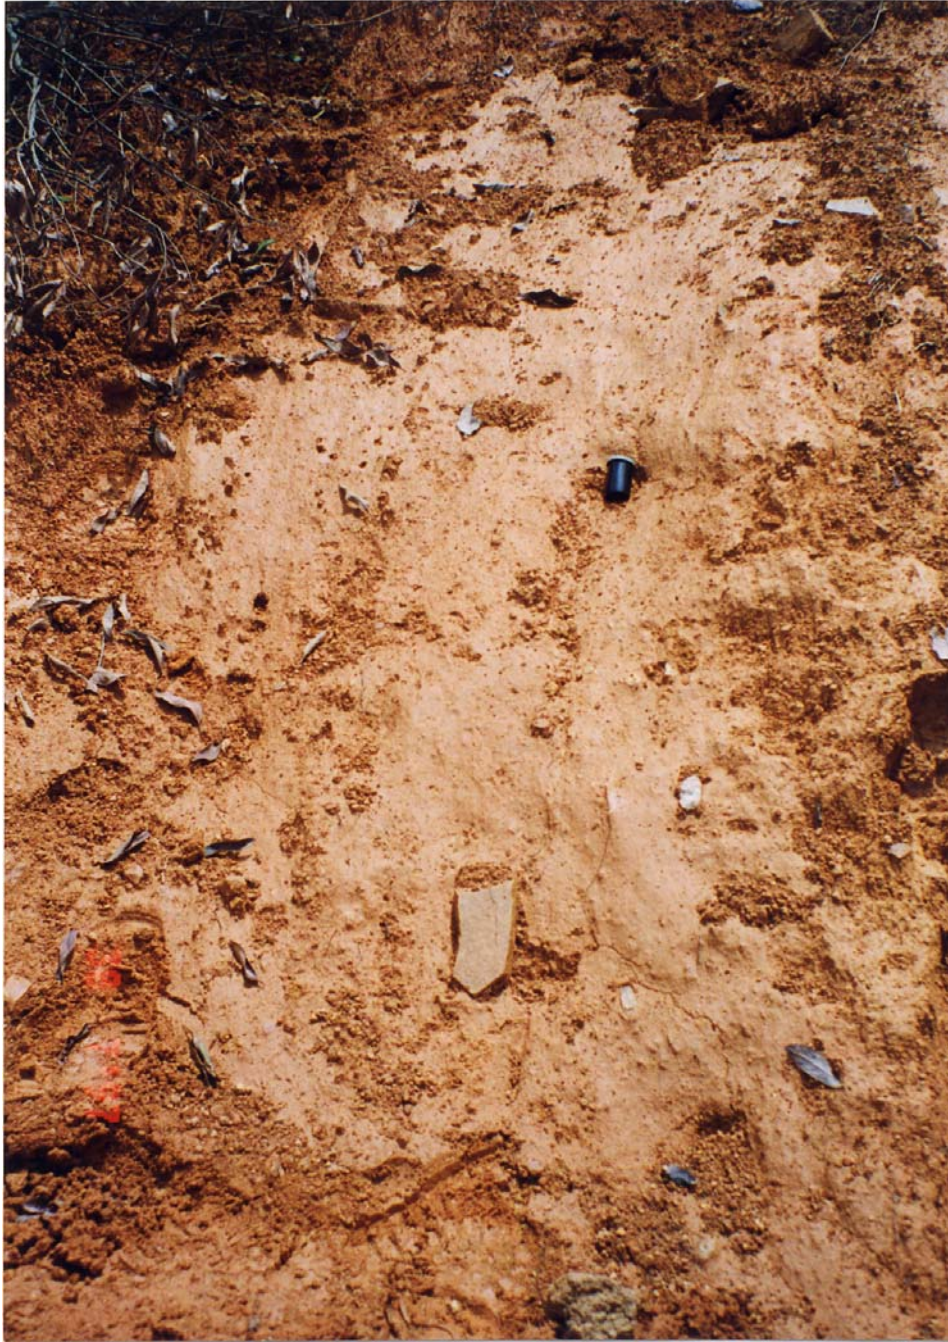
Plate 12 - Planar Slickensided Surface of Rupture Exposed below the Crown of Landslide Scar 1 (Plate Location Shown on Drawing EG503) (Taken on 30/7/97)

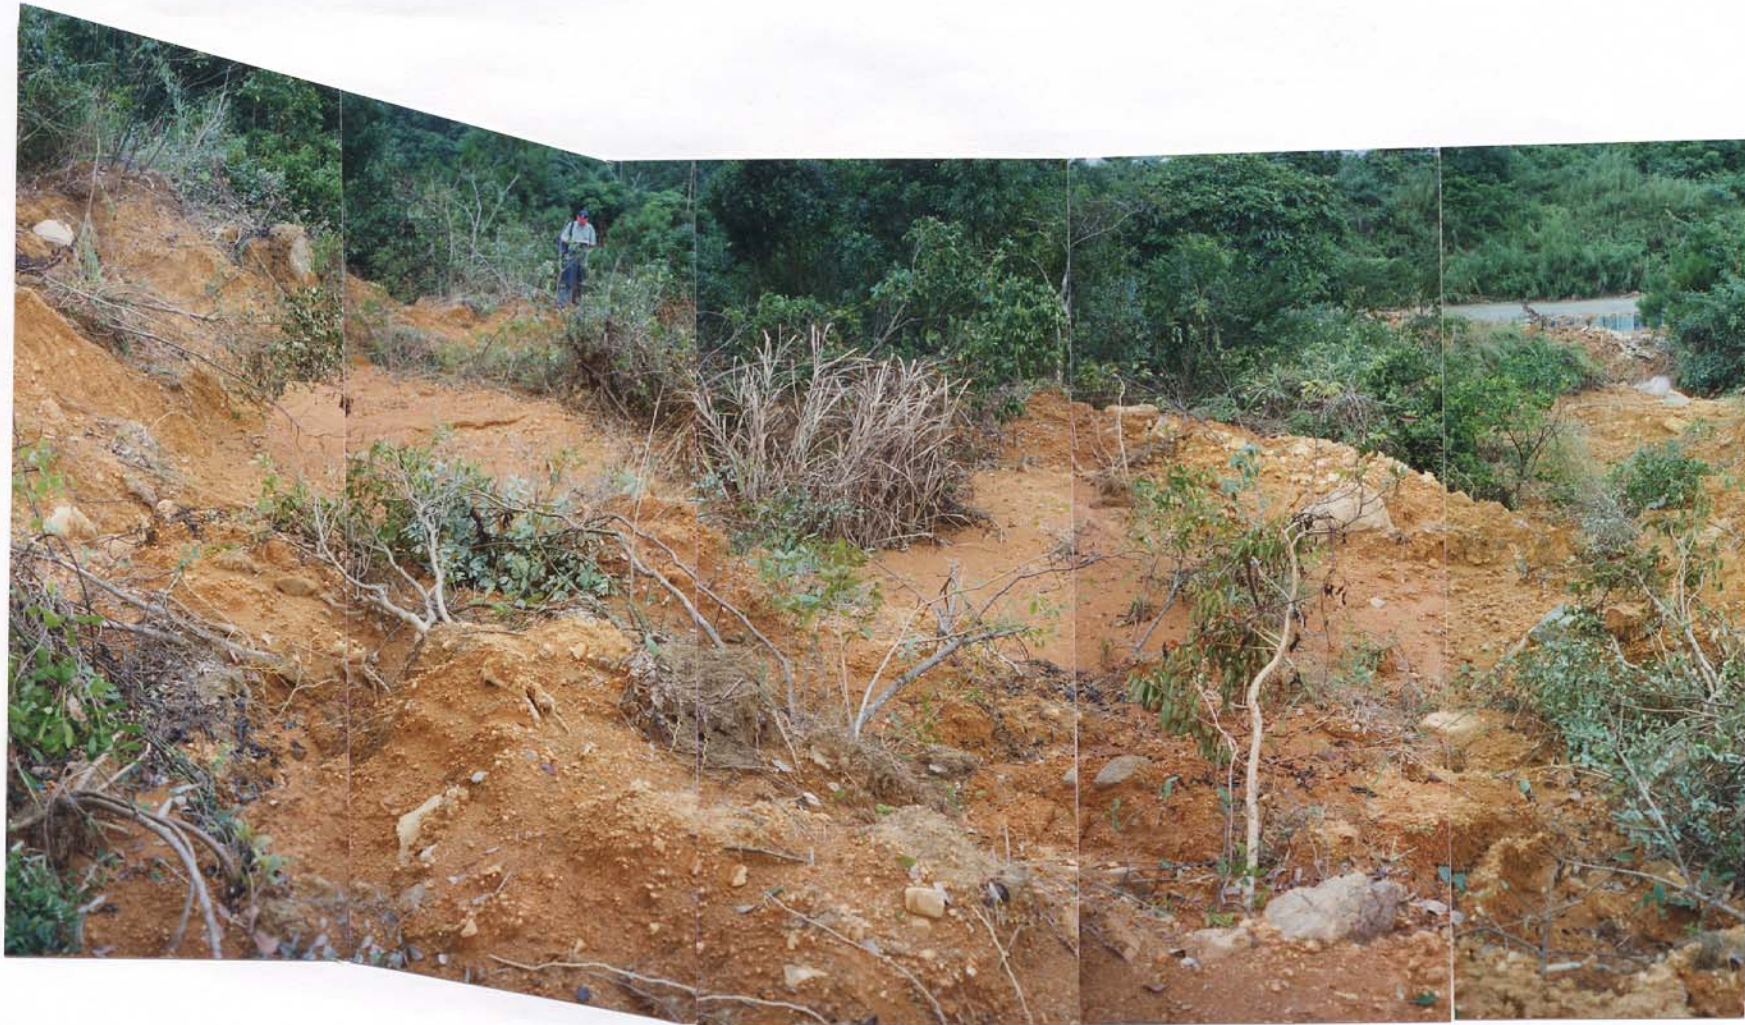
Plate 13 - Flat Area of Deposition and Debris Mound in Area Up-Slope of the Intact Debris Raft in Landslide Scar 1 (Plate Location Shown on Drawing EG503) (Taken on 30/7/97)

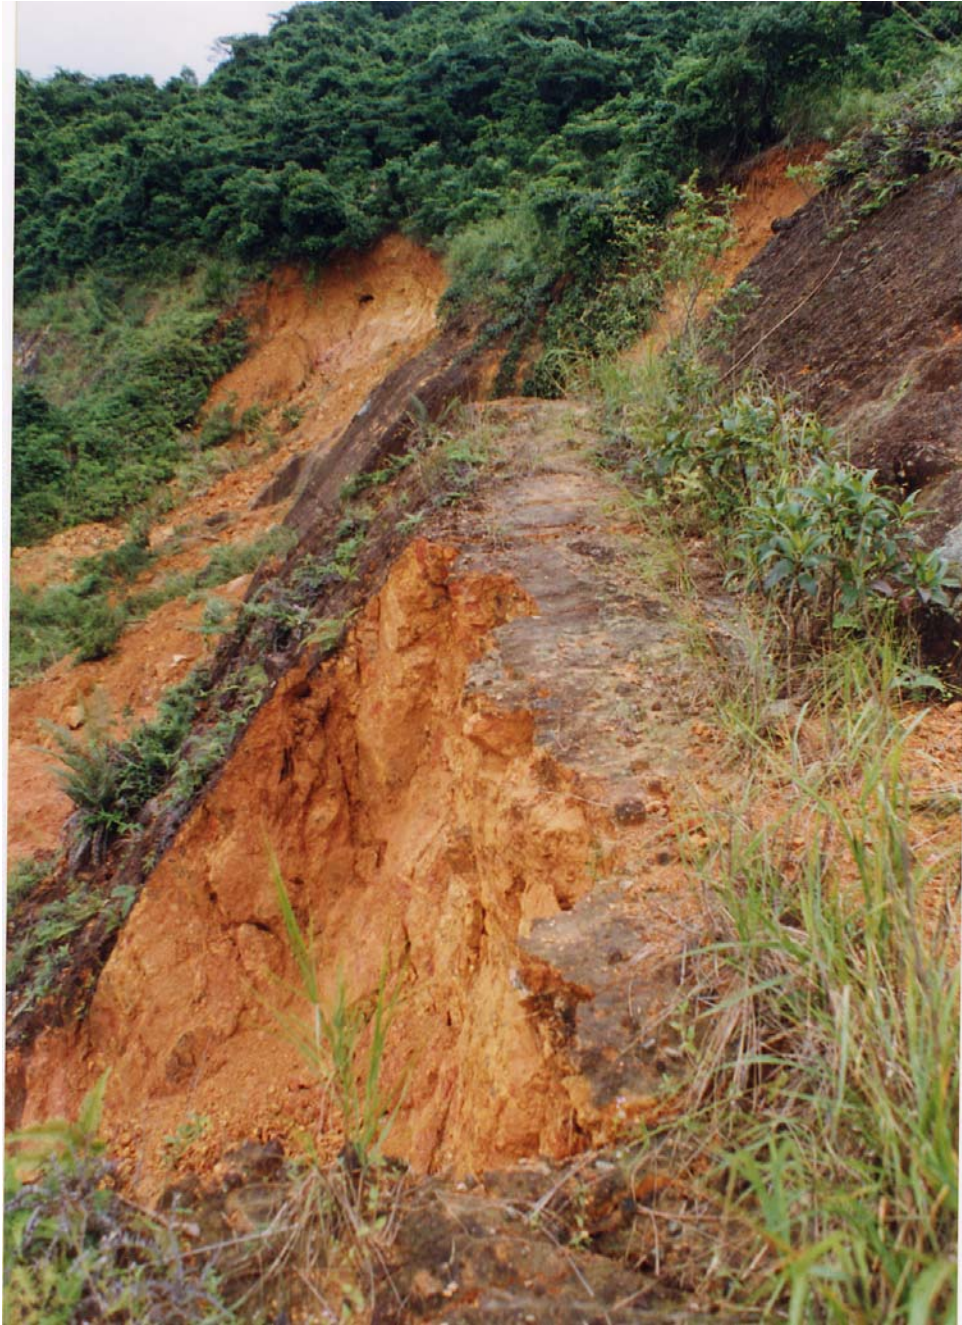
Plate 19 - Landslide Scar 3A Viewed from the South-East (Plate Location Shown on Drawing EG503) (Taken on 7/7/97)

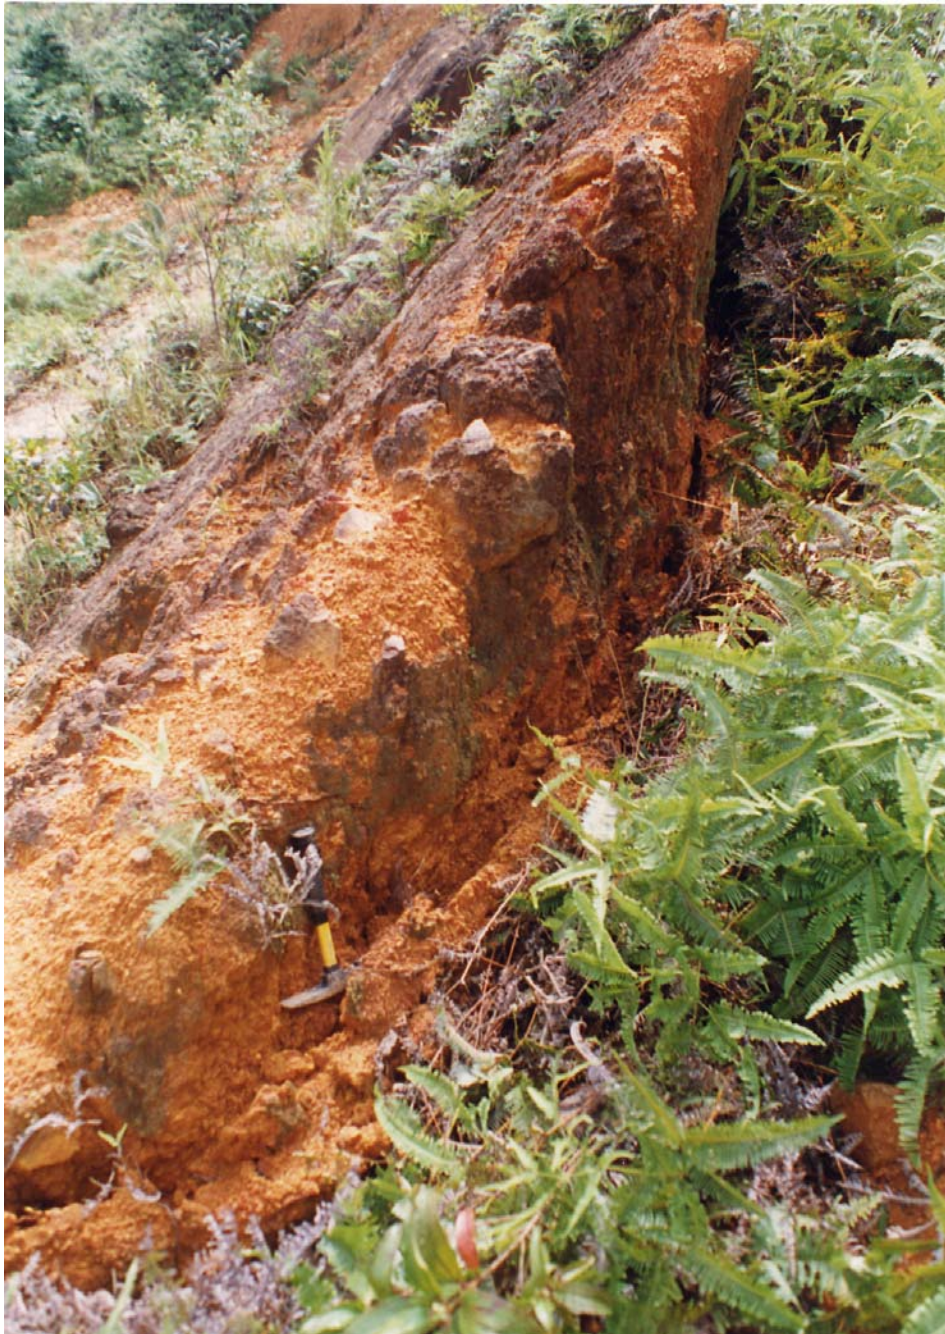
Plate 20 - Counter-Scarp Tension Cracks above Landslide Scar 3A
Indicating Possible Toppling Mode of Failure (Plate
Location Shown on Drawing EG503) (Taken on 10/7/97)

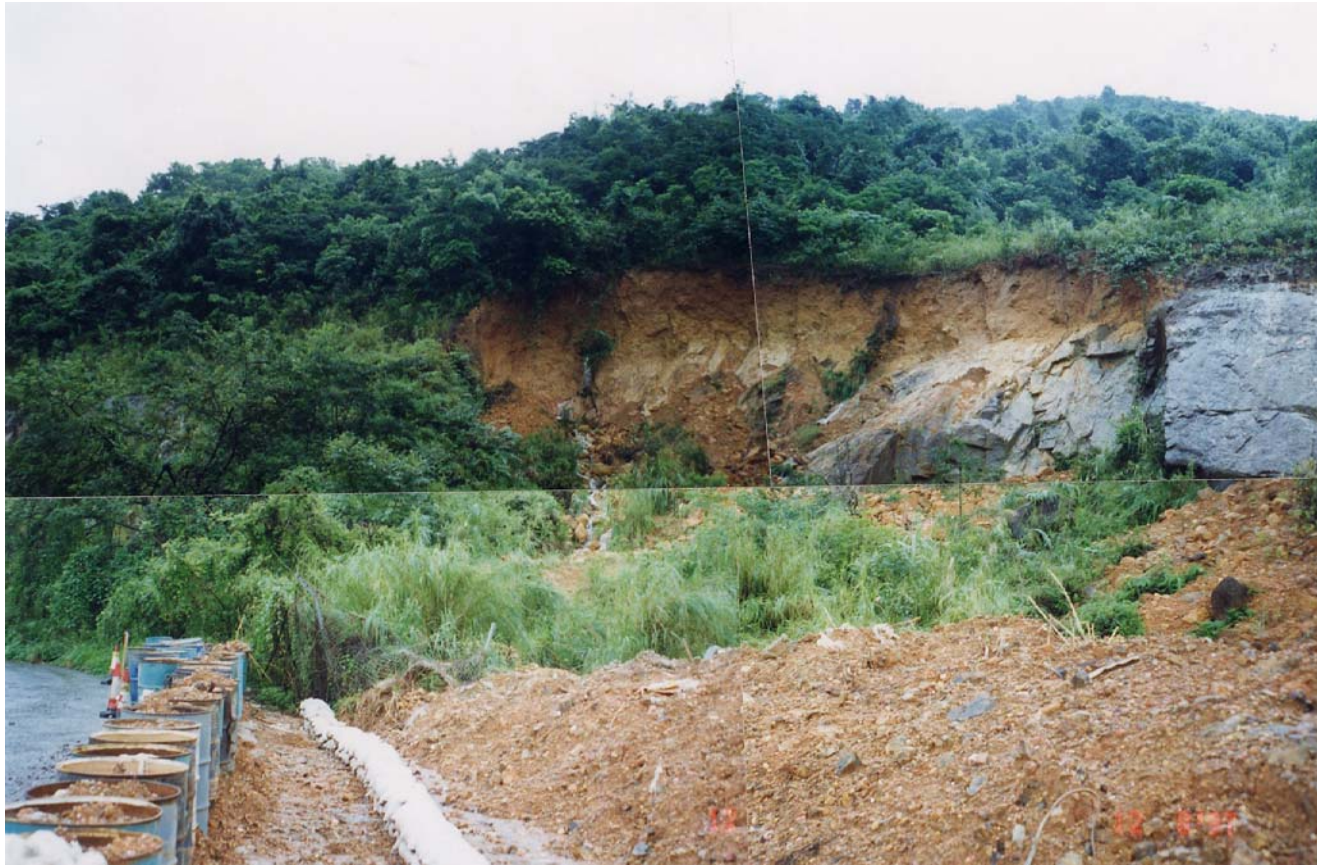
Plate 21 - View of Landslide Scar 4 & 4A (Plate Location Shown on Drawing EG503)
(Taken on 12/8/97)

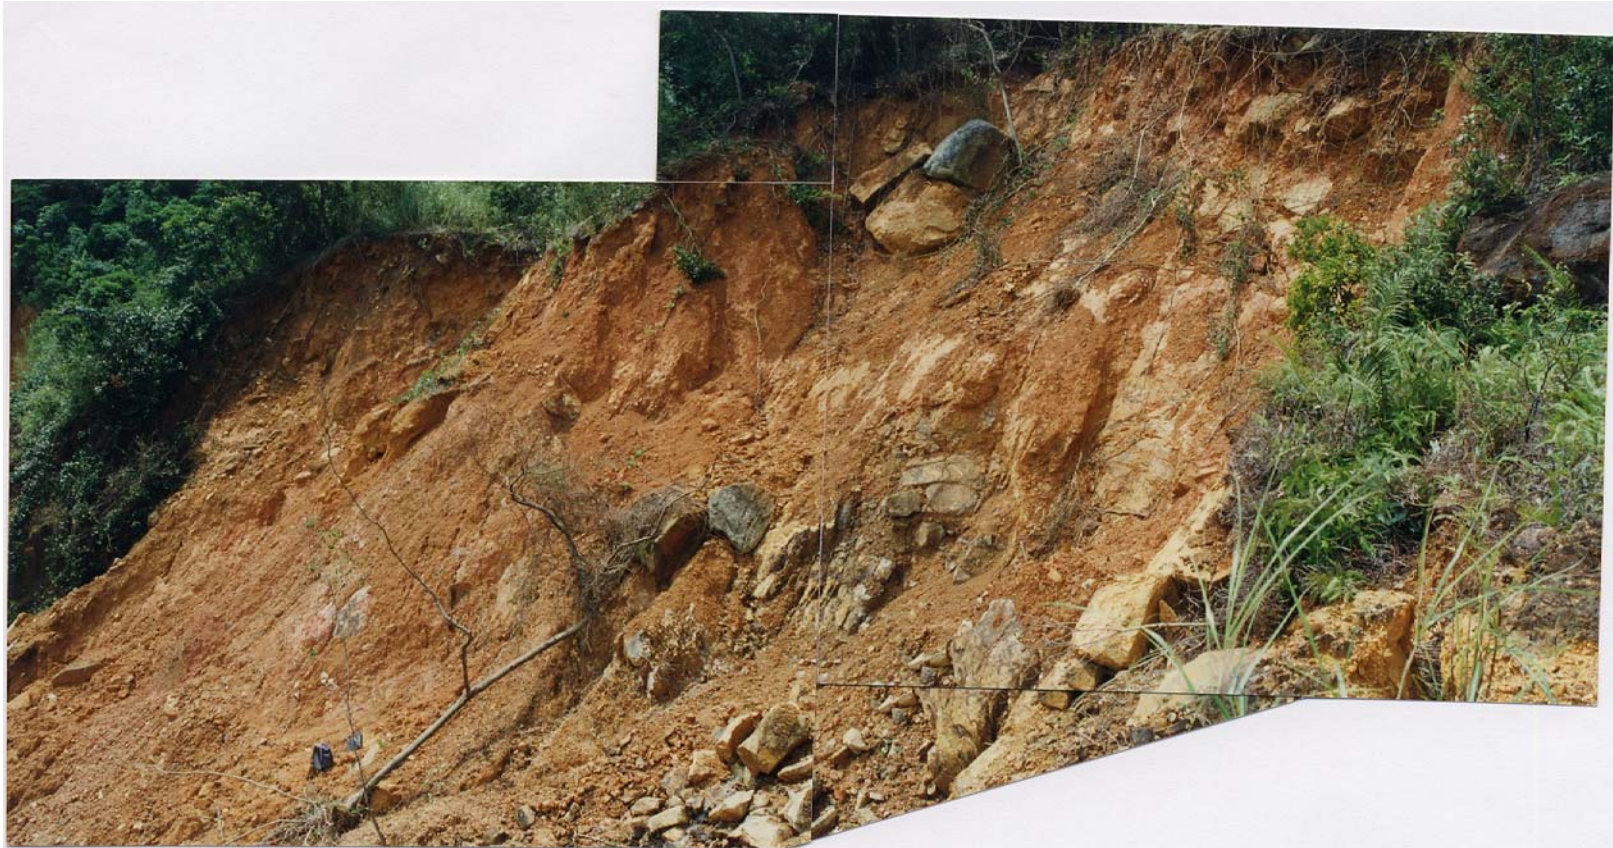
Plate 23 - Joint Controlled Surface of Rupture Exposed in Landslide Scar 4 (Plate Location Shown on Drawing EG503) (Taken on 6/8/97)

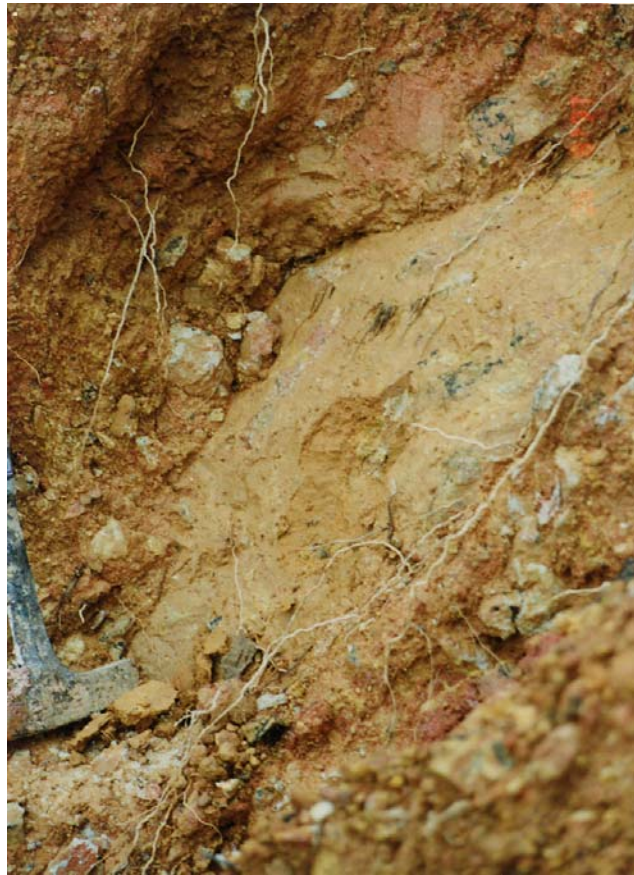
Plate 24 - Surface of Rupture Through Intact Saprolite Exposed in Landslide Scar 4A - Note Sharp Interface Between Recent Debris and Surface of Rupture (Plate Location Shown on Drawing EG503) (Taken on 27/8/97)
EG 97/109/15

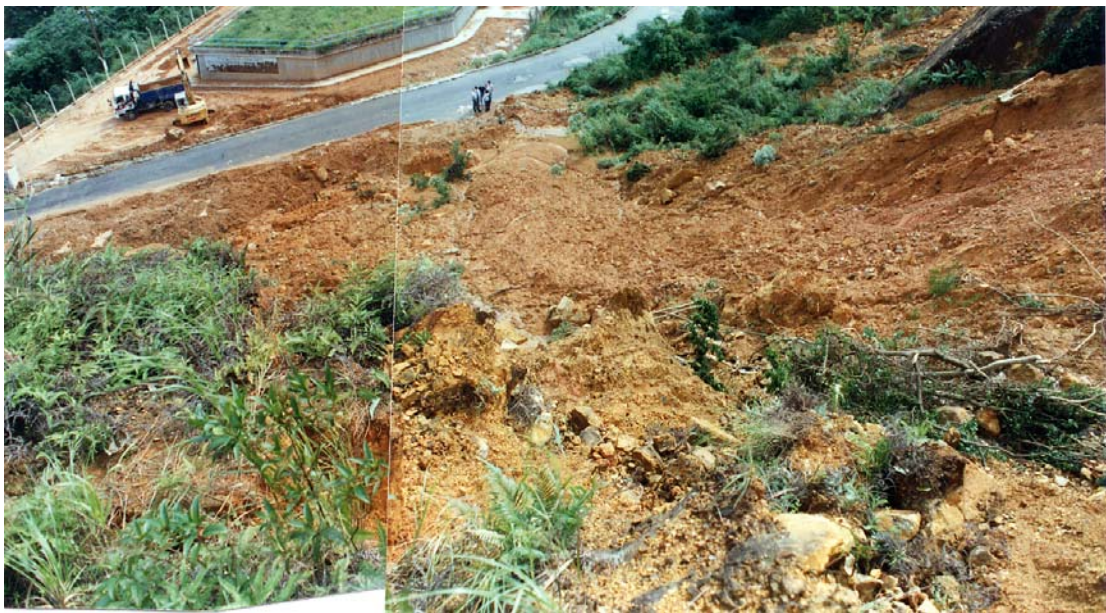
Plate 25 - Debrisflow-Earthflow Lobes from Landslide Scar 4A (Plate Location Shown on Drawing EG503) (Taken on 10/7/97)
GS 97/64/10 - 11

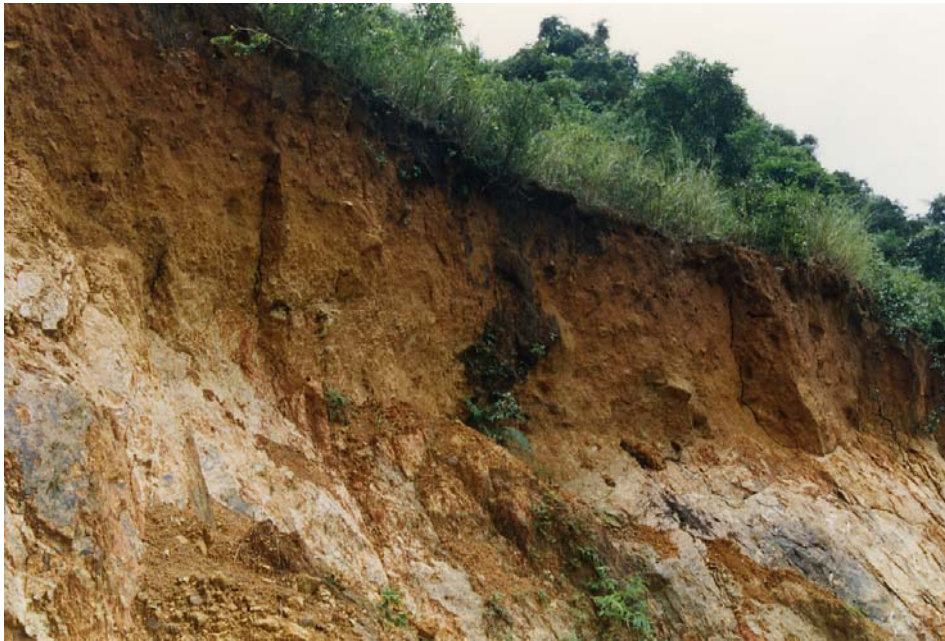
Plate 27(a) - Main Scarp of Landslide Scar 5 Viewed from the West - Note Older Mottled Colluvium, Dark Brown Staining on Scarp Surface and Sharp Interface Between Colluvium and Saprolite (Taken on 8/8/97) GS 97/107/33

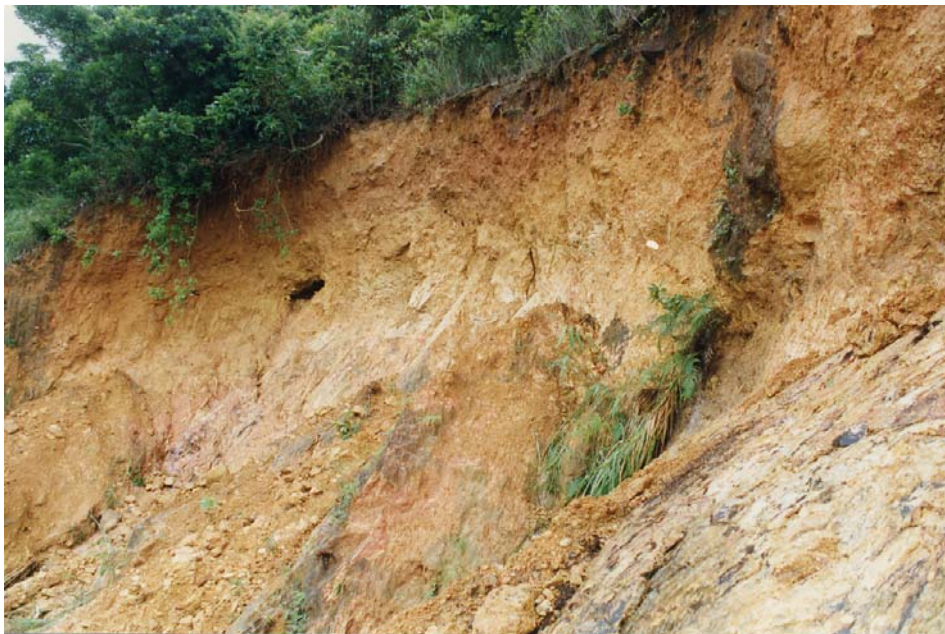
Plate 27(b) - Main Scarp of Landslide Scar 5 Viewed from the East - Note Large Soil Pipe (Plate Location Shown on Drawing EG503) (Taken on 7/7/97) GS 97/53/15

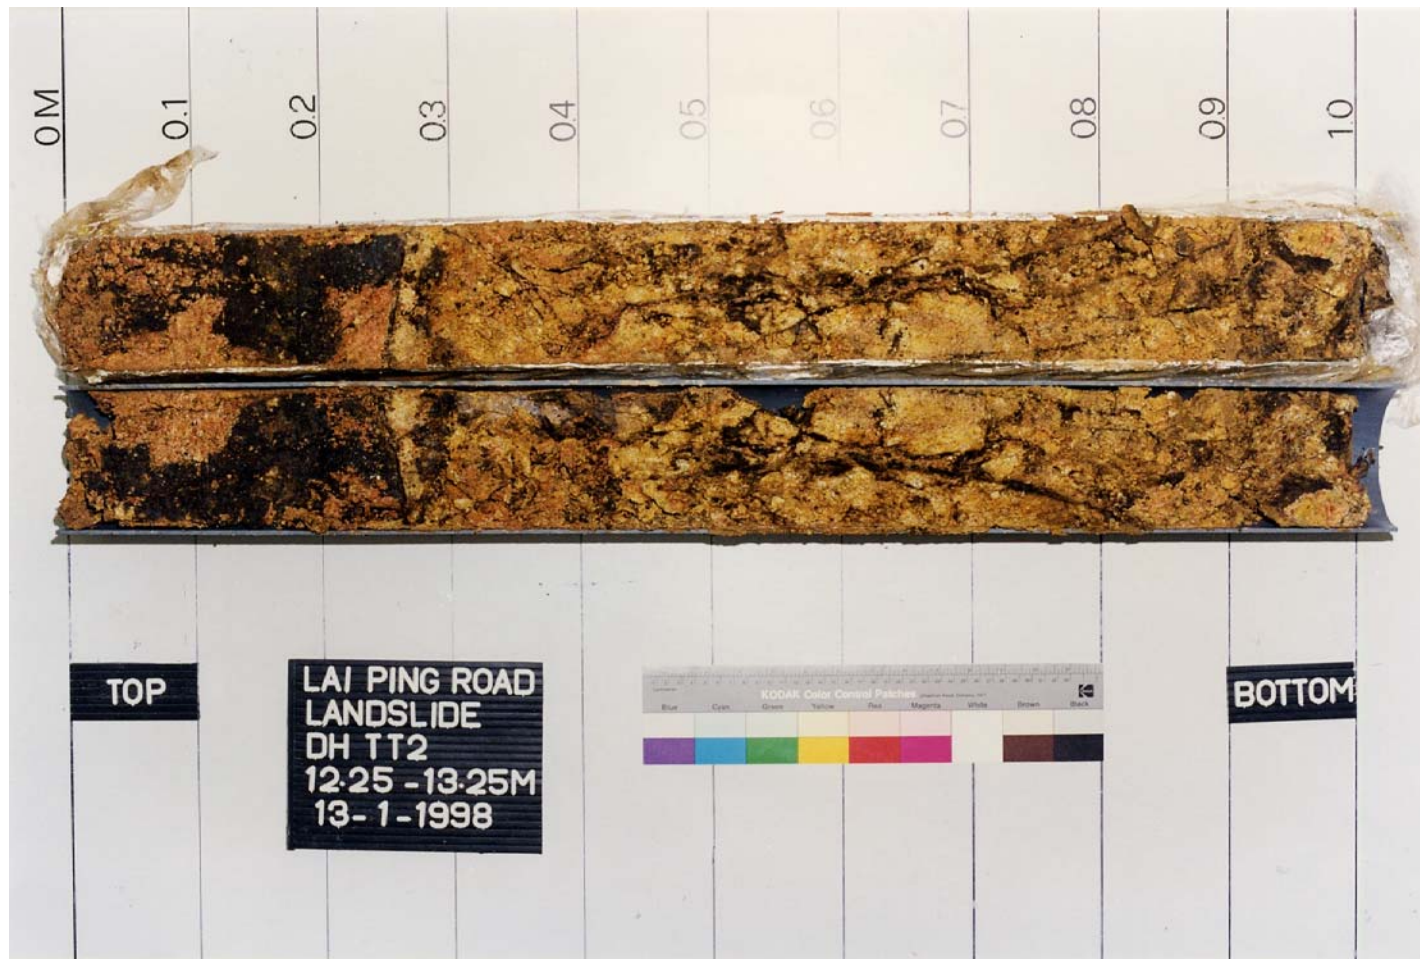
Plate 32 - Split 4CMLC Core from Drillhole TT2 Showing Sub-Vertical Relict Joints with Much Manganiferous Staining on the Joint Surface and within the Rock Fabric (Taken on 31/1/98)
