Failure Analysis of Welded Reformer Tubes of a Fertilizer Unit

J. Swaminathan*, Raghubir Singh, Swapan Kumar Das and Goutam Das

Materials Science and Technology Division,
National Metallurgical Laboratory, Jamshedpur- 831007, India

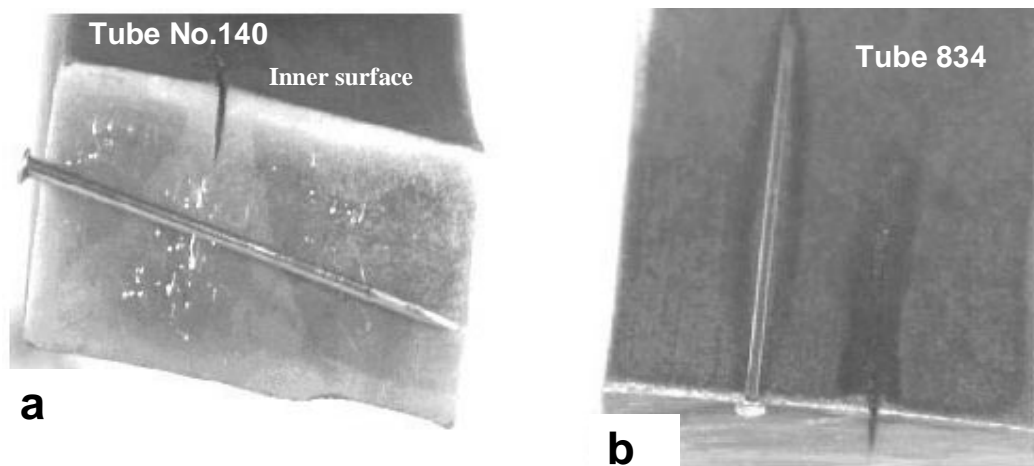
In both ring pieces, crack originated on the inner surface side on the weld root, which appeared to have grown in the circumferential direction (Fig.1). The crack length is 24 mm, depth is 3.7 mm and the crack opening is 0.6mm in the tube No.834 where as in tube No.140 it is 17mm, 4mm and 0.35mm respectively. There were no visible cracks in the base metal adjoining the weldment or in the weld root at sites other than the one shown in Fig.1

Fig.1. Macrographs of samples from tube received (a) showing crack originating from the inner surface (weld root) (b) showing crack growing in the circumferential direction

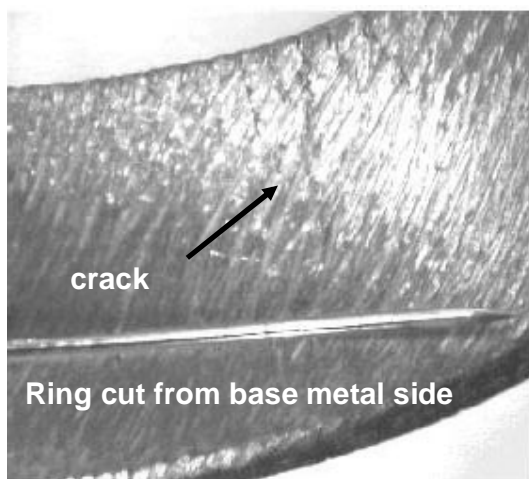
The tapered section of the base metal showed crack originating from the inner wall side and extending towards the outer wall (Fig.2). The crack is of sufficient depth covering about 2/3 of wall thickness. On the outer wall side no cracks were visible. On polishing and etching this sample, it was revealed (micrograph details are given later in this report) that the tapered section is not fully of the base metal. About 2 mm of weld region is also present and the cracks were actually in this weld region and base metal close to it i.e. heat affected zone (HAZ). These cracks propagated longitudinally on the inner surface. More number small

longitudinal cracks were also observed on the inner wall and close to the weld HAZ in addition to that shown in Fig.2

Fig.2 Macrograph showing the tapered ring section of tube No.840 with crack

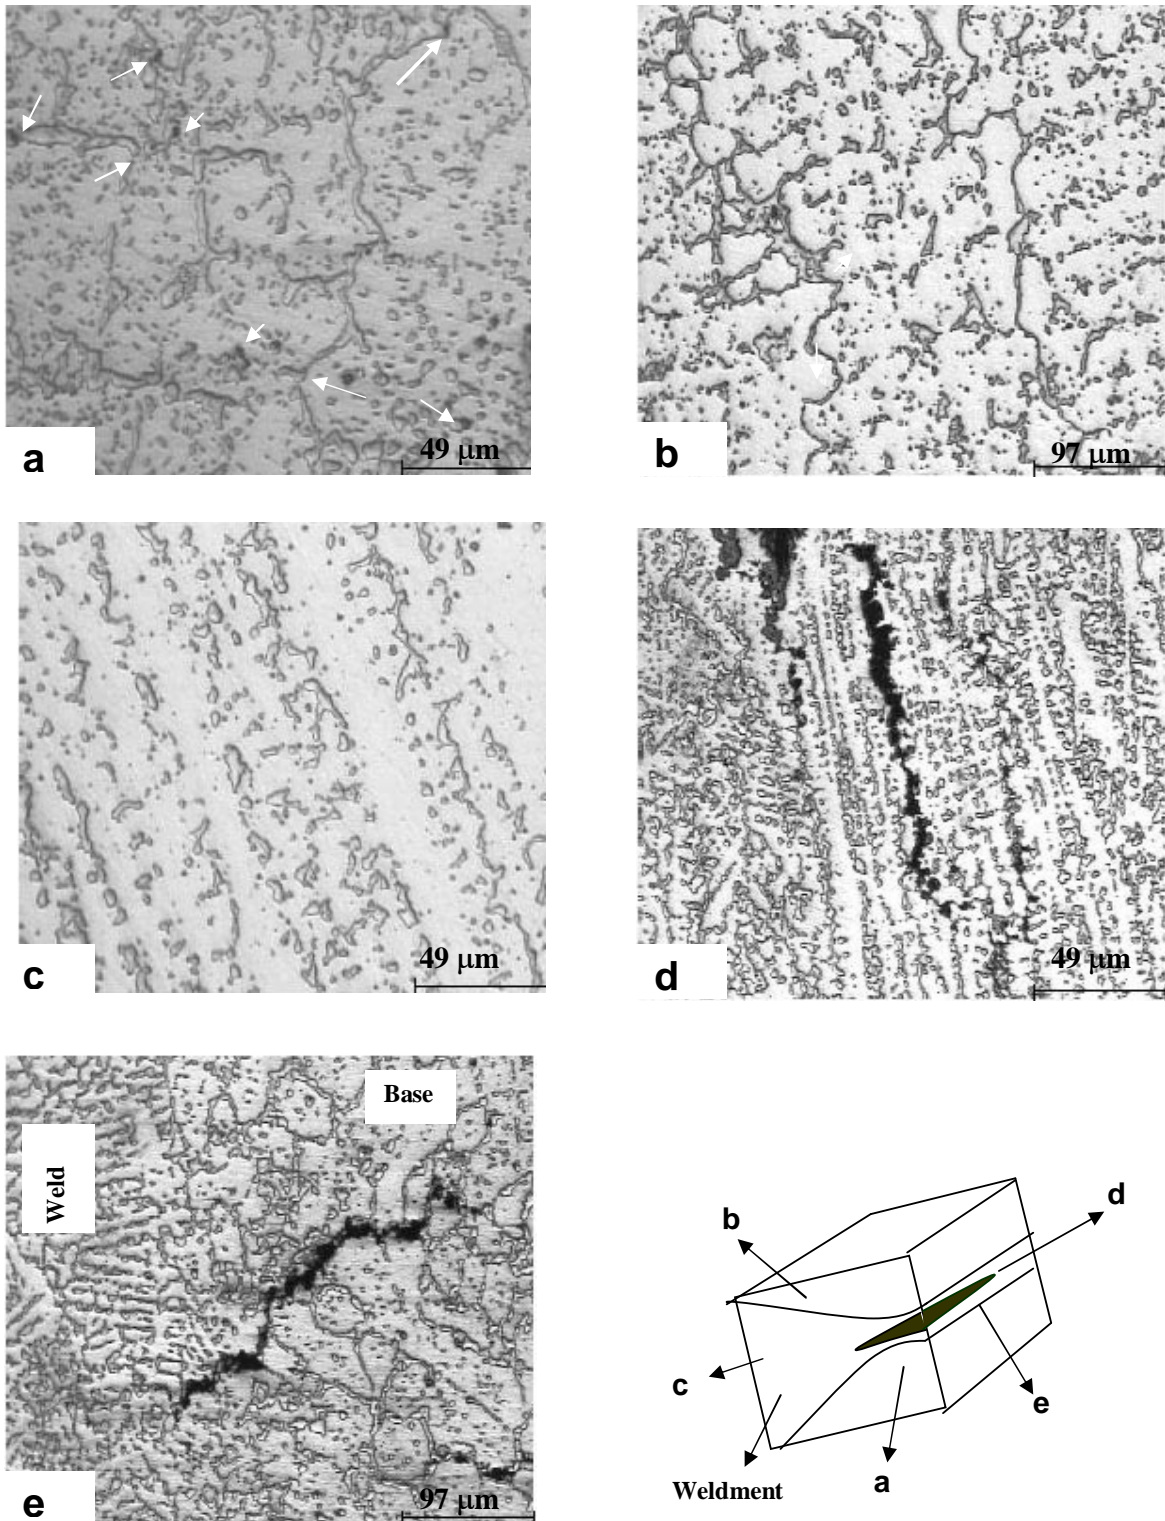
In tube No.140 (Fig.3) and No.834, the crack was observed on the inner surface propagating in the circumferencial direction along the weldment. Also, aligned creep voids and joining of these aligned voids to form microcracks in the circumferencial direction were observed ahead of the main crack. Cracks were also observed in longitudinal direction on the inner surface in the region of the base metal very close to the weldment i.e. HAZ. As one moved away from weld region, the creep voids are less aligned and mostly isolated.

The main circumferencial crack in the weldment was observed to have longitudinal branches extending on to the base metal. On closer examination it was revealed that the longitudinal cracks were originated in the edge of weld heat affected zone and leading on to the base metal (Fig 3e). The weld did not show cracks or voids through out the circumference on the inner wall side. Similarly longitudinal cracks in the base metal adjacent to the weldment

Fig.3. Optical micrographs of cracked weld of tube no.140 (schematic diagram show the location on the metallographic specimen) (a) equiaxed zone (b) columnar zone (c) weldment (d) ahead of crack on the inner wall in the circumferential weld (e) inner wall base metal near the fusion line. Arrows indicated creep voids

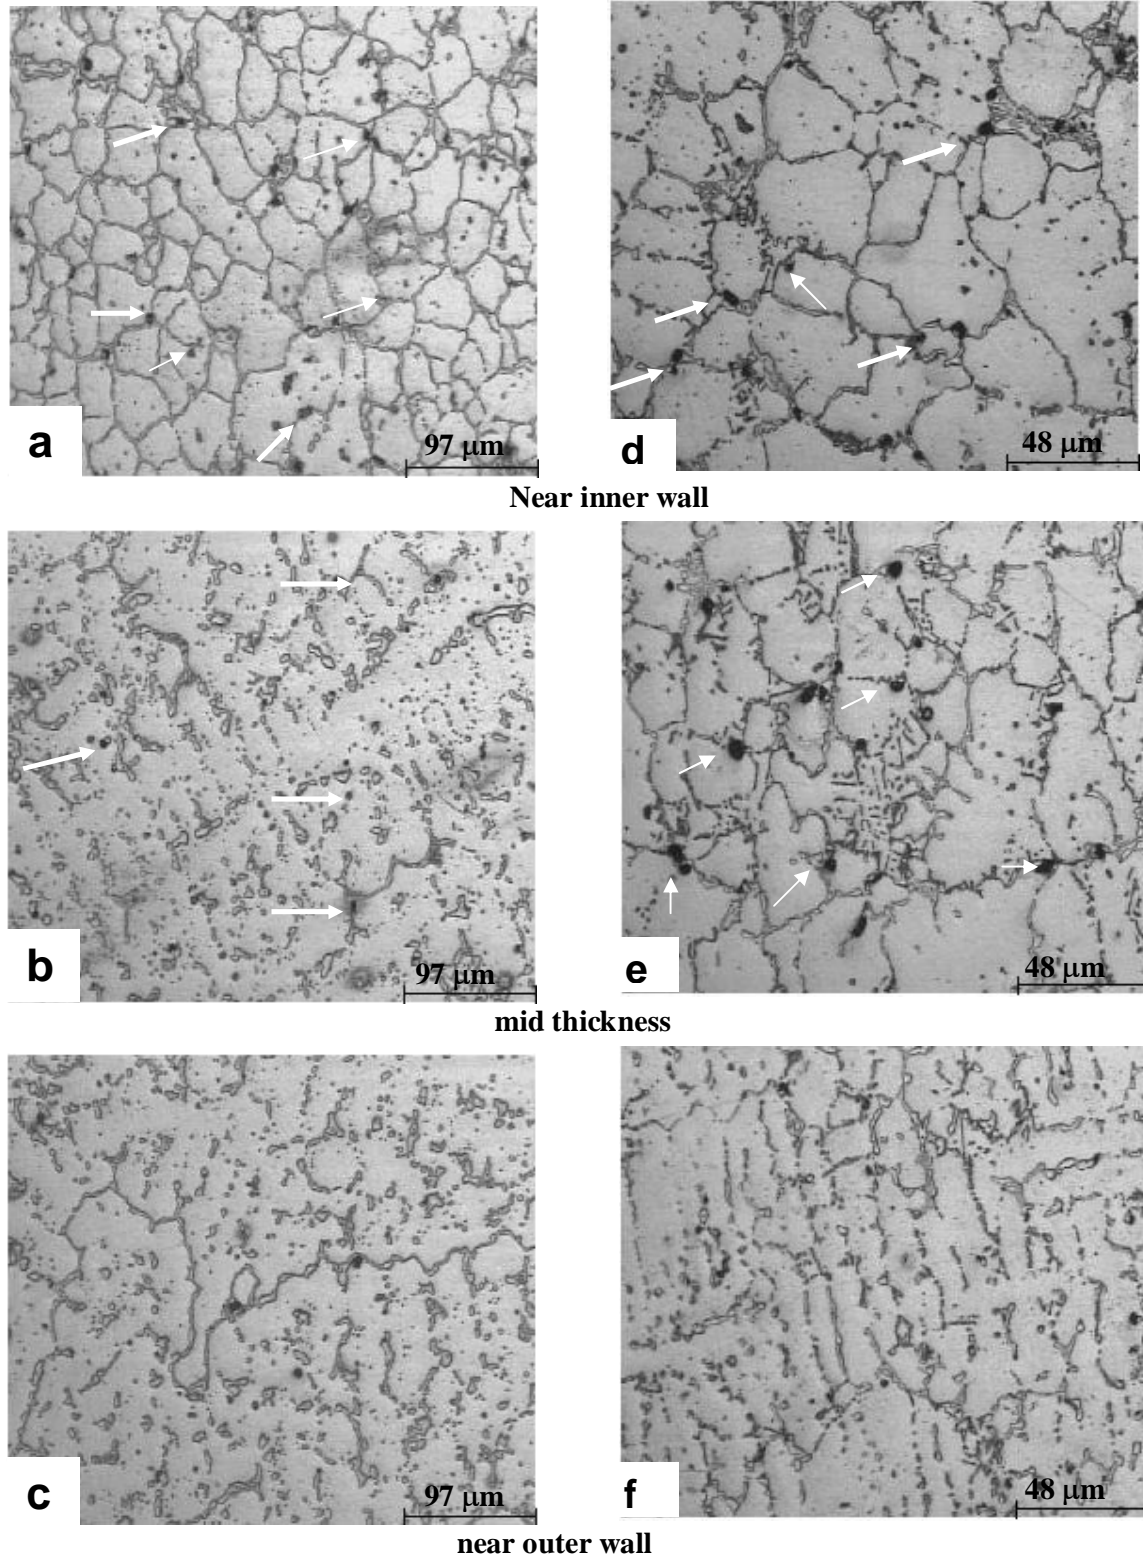
Fig.4. Photomicrographs of transverse section (a,b,c) tube 831-C-as service exposed. GB primary carbides are coagulated and continuous. Intragranular secondary precipitates are bulky. (d,e,f) tube 831-C-post service annealed. Change in carbide morphology. In both sample pieces isolated creep voids are present near the inner wall and mid thickness regions. Near the outer wall region creep voids are absent.

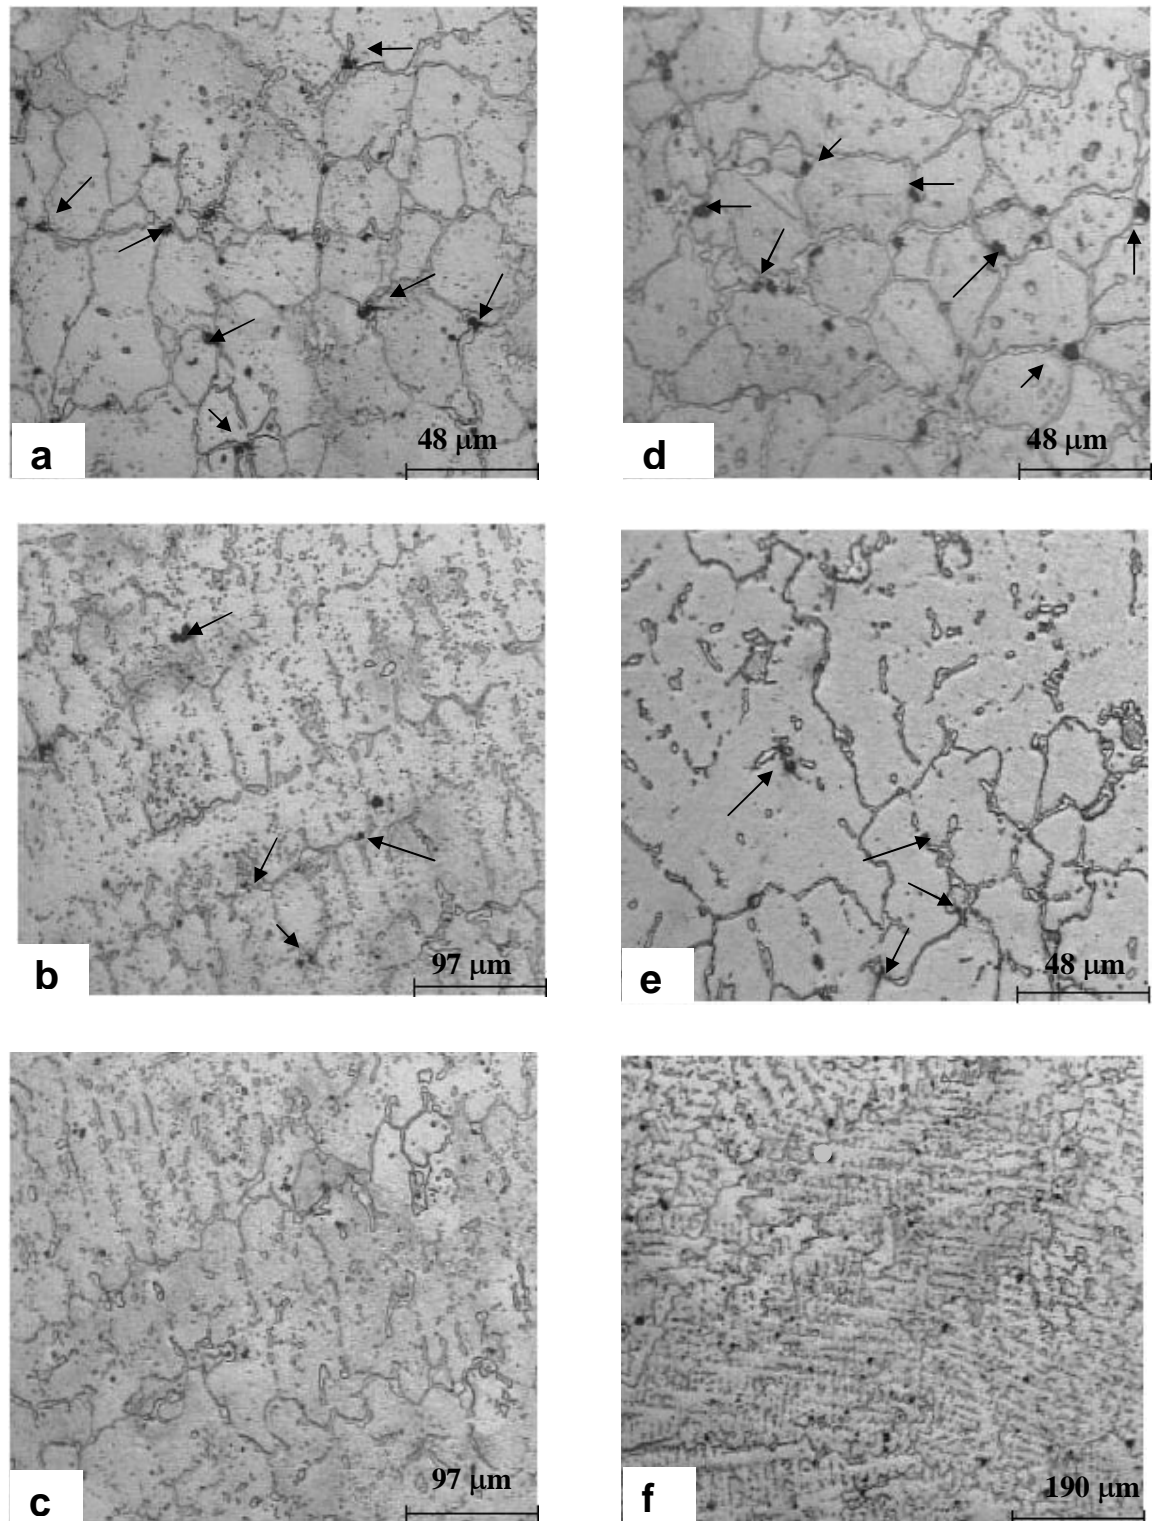
Unlike the tube No.140 and No.834, the weld of tube 831-D weld-SE did not show (Fig.5f) any creep induced cracks although the base metal showed isolated creep voids in the regions close to inner wall and mid thickness. Absence of creep induced cracks and aligned voids in the weld may be due to the lower temperature experienced at the "D" weld zone.

Fig.5 Photomicrographs of tube no831 cut from the 'D'weld region in the as exposed condition (a) near inner wall -.creep voids arrowed (b) near mid wall region-fewer creep voids (c) near outer wall-no creep voids (d) inner wall base metal adjacent to the weldment - creep voids present (e) mid wall region (f) weldment on the inner wall side showing no creep voids (the black dots are etching artefacts confirmed in SEM).(a-c) LS= longitudinal section (d-f) TS = transverse section

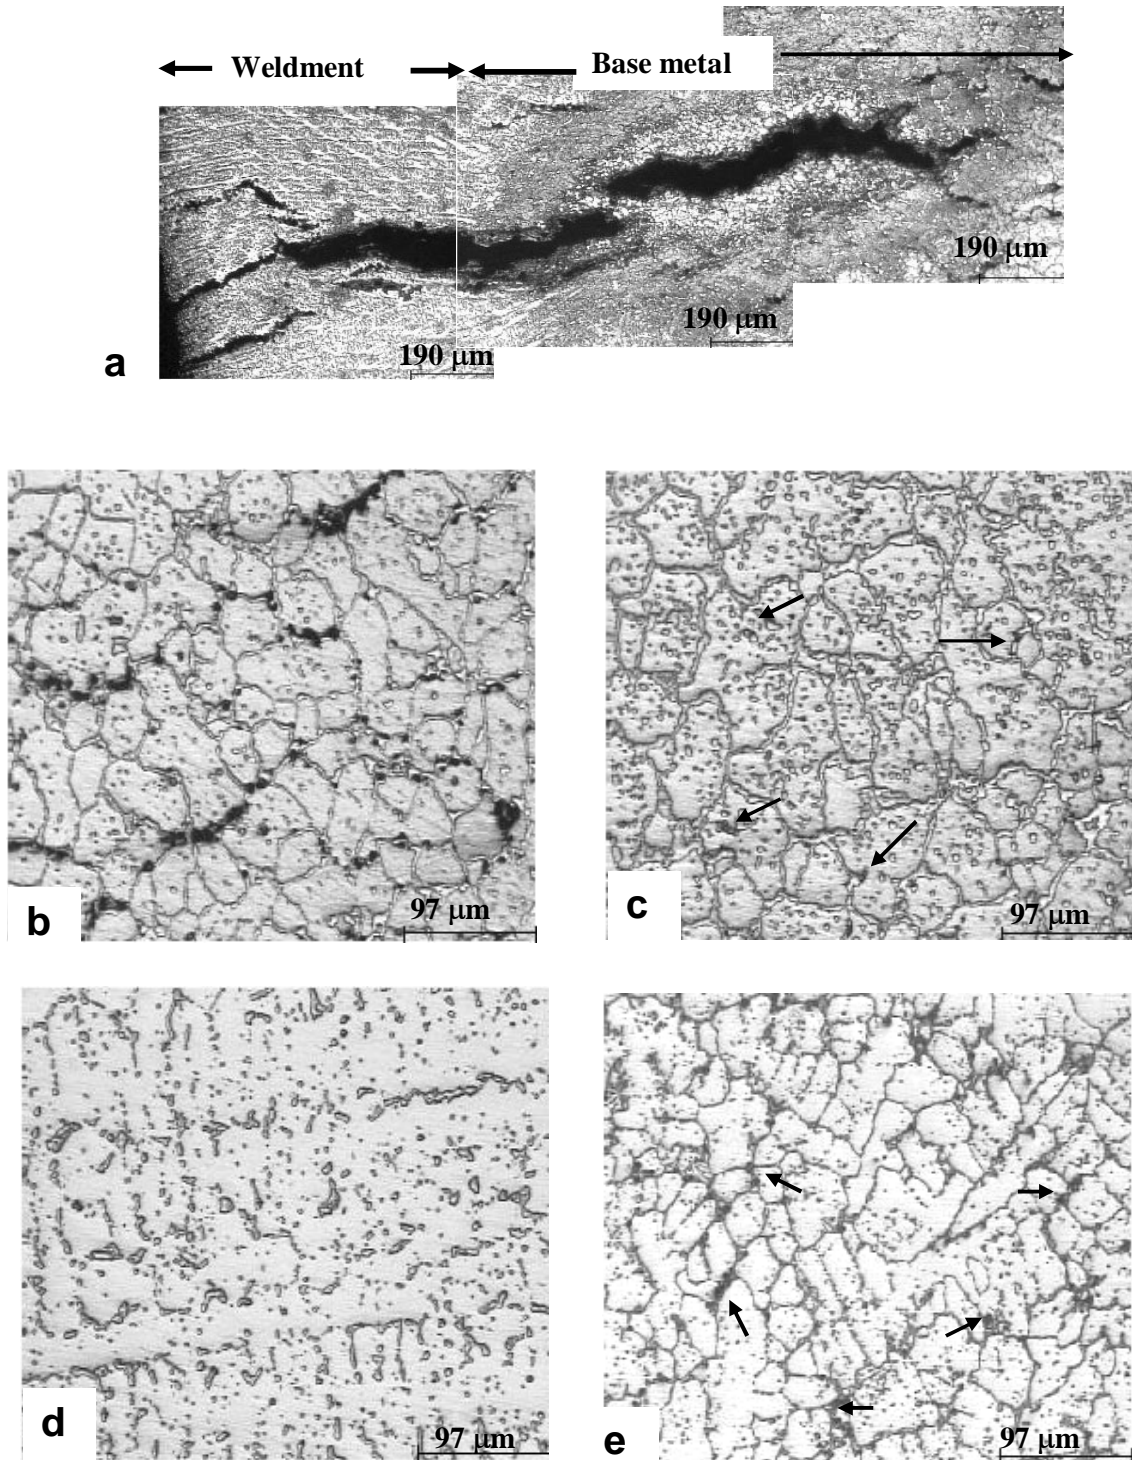
In the tapered section sample, base metal with the visible crack appeared to extend towards the outer wall (Fig.2), optical metallography showed (Fig.6) that these cracks were longitudinal and existed in the HAZ and the base metal adjacent to it. A number of longitudinal cracks were observed on the base metal closer to the weldment on the inner wall surface. The cracks were growing due to coalescence of aligned creep voids. As one move (about 10mm) from the weld line, the longitudinal cracks were absent but isolated creep voids without preferential alignment were observed.

Fig.6 Photomicrographs of the tapered section base metal sample (a) the inner wall showing longitudinal cracks in the weldment and base metal close to it (b) inner wall – equiaxed grains close to the weldment – aligned creep voids induced cracks (c) inner wall – equiaxed grains well away from the weld – only isolated creep voids (d) TS of the same sample- near outer wall- absence of creep voids (e) TS of same sample -near the inner wall- isolated creep voids . **TS:** transverse section

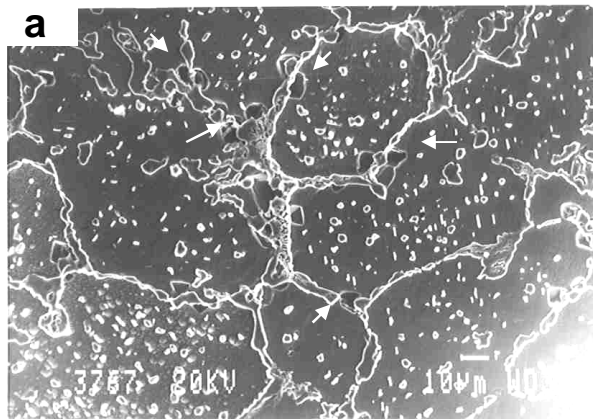
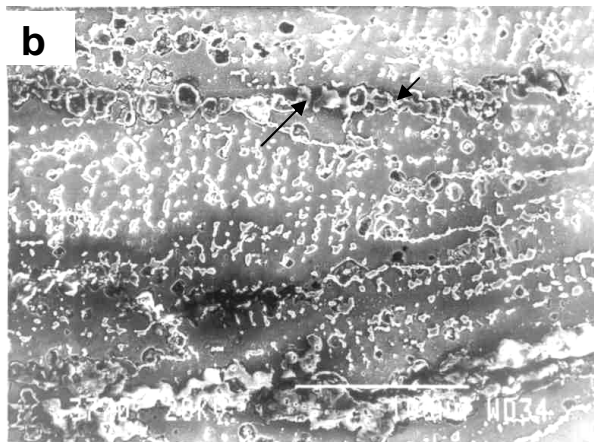
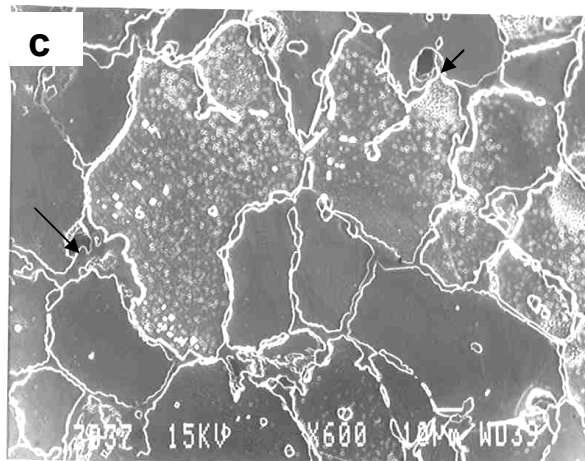
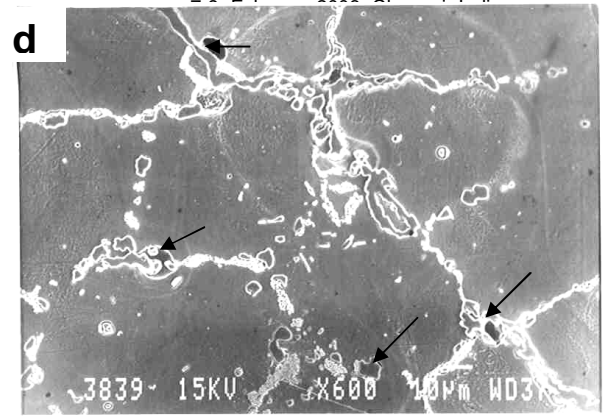
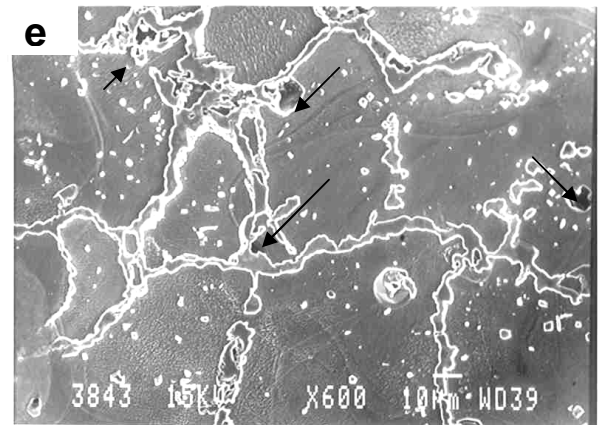
Standard metallographic specimens were prepared and slightly over etched for better relief of the precipitates for SEM examination. Typical microstructures observed for the tube samples under investigation are shown in Fig.7. As observed in the optical microscopy, coalesced primary carbides in the grain boundaries and secondary carbides inside the grain were observed. In some cases the secondary carbide is very fine. It may be recalled that the tubes had experienced temperature around 1000°C for few hours during operation in its 5th year. At such high temperatures, the secondary carbides may dissolve and reappear when the temperature is lower in the region of $850\text{-}900^{\circ}\text{C}$. Coarsening of carbides is observed in the equiaxed zone and in the inter-dendritic region of the base metal. The circumferential weld showed voids only ahead of the crack. The EDAX analysis on the grain boundary precipitates (appearing as greyish in Fig.7) both in the base metal and weldment showed that they are chromium carbides of the type Cr_{23}C_6 . Inside the grains the secondary carbides are also of the same type. In addition, inside the grains very fine precipitates (appearing as white in Fig.7) rich in nickel, niobium and silicon were found. The compositions of the precipitates are given in Table 3:

Fig.7. Scanning electron micrographs of the tube samples (isolated creep voids are arrowed) (a) inner wall-base metal region of tube no.140 -; (b) ahead of the main crack in the circumferential weld on the inner wall side of tube no.140 showing crack along the precipitate/matrix interface in the circumferential direction as arrowed; (c) tube 831-C weld-SE; base metal region on the inner wall (d) tube 831 -C weld-SA; base metal region on the inner wall with changed carbide morphology due to solution annealing; (e) tube 831-D weld-SE; base metal region on the inner wall
