Industrial corrosion failure – Case studies

I. CHATTORAJ

National Metallurgical Laboratory, Jamshedpur - 831 007

CASE I : IDENTIFICATION OF CORROSION MECHANISM IN A BOILER DRUM BY CORROSION PRODUCT ANALYSIS

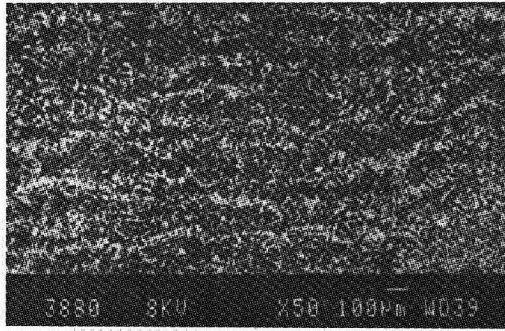
Microstructural observation of the replicas revealed that irrespective of the location, ferrite and pearlite were observed with some evidence of banding (Fig. I.1). Fig. I.2 shows a higher magnification microstructure of the substrate beneath the craters. It is evident that there is no discernible deterioration of the cementite in terms of spheroidization of the lamellae of cementite in the pearlite colonies. There is no evidence of cracking, intergranular or transgranular, which rules out the possibility of any form of stress corrosion cracking. The latter was a possibility since craters can act as crack initiators and in the presence of residual stresses or operational cyclic or static stresses, hydrogen embrittlement, caustic embrittlement and corrosion fatigue are often observed.

Fig. I.1 : Low magnification microstructure of the boiler drum material

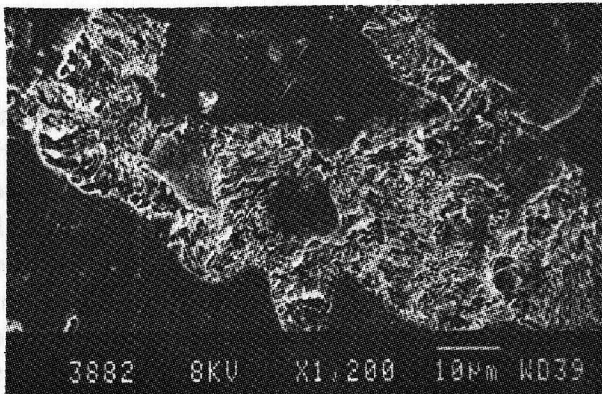
Fig. I.2 : High magnification microstructure of the substrate beneath the damaged sites

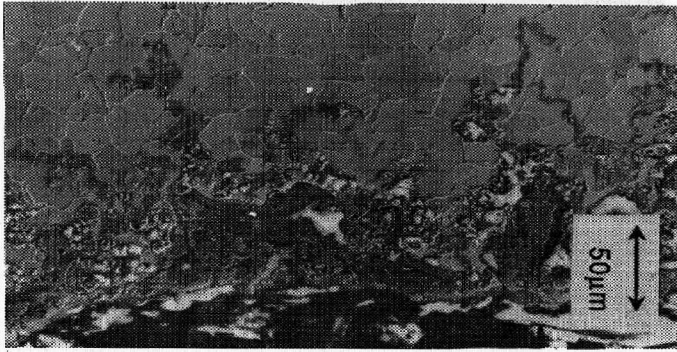
When a section was taken across the thickness, a layer of what appears to be corrosion product was observed close to the inner surface (Fig. II.1). Thin finger like intrusions into the matrix were also observed, a occurrence which may be significant considering the pinhole type of failure observed in other tubes. This corrosion product layer is about 50–150 μm thick. It may be deduced from the same micrograph that decarburization has occurred even near the inner wall of the tube. This decarburization would have some bearing on the mechanical properties, especially surface toughness and wear resistance. Although it would be presumptuous on our part to say that surface erosion would be accelerated due to the decarburization of the region adjacent to the inner tube wall, the possibility of such occurrence cannot be ruled out. It is also beyond our understanding as to how under the near ambient temperatures and the environment present inside the tube, decarburization could have occurred near the inner wall.

It is possible that the finger like projections shown in Fig. II.1 are the precursors to the pinhole actually observed in some other tubes. We believe that these porous layers are the results of a corrosion mechanism which left behind the porous intrusions, denuding the steel substrate of coherency and strength as well as providing the channel for water leakage. The corrosive mechanism will become clearer from the subsequent discussions. The next set of micrographs are of the interior surface of the tube and provide a good idea of the corrosive mechanism. The interior surface is seen to have corroded in a peculiar fashion (Fig. II.2). It is characterized by spherical and hemispherical particles (Fig. II.3) of varying sizes which are loosely bound to the surface, and areas having a relatively more adherent scale (Fig. II.4). The loose porous particles were analyzed and found to show Fe, Cl (Fig. II.5). It seems to us that these are chlorine rich oxides or hydroxides of iron (note : O and H cannot be detected by EDS). Such products are non-protective and allow easy access of the corrodent to the substrate. Evidently the chromate treatment was only partially successful in forming a protective surface scale, the chromate rich nature of such scales is noted from the EDS analysis of this scale (Fig. II.6).

Fig. II.1 : Corrosion product layer on the inner tube surface, protruding into the metal substrate, shown on a section taken across the tube width

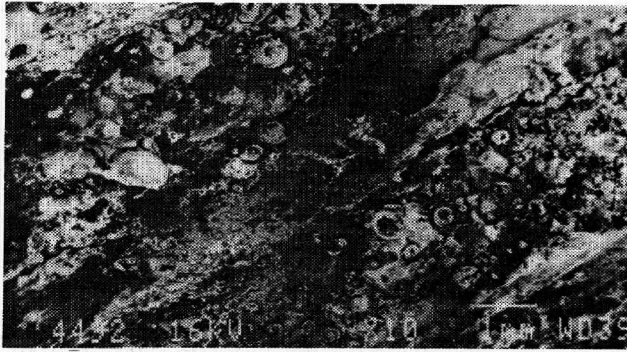
Fig. II.2 : Corrosion debris on the inner tube surface of the service exposed tube

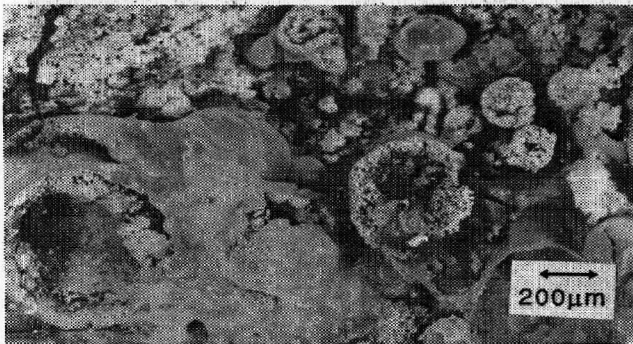
Fig. II.3 : Spheroidal and hemi-spheroidal corrosion products observed on the inner tube surface

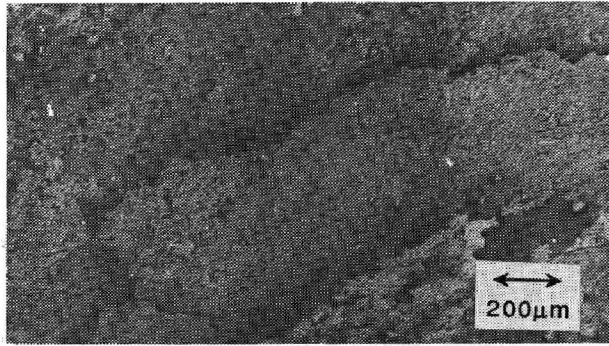
Fig. II.4 : Chromium rich scales observed on the inner tube surface

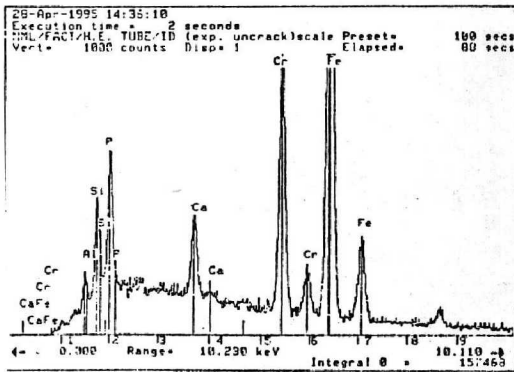
Fig. II.5 : Elemental distribution in the hemispherical corrosion product

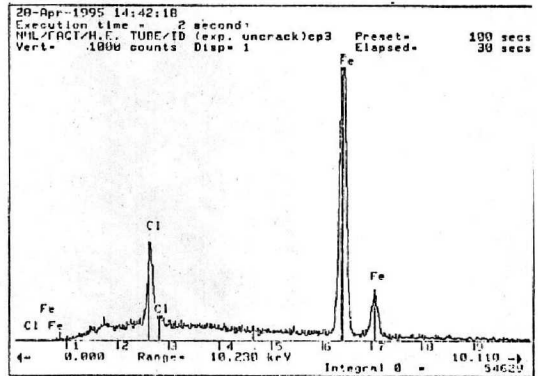
Fig. II.6 : Elemental distribution in the scale type corrosion product

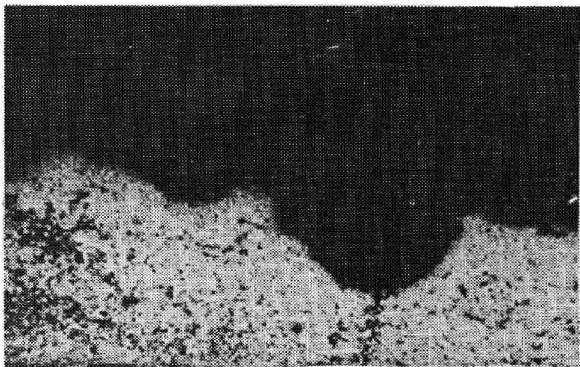
The severity of decarburization was evident in the damaged tube (containing pinhole) as shown in Fig II.7. The decarburization would have an indirect effect in accelerating pinhole attack. This would result in a softening of the inner and outer surfaces, and subsequent cratering of the inner tube surface, like the one shown, would be easy. These craters and pits act as initiation sites for pinhole attack.

Fig. II.7 : Cratering in the damaged tube. Decarburization near the inner tube surface is evident

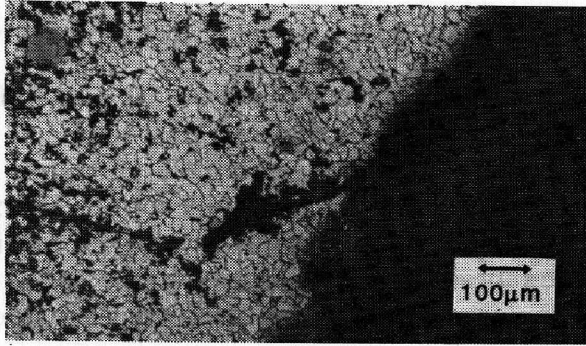
The pinholes initiated at the inner surface, either from the bottom of craters or incipient pits. The growth of such pits were very insidious so that the extent of material removal was often not appreciated by a casual observation of the surface. This is very well illustrated in Fig. II.8, which shows a partial pinhole which had initiated at the inner tube surface. Subsequent propagation had occurred along with branching. SEM observations of such pinholes reveal that the pinholes have corrosion products in them (Fig. II.9) which were analyzed by energy dispersive spectroscopy (EDS) and revealed iron (Fe) as the only detectable element. Light polishing was able to remove these corrosion products and a shallow trough corresponding to the pinhole could be observed. Whereas many pinholes were observed in the damaged tube, such pinholes, even partial ones were absent from the service exposed but undamaged tube obtained from the third stage intercooler. The fact that the latter experienced higher pressure service than the damaged second-stage intercooler tube, would mean that the supplied tube was possibly not responsible for failure due to metallurgical defect inherent in them. However, in making this statement we have assumed that the chemical composition of the three tubes supplied were identical and that the environment and mechanical and thermal stresses experienced by tubes in all the three stages are similar (if not identical). It is our belief that some service irregularity affected the second stage intercooler to cause pinholes and as such the supplied tubes are not exceptionally prone to pinhole attack.

Fig. II.8 : Optical microscopic observation of a partial pinhole.

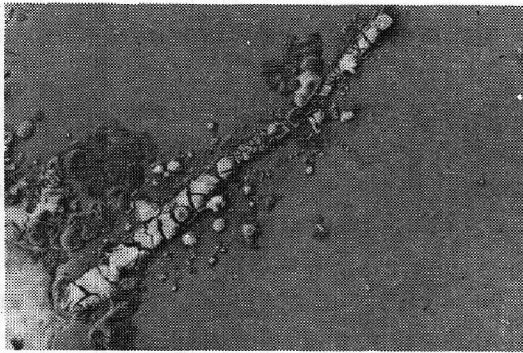
Fig. II.8 : SEM observation of a partial pinhole
