SOME OBSERVATIONS ON FAILURES IN AIRCRAFT ENGINES AND FUSELAGE PARTS

S.C. De, B. Met. (Sheffield)

G.P. Contractor Ph. D. (Manchester).

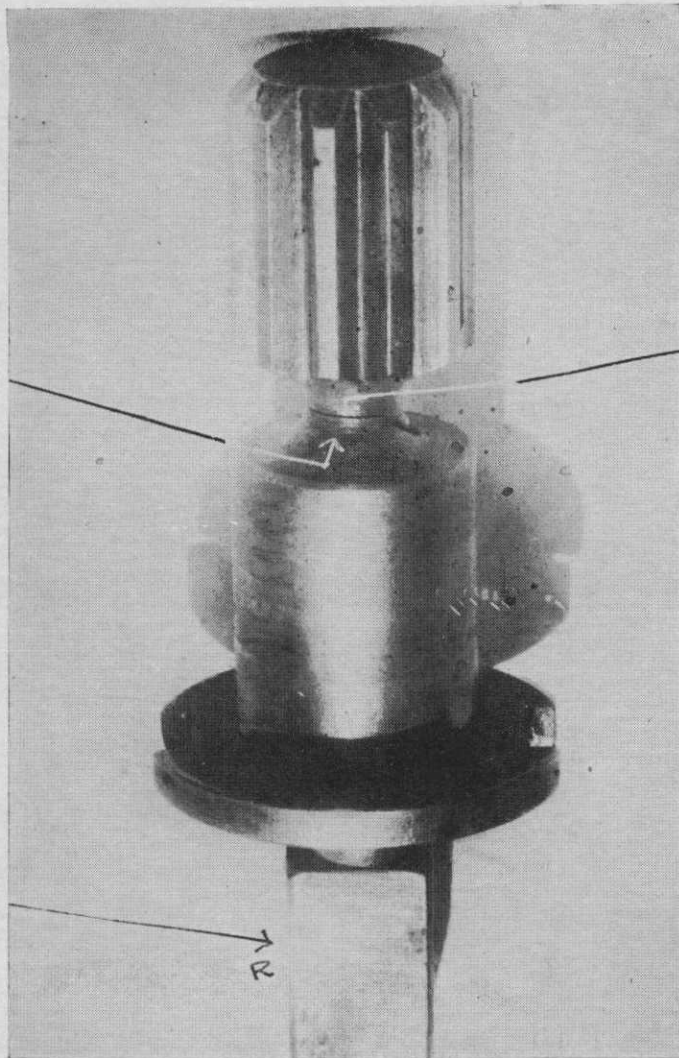
Two other cases of fatigue failures of fuel pump driving shafts in aircraft engines are illustrated in Figs.1 and 2. The waisted portion of the driving shafts showed clearly rough machine mark (Fig 1) and dents (Fig 2). Both the shafts were properly case hardened having hardness 890 VPHN on the case and 270 VPHN in the core. Chemical analysis of both the samples conformed to SAE 4320*. Machine groove and dents aggravated the stress concentration so as to bring about fatigue failure in both the shafts. Bright worn out square stud face marked R in Fig. 1 is indicative of looseness in fittings. The driving shaft was new and had done only 334 hours and 10 minutes before the failure took place. In both the cases the engine had to be dismantled before they were due for overhaul. Fig 3 illustrates the failure faces of Fig. 1. Areas ABC and XYZ in Fig 3 showed polished surfaces as a result of two faces of the crack rubbing together. The rest of the portions were crystalline due to sudden fracture.

FIG. 1. Photograph showing the line of fracture and deep tool mark at the waisted portion of the drive-shaft of the aero-engine fuel pump. X4

In this particular case, there were tool marks on the material. The material had properly been case-hardened at the tool marks. The looseness in the fitting had caused the fatigue failure. It was case-hardened all through.

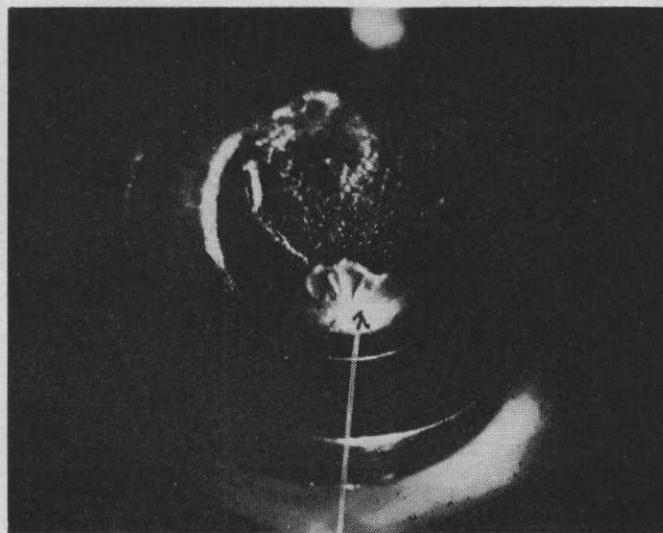
FIG. 2. Photograph of the fracture face showing dent marks in another aero-engine fuel pump drive-shaft. X4

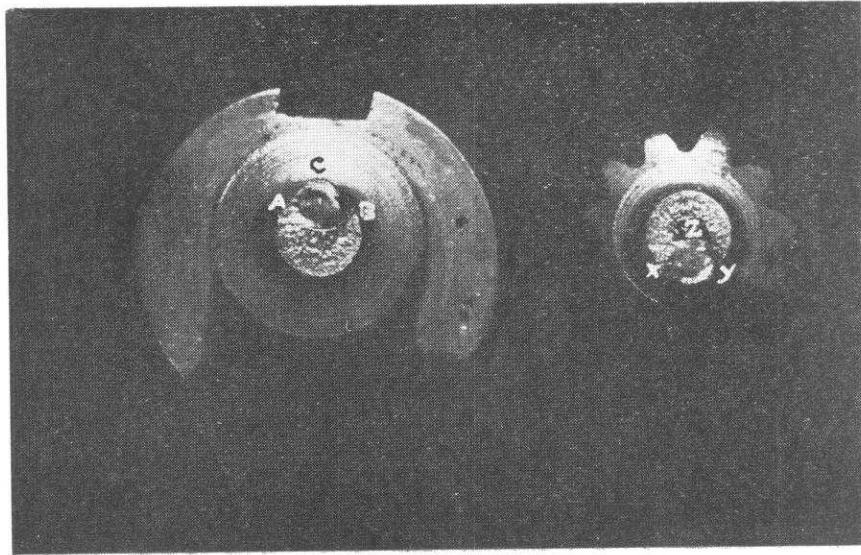
FIG. 3. Fracture face of Fig. 3 showing fatigue failure,

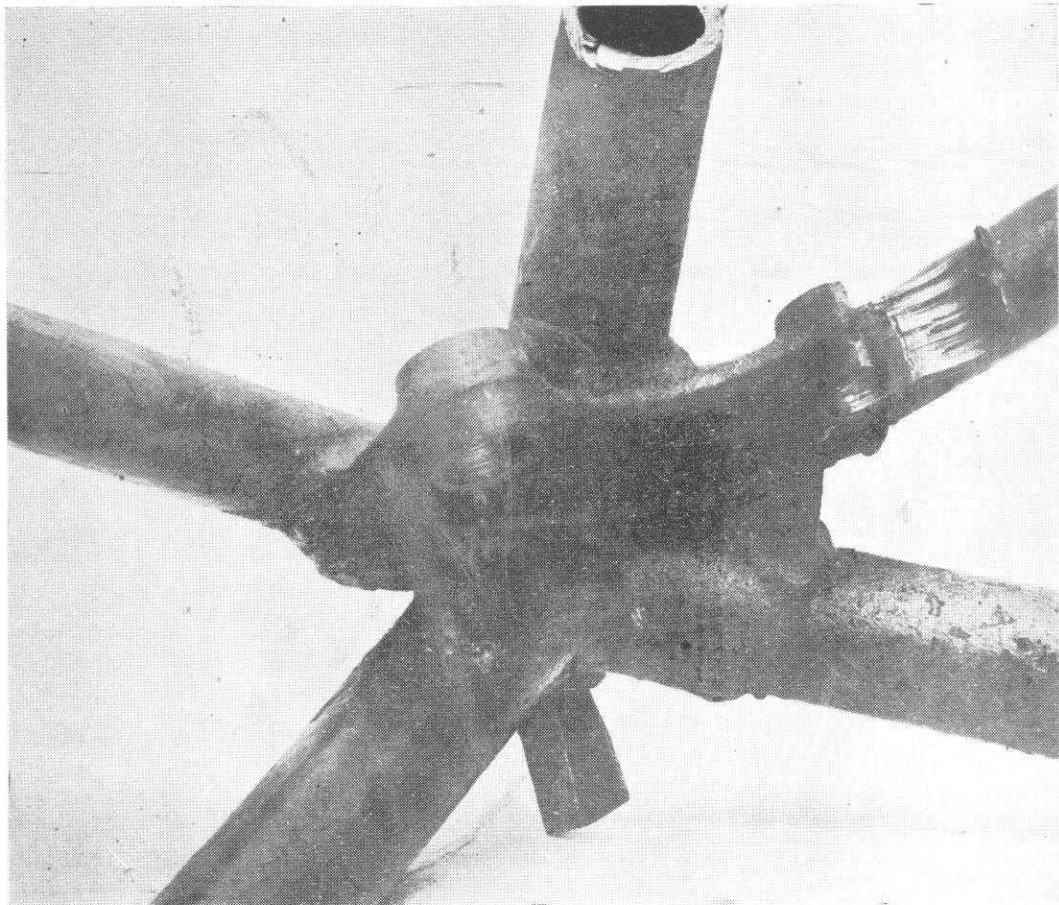
Fig. 4 illustrates a welded cluster joint with broken lug from fuselage of an aircraft which was sent for metallurgical examination. The aircraft met with an accident as one of the wheel collapsed due to failure of lug fittings which was holding the under-carriage compression strut. Deep tool marks in the broken lug could be seen in Fig 4. The chemical composition of the lug conformed to SAE 4130 and was properly heat-treated having uniform hardness of 270 VPHN. Microphotograph of the lug (Fig 5). showed grain distortion and a crack. The failure of the lug was probably due to heavy landing and was accentuated by the presence of deep tool marks which acted as stress raisers causing failure under shock. It is probable that cracks similar to XY in Fig5. might have developed in the lug before the actual failure took place during landing.

FIG. 4. The cluster joint with broken lug.

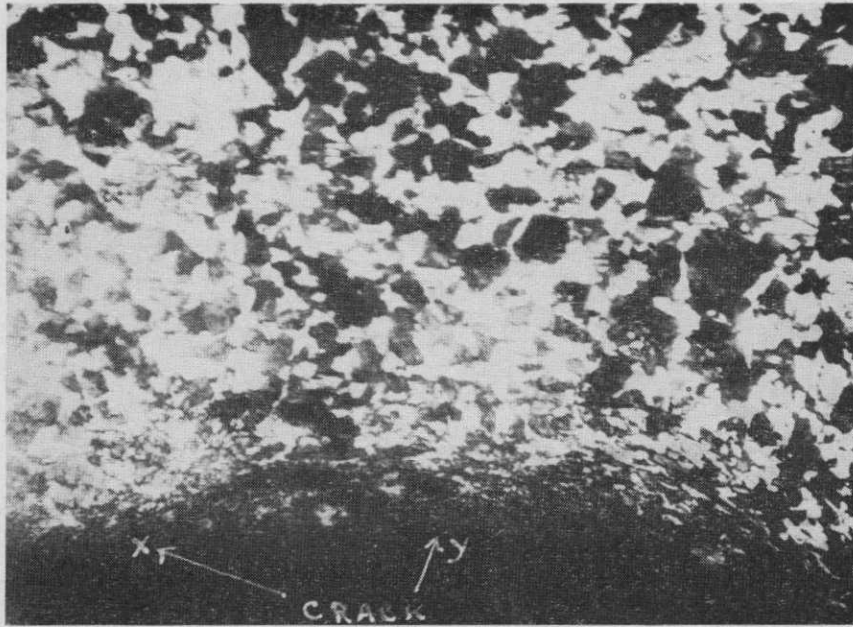
FIG. 5. Photomicrograph of the broken lug showing grain distortion and crack.

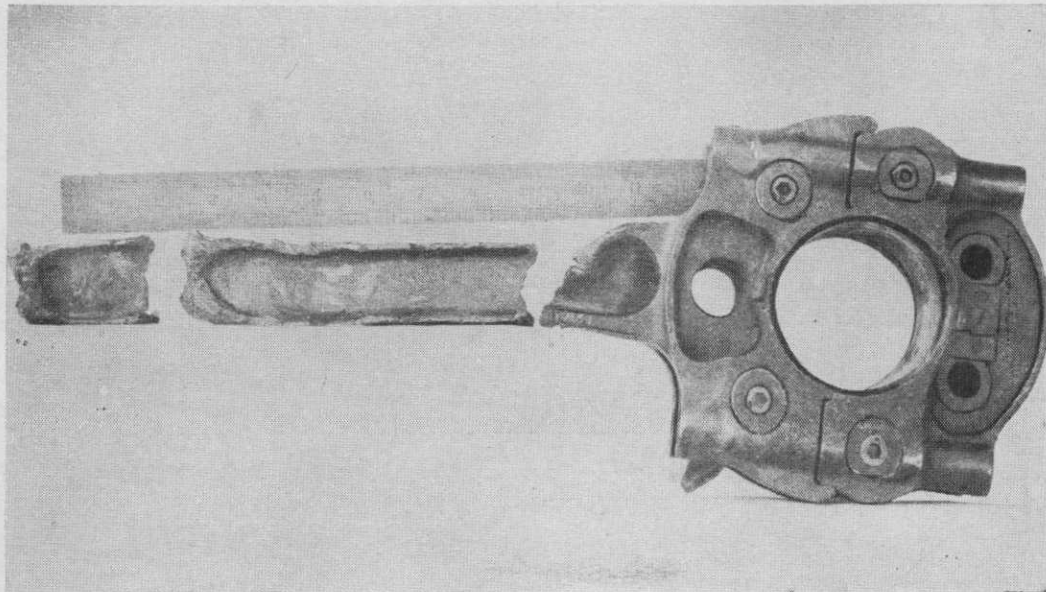
Aircraft bearings and other frictional parts need abundant and continuous flow of lubricant to reduce undue heating and wear. Usually oil pressure varies from 60/90 lbs per square inch. Lubrication failure may take place due to various reasons namely unclean filter, foreign matter in oil, carbon deposit in oil holes, rough operation during start and in air, inefficient lubricating pump, incorrect oil pressure gauge, etc. Failure of lubrication causes serious damage to aero-engines. A few cases of failure of master rods received for metallurgical examination were attributed to the break-down of lubrication. Fig 6 illustrates a broken master rod belonging to an aero-engine. The chemical composition of the master rod conformed to SAE 4340 and the material was uniformly heat-treated, having hardness of 321 VPHN. Lubrication failure caused complete melting of the bearing metal from the split bush and some of the molten metal choked oil holes in the bush marked X & Y in Figs. 7 and 8. Absence of bearing metal in the bush caused constant hammering action of the big-end on crank shaft. In all probability the master rod failed due to severe knocking, but the severe damage shown in Fig. 6 was caused afterwards due to rotation of crank shaft by other engines.

FIG. 6. Pieces of the broken Master Rod of an aeroengine as received.

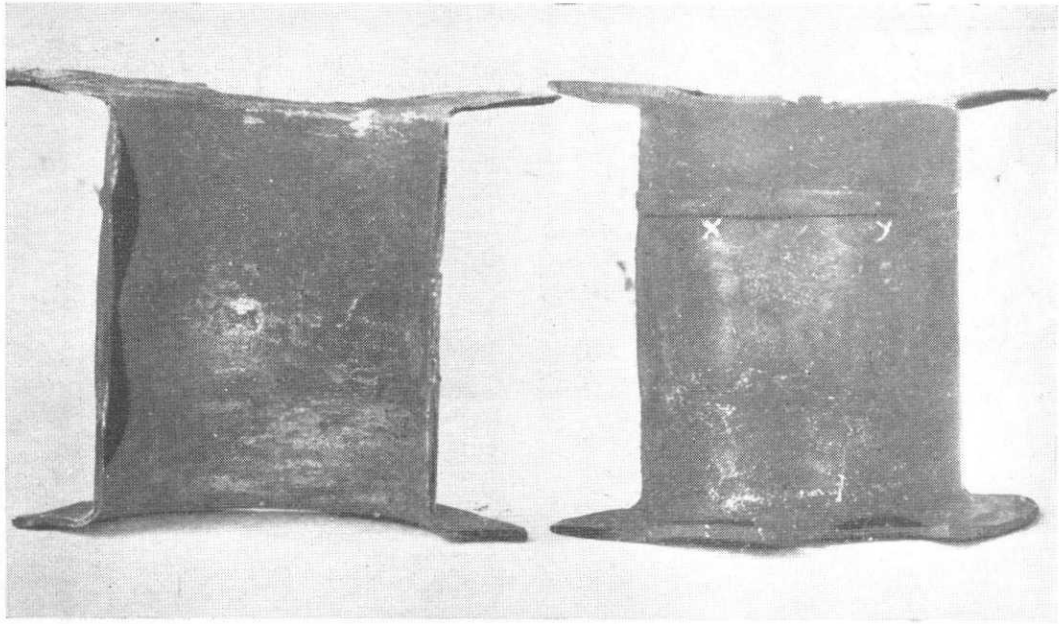
FIG. 7 Shows split bush with oil holes closed.

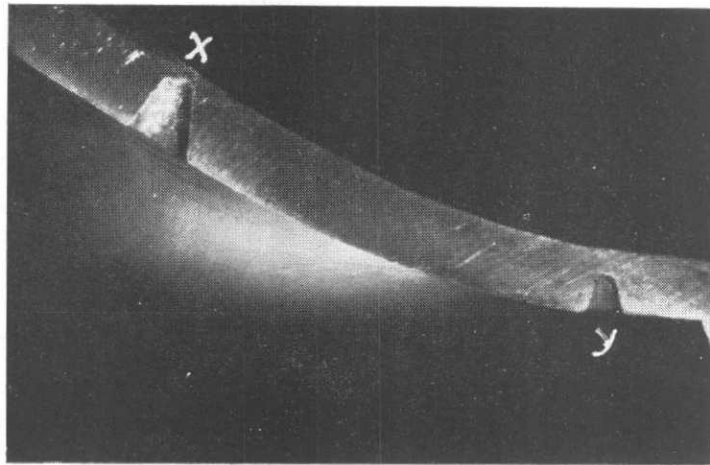
FIG. 8. Macro photograph of a section through the bearing bush showing oil holes closed.

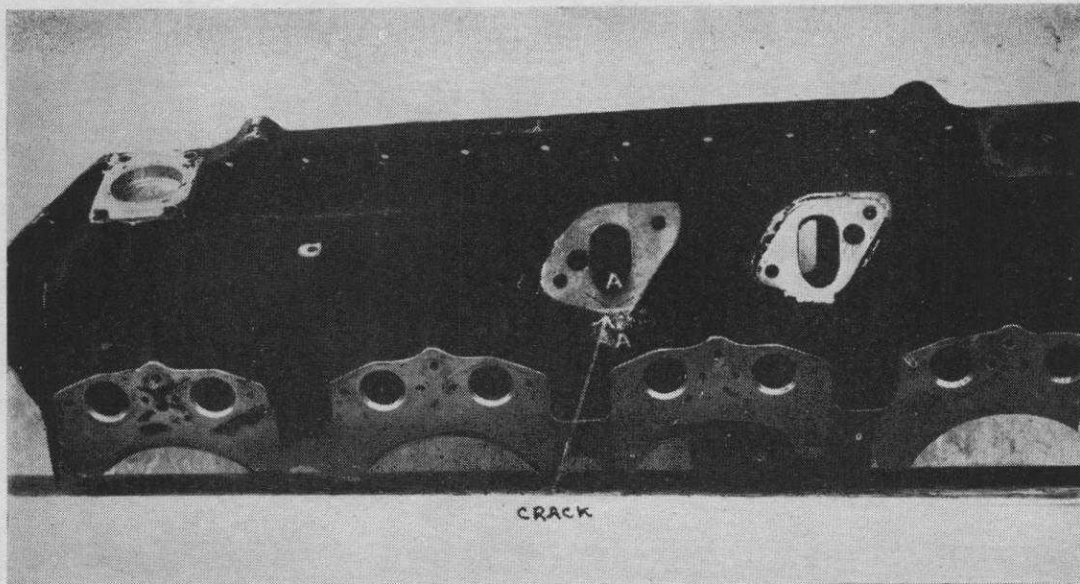
The crank case conformed to specification—RR-50. The failure of the material was attributed to casting defect, and to the propagation of cracks from the shrinkage cavities. The propagation of the crack was caused by undue vibration of the engine.

FIG. 9. Photograph of an aircraft crank case showing the position of crack at the fuel pump aperture.

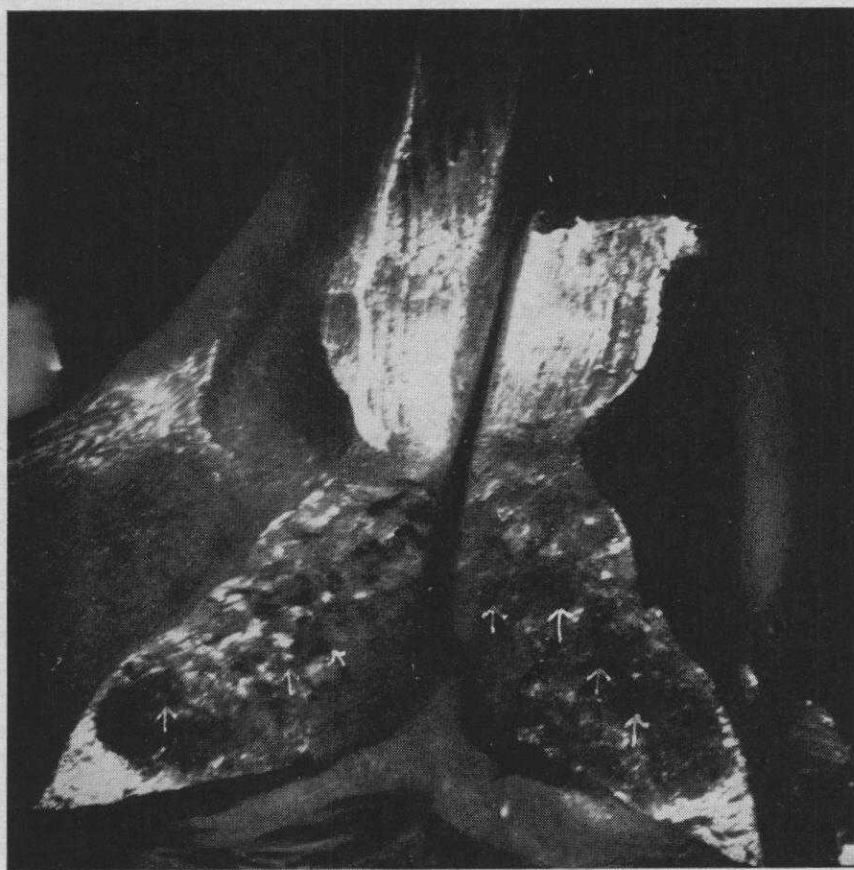
FIG. 10. Photograph of the fracture face of the fuel pump aperture showing porosity (shown by arrows). X2.5
