FAILURE ANALYSIS OF A 304 SS GIRDLING LOOP OF THE BOILER IN A 500 MW THERMAL POWER PLANT

J.B. GNANAMOORTHY T. JAYAKUMAR & BALDEV RAJ

Indira Gandhi Centre for Atomic Research

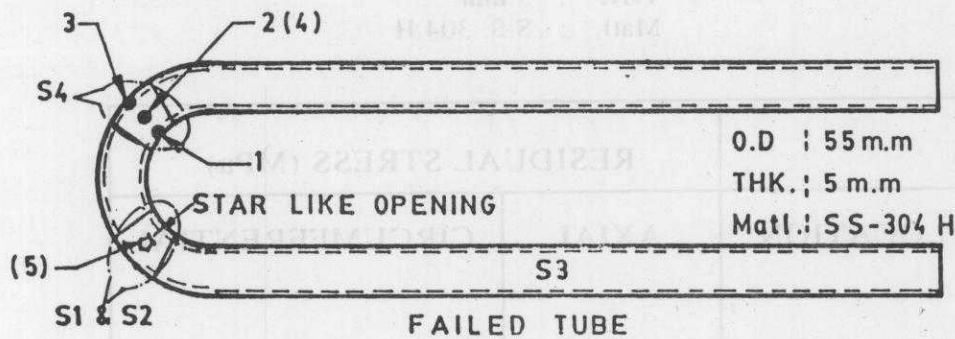
showed a star like opening at the bend of the U tube (fig. 1). This opening was of smaller size at the inner wall of the tube compared to that on the outer wall. Both visual and stereomicroscopic examinations revealed flow patterns on the tube wall at the opening, suggesting that this large opening was formed as a result of leakage of high pressure steam from inside of the tube. A steam wash dimple was seen on the inner surface of the tube on the side opposite to the opening. Figures 3a and 3b are stereomicroscopic pictures showing characteristic features of erosion at the edges of the opening. The inner surface of the tube had two long cracks extending from the hole. stereomicroscopic examination also showed cracks starting from inner surface of the tube and running across the wall thickness. The oxide scale on the inner surface of the tube had cracked at many places. Bright, colourless salt crystals were also seen embedded in the oxide scale at the inner surface of the tube.

The measurements were carried out on the outer surface of the tube segment S4 (Fig. 1) of the failed tube and also on the outer surface of the new tube. Residual stress on the inner surface was measured only in the failed tube section near the steam wash dimple (point 5 in fig. 1). The measured values of residual stress are presented in figs. 1 & 2. At one location on the failed tube segment S4, residual tensile stresses of 164 MPa (Circumferential) and 7 MPa (axial) were measured. Similarly a residual tensile stress of 133 MPa (circumferential) and a compressive stress of 180 MPa (axial) were measured at another point. At all other locations on the outer surface only compressive stresses were present both in the failed tube segment and in the new tube. Measurements were not carried out on the inner surface as this requires the sectioning of the tubes which will change the extent and pattern of residual stresses in the tube. The only measurement of residual stress done on the inner surface of the

failed tube section has given a compressive stress value of 170 (axial) near the steam wash dimple. *Discussion*

LOCATION	RESIDUAL STRESS (MPa)	
	AXIAL	CIRCUMFERENTIAL
1	- 180	+ 133
2	+ 7	+ 164
3	- 343	- 95
4	- 200	- 319
5	- 170	-

Notes : 1. Points 1 & 3 are at diametrically opposite locations similarly 2 & 4 are diametrically opposite point.
 2. Points 1 to 4 are on the outer surface of the tube.
 3. Point 5 is on the inner surface of the failed section of the tube, near the steam-wash dimple

Fig. 1 : A schematic of the failed U-bend showing the pipe sections S1, S2, S3 and S4 and the locations where residual stress measurements were carried out. The measured values of residual stress are also tabulated.

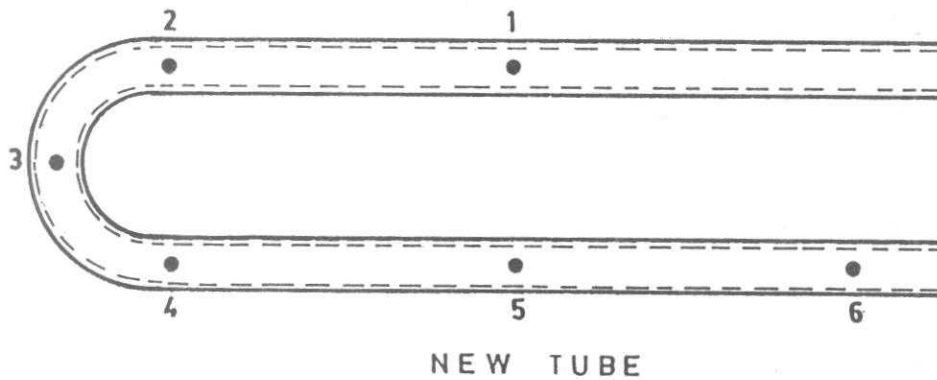
NEW TUBE
 O.D : 55 m.m.
 THK : 5 mm
 Matl. : S.S. 304 H

LOCATION	RESIDUAL STRESS (MPa)	
	AXIAL	CIRCUMFERENTIAL
1	- 120	+ 21
2	- 170	- 153
3	- 110	0
4	- 140	- 76
5	- 154	- 146
6	- 134	- 121

Fig. 2 : A schematic of the new solution annealed U-bend showing the locations where residual stress measurements were carried out. Measured values of the residual stress are also tabulated.

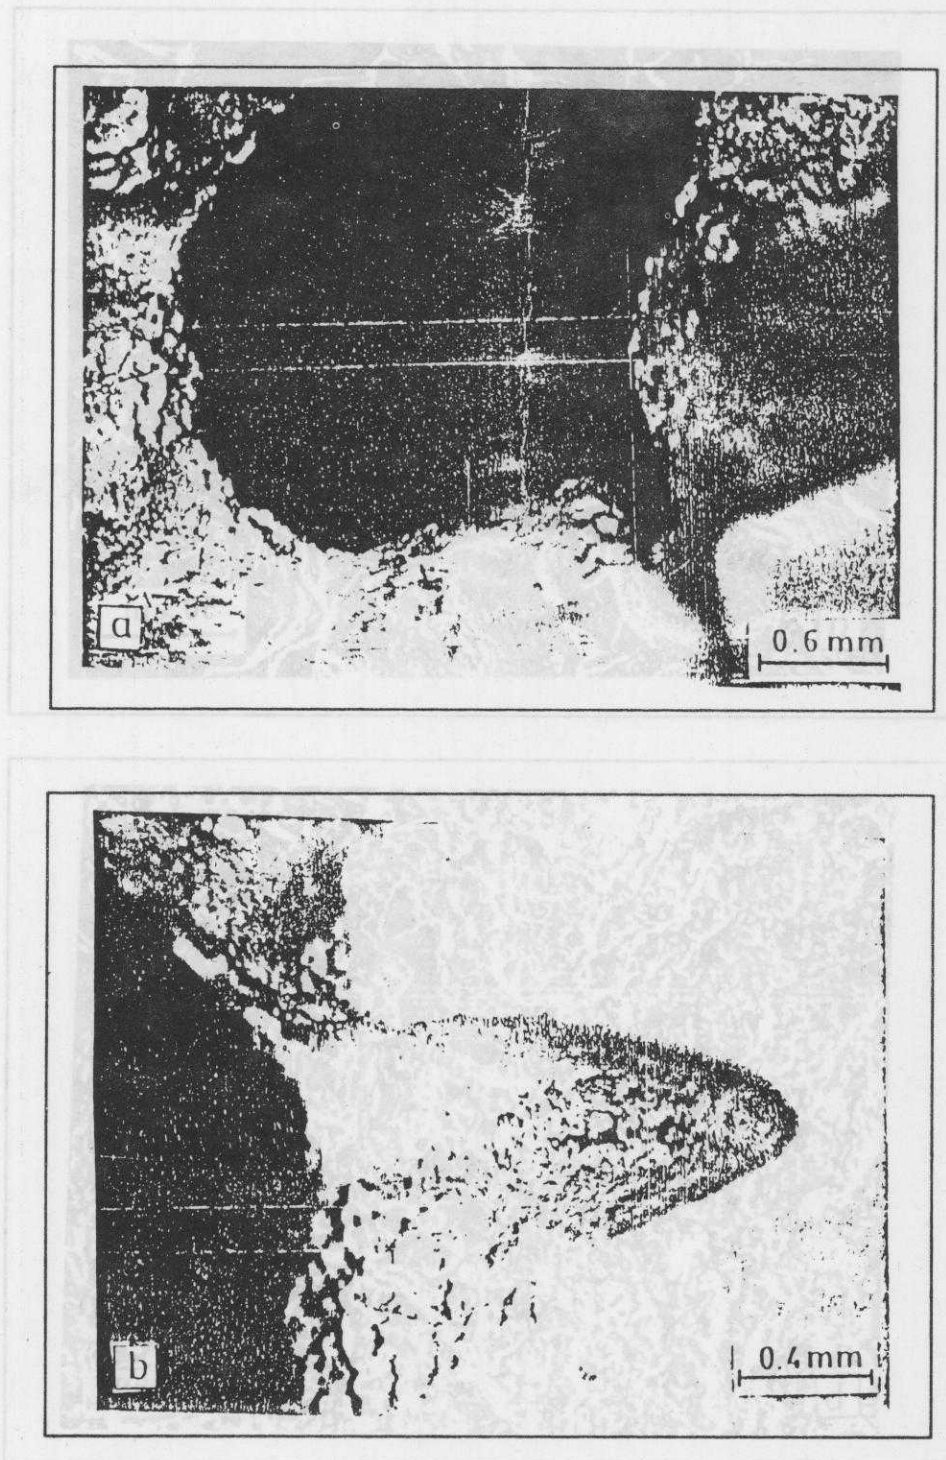
Fig. 3 : Stereomicroscopic pictures of the opening in the failed tube at different magnifications showing erosion of the tube wall

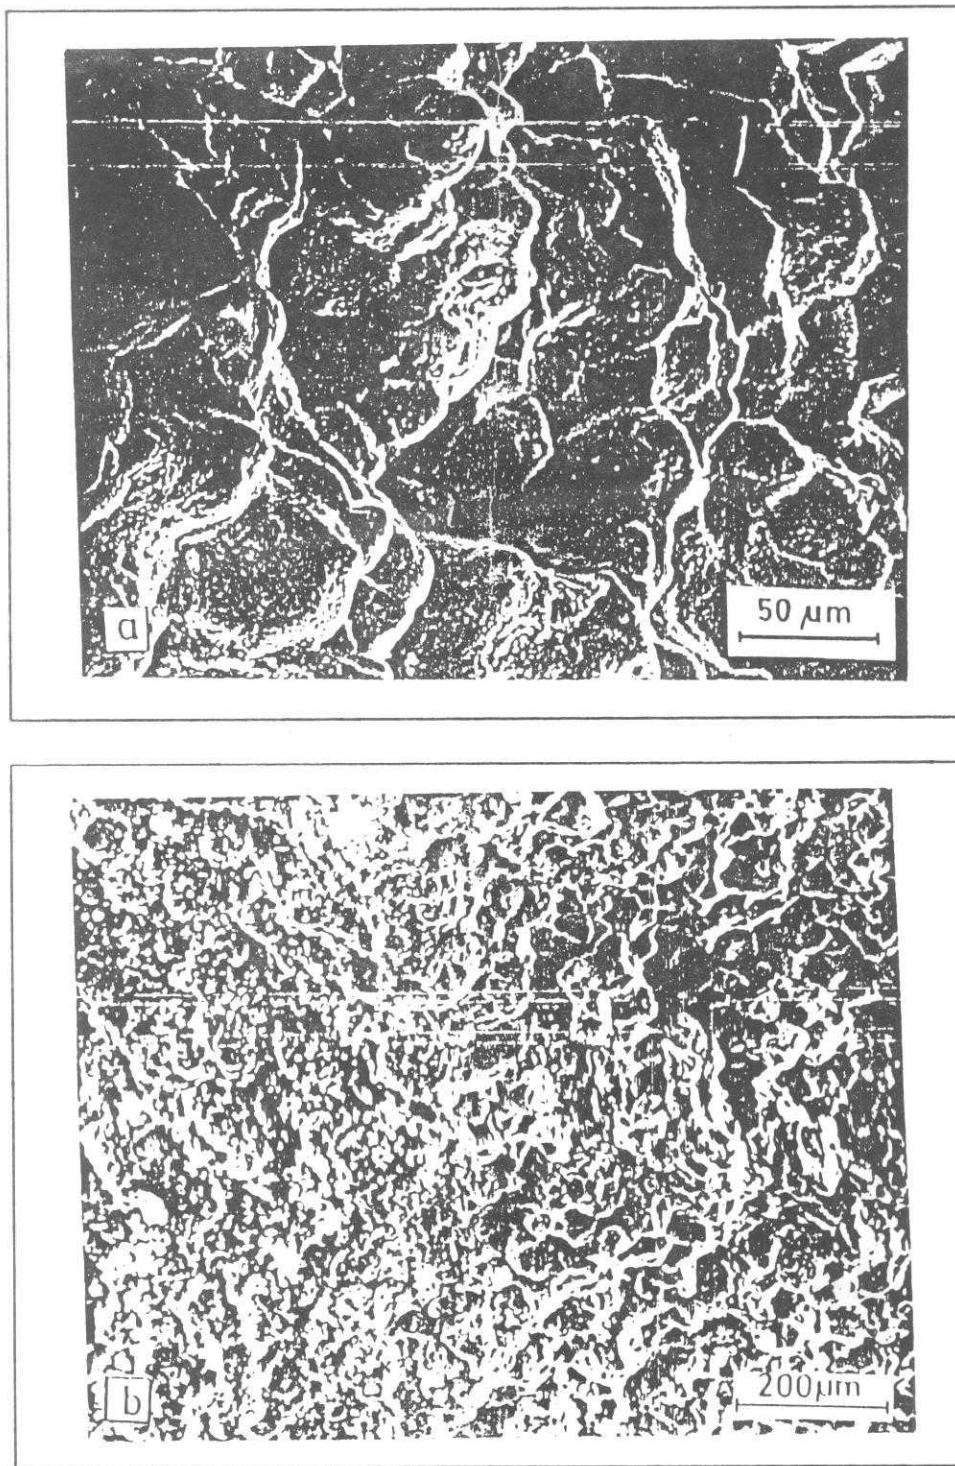
opened out and examined in a SEM. The fracture was of typical intergranular morphology (fig. 4a) and many areas of the fracture surface were covered by corrosion products (fig. 4b) suggesting a corrosion cracking mechanism for the failure. The SEM examination of the inner surface of the tube showed severe cracking of the oxide scale (fig. 5a) near the cracked portion of the tube. Intergranular corrosion attack was also noticed (fig. 5b) in some regions where the oxide scale was damaged. Bright salt crystals embedded in the oxide scale were also seen in this region.

Fig 4 : SEM pictures of the fracture surface : (a) showing purely intergranular fracture, (b) showing a region covered by corrosion products and a region of intergranular cracking adjacent to it.

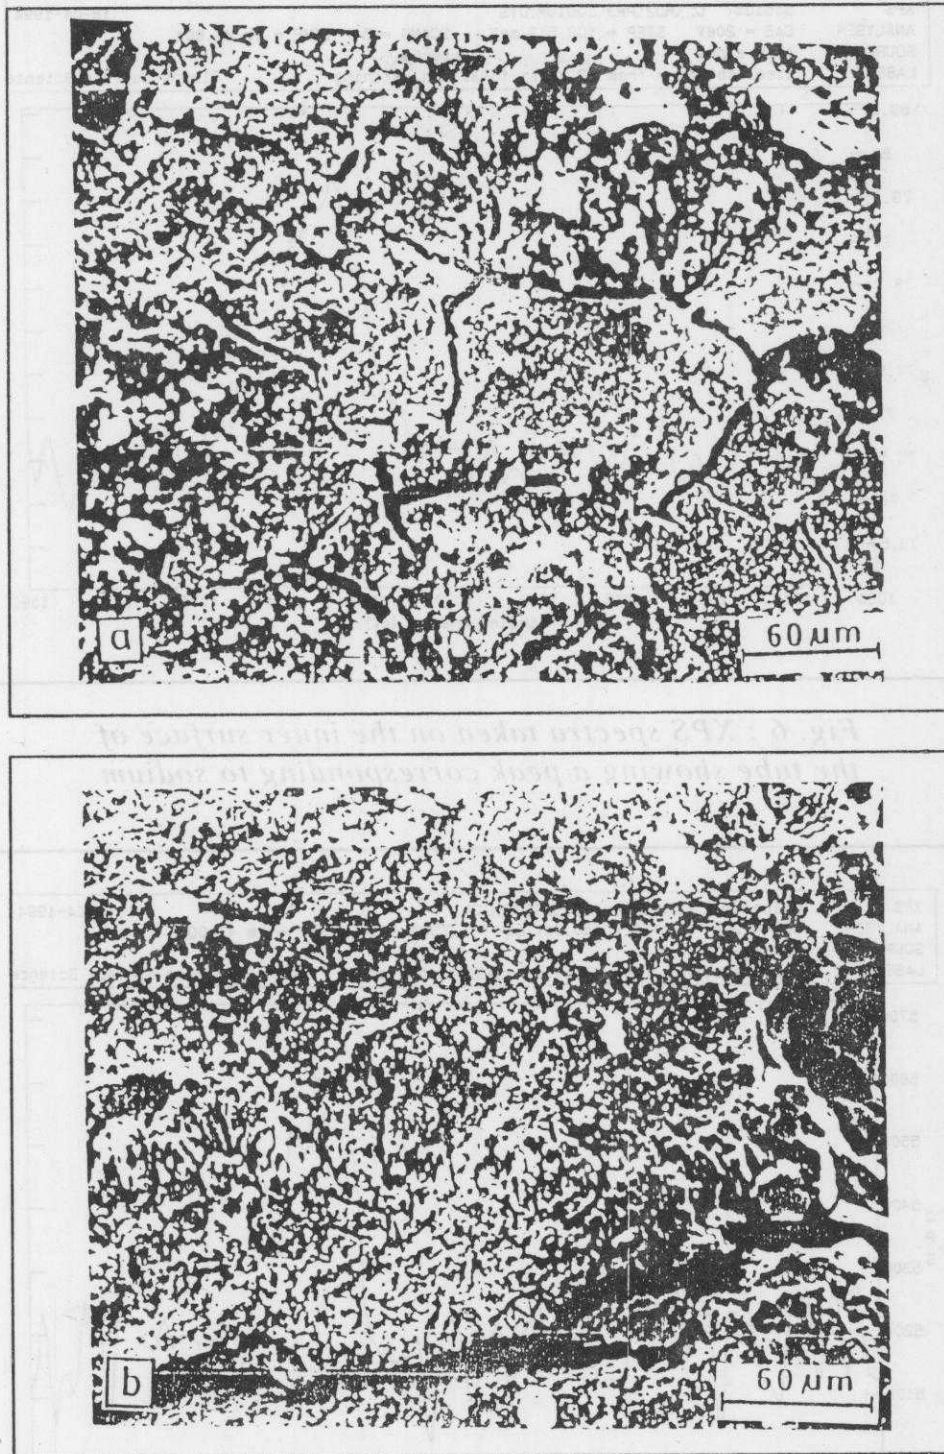
Fig. 5 : SEM pictures of the inner surface of the tube near the failed region : (a) showing cracking of the oxide scale, (b) a region of intergranular attack and a crack initiating from there; bright salt crystals are also seen in the picture.

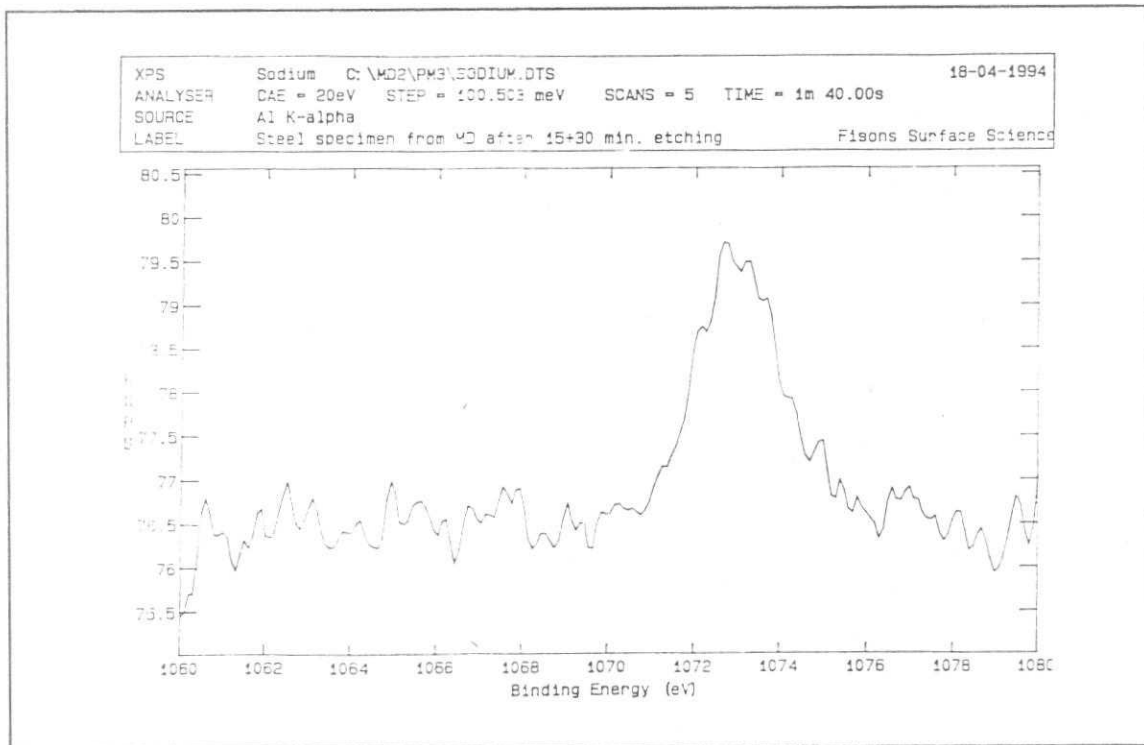
The oxide scale on the inner surface of the tube was analysed using XPS in order to understand the nature of the salt deposits on the tube surface. Apart from Cr, Ni, Fe and C (whose spectra are not given here), elements such as Na, Cl and Ca were detected indicating the presence of Na and Ca salts possibly in the form of their chlorides on the inner surface of the tube. Figures 6 and 7 give the XPS spectra showing peaks of Na and Cl respectively.

Fig. 6 : XPS spectra taken on the inner surface of the tube showing a peak corresponding to sodium

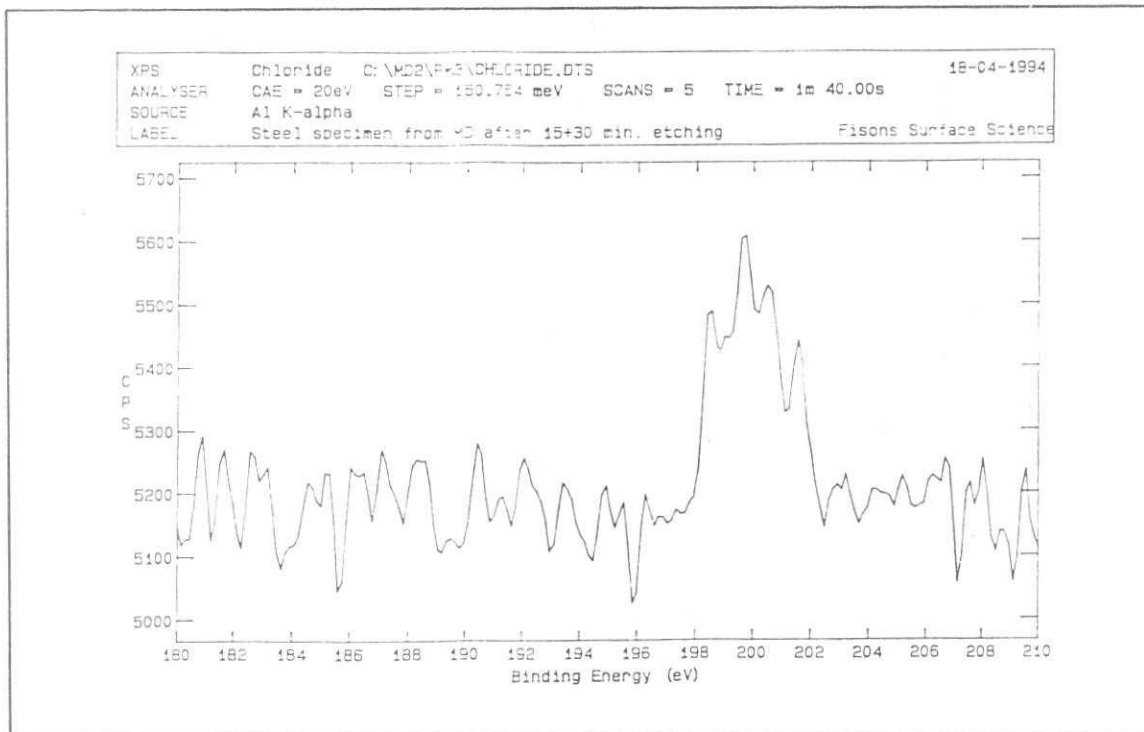
Fig. 7 : XPS spectra taken on the inner surface of the tube showing a peak corresponding to chloride
