STRESS CORROSION CRACKING OF STAINLESS STEEL SUPER HEATER TUBES IN 200 MW BOILER

P. JAIN, A.K. SINHA AND U.C. BHAKTA

R&D Centre, NTPC Ltd.,

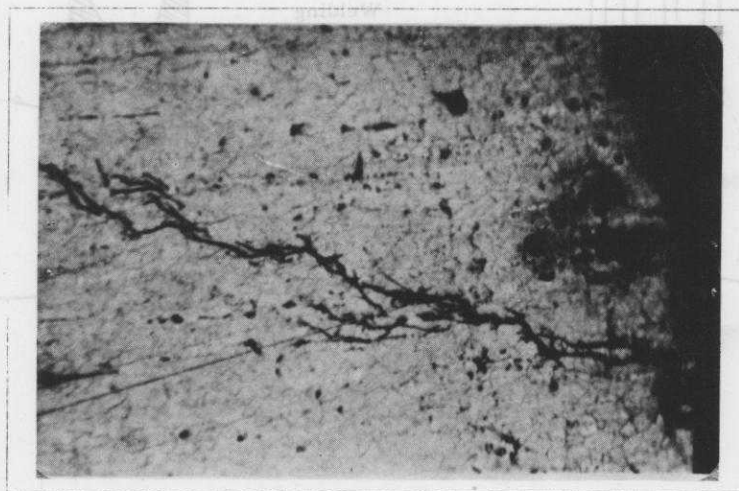
Both the samples were cut to take out the pieces for metallographic examination. The samples were mounted and polished in usual way and etched to reveal the mode of cracking. The etched and unetched samples viewed under optical microscope revealed the transgranular cracks with branches originating from inside as shown in Fig. no. 3 and 4. The cracks were blunt and wide and few were sharp. The pits viewed under microscope at edges of sample were not always initiation points. One crack was found originating from the pits.

Fig. 3 : Optical micrographs showing transgranular cracks with branching. (mag. x 100)

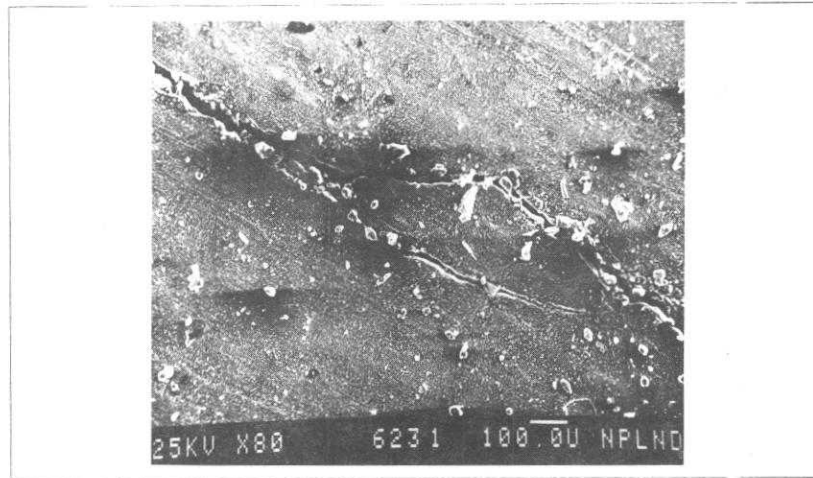
The morphology of the cracks and deposits were examined by SEM and analysed under Energy Dispersive X-ray analyser. The morphology could not reveal much except the large number of machine markings on the internal surface of the tube. The cracks were mainly around the circumference about 10 mm away from the weld as shown in micrographs no. 5, 6 and 7. The fracture surface was found to contain black surface deposit. The surface analysis at different spots are given in Table 3. First sample was found to contain chloride and sulphur ions on the fracture surface. The second sample was containing the dye penetrant inside crack showed large number of elements on the surface as shown in Table 3.

Fig. 7 : Electron micrograph showing wide cracks around the circumference

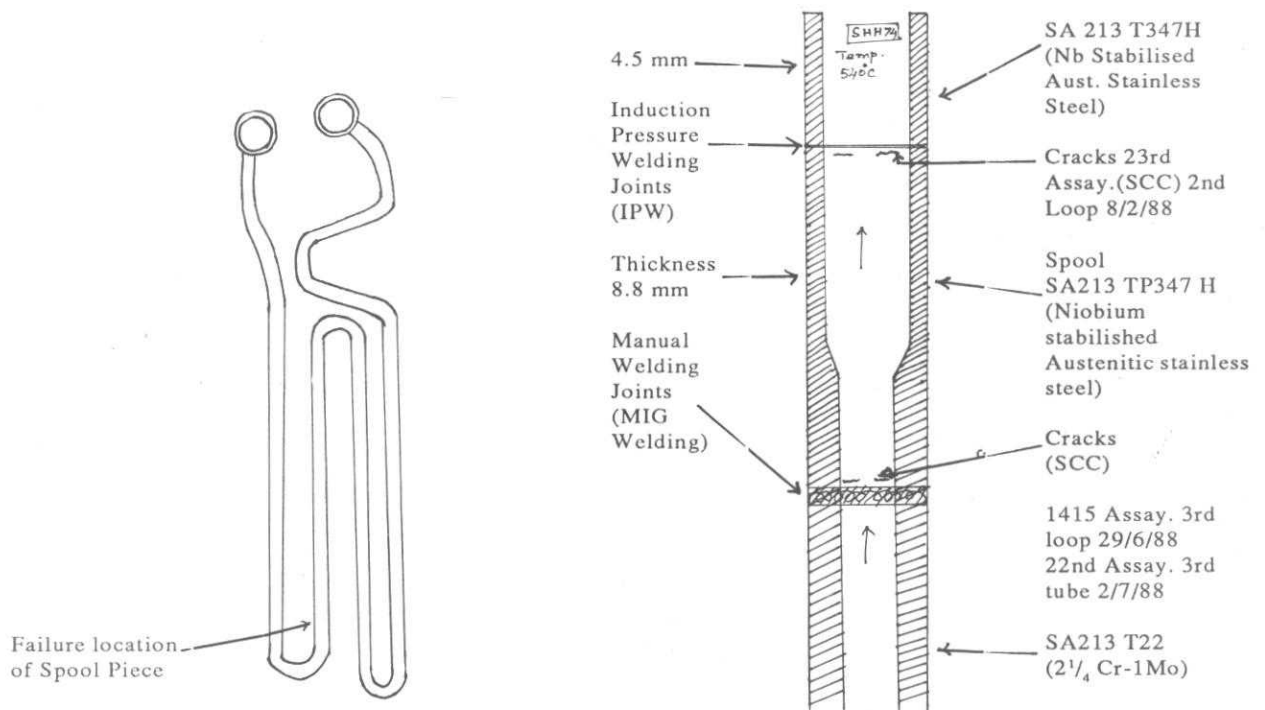
One of the 200 MW boiler at NTPC station had faced a series of super heater tube failure which was detected at different stages of commissioning activities. These failures were mainly at or near the welding joints. Fig. 1-2 and Table no.1 show the locations and failure histories of tube failures. This paper presents details of the failure investigation of stainless

The tube were cut in longitudinal direction with hand hacksaw without any use of lubricant and coolant to avoid the possibilities of ingress of impurities on the sample. The spool pieces were found to have circumferential cracks near the MIG welding alongwith the red iron oxide deposits and organic films. The cracks were 10 mm away from welding point. A few pits were also observed under stereo microscope near the MIG welds as shown in Fig. 2.

Fig. 1 : Final Super Heater Assy. (Coil) Showing Failure Location of Spool Piece

Fig. 2 : Spool Piece Joining Two Dissimilar Metal T22 and T347

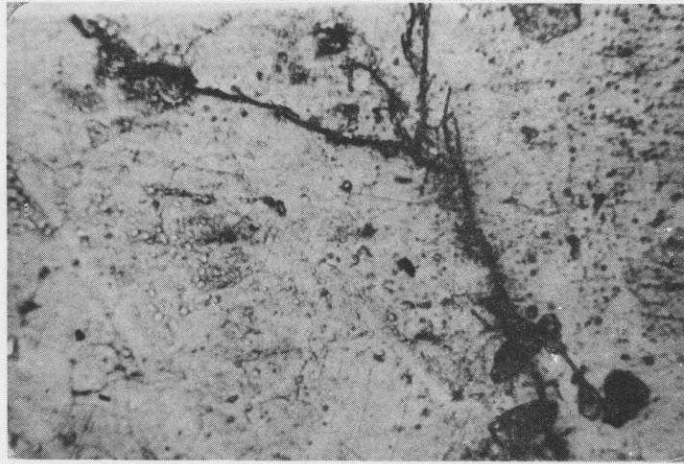
Fig. 4 : Optical micrograph showing transgranular cracks with branches (mag. x 200)

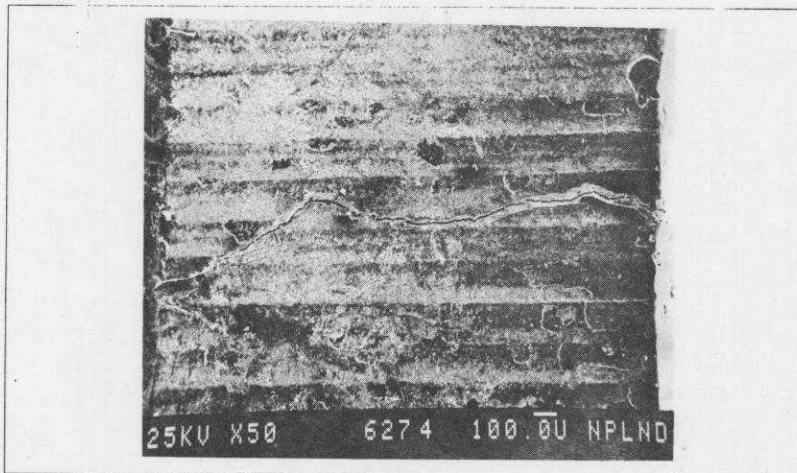
Fig. 5 : Electron micrograph showing cracks and thin layer of red oxide deposit inside the surface

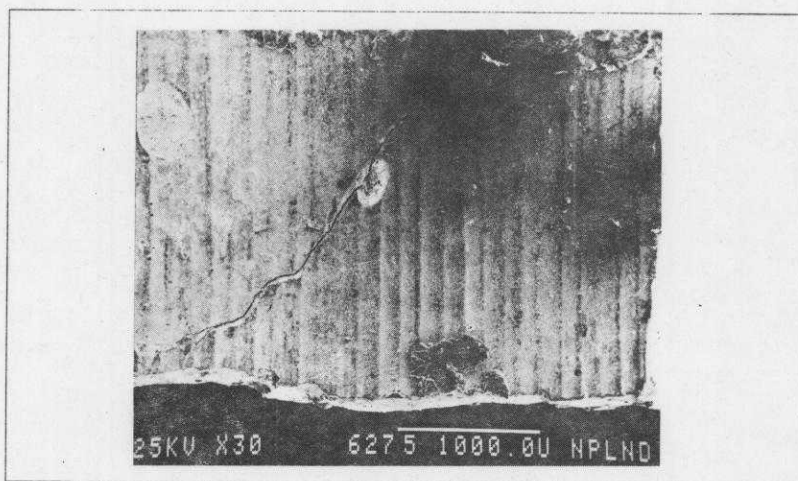
Fig. 6 : Electron micrograph showing circumferential cracks inside the surface
