# Failure of evaporator tubes initiated by lamellar tearing during the commissioning of a waste heat recovery boiler

Successive failures of several new evaporator tubes during commissioning and trial run of a waste heat recovery boiler has been analyzed. The evaporator tubes are cold bent into U-shape and subsequently TIG welded to a 24-mm thick wear plate on either sides of the tube immediately adjacent to the bend. The failed samples showed stepped longitudinal cracks along the rolling direction and parallel to the weld fusion boundary at the fireside surface of the inner bend of the tube, prominently at the center of the bend. It was found that the failure of the evaporator tubes at the tube bends was initiated by lamellar tearing because of inherent defects in the material (segregation leading to banded structure), improper processing of material (inclusions with high aspect ratios along the rolling direction) and accelerated by high transverse shrinkage stresses over the entire bend portion of the tube introduced by the weld. The pre-existing fine cracks in the welded evaporator tube initiated by lamellar tearing have subsequently opened up during service when the total strai

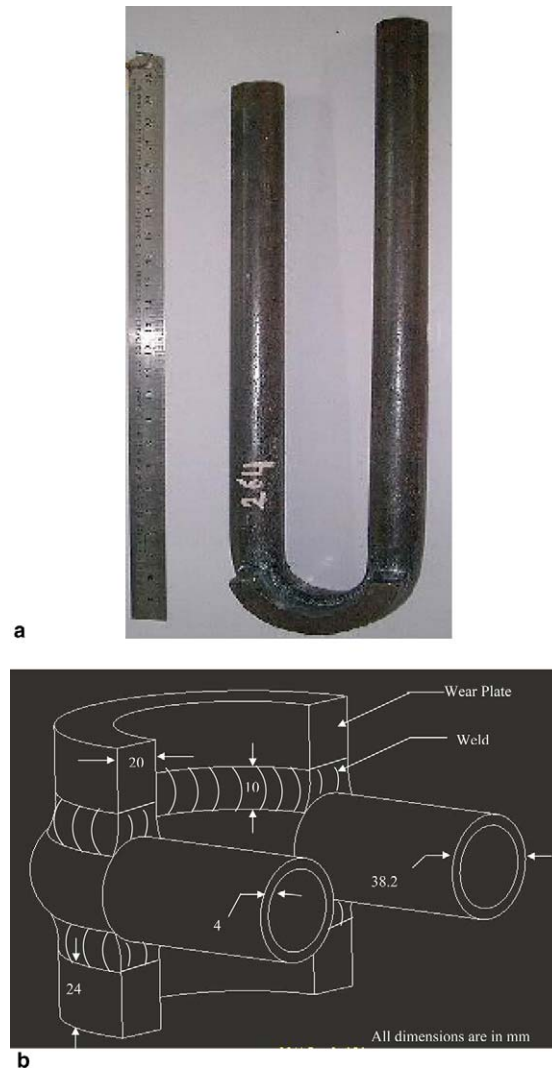
Fig. 1. Section of the evaporator tube showing the wear plate welded at the bend.

plate made of ASTM-A387 on either sides of the tube at the bend. The weld joint is similar to that of a T-joint. The length of the weld or the fusion zone on either side of the bend in each tube is 116 mm. The tube bends as well as the welds were reported to be routinely subjected to dye penetrant test and the coils to a pneumatic test at  $0.5 \text{ kg/cm}^2$  and a hydrostatic test at  $75 \text{ kg/cm}^2$ . All the evaporator tubes commissioned in the boiler are reported to have passed the tests. The evaporator tubes are not subjected to stress relieving after bending as well as after welding to the wear plates. The evaporator tubes are seamless and were reported to conform to the chemical and mechanical requirements of ASTM-A210 Grade A1, prior to bending of tube and welding of wear plate. A photograph of the evaporator tube along with the wear plate welded at the bend is depicted in Fig. 1. Three of the failed evaporator tubes (F1, F2 and F3) as well as two unused evaporator tubes (UF1 and UF2) were taken up for a thorough investigation.

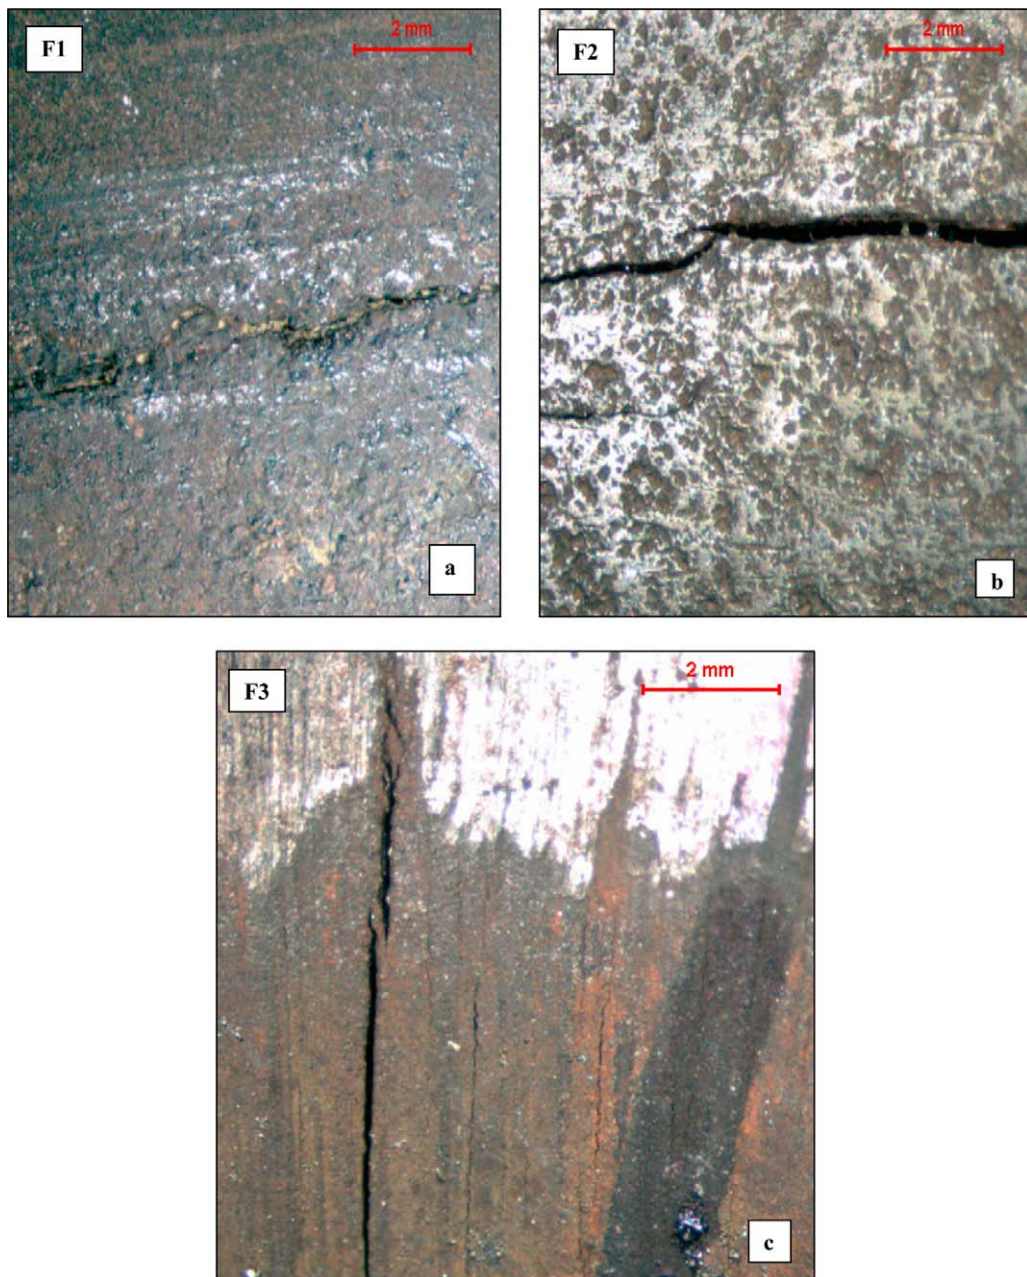
Almost all the failed tube samples showed visible longitudinal cracks along the rolling direction at the fireside surface of the inner bend of the tube and prominently at the center of the bend. Stereomicroscopic pictures of the centerline cracks observed at the fireside surface of inner bends in three of the failed samples are depicted in Fig. 2. The X-ray radiographs of two of these samples are also shown in Fig. 3. Fine visible cracks were also observed in the waterside surfaces of the failed samples, especially near the weld. The stereo-micrographs of the waterside surface depicting the cracks are shown in Fig. 4. The failed samples also showed transverse cracks when observed at higher magnifications as shown in Fig. 5(a). The micrographs in the unetched condition of the failed samples showed several sulfide type inclusions with high aspect ratios and elongated along the rolling direction as shown in Fig. 5(b and c). The elongated inclusions could be either manganese sulfide or iron oxide inclusions. It is difficult to distinguish them in optical microscopy. Both, manganese sulfide and iron oxide inclusions appear light gray in vertical bright-field illumination and both are plastic (i.e., easily deformed) at lower temperatures. Attempts to resolve them in optical microscopy by using special etching techniques [1,2] were unsuccessful. Some globular oxide type inclusions are also evident in these micrographs. Fine cracks interconnecting the elongated inclusions, both in the longitudinal and transverse directions are observed in these unetched micrographs. The microstructures (observed after etching) of samples drawn from various locations in the bend region of the failed tubes are illustrated in Fig. 6(a–f). There are several striking features observed in the micrographs. All the samples, except those very close to the weld show a banded ferrite and pearlite structure, the banding being along the rolling direction. There were several inclusions with high aspect ratios, elongated along the longitudinal direction and located preferentially within the ferrite bands (Figs. 6a and d). At higher magnifications, the interconnection of the elongated inclusions through fine cracks is also obvious (Fig. 6c). However, fine cracks connecting groups of inclusions in the transverse direction could also be seen (Fig. 6e). The microstructures very close to the weld region show the formation of bainite as seen in Fig. 6(f). The SEM fractograph of one of the failed tubes is depicted in Fig. 7. The fractographs of all the failed samples show extensive iron oxide rust covering the fracture surface. Mild cleaning of the fracture surface with dilute acids could not remove the iron oxide from the fracture surface. Although the fractographs of the failed samples were not very clear because of the iron oxide coating at the fracture surface, features characteristic of a brittle transgranular fracture could be distinguished. In some of the fractographs, a stepped appearance of the fracture surface could also be distinguished. The elemental analysis of the fracture surface by energy dispersive spectral (EDS) analysis (Fig. 7b) shows the presence of only Fe, Mn, Si and traces of Ca. Bulk elemental analysis using EDS are only approximate and should be cross-checked against direct conventional/instrumental analysis.

Fig. 2. Stereo images showing longitudinal cracks in the fireside surface of the inner bend (at the centre) of the failed tubes F1, F2 and F3, respectively.

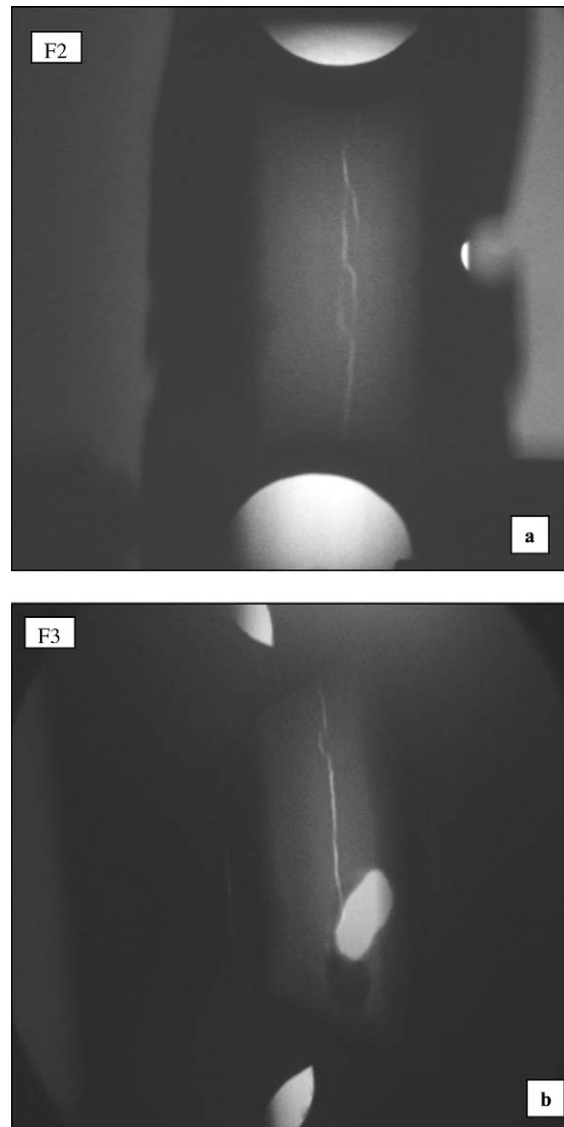
Fig. 3. X-ray radiographs of failed bend tube samples F2 and F3 showing long longitudinal cracks along the rolling direction at the center of the bend. The cracks appear stepped with treads parallel to the rolling plane. The large holes appearing in the radiographs (right hand side) are holes punched to drain the water.

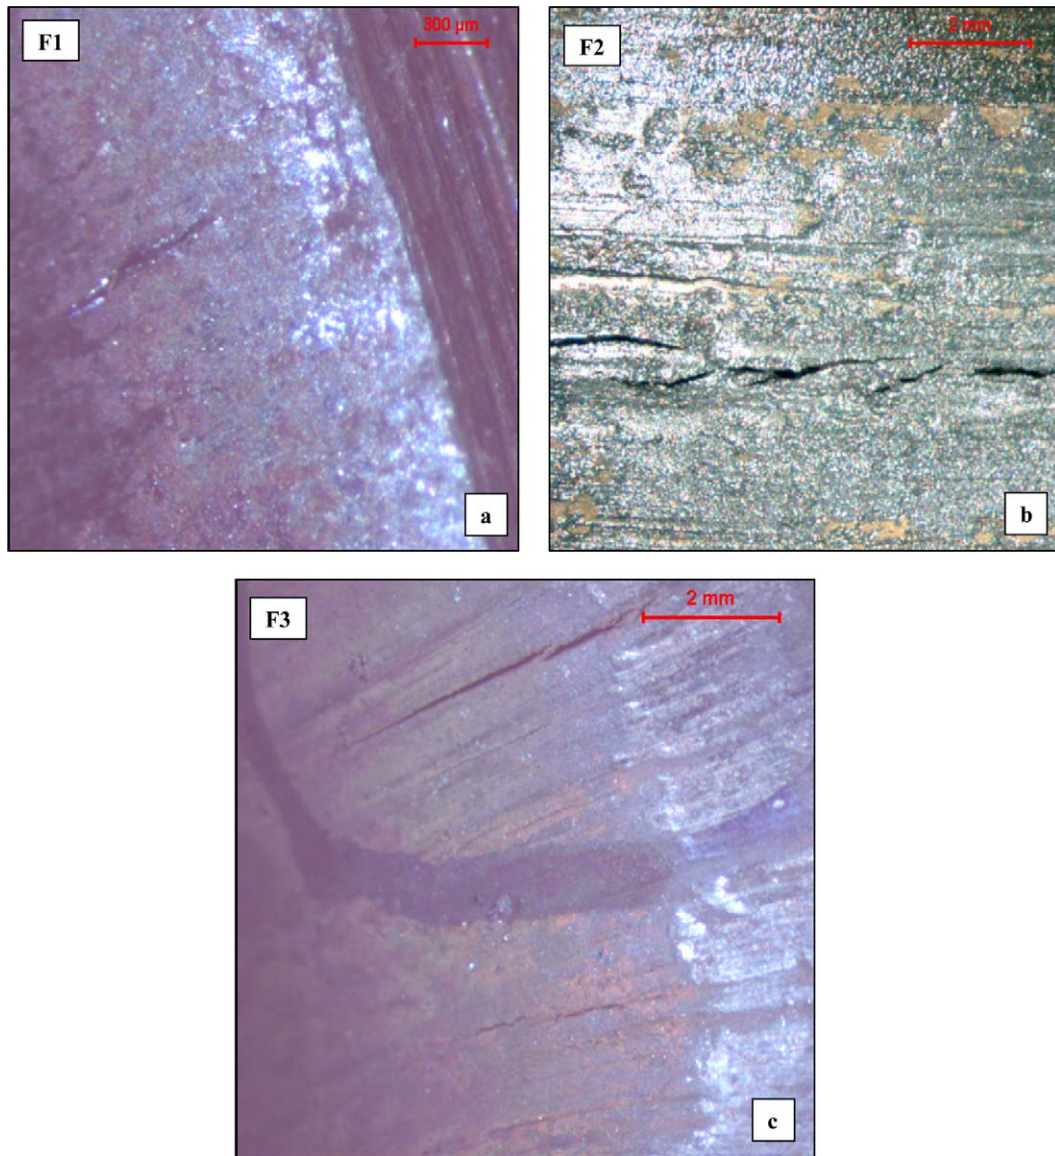
Fig. 4. Stereo images of the waterside surface of the failed samples showing longitudinal cracks along the rolling direction.

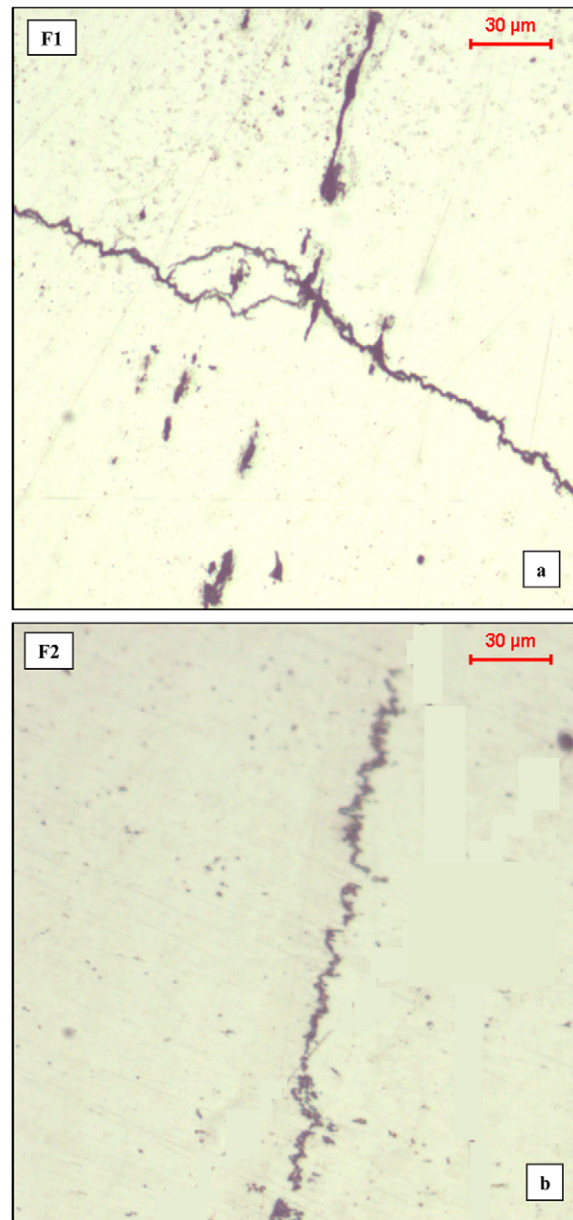
Fig. 5. Micrographs in the unetched condition of samples cut from the waterside surface at the region of failure from two different failed tubes. (a) Continuous crack in the transverse direction of the tube and a large volume fraction of elongated inclusions with high aspect ratios are observed and (b) inclusions elongated in the rolling direction and fine cracks interconnecting the inclusions are seen. Globular oxide type inclusions are also observed.

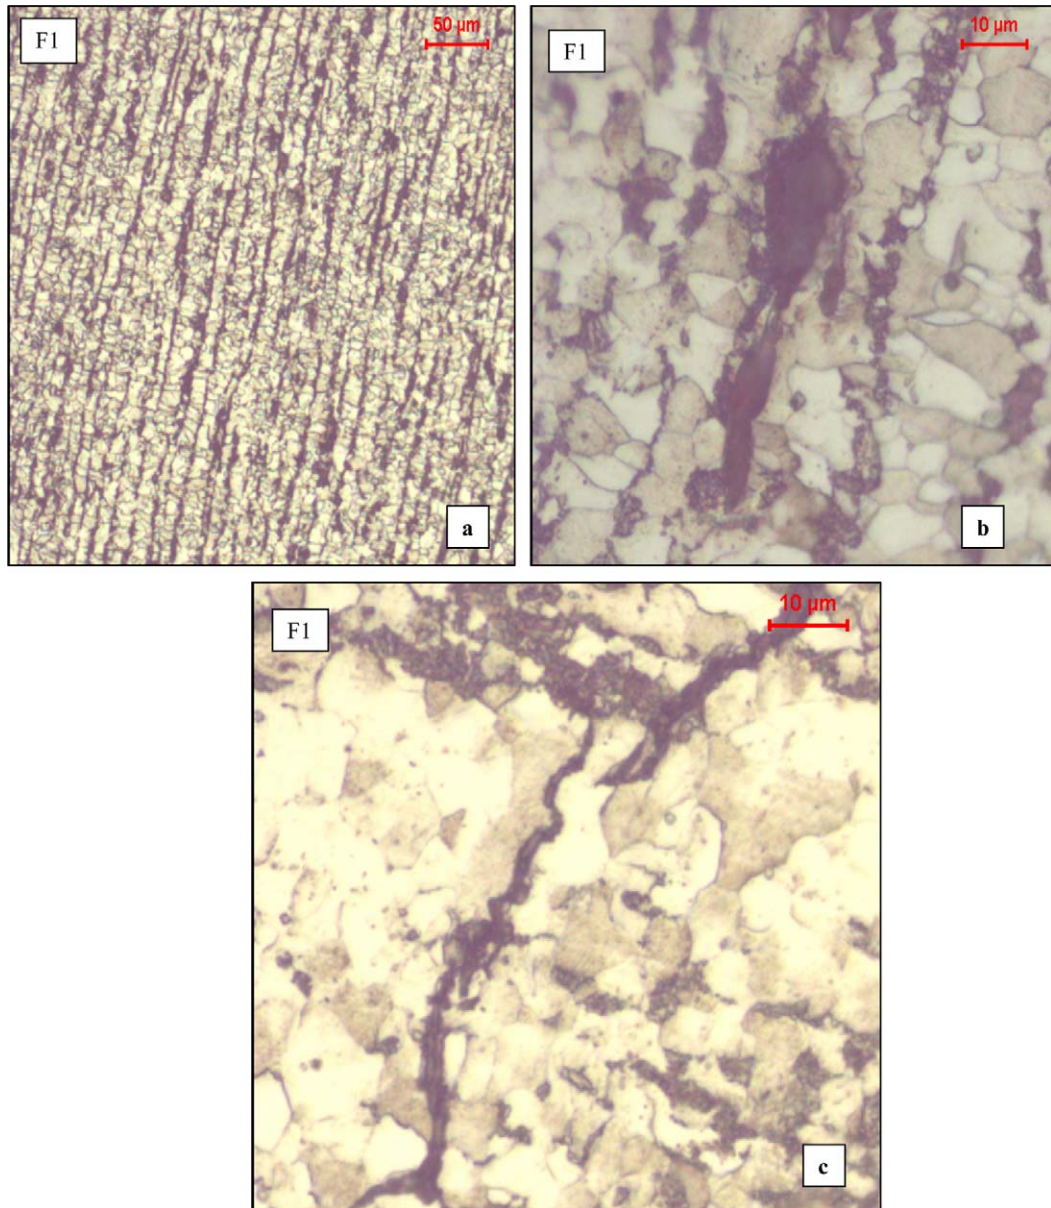
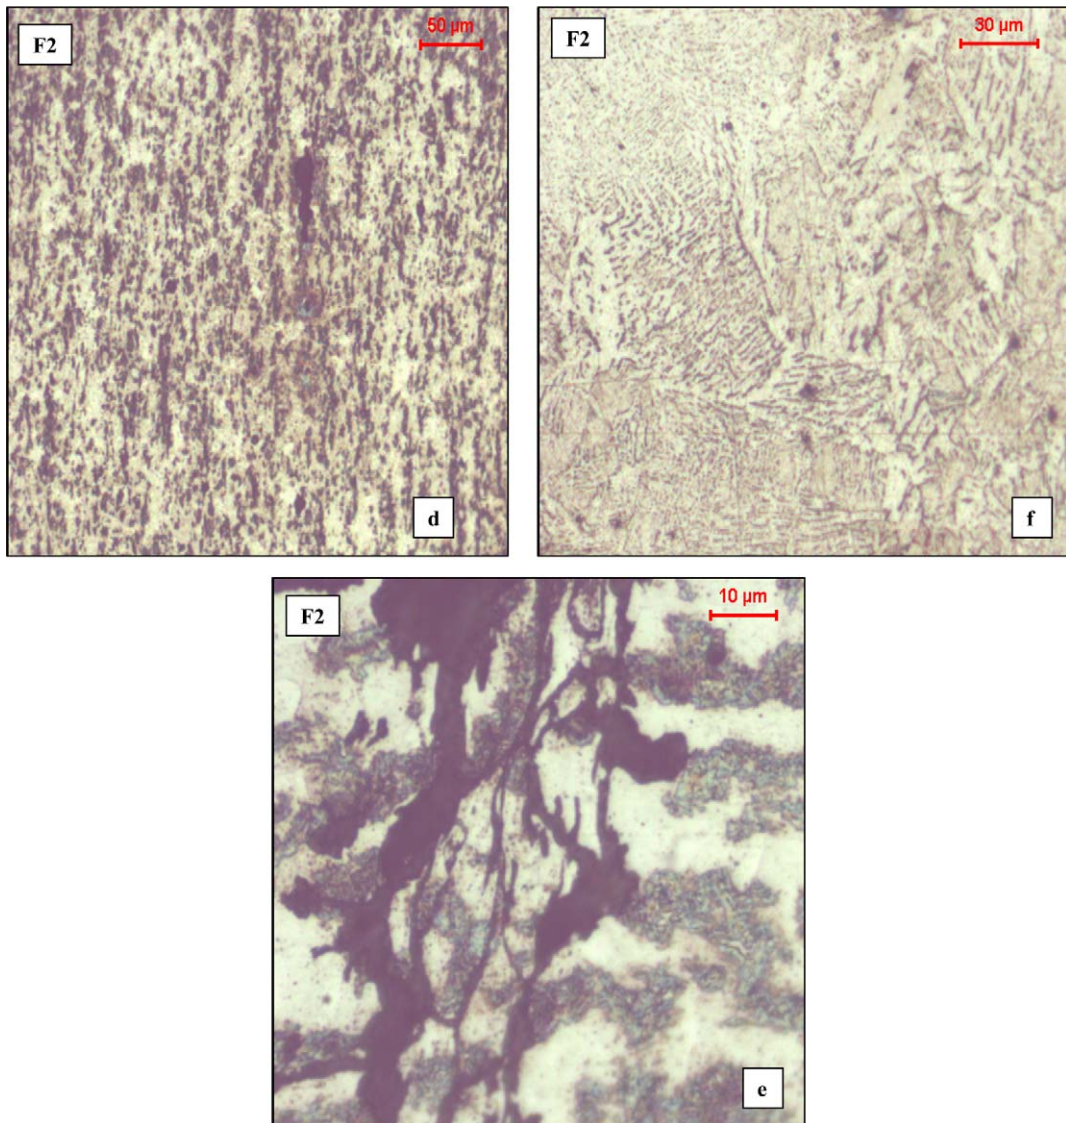
Fig. 6. Micrographs (at different magnification) in etched condition of samples cut from different locations in the failed zone of two different failed tubes: (a) microstructure at the fireside surface of the bend showing polygonal banded ferrite and pearlite; (b) micrograph at higher magnification showing groups of interconnected inclusions; (c) microstructure showing the propagation of crack along the inclusions; (d) microstructure showing a banded structure and elongated inclusions preferentially located within the ferrite bands; (e) microstructure showing fine micro-cracks connecting the groups of inclusions and (f) microstructure of sample from close to the weld region showing the formation of bainite.

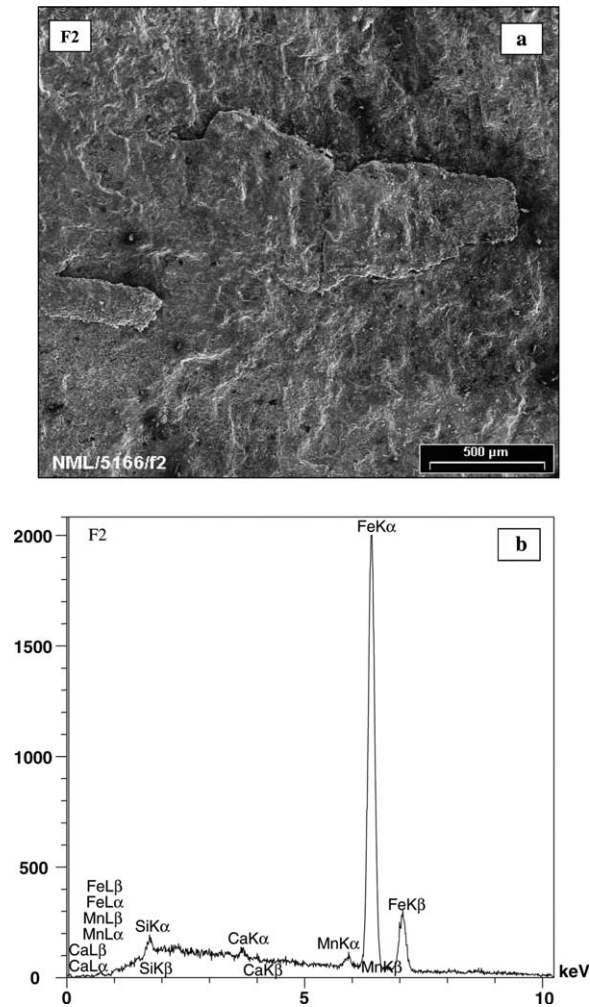
Fig. 7. (a) SEM fractograph of one of the failed surfaces showing extensive iron oxide covering the fracture surface. Features of brittle transgranular fracture observed and (b) EDS elemental analysis of the fracture surface showing only the constituents of steel.

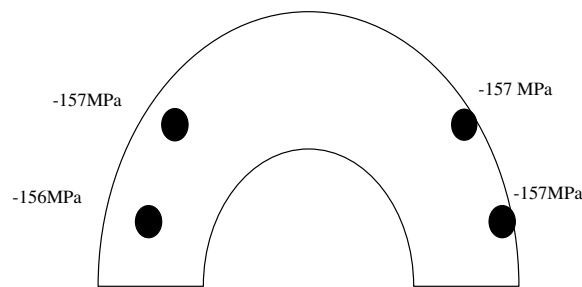
Fig. 8. Residual stresses at the outer fireside surface of the bend in one of the failed tubes.

stress concentration is especially higher as observed by the very large hardness. The presence of shrinkage stresses across the thickness of the evaporator tube is also confirmed by the unexpected presence of large compressive residual stresses at the fireside surface of the outer bend of all samples.

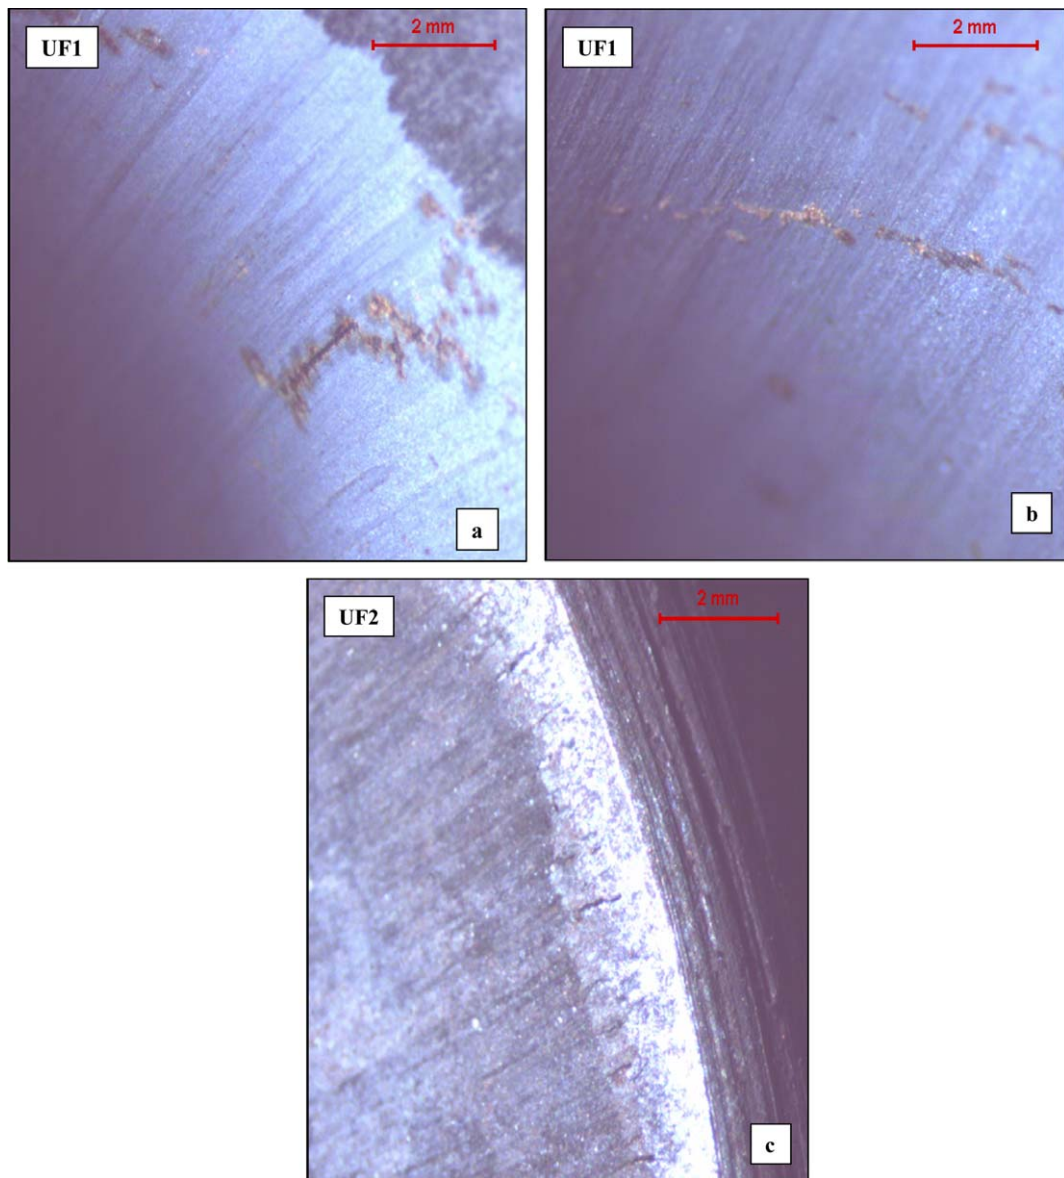
The unused tube samples showed elongated inclusions and several fine cracks mainly along the rolling direction when viewed at magnification under a stereomicroscope (Fig. 9). These cracks were prominent at the bend region of the tube, specifically near the weldment. The microstructures in the unetched condition

Fig. 9. Stereomicroscopic pictures of the waterside surface of the virgin tubes showing fine cracks and elongated inclusions along the rolling direction.

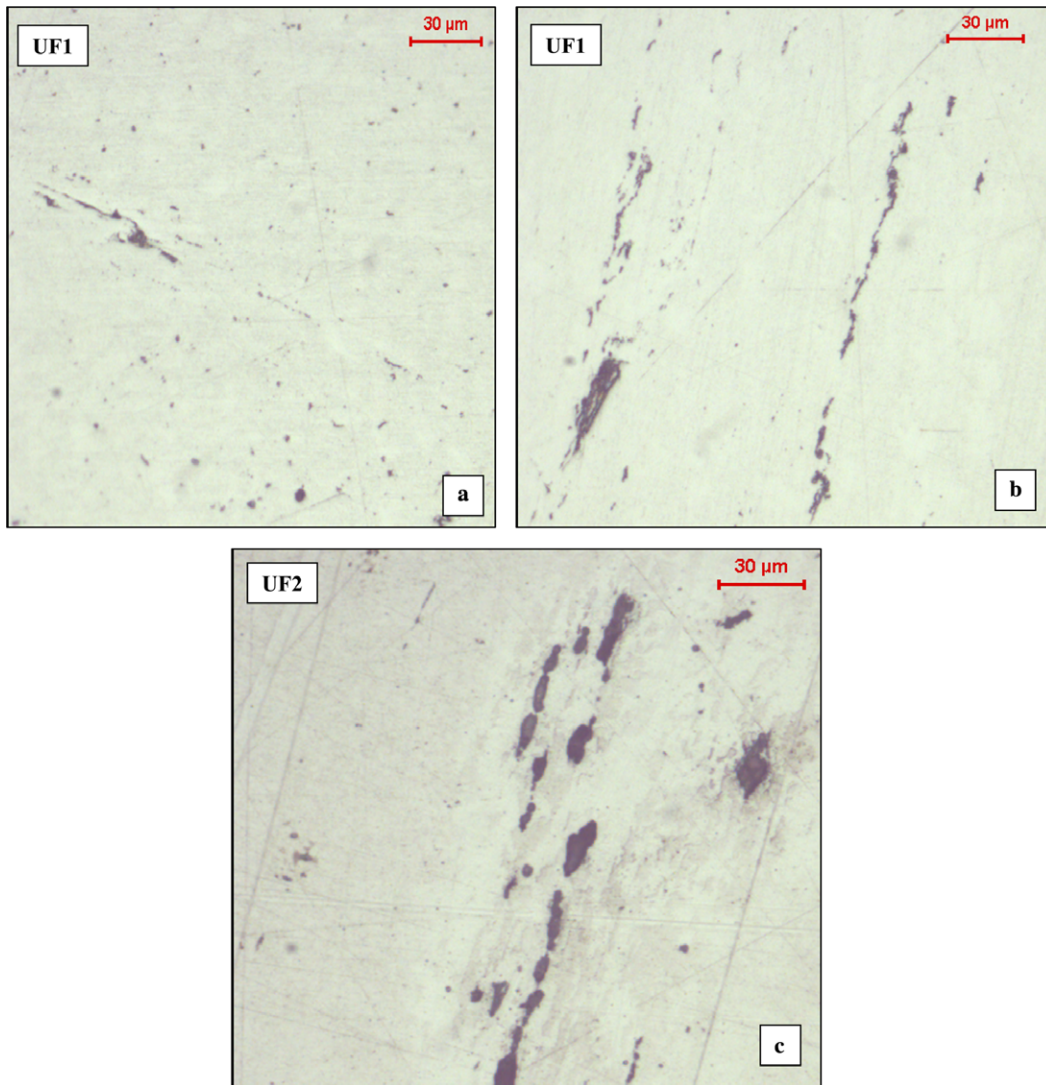
(Fig. 10) once again clearly showed large volume fraction of long sulfide type inclusions elongated along the rolling direction. These elongated inclusions appear interconnected by fine cracks. Some globular oxide type inclusions were also observed. The microstructures in the etched condition (Fig. 11) once again showed a banded pearlite and ferrite structure along the rolling direction, large volume fraction of inclusions with high aspect ratios, preferential location of the elongated inclusions on the ferrite bands and fine cracks interconnecting the inclusions. The fine transverse cracks that were observed in the failed samples were not present in the virgin tube samples. The results of scanning electron microscopy (secondary electron images) of the polished and etched (2% Nital) samples drawn from the various locations (fireside and waterside surfaces) of this

Fig. 10. Microscopic pictures in unetched condition of the virgin tube samples showing large volume fraction of sulfide type inclusions elongated along the rolling direction and interconnection of inclusions in the longitudinal direction through fine cracks.

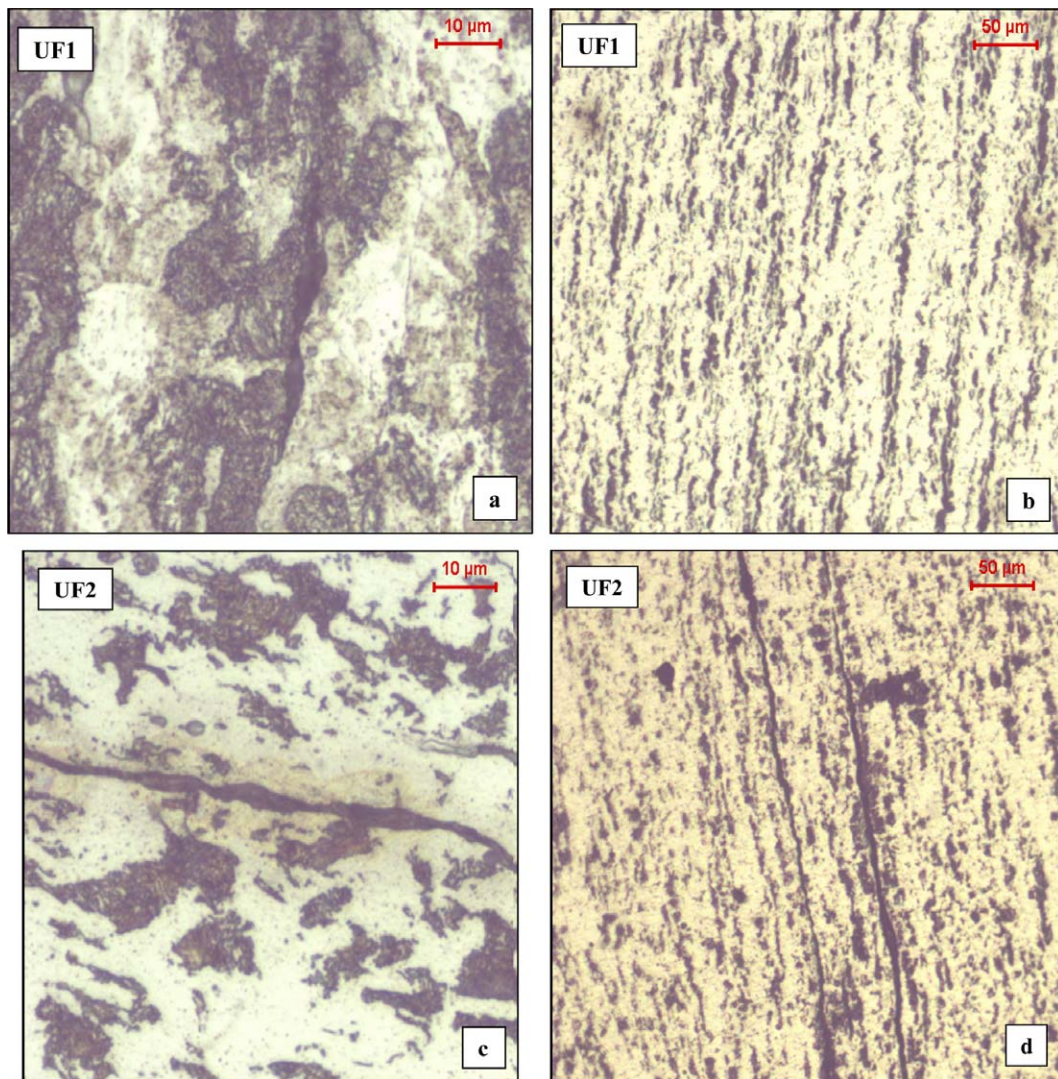
Fig. 11. Micrographs (at different magnification) in etched condition of samples cut from different locations from virgin tubes. (a) Microstructure at high magnification showing the location of elongated inclusions lying within the ferrite matrix; (b) microstructure showing a banded ferrite and pearlite structure (c) micrograph showing long elongated inclusions lying within the ferrite band and (d) microstructure showing banded ferrite and pearlite and decohesion at the boundary of the inclusion leading to cracking.

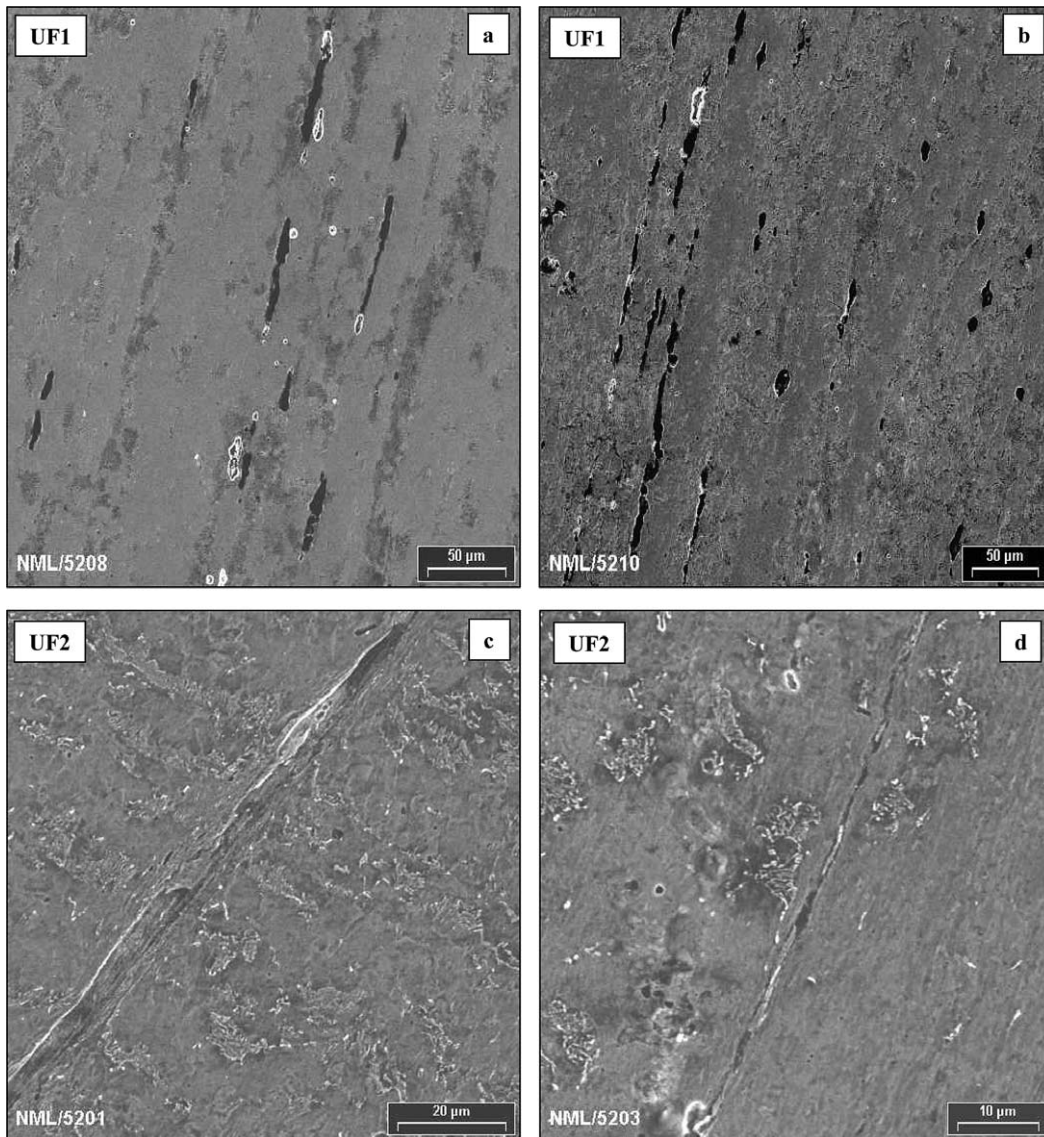
unused evaporator bend tube are depicted in Fig. 12. It is seen that there are several long elongated inclusions of mostly iron oxide (appearing dark in the SEM secondary electron images) and some manganese sulfide (appearing light gray) in the rolling direction at all locations including the fireside and waterside surfaces. Several longitudinal cracks along the inclusions are also visible. The EDS analysis of the inclusions appearing in dark and light gray contrast is given in Fig. 13. EDS analysis confirm that the inclusions showing a light gray contrast is predominantly manganese sulfide and the iron oxide streaks appear dark.

Fig. 12. Secondary electron images of polished samples from virgin tubes. (a) SEM micrograph shows elongated inclusions with two different contrasts, light gray and dark; the light gray inclusions were found to be MnS and the dark streaks were found to be iron oxide scales; (b) micrograph showing the dark iron oxide scales encapsulating the MnS stringers in some cases; (c) micrograph showing fine longitudinal cracks covered with iron oxide and (d) fine micro-cracks connecting the inclusions are evident in the SEM image.

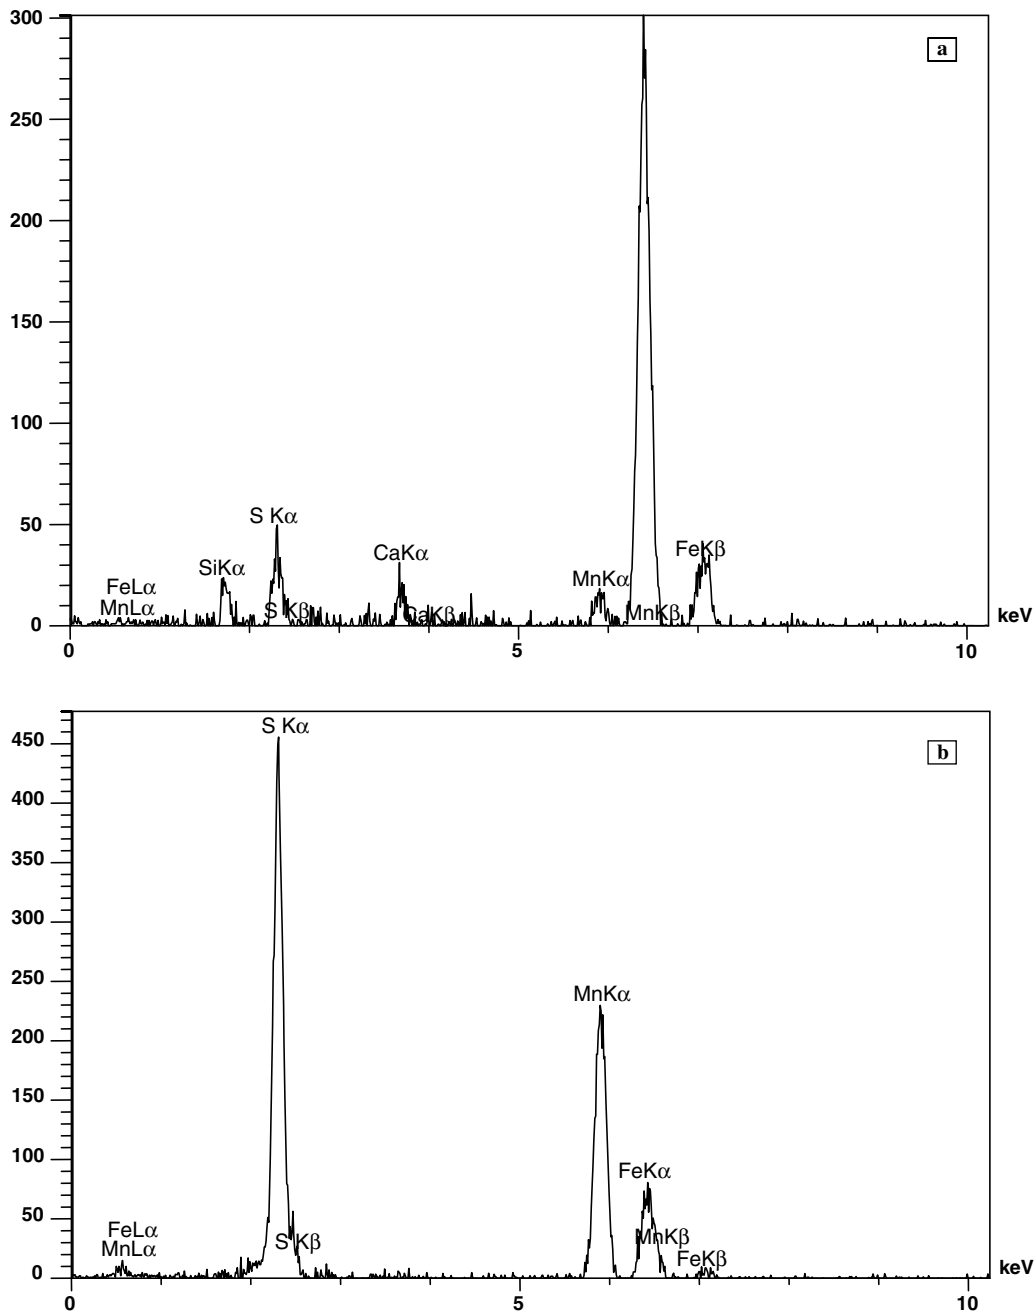
Fig. 13. (a) EDS analysis of the dark elongated inclusions seen in the bright field image confirming that these are iron oxide scales and (b) EDS analysis of the inclusions seen in light gray contrast in the bright field image revealing mainly MnS.
