Shattered Rim and Shelling of High-Speed Railway Wheels in The Very-High-Cycle Fatigue Regime Under Rolling Contact Loading

Engineering Failure Analysis, Vol. 97 (March 2019): 556-567. [DOI](#). This article is © Elsevier and permission has been granted for this version to appear in [e-Publications@Marquette](#). Elsevier does not grant permission for this article to be further copied/distributed or hosted elsewhere without the express permission from Elsevier.

Due to the improvement of the wear property, rolling contact fatigue including shattered rim and shelling are the main failure causes of the high-speed railway wheels. In this paper, shattered rim and shelling occurred on the service wheels of the China Railway High-speed (CRH) trains were systematically investigated. The recorded data of the last ten years CRH operation indicated that all shattered rims and shelling were detected with serving $>10^6$ km (corresponding to the fatigue life 10^7 – 10^9 cycles) which is very-high-cycle fatigue (VHCF). The crack initiation region of shattered rim located at the depth of 10–25 mm from the tread, while that of shelling located at the depth <10 mm from the tread. The VHCF feature

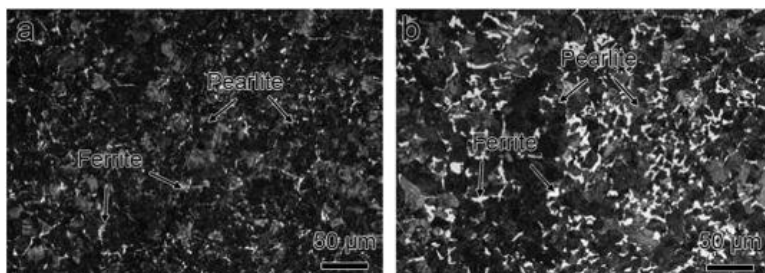
The microstructure under the tread is abundant pearlite with trace ferrite (Fig. 3a). The microstructure in the interior was found to consist of pearlite and ferrite (Fig. 3b), and the distribution of the ferrite is heterogeneous. Fig. 4 presents the typical inclusions in the wheel steels. The size of the inclusion is about 20 μm . Nonmetallic inclusion is prevalent in the steels. The aluminium acted as deoxidizer during the smelting processing of steels which results in the introduction of aluminium oxide inclusions to steels. In addition, the mechanical properties of the material were measured by tensile testing on an MTS 810 system with cylindrical specimens of 6 mm in diameter and at a strain rate of 10^{-4} s^{-1} . Five specimens were tested to obtain the yield strength of 673 MPa, the tensile strength of 950 MPa and the uniform elongation of 11.5% for the material.

Fig. 3. Microstructure of the wheels by optical microscopy, (a) surface, and (b) interior.

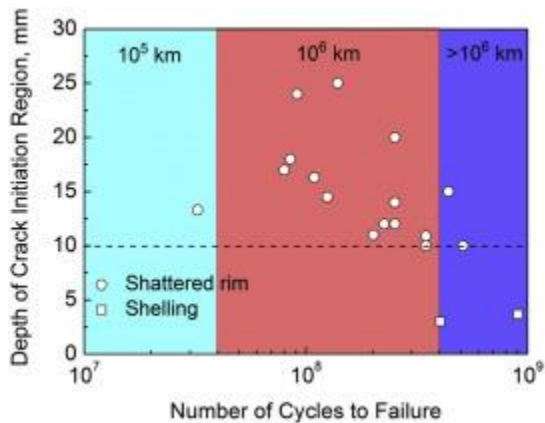
shelling on the CRH wheels were collected and recorded which make the systematic investigation possible. As the key components, railway wheels in the CRH are under close surveillance. All the wheels are detected on by the automatic online ultrasonic detection every two days. During the primary repair, secondary repair and third repair, the careful ultrasonic detection will be conducted for every wheel. Once the cracks in the wheels were detected, the severing mileage and crack initiation location were recorded. Fig. 6 presents the depth of the crack initiation region from the tread versus the fatigue life for shattered rim and shelling. The fatigue life is independent with the depth of the crack initiation region. The depth of the crack initiation region from the tread is in the range of 10–25 mm for all the shattered rims, and that for shelling is <10 mm. The wheels with shattered rim or shelling were recorded with the service of 10^5 – 10^7 km, and the corresponding fatigue life is within a range of 10^7 – 10^9 cycles. In general, the service stress is below the conventional fatigue limit. Considering the crack initiation site, service stress and fatigue life, the shattered rim and shelling can regarded as VHCF behavior.

Fig. 6. Depth of crack initiation region versus fatigue life.

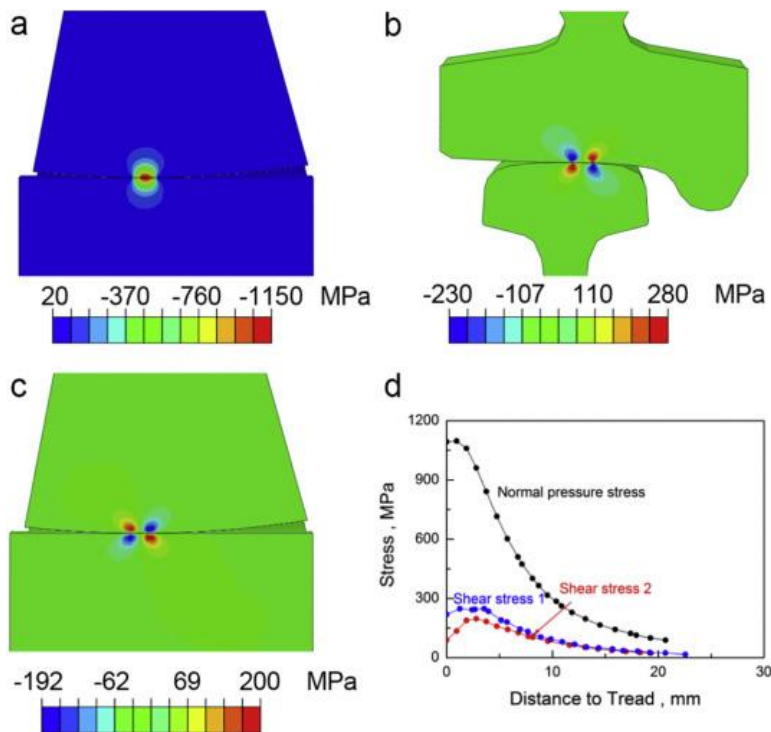
As mentioned above, the fracture surfaces for the case of interior and subsurface crack initiation are different, which is attributed to the stress distribution of rolling contact loading. Here, finite element method was applied to analyze the stress around the contact surface. The multiaxial stress consists of a pressure stress in the radial direction (Fig. 14a), a shear stress in axle direction (Fig. 14b) and a shear stress in circumference direction (Fig. 14c). The results in Fig. 14 indicated that only a small region of the contact location bears high stress, the maximum stress located at the depth of about 2 mm while the stress in the other parts of the wheel is almost zero. Fig. 14d presents the stress variation along the radial direction of the wheel. For the case of shelling (subsurface crack initiation) with the depth 0–10 mm, the pressure stress is very high and decreases with the increase of the depth. The existence of the high pressure will cause the severe plastic deformation near the tread (Fig. 10c and 12c) and the press of the crack surfaces (Fig. 9b and 11b). The two shear stress increase first from the tread surface to the 2 mm depth of the wheel, and the maximum shear stress occurs at about 2 mm depth from the tread. These two shear stresses are the driven force of the subsurface crack initiation and propagation. For the case of shattered rim (interior crack initiation) with the depth 10–25 mm, the pressure stress is in the elastic stage, and no evident press between the crack surface was observed (Fig. 6). Meanwhile, the two shear stresses are also in the low level. It is consistent with VHCF features of a relatively low cyclic stress below conventional fatigue limit and beyond 10^7 fatigue cycles.

Fig. 14. Stress distribution of wheel/rail contact, (a) pressure stress contour in radial direction, (b) shear stress contour in axle direction, and (c) shear stress in circumference direction, and (d) stress variation along the radial direction of the wheel.

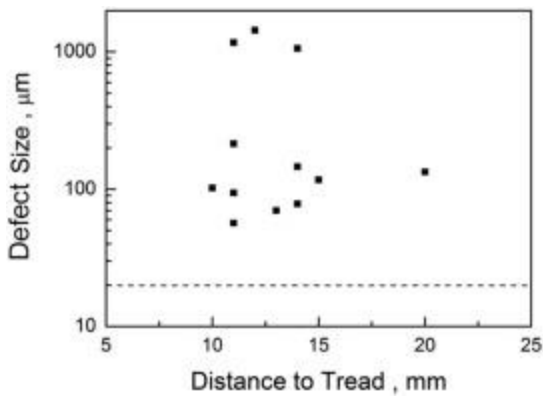
Although the Murakami model is applied to evaluate the VHCF in uniaxial loading, the fatigue strength under rolling contact loading can be regarded as proportional to the hardness and inversely proportional to the defect size. According to Eq. (1), the defect size and hardness distribution were measured. Fig. 15 presents the defect size that induced shattered rim and shelling of the wheels. In general, the size of defects that induced fatigue is larger than the average defect size in the material. In Fig. 15, The minimum size of defect that induced shattered rim and shelling is 56.7 μm , which is almost more than three times of the average defect size (20 μm). The maximum defect size is 1439.4 μm , about 72 times of the average defect size. Therefore, all of the defect sizes that induce crack initiation exceeded the average size. As listed in Eq. (1), the fatigue strength decrease with the increase of the defect size.

Fig. 15. Defect size versus depth from the tread.

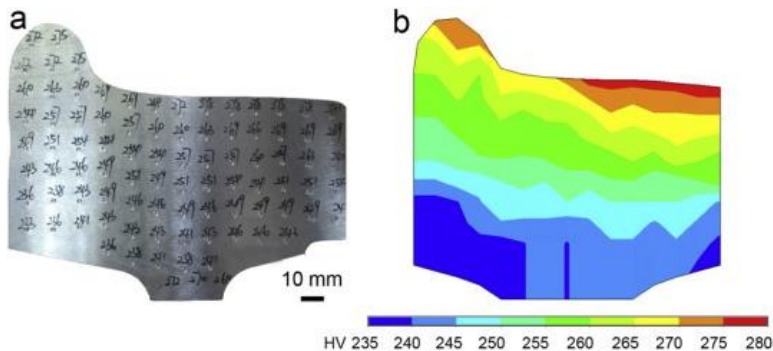
The hardness for the wheel profile has been tested by the method of Brinell hardness. The wheel has served for a while. Fig. 16 presents the hardness distribution of the wheel profile. Fig. 16a shows the measure points and corresponding values of Brinell hardness. Vickers hardness was used in the prediction of fatigue strength in Eq. (1). Then, Fig. 16b presents the corresponding Vickers hardness distribution, indicating that the hardness value decreases gradually with an increasing depth from the tread. The hardness for the depth of 0–10 mm to the tread is in range of 270–280 Hv, The value of the hardness for the 10–25 mm depth is 260–270 Hv. Although the stress is larger in the surface, the gradient distribution of hardness for hard surface and soft core can suppress the surface crack initiation.

Fig. 16. Hardness distribution of the wheel profile, (a) measure points and corresponding values, and (b) corresponding Vickers hardness contour.

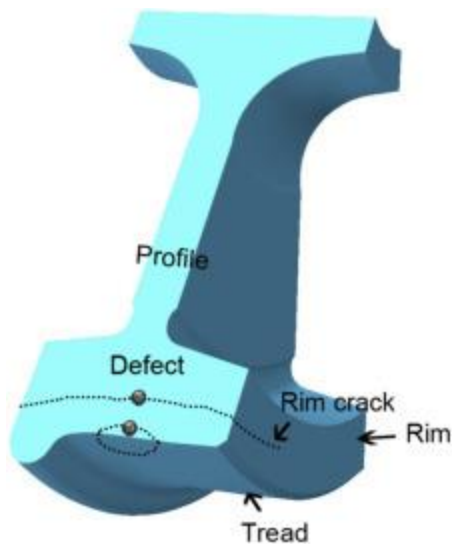
Fig. 17 presents the schematic for the formation mechanism of shattered rim and shelling induced by defects. When the defect locates at the subsurface of the tread with the depth <10 mm, crack induced by the defect will prefer to propagate to the tread instead of the rim, called shelling. This will cause damage on the tread, and influence the service of the wheel. With turning repair, the wheel can continue the service. When the defect is located at interior of the wheel and is deeper than 10 mm, the crack will propagate to the rim instead of the tread. The shattered rim will lead to the failure of the wheel, even disaster to the train. Models such as “hydrogen assisted crack growth” [27,28], “decohesion of spherical carbide” [29,30], and “formation and debonding of fine granular layer” [19,20] have been proposed for describing the crack initiation mechanism for the VHCF of steels. For the mechanism of “hydrogen assisted crack growth”, it was stated that the existence of locally concentrated hydrogen trapped by a defect induced the discrete crack growth at a very slow rate during crack initiation. The mechanism of “decohesion of spherical carbide” attributes the decohesions of spherical carbides from the matrix to the crack initiation of VHCF. The debondings of the fine granular layer and the matrix are responsible for the early cracks in the model of “formation and debonding of fine granular layer”.

Fig. 17. Schematic of shattered rim and shelling induced by defects.
