**PERFORMANCE EVALUATION OF THE PERMANENT NEW JERSEY  
SAFETY SHAPE BARRIER – UPDATE TO NCHRP 350 TEST NO.  
4-12 (2214NJ-2)**

**MIDWEST ROADSIDE SAFETY FACILITY**

MwRSF Research Report No. TRP-03-178-06

October 13, 2006

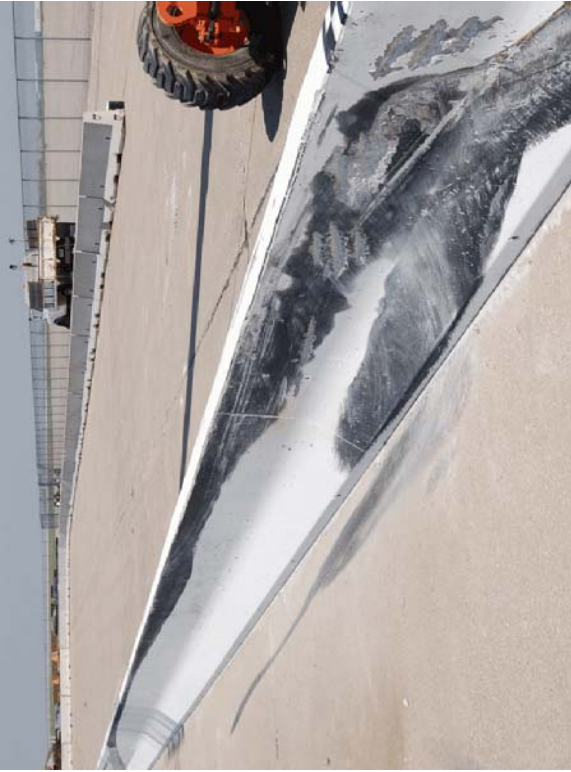
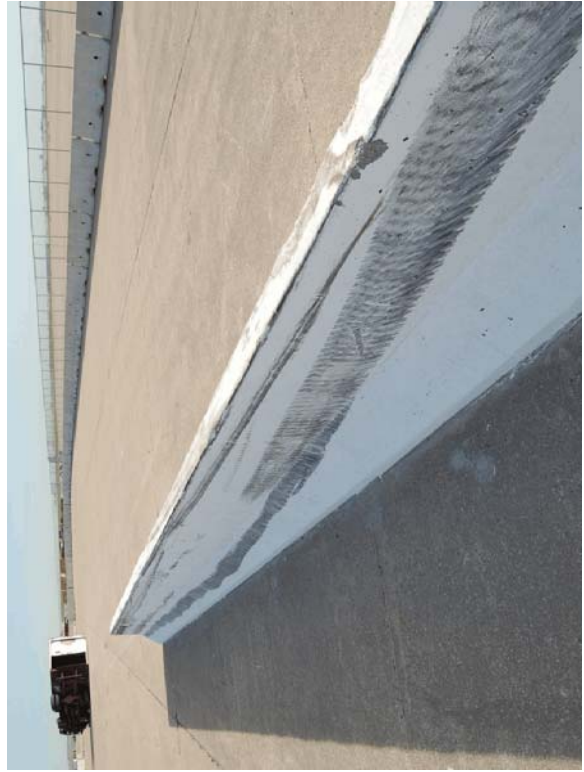
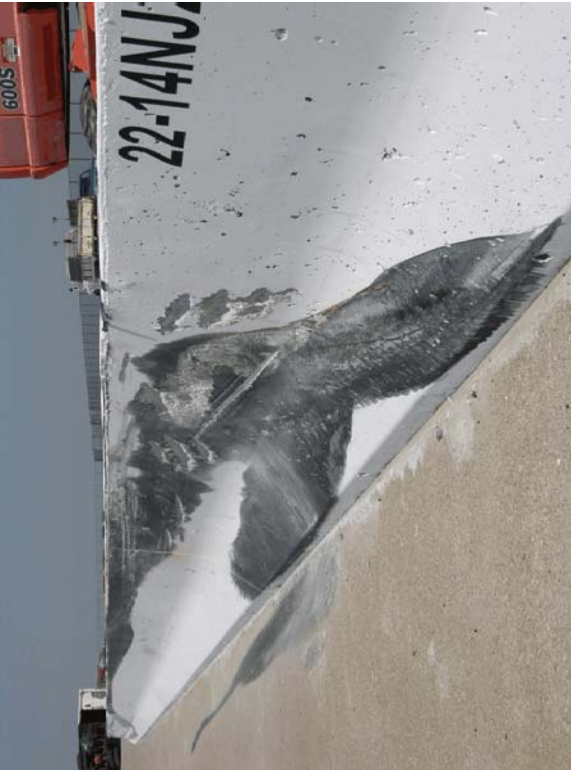
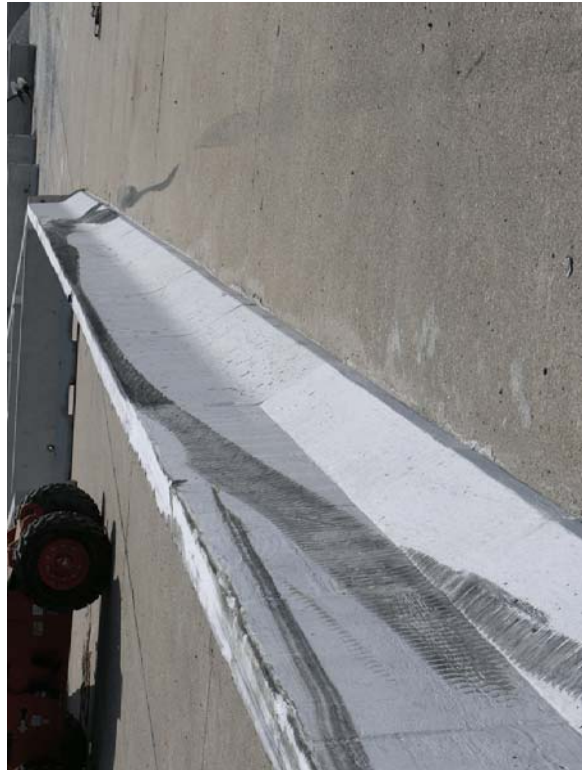
Figure 20. Permanent New Jersey Safety Shape Barrier Damage, Test 2214NJ-2

Damage to the barrier was minimal, as shown in Figures 20 through 22. Barrier damage consisted of contact and gouge marks. The length of vehicle contact along the concrete barrier system was approximately 31.29 m (102 ft - 8 in.), which spanned from 5,283 mm (208 in.) downstream from the upstream end of the barrier through the downstream end of the barrier.

A 368-mm (14.5-in.) long tire mark was found on the lower face of the barrier. Another tire mark began 9.14 m (30 ft) upstream from the downstream end of the barrier. A 279-mm (11-in.) wide by 229-mm (9-in.) high by 13-mm (0.5-in.) deep wheel gouge began at the targeted impact point. The center of a 406-mm (16-in.) wide by 203-mm (8-in.) high by 6-mm (0.25-in.) deep wheel gouge was located at 635 mm (25 in.) downstream from the targeted impact point. The center of a 356-mm (14-in.) wide by 229-mm (9-in.) high by 13-mm (0.5-in.) deep wheel gouge was located at 1,245 mm (49 in.) downstream from the targeted impact point. Spalling on the back side of the barrier began 6.71 m (22 ft) downstream from the impact point and continued to the end of the barrier. Minor spalling was located on the top front side of the barrier at 7.62 m (25 ft) downstream from the targeted impact point. The front side of the barrier also encountered spalling which began 6.10 m (20 ft) upstream from the downstream end of the barrier and continued through the end of the barrier. The permanent set of the barrier system was negligible.

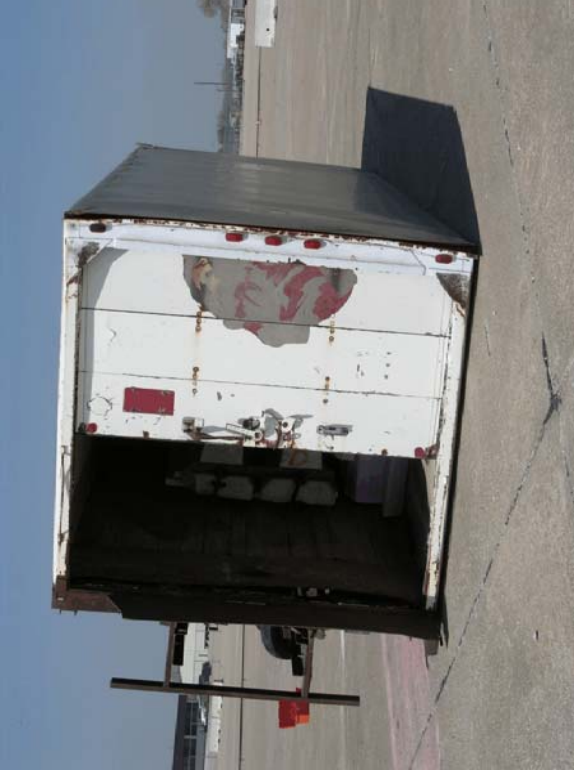
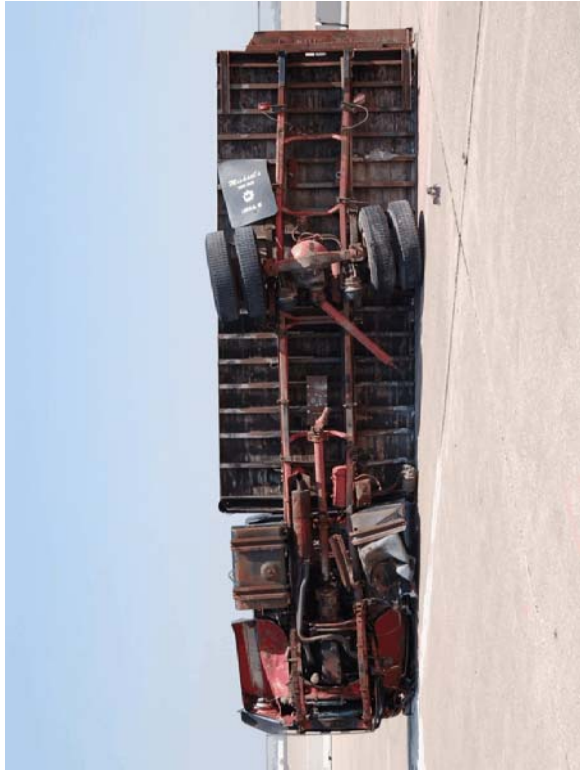
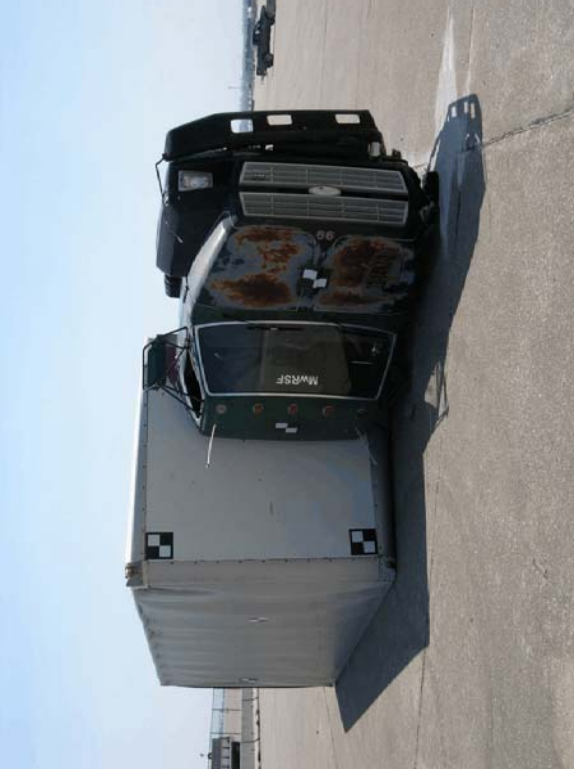
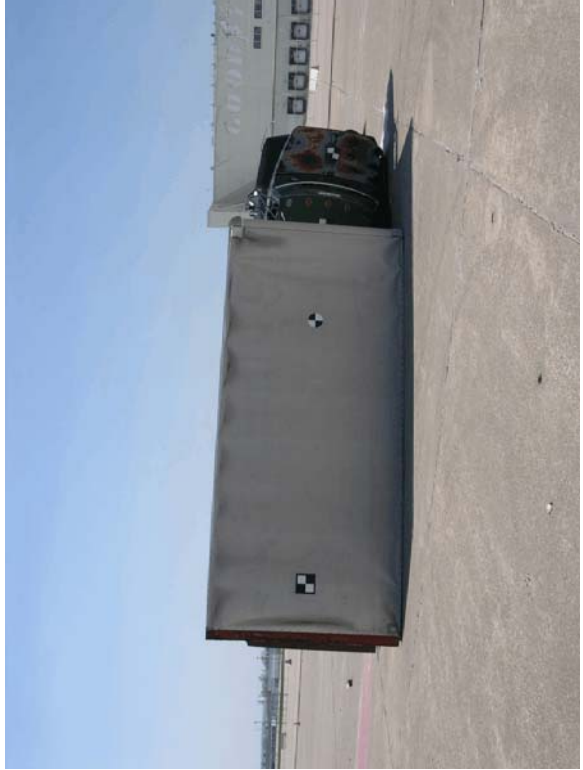
Figure 23. Vehicle Damage, Test 2214NJ-2

Exterior vehicle damage was extensive, as shown in Figures 23 through 26. Occupant compartment deformations to the right side and center of the floorboard were judged insufficient to cause serious injury to the vehicle occupants. Complete occupant compartment deformations and the corresponding locations are provided in Appendix C.

Damage was concentrated on the right side of the vehicle. The right-front quarter panel was deformed inward toward the engine compartment. The right side of the front bumper was flattened and bent back toward the engine compartment. The left side of the front bumper was also deformed inward toward the engine compartment. The right-front fuel tank was severely dented. The right-front exhaust disengaged from the truck and was dented. The bracket attaching the right-right front exhaust was bent backward 90 degrees. The right side of the frame buckled at the front flange and was bent and twisted near the rear end. The front axle and drive shaft disengaged from the truck. Scratches and contact marks were found along the entire right side. The hood deformed slightly. The third and fourth U-bolts attaching the cargo box to the frame fractured. The cargo box frame at the rear axle was bent backward. The top rear of the cargo box encountered minor buckling. Contact marks were found on the bottom of the cargo box and the steel cross beams were deformed. The right leaf spring disengage at the front of the rear tire. The right-rear inside tire encountered a severe gouge. The right-front mirror was broken. All window glass remained undamaged.
