COMPLIANCE TESTING OF IOWA'S SKID-MOUNTED SIGN DEVICE

MIDWEST ROADSIDE SAFETY FACILITY

MwRSF Research Report No. TRP-03-86-99

July 23, 1999

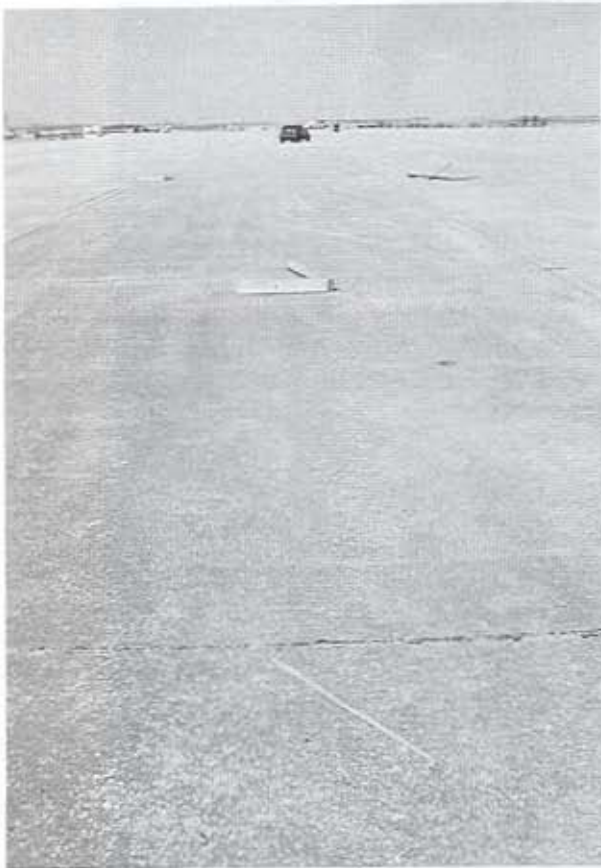
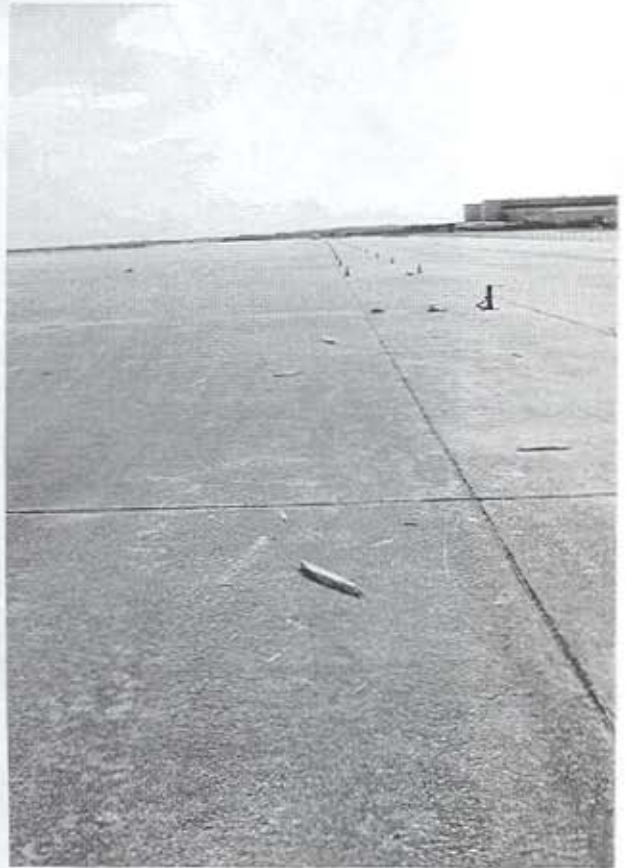
Figure 14. System No. 1 Overall Damage, Test I-1

Damage to System No. 1 is shown in Figures 14 and 15. System No. 1 encountered moderate damage to the sign support. The wooden base broke into two larger pieces and many smaller pieces. The pipe base, vertical tubing, mast, support rod, and sign panel all remained intact, but encountered deformations. Each leg of the pipe base bent to a 30 degree angle in opposite directions. The vertical tubing was bent in the shape of the nose of the vehicle. The support rod was bent into a 90 degree angle about the top third of the rod. The sign panel encountered scrape marks near the bottom front of the impacted side. The two bolts furthest away from the impact were slightly pulled through the plywood. No major damage was found to have occurred to the mast.

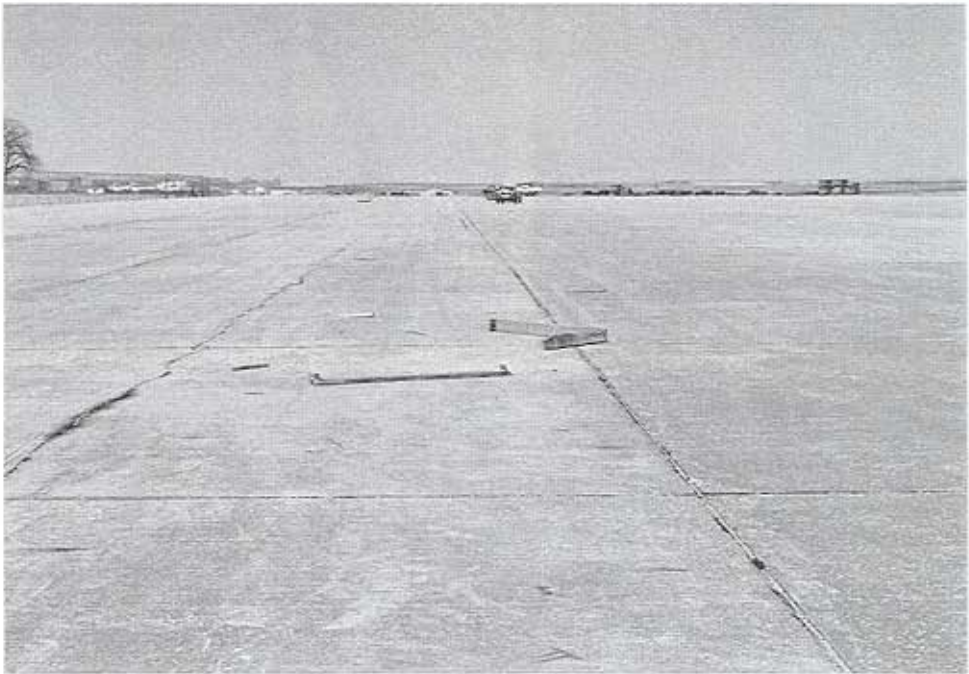
Figure 21. System No. 2 Overall Damage, Test I-2

Damage to System No. 2 is shown in Figures 21 through 23. System No. 2 has moderate damage to the sign support. The wooden base broke into three larger pieces and many smaller pieces. One of the larger pieces, the back piece with the support rod connected to it, was bent into a 120 degree angle about the rod's midpoint. The pipe base, vertical tubing, mast, and sign panel all remained intact but encountered deformations. Each leg of the pipe base bent evenly about the attached triangular gussett plate. The vertical tubing bent at 381 mm above the triangular gussett plate and was slightly dented at the support rod's connection point. Weld failures were found at the flat plate and gussett connection and the lower crossbrace and vertical tubing connection. The lower crossbrace was bowed slightly away from the sign panel. The sign panel was cracked on the left side near the lower crossbrace, and the bottom tip of the sign panel was also broken. No major damage was found to have occurred to the upper crossbrace.
