Analysis of End Crack in Boiler Tube

Shahida Begum^{1,a}, A.N Mustafizul Karim², Mohamed Ansari M. Nainar¹
and Sukhana Sevah¹

Key words: Boiler tube, end crack, ceramic ferrule, heat flux.

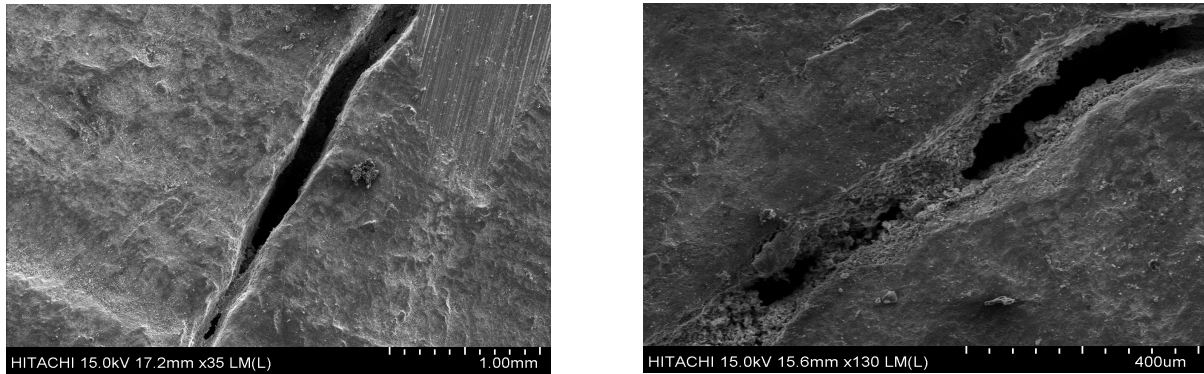
The end cracked boiler tube material was of BS 3059 carbon steel with diameter (\varnothing) and thickness (t) of 63.5mm, 3.6mm respectively. The steam flow was 15-30 tonne/h with steam pressure of 14 – 16 bar and temperature 120 °C. The visual examination revealed minute cracks at the welded zone and the SEM photograph of samples are given in Fig. 1.

Fig. 1: SEM photograph of crack in boiler tube (a) sample 1 (b) sample 2

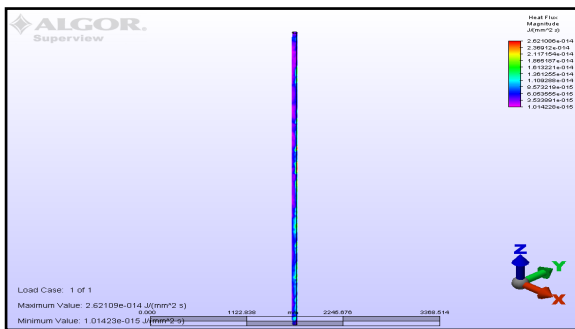
Thermal-Heat Flux Magnitude. The thermal heat transfer analysis was conducted by applying surface heat flux on the inner wall surface of the tube that will either supply heat or take away heat during the process. The vector option was then activated and the vector plot of the heat flow was displayed. Fig. 2 illustrates the heat flux magnitude along the boiler tube. The color contour best illustrates the heat distribution where red color has the maximum magnitude, $2.62\text{E-}14 \text{ J/mm}^2$ and purple has the lowest value of $1.014\text{E-}15 \text{ J/mm}^2$.

Fig. 2: Heat Flux distribution along the tube

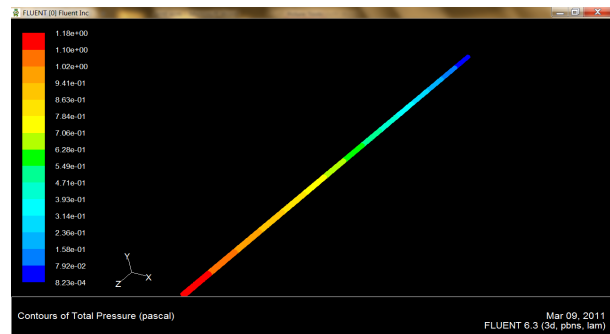
Fig.3: Contour of total pressure in boiler tube

The colour contours, vectors and residual plot were obtained from the FLUENT analysis. In heat transfer analysis it was observed that the pressure ranges from 1.18Pa to 8.23E-4Pa. The highest pressure is at the tube inlet area which is 1.18Pa; while at the outlet pressure is minimal. The pressure distribution is given in Figure 3. The analysis showed that heat flux was constant throughout the tube. There was also no radiation heat transfer. The total heat transfer rate is 1154886.4W across the boiler tube.

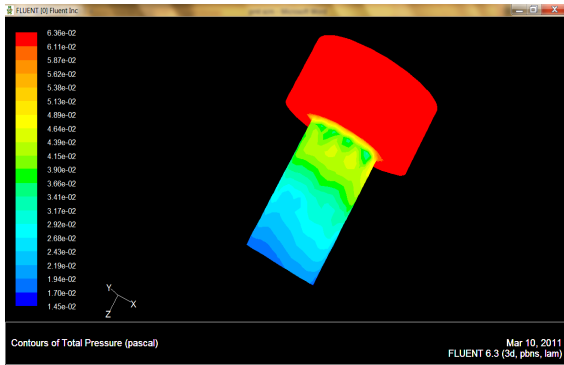
Fig. 4: Total pressure contour for ferrule

Ceramic (ZTA) ferrule was used in the analysis to prevent the end crack. The highest pressure is located at the inlet area of the ferrule which is within the range of 6.36E-2Pa to 1.45E-2Pa as presented in Fig. 4. However, it is much lower than the boiler tube inlet pressure. Hence, summarizing that the ceramic ferrule will be able to withstand the load and delay the fracture’s occurrence. The highest heat flux value is 21.7 W/m² as can be seen from Fig. 5. Heat transfer rate at the inlet of the ceramic ferrule is 112.53W and a very low of total heat transfer rate is produced which is approximately zero. The theoretical characteristics of the ceramic ferrule (low thermal conductivity) are supported by the findings [9].

The mode of failure for a boiler tube end crack was investigated and a ceramic ferrule is the suggested solution. The ferrule is to be fitted on to the inlet end of the tube to prevent thermal shock when hot flue gas enters the tube. Ceramic materials are chemically inert to almost all materials, however, it has the risk of fracture. Though, the design may contain flaws that can be further improvised for a better implication. The application of the ceramic ferrule on a boiler tube can be used to eliminate crack occurrence, or at least delay the crack occurrence.

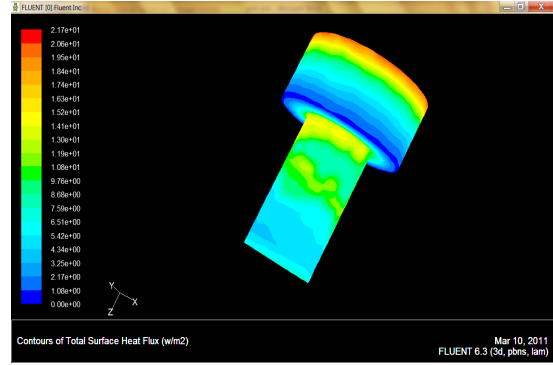
Fig. 5: Heat flux contour for ferrule
