# PAINTING PROCESS IMPROVEMENT THROUGH SIX SIGMA APPROACH IN A MALAYSIAN VEHICLE ASSEMBLY COMPANY

**Keywords:** Six Sigma, DMAIC, automotive assembly, painting process

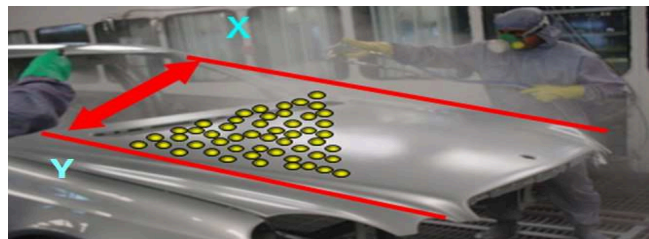
Figure 2: Fiber defect detection through Genba checks

Genba checks were carried out in the Top Coat spray booth during spraying process and it was found out that fiber defects were created in X - Y area (Figure 2).

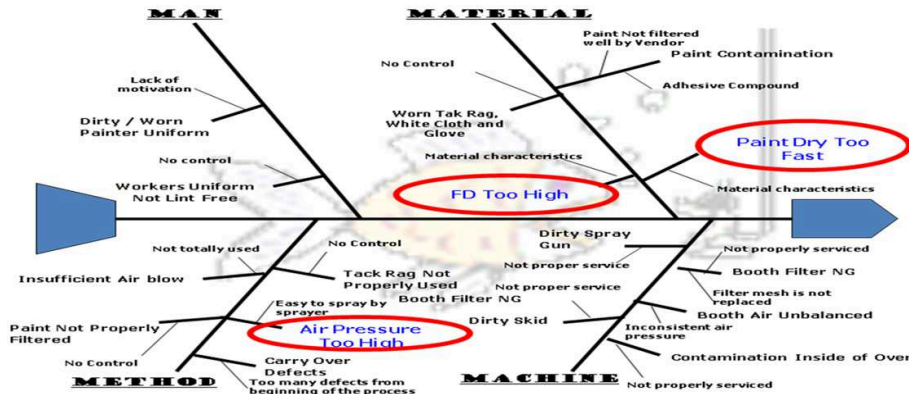
Analysis on the possible causes of fibers was carried out using the cause-and-effect diagram (Figure 3). Fibers could have been caused by dirty painter uniforms but the workers working in the Paint Shop were already given lint-free uniform. Changing the uniform periodically for one trial period also did not reduce the fiber count. Potential causes of fibers were associated with contamination in the material used in the painting process. Action taken to filter the paint up to three times the usual filtration rate also did not resolve the fiber defects. The tack rags which might create fibers were changed and their use controlled but to no avail. Dirty spray guns and skids were periodically cleaned but the problems persisted. For methods, possible causes include contaminated oven, imbalanced air pressure in the spray booth, insufficient air blow and defects carried over from previous painting. Measures taken including increasing frequency of oven cleaning, carrying out total booth refurbishment and re-balancing of spray booth, ensuring sufficient air blow and finally carrying out 100 percent inspection after primer sanding process failed to reduce the number of fibers detected.

Figure 3: Cause and Effect Diagram for fiber defect

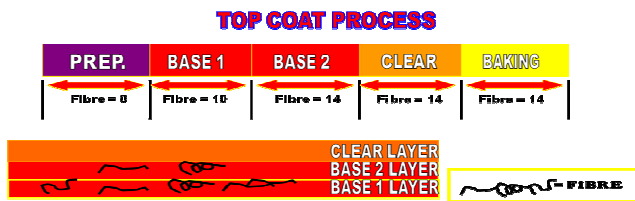
Figure 4 illustrates fiber accumulation in top coat can from preparation station to baking process detected during inspection. After many trials, it was found that during the spraying process, paint overspraying, paint spitting and paint drying too fast had caused the accumulation of fibers on the painted body with the fibers originating from the paint material itself. The first root cause was too much overspray due to air pressure setting recommended by the supplier was too high (5 to 5.5 bars). High air pressure setting was for easy spraying i.e. paint coverage was high and spraying time short. The second root cause was paint spitting caused by inappropriate (high) fluid delivery setting for polyester-based paint. The third root cause was due to paint drying too fast thus unable to absorb paint overspray which then turned into fibers.

Figure 4: Accumulation of fibers during spraying process

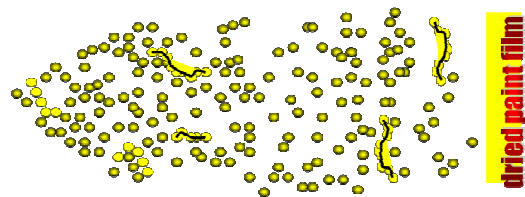
Figure 5: The forming of paint particle chain

High fluid delivery resulted in more paint particles triggered during spraying causing overspray and paint spitting (Figure 5). The paint particles will link to each other forming long chains of paint particles resulting in fibers. High air pressure induced the formation of more fibers through particles knocking each other. The long chain of paint particles turned into higher molecular weight fibers and dropped on the surface of semi-dried paint film and remained on the painted body and detected as fibers which can be clearly seen with naked eyes.

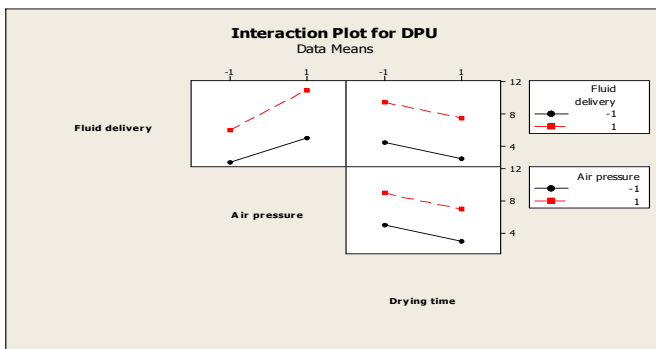
Figure 6: Interaction diagram for DPU

It can be concluded from the DOE that adjusting the parameter setting of the spraying gun had reduced the fiber count in the paint materials (Figure 6). The optimum combinations for the spray gun are (1) the fluid delivery was set at 450 ml/minutes, (2) the air pressure was set at 3.5 bar and (3) adjusting paint drying time from 0.5 second to 1.5 second by adding slow boiling thinner. As shown in Figure 7 the improvement activities was able to reduce fiber DPU from 10 to 1 DPU in September 2012 with DPU of foreign material also dropped from 100 to 50. The figures must be maintained through monitoring of the process by the personnels responsible. Before improvement, vehicles needed to be re-sprayed due to fibers present. Rework units needs to go through sanding process all

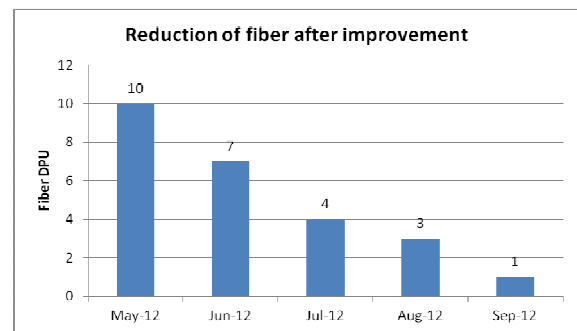
Figure 7: Reduction of fiber after improvement
