# **RESEARCH FINAL REPORT**

**FRGS15-192-0433**

**IDENTIFYING THE MINIMUM INVASIVE ACTIVE FIRE PROTECTION MEASURES FOR  
MALAYSIAN HERITAGE BUILDINGS TOWARDS BETTER PRESERVATION OF THE BUILT  
HERITAGE**

**18 SEPTEMBER 2018**

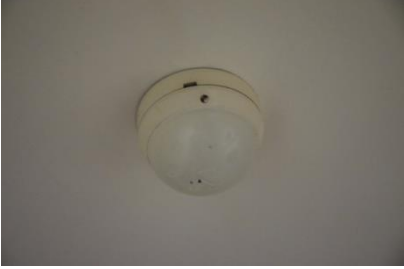
<p>The building mainly uses heat detectors in every area of the building and considered to be effective. However, heat detectors will only activate when the fire has reached flaming combustion. In terms of design, the detector generally blends well with the white ceiling found in most part of the building and the wiring is hidden within the ceiling.</p>

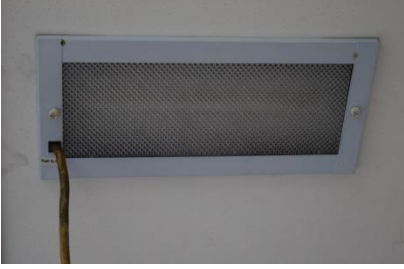
<p>The installation of the emergency light was designed to be as part of the ceiling. The wirings are hidden within the ceiling. However, some of the emergency lights are no longer functioning and require immediate replacement.</p>

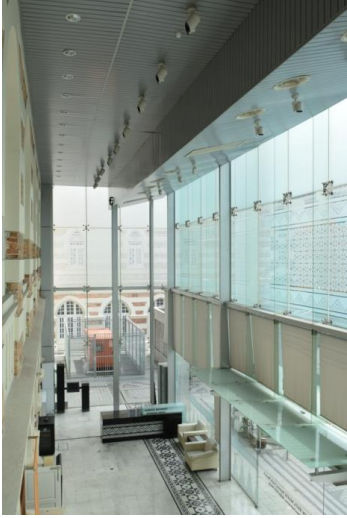
<p>In the glass lobby area, the detectors are installed at the centre of the ceiling in a single row. The white detector blends well with the colour of the grey ceiling. While the number of detectors is more than enough to cover the whole area, the ceiling height is too high for a smoke/heat detector to function properly. The distance between the floor and ceiling is more than 6 metres and it will already be too late by the time the detectors are able to detect the presence of fire.</p>

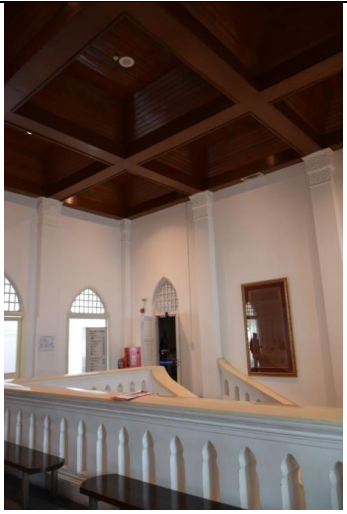
<p>On top of the main staircase, the detectors are installed at the centre of each box on the ceiling. The detectors are white in colour but blends well with the timber ceiling due to its positioning. While the number of detectors is more than enough to cover the whole area, the ceiling height is too high for a smoke/heat detector to function properly. The distance between the floor and ceiling is roughly around 6 metres and it will already be too late by the time the detectors are able to detect the presence of fire.</p>

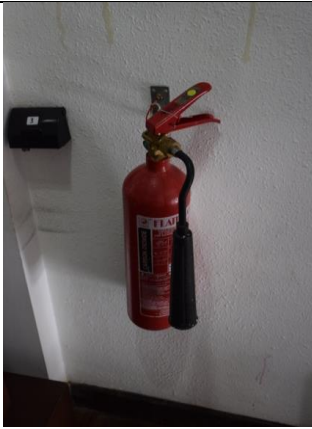
CO<sup>2</sup> fire extinguishers were mostly placed in services room or next to electrical utilities. They are generally more effective in dealing with such particular environment and well hidden within the room.

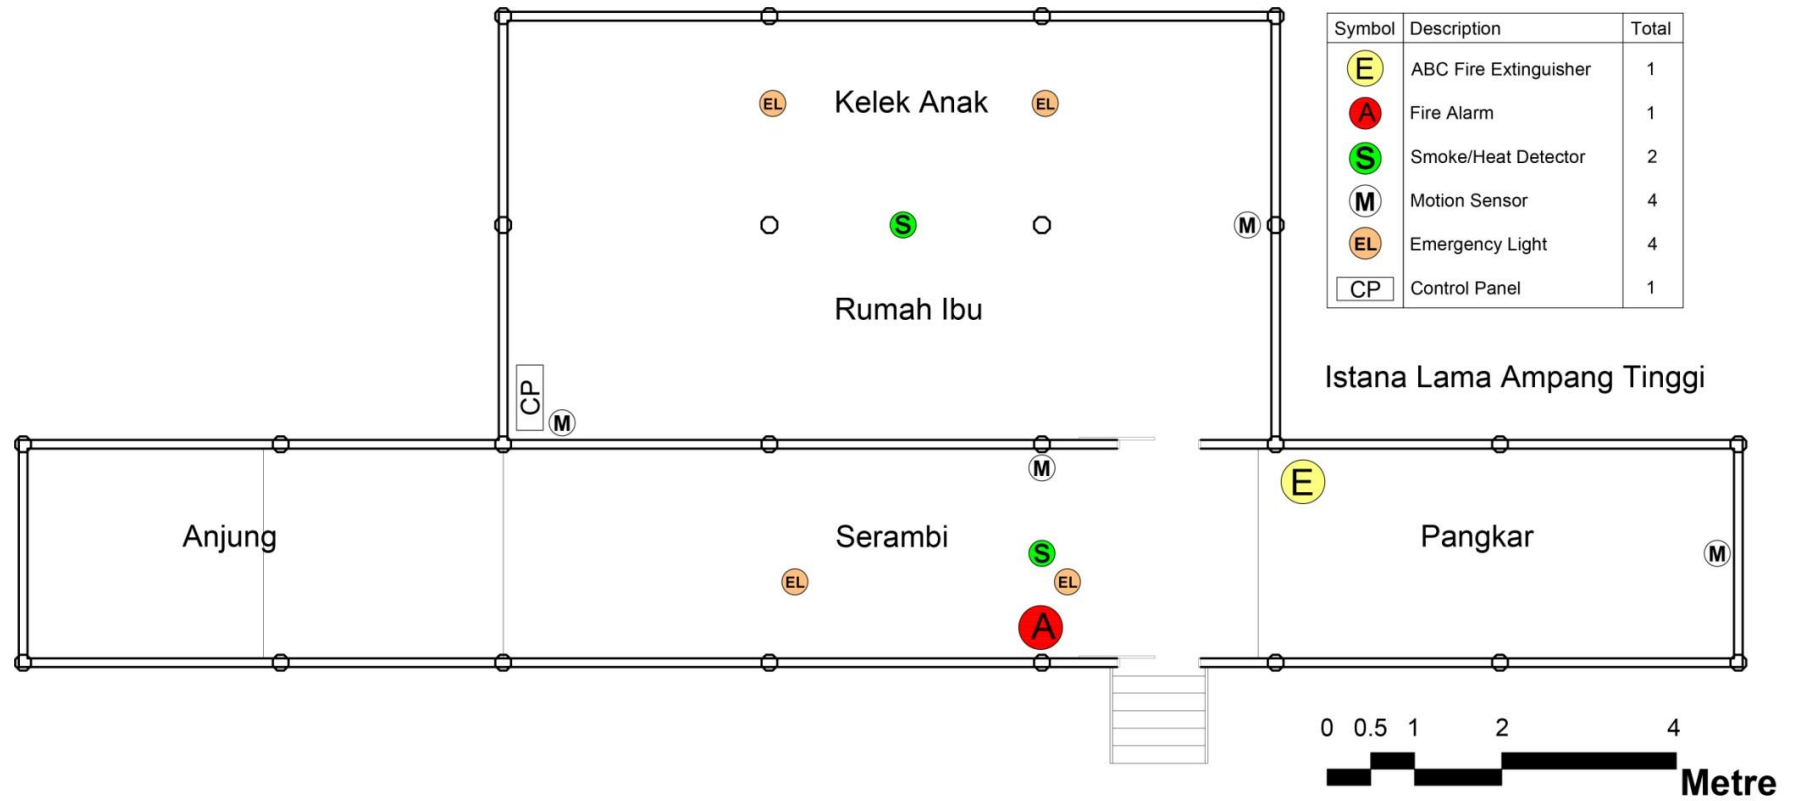
Figure 7: Location of active fire protection measures in Istana Lama Ampang Tinggi, Negeri Sembilan

As for the smoke or heat detector, three of them can be found within the verandah area whereas another three is located inside the living area. The coverage for the living area is adequate but as for the verandah, the current placement of each detector may limit the coverage due to the length of the area. The left end of the verandah may be left exposed since the closest detector is about 10 metres away.

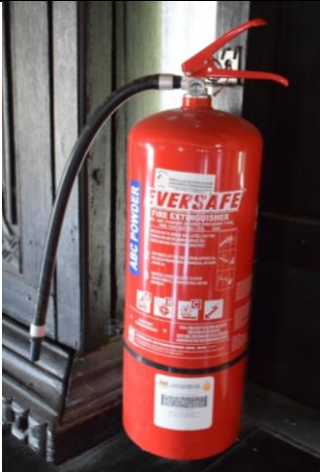
<p>One fire extinguisher is provided inside the building. Due to the size of the building, this may be fairly sufficient to cover both area of the building. The farthest distance from the extinguisher is only roughly 14 metres long.</p>

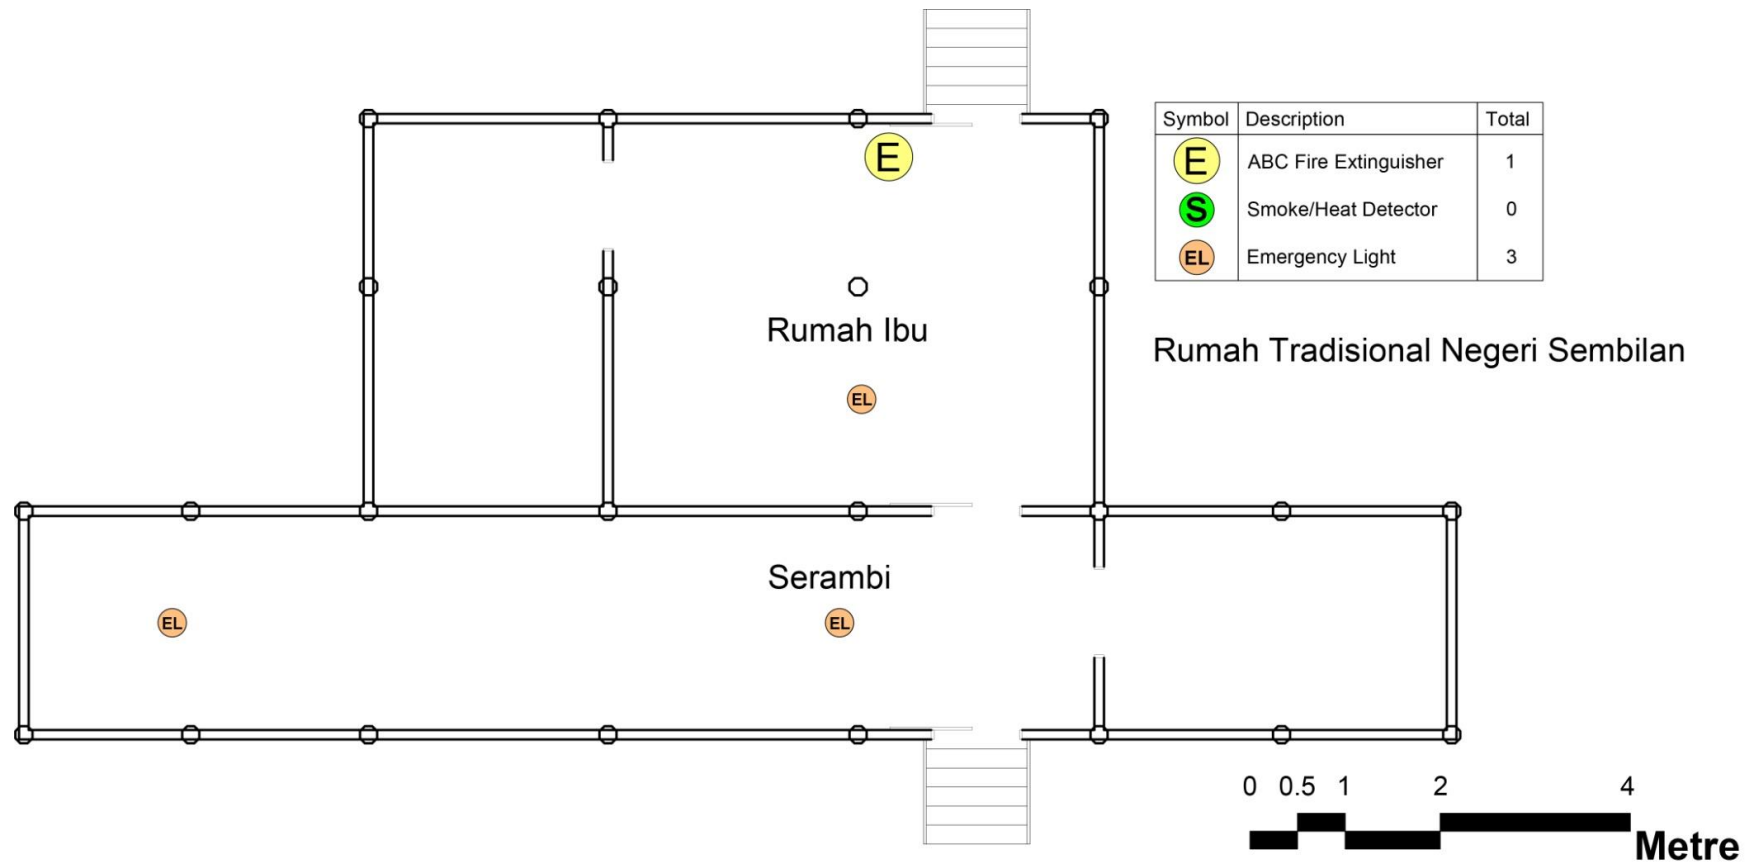
Figure 10: Location of active fire protection measures in Rumah Tradisional Negeri Sembilan

and another one inside the living area. Based on observation, no smoke or heat detector is installed inside the building.

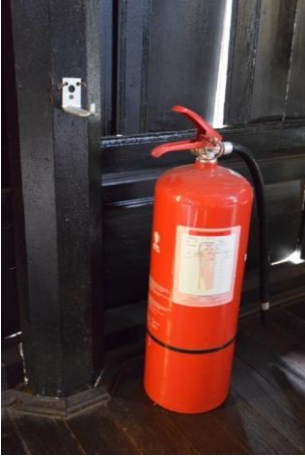
<p>One fire extinguisher is provided inside the building. Due to the size of the building, this may be fairly sufficient to cover each area of the building.</p>

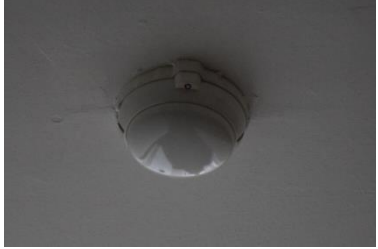
<p>Heat detectors are installed only at the rooftop. Heat detectors are generally not recommended in area which involves the threat of life safety. The wiring for the detectors is hidden within the ceiling and the colour of the detector blends in with the white ceiling.</p>

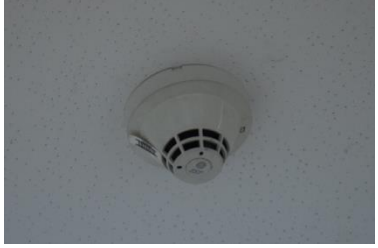
<p>Smoke detectors were installed in most area of the building except the rooftop. Smoke detectors are more efficient at detecting smoke particles during the early stage of fire. The wiring for the detectors is hidden within the ceiling and the colour of the detector blends in with the white ceiling.</p>

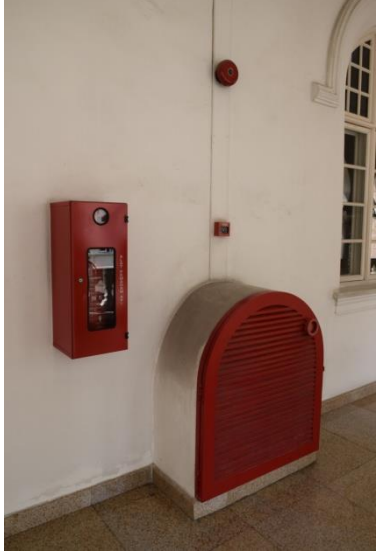
<p>ABC Fire extinguishers and hose reels were installed alongside one another in most area of the building. They are placed inside a storage box and are clearly visible to the occupants of the building. Most of them are situated alongside the corridor of the building. The design of the hose reel storage blends in quite efficiently with the building aesthetic in comparison to fire extinguisher storage.</p>

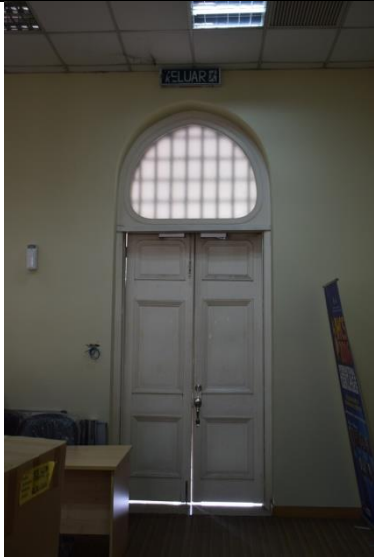
<p>The exit sign is installed above the door but the placement may be too high for the occupants to notice. This is most likely to prevent the sign from disturbing the design of the door. However, exit signs are usually installed directly on top of the door frame and are supposed to be easily spotted during emergency to point out the evacuation direction.</p>

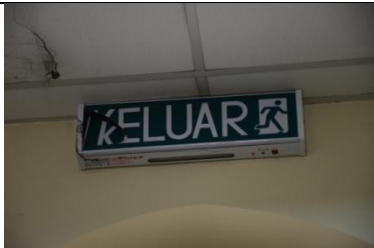
<p>The exit sign throughout the whole building appears to be quite new. However, some of the Exit signs are in terrible condition and may be required to be replaced immediately.</p>

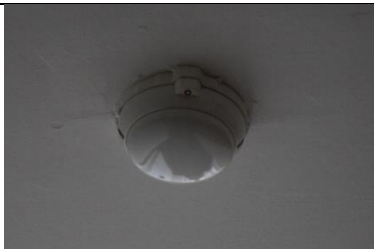
<p>Heat detectors are installed at the walkway corridor and services room. Heat detectors are generally not recommended in area which involves the threat of life safety. The wiring for the detectors is hidden within the ceiling and the colour of the detector blends in with the white ceiling.</p>

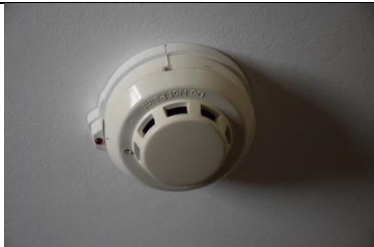
<p>Smoke detectors were installed in most area of the building. Smoke detectors are more efficient at detecting smoke particles during the early stage of fire. The wiring for the detectors is hidden within the ceiling and the colour of the detector blends in with the white ceiling.</p>

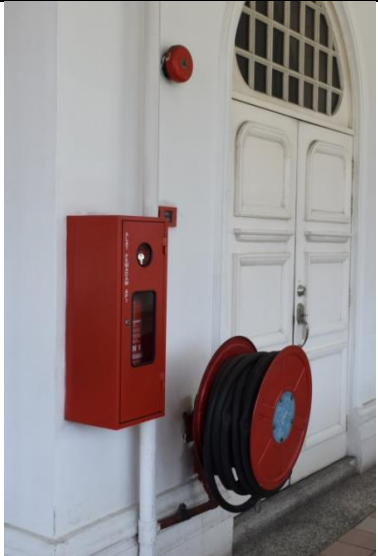
<p>ABC Fire extinguishers and hose reels were installed alongside one another in most area of the building. They are generally placed at each corner of the building and provide enough coverage throughout the whole building. While the fire extinguishers are placed inside a storage box, the hose reels are left exposed. As a result, the untangled hose becomes an eyesore and disturbs the aesthetic of the building.</p>

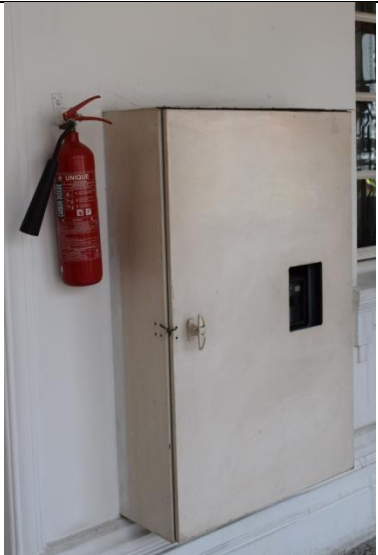
<p>CO<sup>2</sup> fire extinguishers were mostly placed in services room or next to electrical utilities and smaller area such as storage room with minimum occupants. They are generally more effective in dealing with such particular environment and most of them are well hidden within the room.</p>

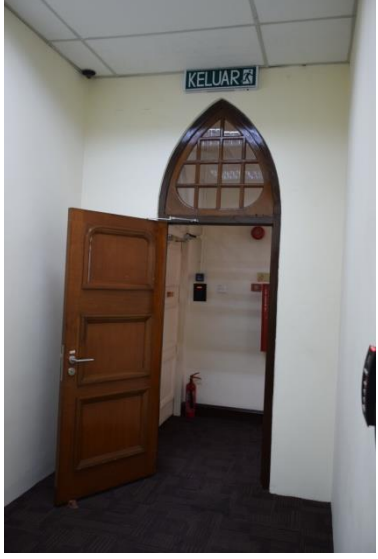
<p>The exit sign is installed above the door but the placement may be too high for the occupants to notice. This is most likely to prevent the sign from disturbing the design of the door. However, exit signs are usually installed directly on top of the door frame and are supposed to be easily spotted during emergency to point out the evacuation direction.</p>

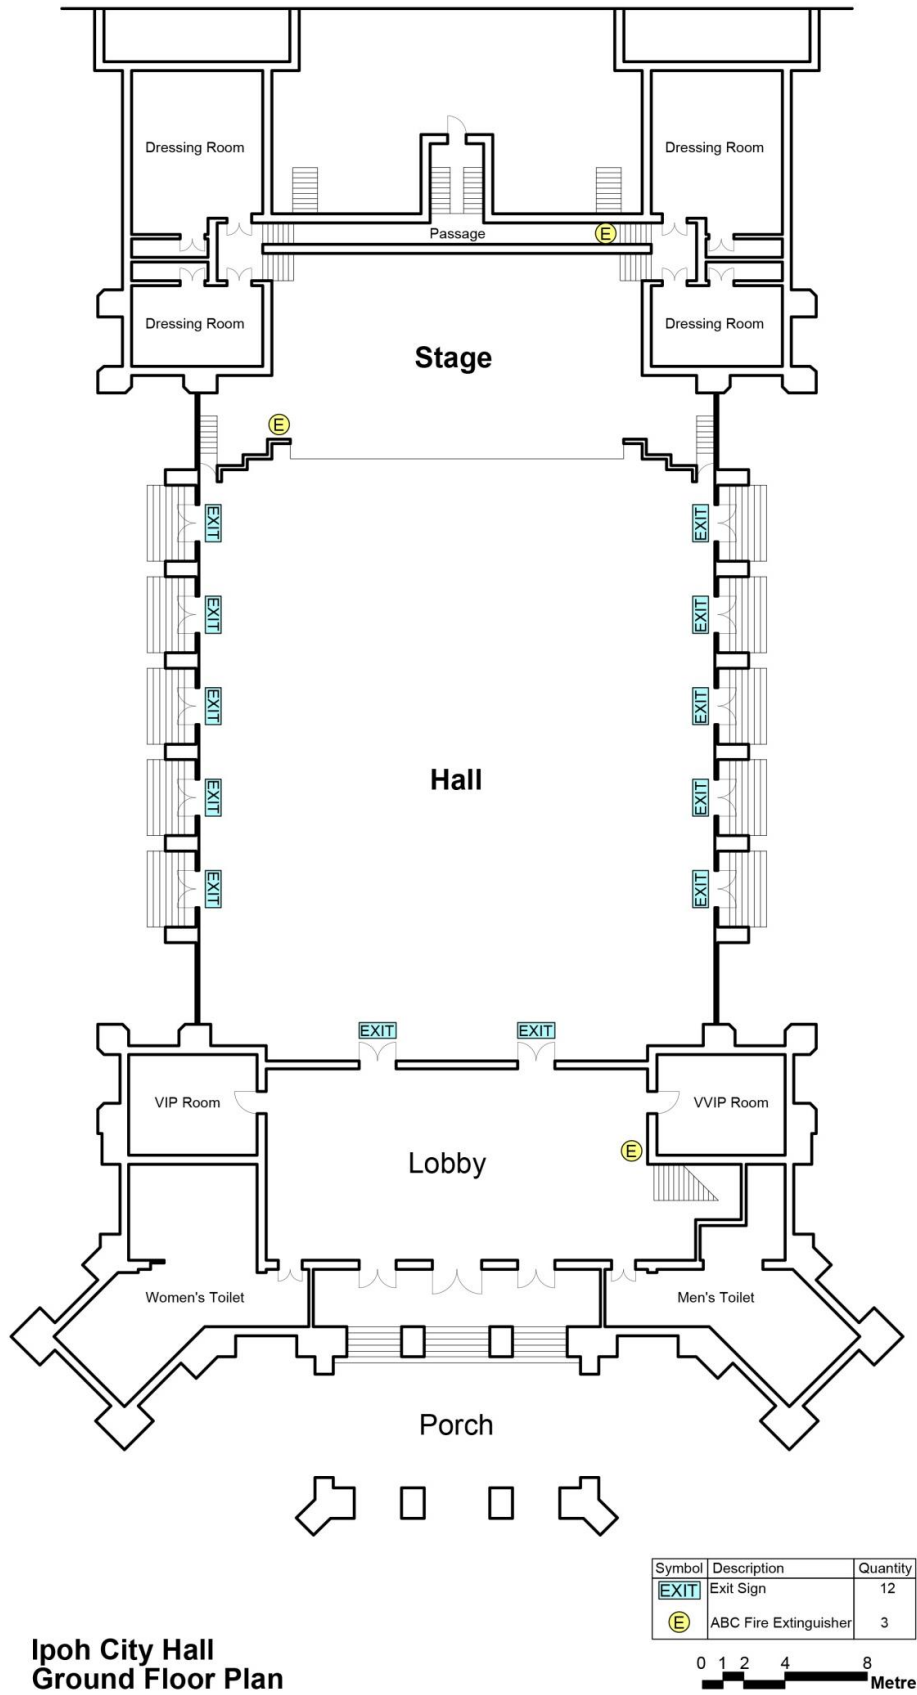
Figure 23: Location of active fire protection measures at Ground Floor Level of Ipoh City Hall

Regardless of its size, the City Hall building seems to be severely lacking in terms of fire protection system. Upon observation, only two fire safety equipments were identified throughout the whole building which consists of exit signs and ABC powder fire extinguishers. The placement of exit signs can only be seen in the main hall area. The signs are installed on top of the doors on each side of the hall. However, despite the building's size, only three fire extinguishers can be found throughout the whole building. One is located in the lobby and the other two are situated hidden at the back of the stage.

Several hooks for holding the fire extinguisher are seen in most part of the building even though no other fire extinguisher can be found.

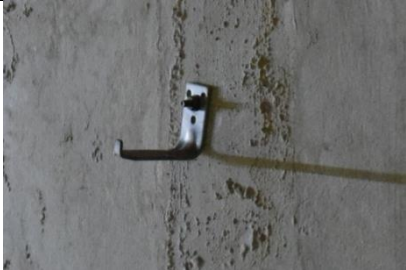
<p>Throughout the whole building, multiple amount of fire extinguisher hook can be found. However, most of them are not attached with any fire extinguishers.</p>
 	<p>The exit signs can only be found in the main hall area and are installed directly on top of each door in that particular area. This may seems appropriate considering it is the mainly used area of the whole building in any sorts of function.</p>
 	<p>Throughout the whole area of the town hall, only one fire hydrant can be found within the building's premise.</p>

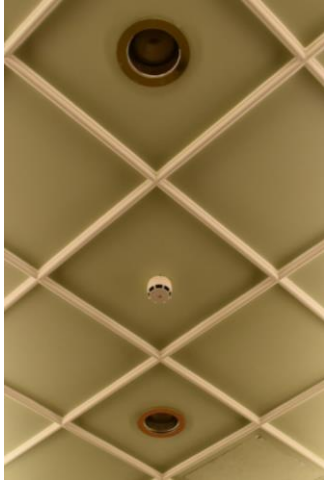
<p>Smoke detectors were installed in most area of the building. The wiring for the detectors is hidden within the ceiling and the arrangement of the detector blends in well with the decor of the ceiling.</p>

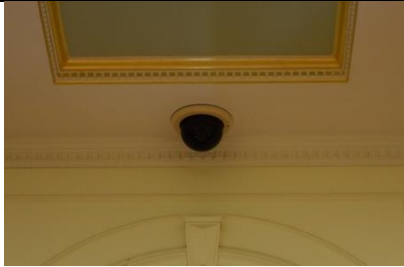
<p>CCTV camera can be found throughout most part of the building. Due to the nature of its design, it tends to stick out and can be obviously seen. The wiring of the system is all hidden within the ceiling. However, during the visit, it was stated that they are no longer functioning due to short circuit.</p>

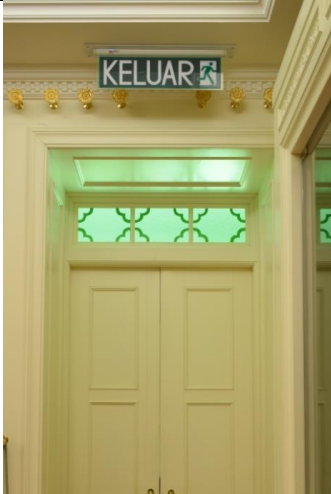
<p>Rather than using the typical box-shaped exit sign, Istana Ulu decided to use the thin acrylic led exit sign. As a result, the sign seems less intrusive to the building aesthetic and can still be easily spotted by the occupants and visitors.</p>

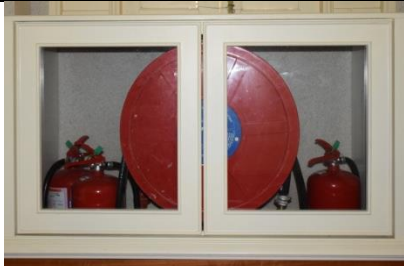
<p>The amount of ABC fire extinguishers and hose reel are slightly limited and can only be found only at several parts of the building. They are often stored inside a timber storage box designed to fit the aesthetic of the building's interior. Some of them are equipped with a timber framed glass door while others are fully covered timber door and can be easily spotted.</p>

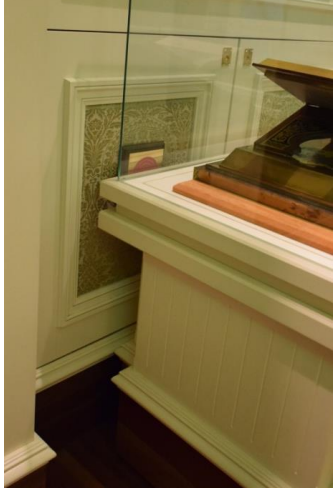
<p>Some of the fire extinguisher and hose reel storages are blocked or hidden by displayed item. Most of the display cases are quite large and heavy. As a result, these equipments cannot be easily access or identified during emergency situation.</p>

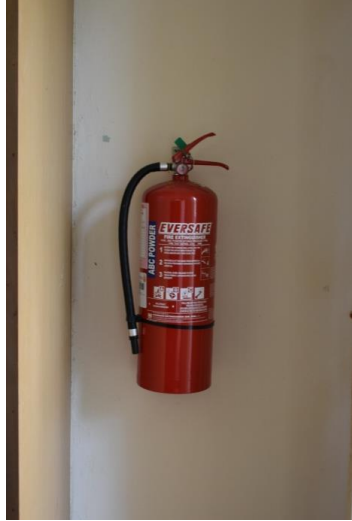
<p>Fire extinguishers hanging on the wall hook can only be seen in a certain room at the back of the building. This is mostly due to the limited space available to install another timber storage box.</p>

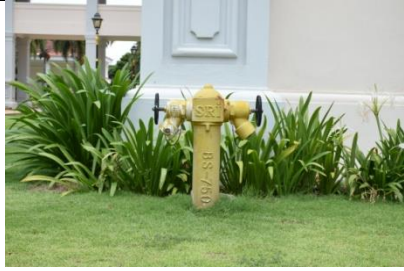
<p>Seven fire hydrants can be found throughout the whole gallery compound. They are easily spotted and accessible in case of emergency.</p>
