Evaluation of Building Performance in Use - A Case Study of the Seager Distillery Development

Evaluation of building performance in use – a case study of the Seager Distillery development

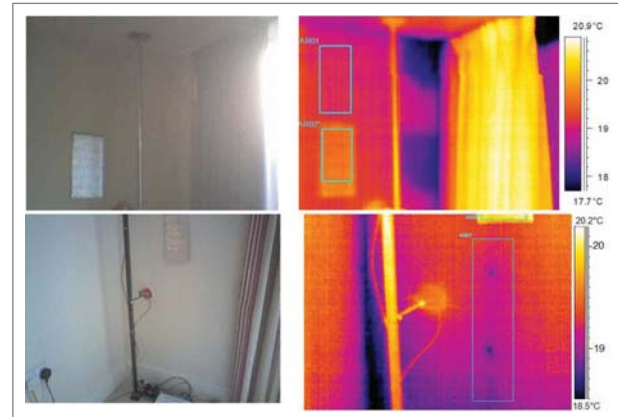
The reported Thermal Index generally suggested actual U-values are in-line with design expectations. Some cold spots were identified, which highlighted potential areas for future improvement. Examples include: (i) colder areas at the top of “boxed-in” sections, perhaps covering section of pipe work, with air leakage problems, (ii) cold bridging from large dabs behind the plaster board, and (iii) some evidence of cold bridging due to penetration of stud-wall fixings. Figure 5 shows images of the latter two examples.

Figure 5: Thermography images showing (top) cold bridging (dark-blue patches) from dabs on plasterboard and (bottom) from penetration of stud-wall fixings.

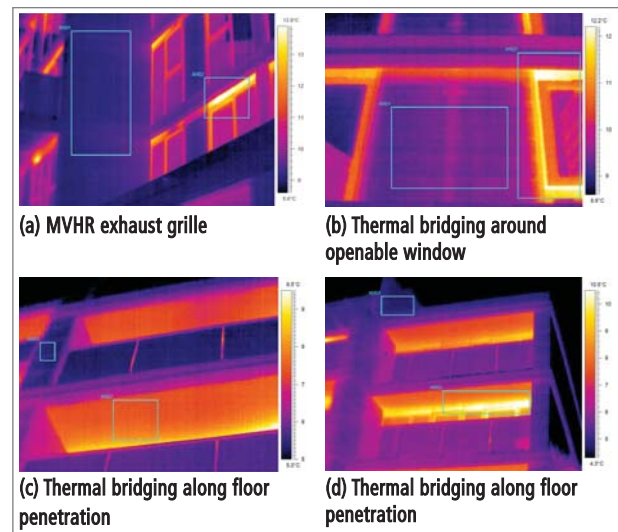
However, salient features remain evident from the survey in the form of higher recorded temperatures related to MVHR outlet vents above windows and thermal bridging around some openable

windows as shown in Figure 6. Also shown are the thermography images of the underside of some of the apartment balcony floor slabs. It can be seen that the surface temperature is higher at the interface with the external wall, indicating potential thermal bridging caused by the penetration of steel structure.

Figure 6: Thermography image showing heat loss (a) on the external façade of Norfolk House associated with the inlet/exhaust vents of the MVHR system, (b) thermal bridging around an openable window and (c & d) thermal bridging on the underside of the apartment balcony floor slab of Norfolk House potentially due to structural steel penetration at the façade..

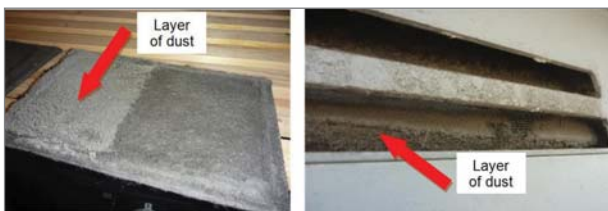
- The filters were dirty, particularly the extract air filters. This is likely due to the units being installed and commissioned during on-going construction work and, thus, capturing dust. The occupants appeared unclear as to what maintenance was necessary and who was responsible. Indeed, this is representative of a wider concern from residents that they had not received instruction on the use of their ventilation and heating systems. Impeded access could have further contributed to lack of filter cleaning/change;
- The external supply grilles were found to be covered with dust. The location of some of the external grilles does not allow easy access for cleaning.

Figure 7: Dirty extract filter (half cleaned for comparison) and clogged up external inlet grille.
