Another Look at the Collapse of Skyline Plaza at Bailey's Crossroads, Virginia

Jeffrey Schellhammer¹; Norbert J. Delatte, F.ASCE²; and Paul A. Bosela, F.ASCE³

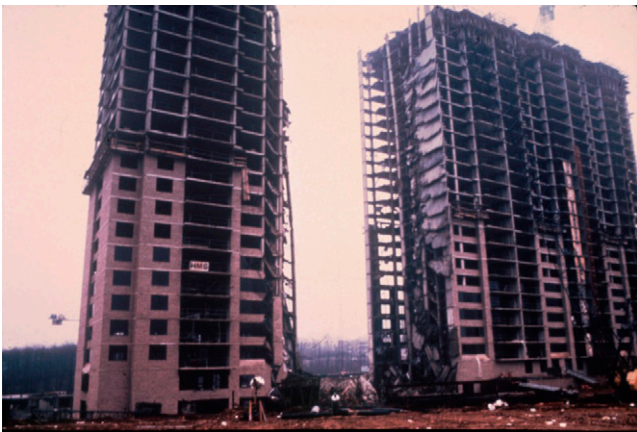
On March 2, 1973, the Skyline Plaza apartment building in Bailey's Crossroads, Virginia collapsed while under construction. The collapse extended vertically through the building, from the 24th floor to the ground, leaving an appearance of the structure as two different high-rise buildings with a gap between them. The collapse tore a 18-m (60-ft) wide gap through the building all the way to the ground. At the time of the collapse, two practically identical RC towers had already been built (Kaminetzky 1991, p. 64). Fig. 1 shows an aerial photograph of the structure taken shortly before the collapse, at about 11 a.m. on the same day. The collapse occurred at about 2:30 p.m. (Leyendecker and Fattal 1977, p. 2). The collapsed structure is shown in Figs. 2–4.

Fig. 2. The collapsed structure (courtesy of NIST)

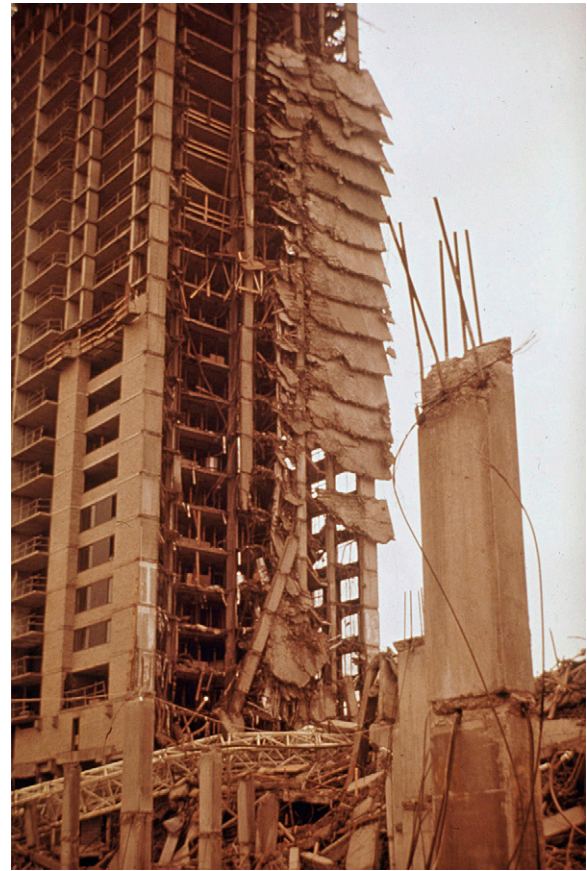
Fig. 4. Close-up view of the collapsed structure (courtesy of NIST)

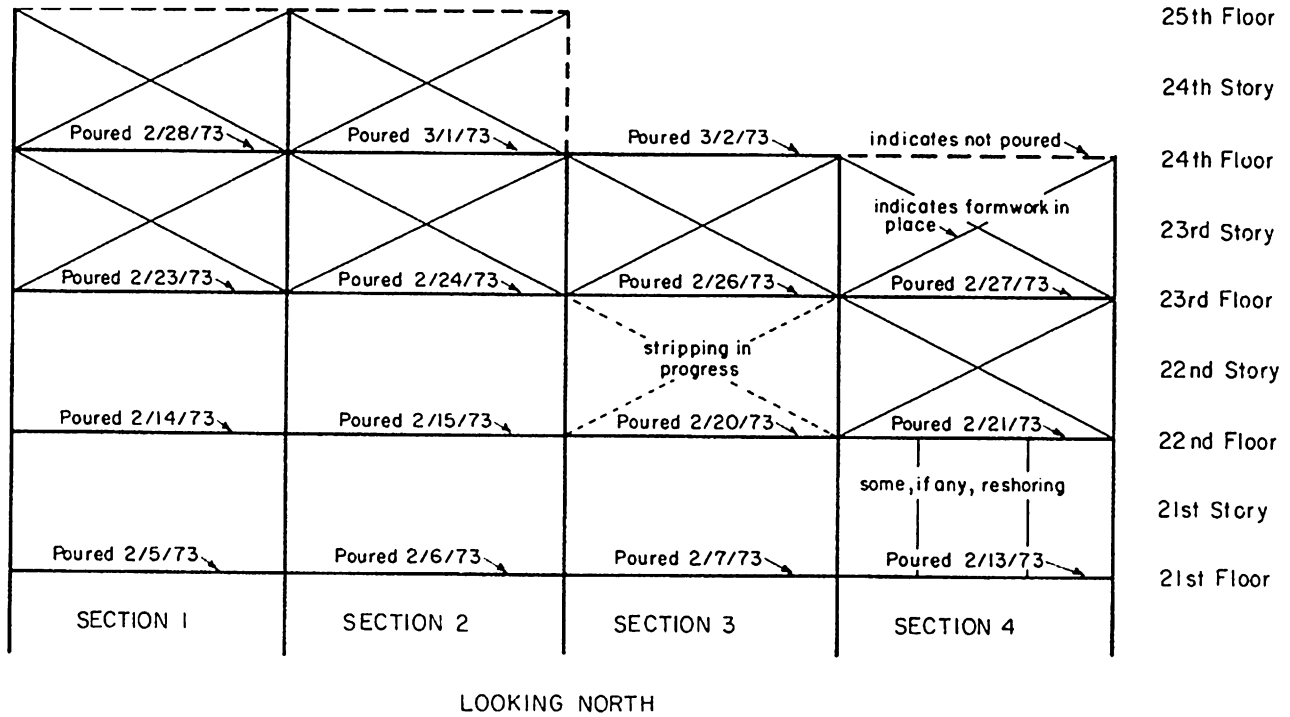
To determine whether premature removal of shoring or failure to install reshoring had caused the collapse, it was necessary to determine what formwork was in place at that time. This proved difficult. Between the March 2nd collapse and the arrival of the NBS team on site, additional reshoring was placed to stabilize some parts of the building. Some of the workers’ statements about the status of the shoring conflicted with each other. One worker who was installing reshores on the 21st floor claimed to have heard formwork and shoring removal on the 22nd floor at about 2 p.m. Careful analysis of photographs taken right after the collapse showed that while full shoring remained on the 23rd and 24th stories, it had nearly all been removed from the 22nd story in sections 1 and 2, but remained in section 4. The condition of the formwork in section 3 could not be observed because nearly all of this section had collapsed. The engineer’s structural drawings required 2 full stories of shoring and 1 story of reshoring while a concrete slab was being cast. The NBS team concluded that the estimated location of forms, shores, and reshores at the time of the collapse was as shown in Fig. 6, with all formwork removed on sections 1–3 of the 22nd floor and little if any reshoring on that floor (Leyendecker and Fattal 1977, pp. 18–31).

Some workers said that all of the shoring was removed on both floors, some said that only some was removed, and others believed that all was still in place at the time of collapse (Leyendecker and Fattal 1977, p. 18). However, the statements of one worker gave the investigators a good idea of the state of the forms at the time of the collapse. Leyendecker and Fattal (1977, p. 31) reported “One workman indicated that, at the time of the incident, he was placing reshores in section 3 of the 21st story and that some reshores were present when he started working. Prior to the incident, all the reshores fell out (except those in the balcony areas). This is consistent with what would be likely to occur if the forms had been removed in the story above.” If the shoring had been removed in the 22nd floor, the 22nd floor slab would have been relieved of its previous loads. With less loading, the deflection would have decreased in the slab, causing the reshores on the 21st floor to fall out.

Fig. 6. Estimated location of forms and reshores at the time of the collapse (Leyendecker and Fattal 1977, p. 30)
