Collapse of 2000 Commonwealth Avenue: Punching Shear Case Study

Suzanne King, S.M.ASCE,¹ and Norbert J. Delatte, M.ASCE²

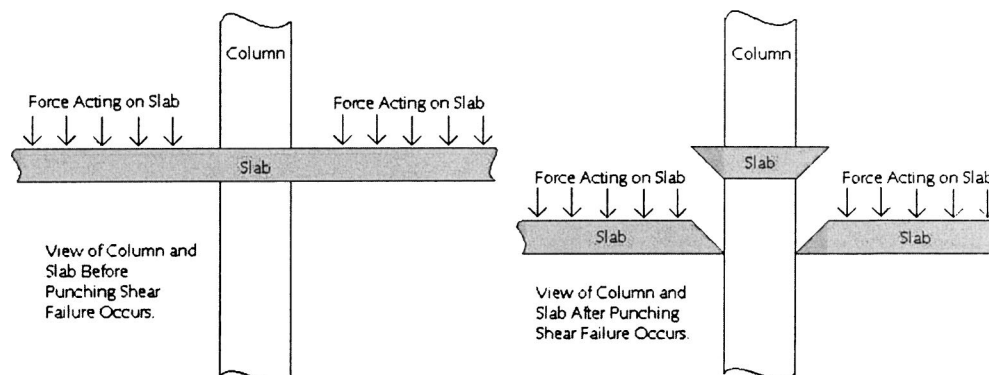
Punching shear is usually the critical failure mechanism for flat slab reinforced concrete structures. This mechanism is illustrated in Fig. 5. With this type of failure, the column and part of the slab punch through the slab as it moves downward.

Fig. 5. Punching shear mechanism
