Restoration of a Sandstone Facade: From the Project to the Monitoring

RESTORATION OF A SANDSTONE FACADE: FROM THE PROJECT TO THE MONITORING

KEY WORDS: sandstone, facade, decay, restoration, monitoring

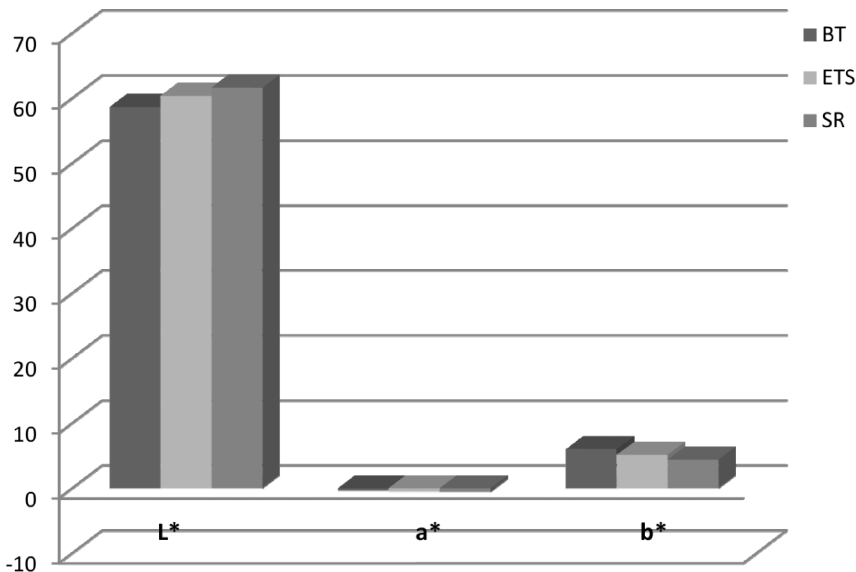
**Figure 7.** L*, a*, b* values of test samples before treatment and after treatment with ethyl silicates and siloxanic resin.

The change of color was tested after the application of the two treatments. In Figure 7, the values of L*, a* and b* are reported, before treatment (BF) and after treatments with ETS and SR. The ΔE values are, respectively, 1.92 after ETS treatment, and 1.46 after the SR treatment.

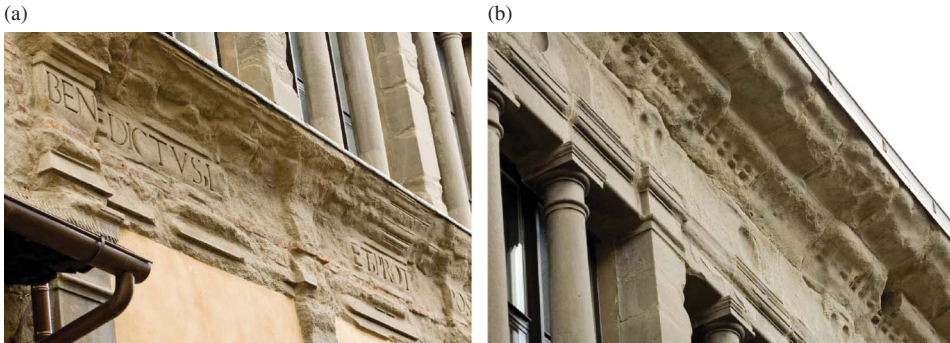
**Figure 8a, b.** Details of the Palace after restoration (color figure available online).

The facade was then preconsolidated and the black crusts removed before treatment with selected commercial products. The preconsolidation was realized with ETS or injections of lime fluid mortar in the partially detached portions. The totally detached fragments were reattached with epoxy resins.

The black crusts were removed using a cellulose paste containing ammonium carbonate. In a second step, a biocide product was applied with a brush to remove the biological agents. The ancient plastering made of cement, iron springs and nails were removed, all the flows and micro-crackings were filled with a mortar composed of lime and stone powder. Some areas were selected to evaluate the conservation treatment on the basis of their accessibility after the removal of scaffolds.

The data on the water absorption of the facade before and after the treatment with the selected commercial products are reported in Table 5. Some details of the restored facade are showed in Figures 8a and 8b. In order to verify the effectiveness of the treatment over the course of time, a monitoring schedule was instituted with the aim of establishing preventive maintenance, and so avoiding emergency interventions. The data collected during the first 14 months of monitoring of the water absorption of the facade, realized in four selected areas are reported in Table 6, while in Figure 9 the changes of L^* , a^* , b^* values are reported. No significant variations of colorimetric parameters are shown (in each case $\Delta E < 3$).

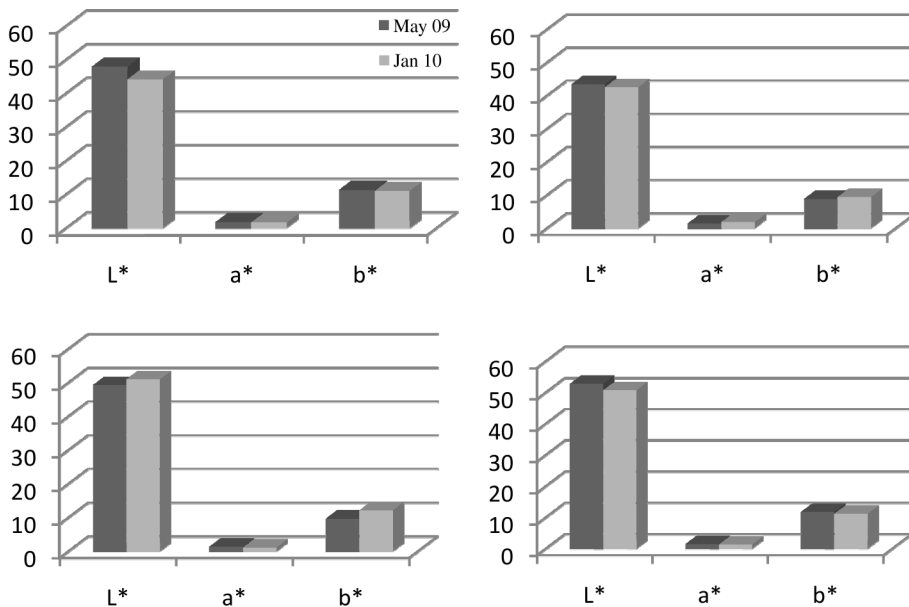
**Figure 9.** L*, a*, b* values in the four areas detected after 6 months (May 2009) and 14 months (January 2010) from the treatment.
